NLR TP 97006

## **Impact damage and failure mechanisms in structure relevant composite specimens**

J.F.M. Wiggeraad and L.C. Ubels

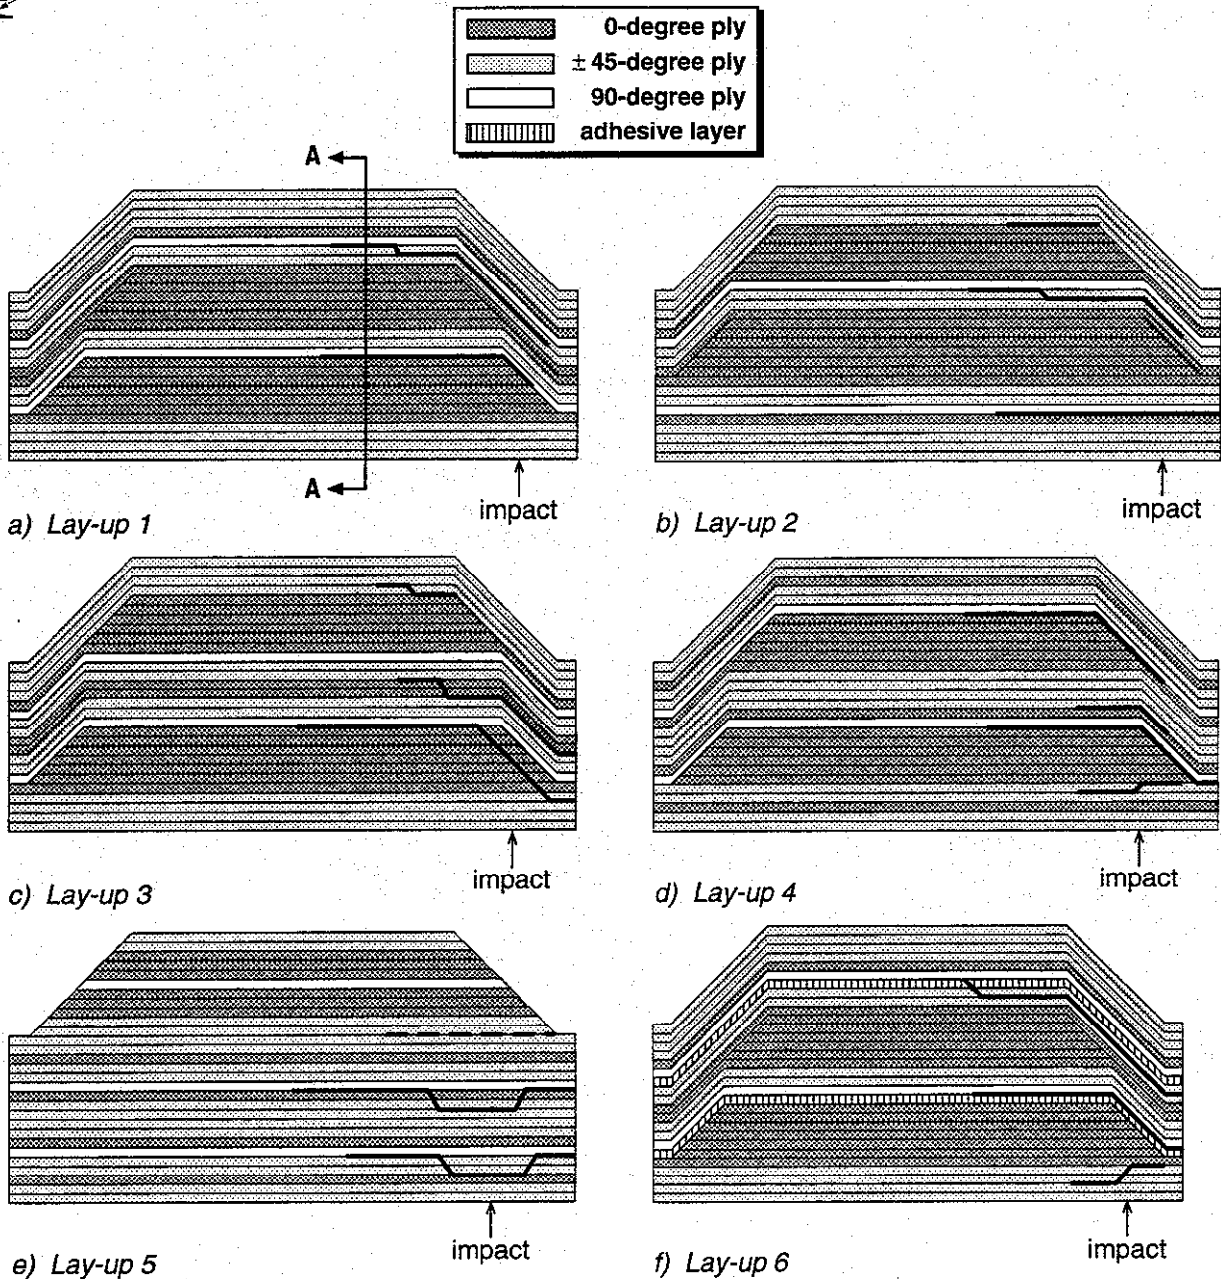
Fig. 4 Lay-ups of six SR-specimens with major impact induced delaminations (cross-section A - A refers to figure 8)

Impact parameters are not discussed, except to indicate that the static and dynamic (35J) responses of the SR specimens were very close, as shown in Fig. 6 for Lay-up 1. This similarity may warrant the approach to design for "static" rather than dynamic impacts, an observation which may simplify optimization procedures in the future, as static responses are easier to compute. The first specimen of each lay-up was dissected, and the major delaminations were made visible with uv-light, illuminating a penetrating fluid (Fig. 7). The cross sections shown are located at a distance of approximately 20 mm from the impact site to eliminate the smaller delaminations. The location of the major delaminations relative to the stacking sequence are indicated in Fig. 4 for all six lay-ups.

In the following discussion the damage is described with reference to the impact direction: the front is the flat, impacted side of the laminate. Most lay-ups contained two 0-degree ply stacks and all lay-ups contained two 90-degree skin plies. The major impact induced delaminations were expected to occur behind the 0-degree ply stacks and along the 90-degree plies when these were nearby. Lay-up 1 shows two major delaminations behind the two 0-degree ply stacks, and along or close to the 90-degree plies which are located behind these ply stacks, as expected. Lay-up 2 shows three major delaminations: two behind the 0-degree ply stacks, very deep inside the laminate, but also one in front of the first ply stack, very close to the free surface. This undesirable delamination is caused by the presence of a 0/90 degree ply interface in front of the first ply stack. Lay-up 3 also shows two major delaminations behind the 0-degree ply stacks. However, another large delamination is found in the wide space between the two thick 0-degree ply stacks, behind a thinner stack of two 0-degree skin plies that pass through this space. Lay-up 4 shows two large delaminations behind the two doubler ply stacks, as well as two smaller delaminations in front of each doubler ply stack. The two continuous 0-degree skin plies passing in front of the two doubler ply stacks are apparently responsible for these smaller delaminations. Lay-up 5 has a discrete doubler ply stack located on top of an uninterrupted flat skin. The damage, very different in character compared to the damage of the other lay-ups, resembles damage in a quasi-isotropic flat laminate, where the many ply angle changes (stiffness jumps) result in a larger number of smaller delaminations. The widest ones are located along the two 90-degree plies. Lay-up 6 is identical with Lay-up 1, except for two bond

films added immediately in front of the two 90-degree plies. Just as for Lay-up 1, the major delaminations are located behind the doubler ply stacks. The bond layers apparently had no benevolent effect on the size of the impact damage.

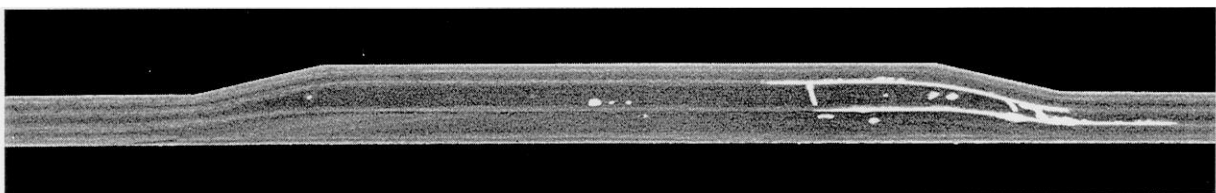
Fig. 7 Major delaminations in SR specimens

Ranking the six lay-ups for expected "damage tolerance", based on the location and size of the major impact induced delaminations, and in correspondence with the postulated failure mechanism of buckling sublaminates, the following order (from best to worst) was tentatively established: Lay-ups 1, 6, 3, 2, 4 and 5. Apparently, to "place" delaminations deep inside a laminate, and to avoid the formation of additional undesirable delaminations at other locations, the number of ply angle changes should be limited. This can best be achieved by stacking the 0-degree doubler stacks adjacent to the 0-degree plies of the skin, by positioning the 90-degree plies immediately behind the 0-degree ply stacks where they will certainly provoke the formation of the major delaminations, and by surrounding these "planks" with uninterrupted  $\pm 45$  ply stacks.

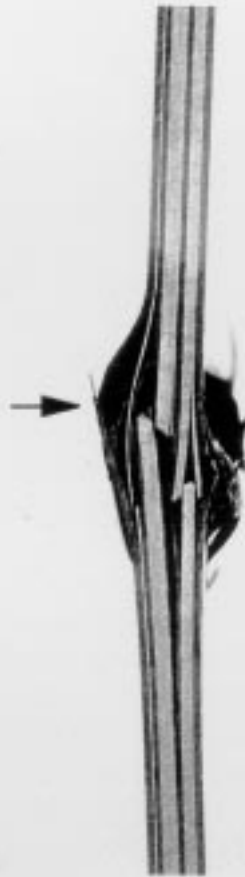
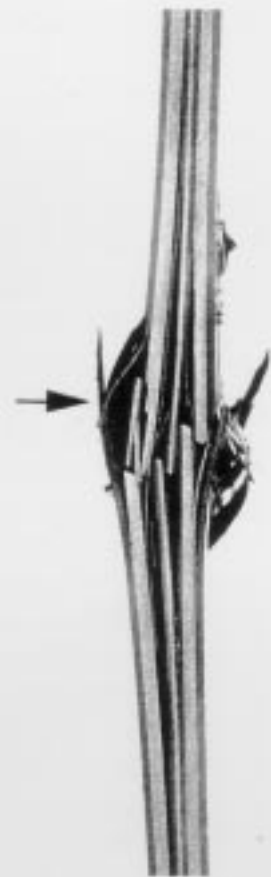
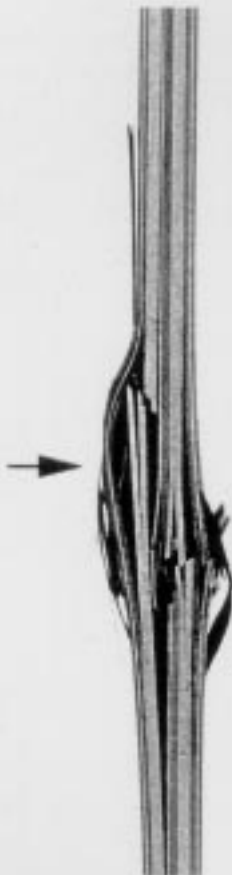
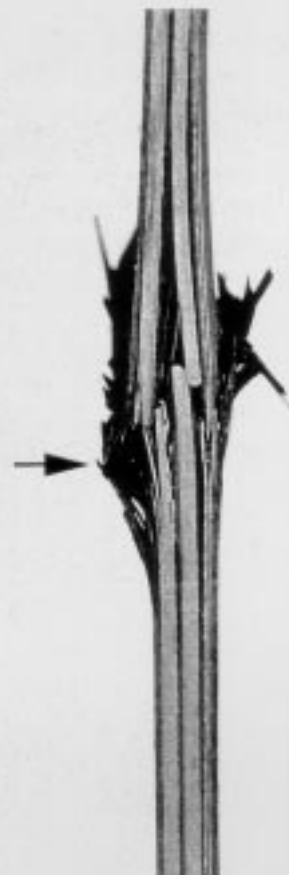
Fig. 8 Post-mortem cross-sections of SR specimens "3", as indicated in figure 4a (A-A)

However, to validate the postulated failure mechanism, of major delaminations growing and sublaminate buckling, post-mortem cross sections (as indicated by A-A in Fig. 4a) were made of specimens 3 of each lay-up, all of which had failed in the same mode: buckling away from the support (opposite to the impact direction). Photographs of these sections are shown in Fig. 8 of the skin/doubler zone, in which the 0-degree plies are visible as the lighter layers. The failure loads of these specimens were 259/266J for Lay-ups 3 and 6, 229/230 J for Lay-ups 1 and 2, and 219/222 J for Lay-ups 4 and 5. Comparing this order of "damage tolerance" to the order concluded above on the basis of the impact induced delaminations, there is not much difference: Lay-up 3 was better than expected and changed positions with Lay-up 1, most likely because it is an almost symmetric laminate and remained straight up to higher loads. Lay-up 6, thought to be equivalent to Lay-up 1 because it has the same stacking sequence, while the added bond layers had not limited the size of the damage, was actually better than Lay-up 1. The superior residual strength of Lay-up 6 may be caused by a higher resistance against delamination spread or by the improved stability due to the added thickness of the bond layers. Based on the post-mortem results it is concluded that the postulated failure mechanism is correct in the sense that the major impact induced delaminations located behind the 0-degree doubler plies are the delaminations that grow, driven by the buckling or bending of these ply stacks. However, the differences between the failure loads of the different lay-ups are smaller than expected, indicating that buckling of the delaminated sublaminates is not the only acting failure mechanism. From the photographs in Fig. 8 it is clear that ultimate failure occurs by transverse shear of the unsupported 0-degree ply stacks. This failure mechanism does not seem to depend much on the location of the 0-degree ply stacks, but rather on the amount of transverse shear deformation that occurred. Increasing the global stability of the laminate, by maintaining symmetry even in the doubler area (Lay-up 3) or by increasing the laminate thickness with bond layers (Lay-up 6) apparently resulted in a higher damage tolerance. The global stability of an impacted laminate is also increased by the presence of a stiffener. In fact, stiffened panels, made according to the same design as shown in Fig. 2, and tested in compression with similar impact damage [3], failed at much higher strains of 0.0062 and 0.0070 than the 0.0050-0.0055 observed for the damaged SR specimens. The failure modes of the panels were not even related to these damages, which illustrates the effect of the support of stiffeners in particular, and the damage tolerance of Boeing's design concept in general.
