NLR-TP-2003-375

## Failure of backstay rod connectors on a luxury yacht

R.J.H. Wanhill

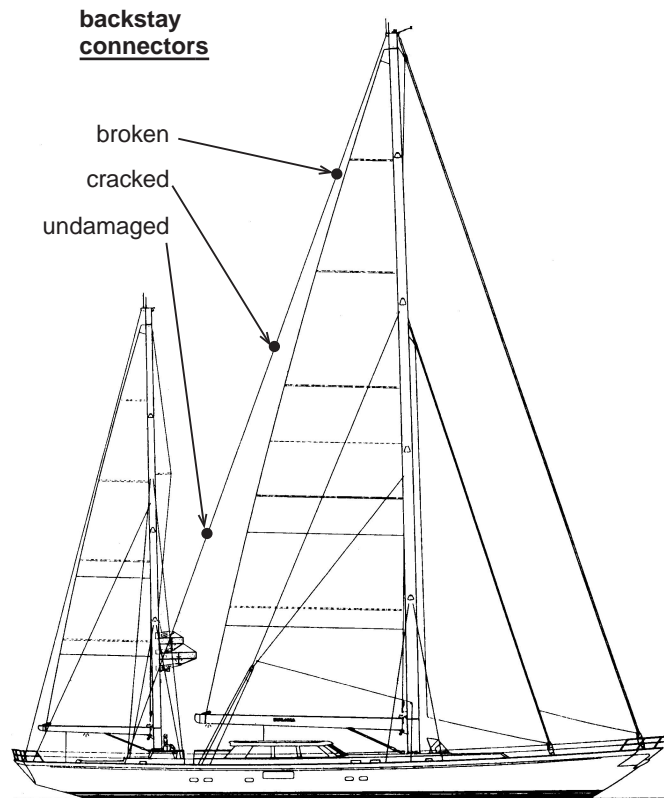
On 6 July 2002 a backstay rod connector from a luxury yacht fractured while the vessel was docked. Half of the connector was recovered from the quay. The fracture caused the backstay assembly to come down on the deck. Subsequent examination revealed a large crack in a second connector. Figure 1 shows the connector locations schematically, and gives an impression of the yacht's size. The backstay collapse could have had serious consequences: the assembly consisted of three steel connectors weighing between 3 and 5 kg, and five steel rods 1 inch (25.4 mm) in diameter and several metres long.

Fig. 1 Schematic of the backstay failure: mainmast is 49 m above waterline

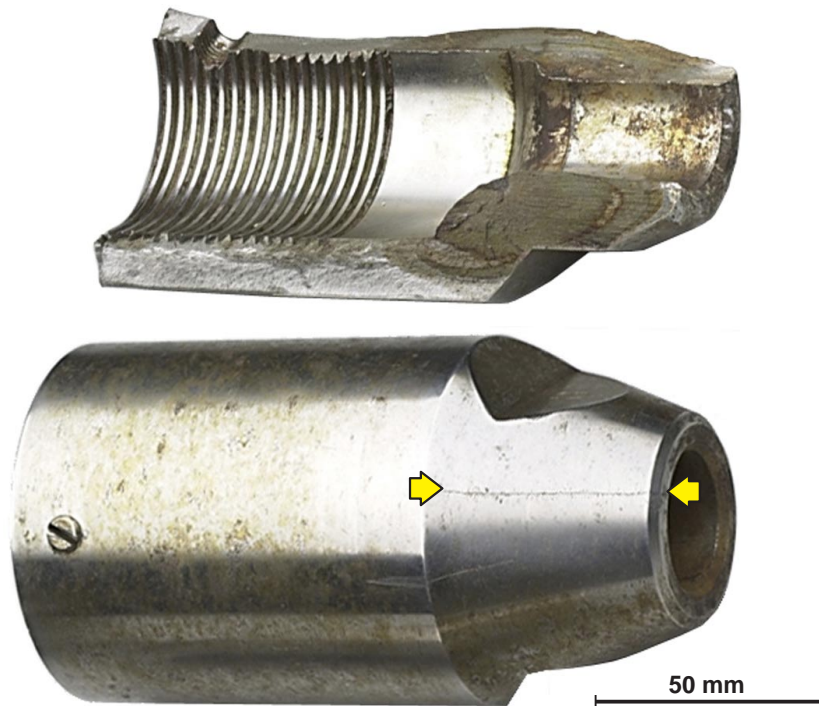
Figure 2 shows the fractured and cracked connectors after superficial cleaning. The fracture surfaces of the broken connector were initially black, then greenish-brown with so-called "beach markings", and finally light grey, which represented overload fracture. The cracked connector showed external surface corrosion pits, which were also present on the fractured connector. All these features will be discussed.

Fig. 2 Superficially cleaned failed connectors, with male end fitting and backstay rods removed from the cracked connector: arrows indicate the large crack

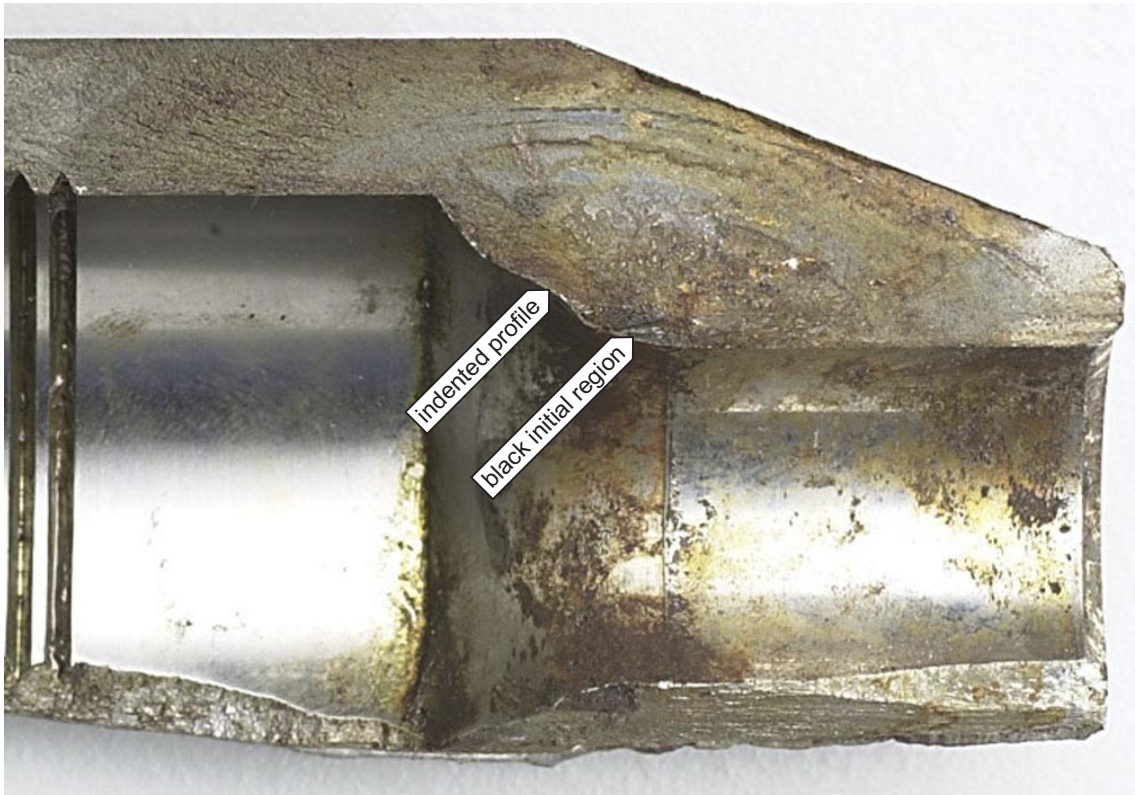
**a** fracture surface #1

Figure 3 shows the fracture surfaces and internal surface condition of connector 1. Significant features are:

- Fracture surface “beach markings”, including some delineating light grey bands between greenish-brown areas, see figure 3b. The beach markings radiate from black initial regions that are just beyond the smaller cylindrical bore.
- The internal shoulder between the cylindrical bores shows relatively severe corrosion and rust-staining.
- Figure 3a shows a local indent of the internal shoulder. The indent was later determined to be post-fracture secondary damage.

Fig. 3 Macrofractographs for connector 1

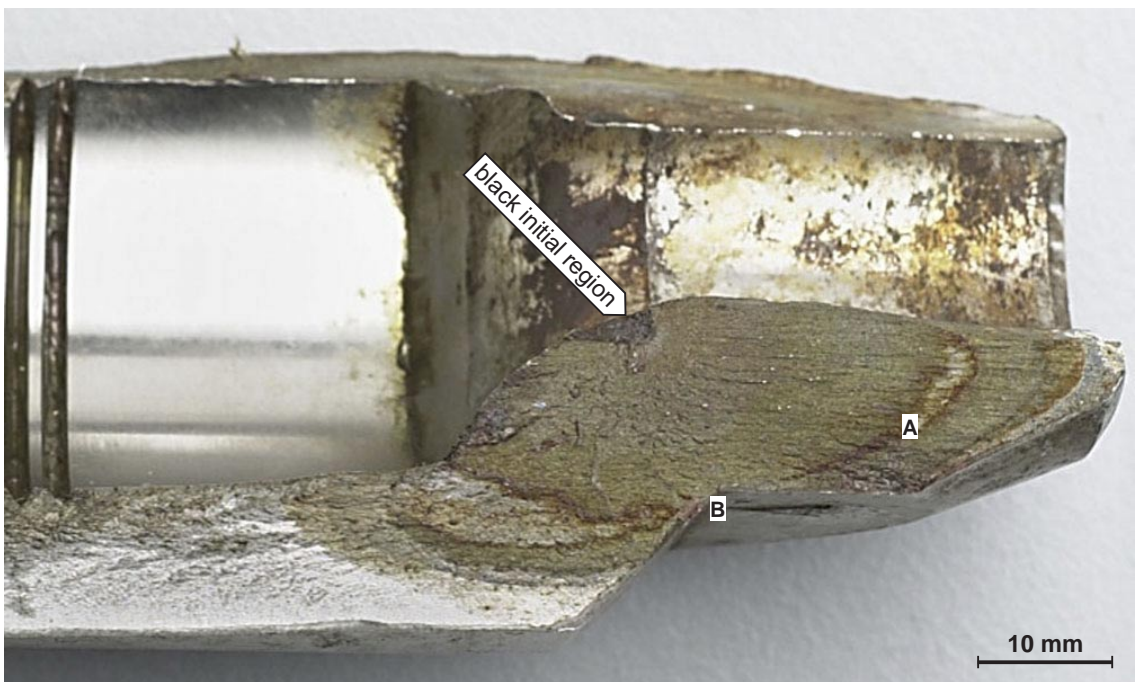
**b** fracture surface #2

Secondary, but significant, aspects of the fracture process are the light grey bands of microvoid coalescence between the greenish-brown areas of stress corrosion cracking, most clearly seen in figure 3b. The bands of microvoid coalescence are the result of “tensile crack jumping”,<sup>[3]</sup> which is a transient instability that is often caused by a peak load. One might think that since the tensile crack jumping was intermittent, then the peak load would have to be transient, otherwise the connector would have fractured. However, this is not necessarily so. For example, a peak load representing an increase in backstay load from 75 kN to 107 kN could be responsible for a tensile crack jump, even though the peak load would be sustained for several hours during even a short sailing trip.

the wall thickness the stress state approaches plane strain. In plane strain the fracture toughness, and hence resistance to tensile crack jumping, is lower than in plane stress. Consequently, as figure 3b shows (more clearly for the band labelled “A”), tensile crack jumping has its greatest extent in the middle of the wall thickness, while it is negligible at the internal and external surfaces. In other words, completely unstable fracture is prevented, at least for the time being, by the local variation in stress state along the crack front. Final instability occurs when the crack has become sufficiently large that a steady load or peak load results in the overall fracture toughness being exceeded.

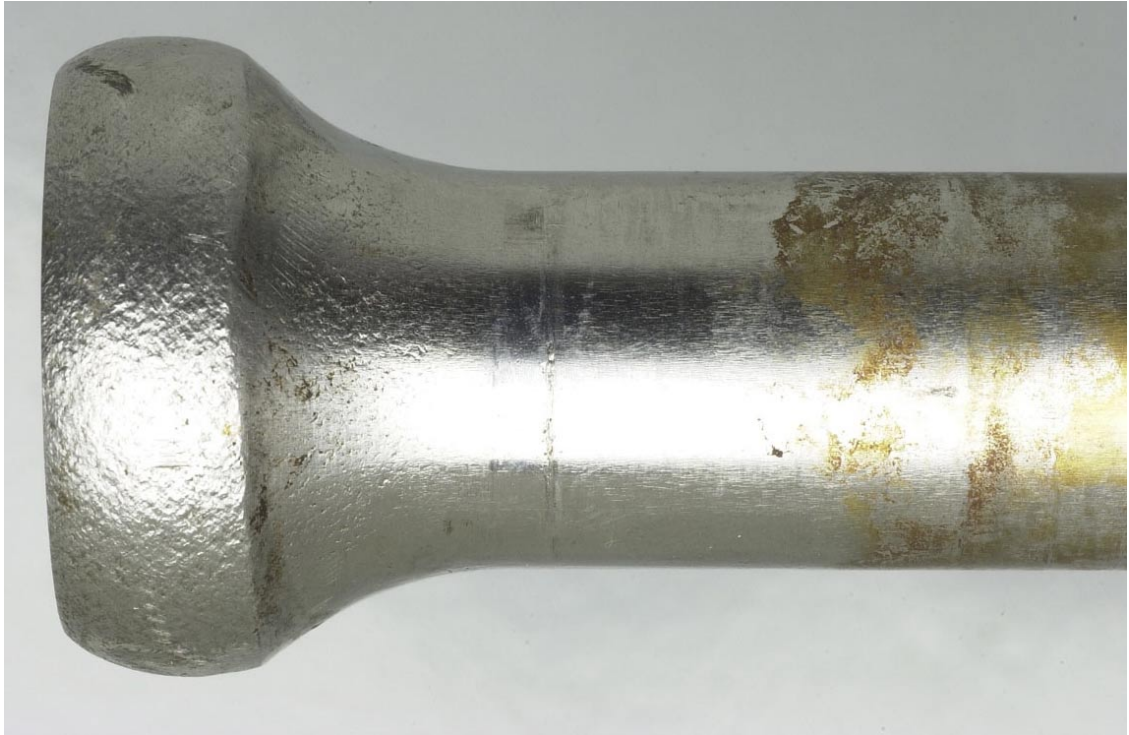
a connector 1 rod end

Figure 4 shows views of the rod ends that had been seated in the connectors. The rod ends were asymmetrical and non-uniform in surface finish, but they were free of corrosion: the staining in figure 4 originated from connector corrosion. Profile and dimension measurements at the NLR showed the out-of-roundness to be mostly within 0.5 mm, though the maximum values were nearly 1.2 mm. These eccentricities were within the manufacturing limits. In other words, the rod ends were not required to be precision-made.

Fig. 4 Two similar views of the rod ends that were seated in the connectors

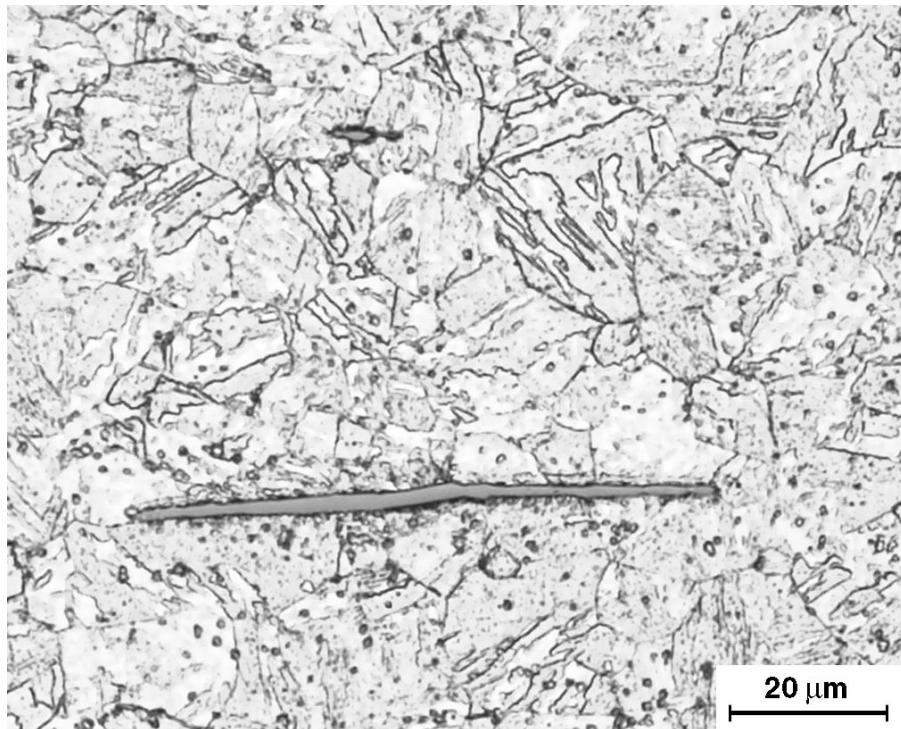
Figure 5 gives an example of the microstructure of connector 1, in the same macroscopic orientation as the fracture surfaces, i.e. parallel to the longitudinal axis of the connector. The microstructure is as expected for 17-4 PH steel heat-treated after working. The overall direction of working (longitudinal) is shown by elongated manganese sulphide (MnS) inclusions.

Fig. 5 Example microstructure of connector 1: Fry's etch reagent.  
Note the elongated MnS inclusions

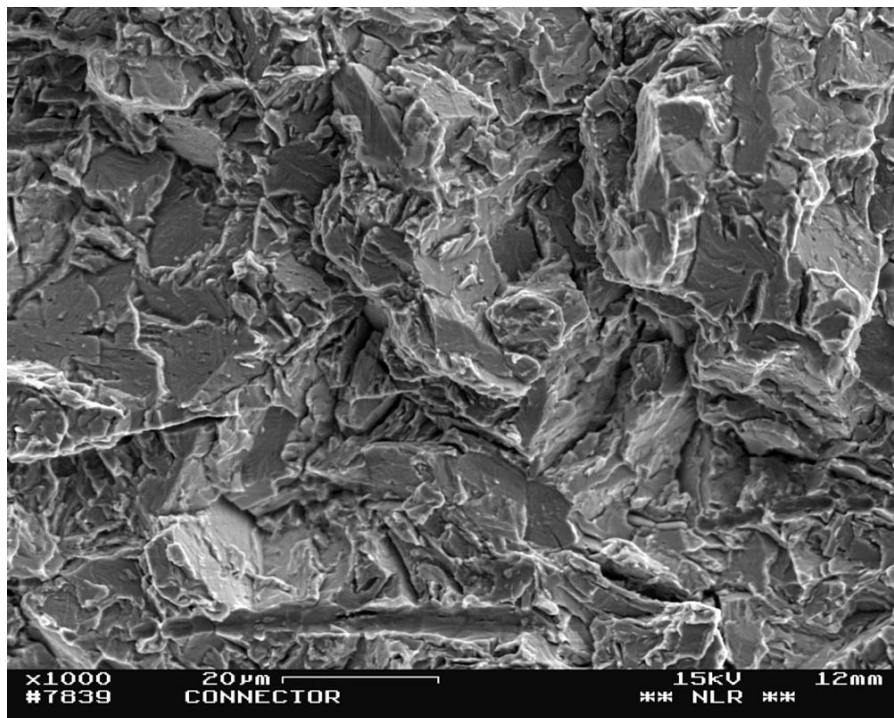
- (1) Severe local corrosion in the black initial regions.
- (2) Faceted and angular cracking, appearing mainly transgranular, in the greenish-brown areas, for example figure 6.
- (3) Microvoid coalescence in the light grey areas, including the light grey bands between the greenish-brown areas on fracture surface #2, see figure 3. An example from one of these bands is shown in figure 7.

Fig. 6 Example of faceted and angular cracking in the greenish-brown areas of the fracture surfaces of connector 1. The elongated feature near the bottom of the fractograph represents separation between the steel matrix and an MnS inclusion

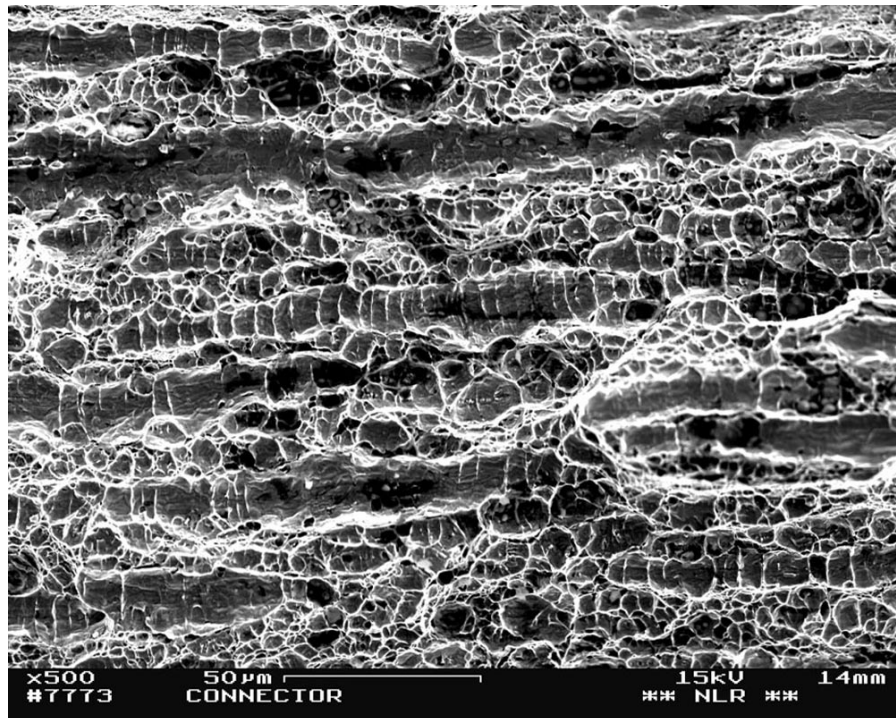
Fig. 7 Example of microvoid coalescence. This is in the light grey area labelled "A" in figure 3b. The elongated features represent separations between the steel matrix and MnS inclusions

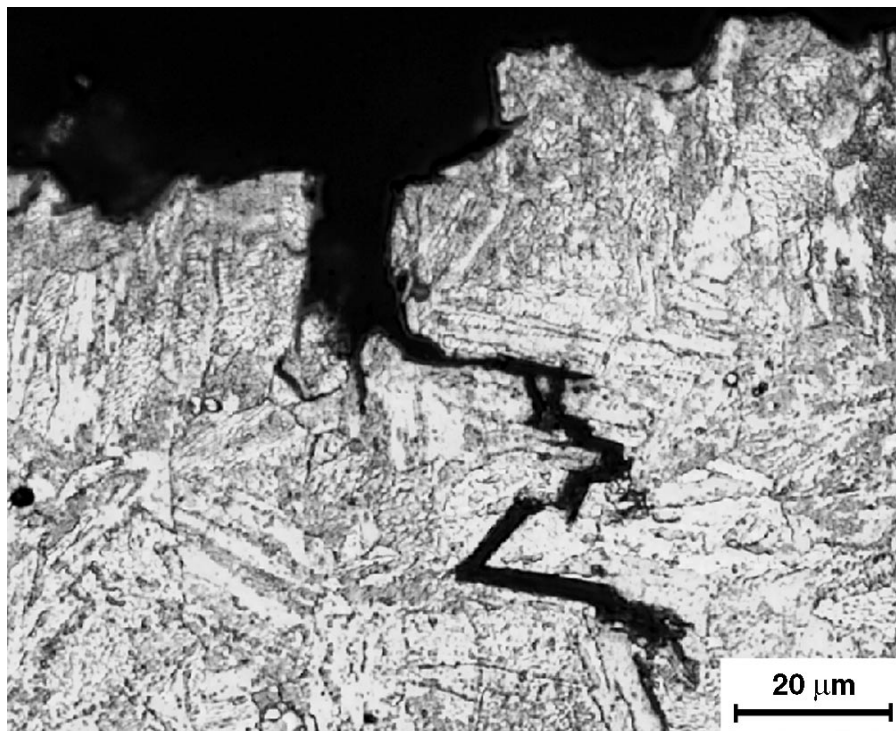
Fracture surface #2 was sectioned from the black initial region to point “B”, see figure 3. A representative metallograph is given in figure 8. This shows secondary, branched cracks below the fracture surface. The cracks ran both transgranularly, including along martensite laths, and intergranularly.

Fig. 8 Example metallograph of secondary cracking below fracture surface #2 and along the line from the black initial region to point "B", see figure 3b

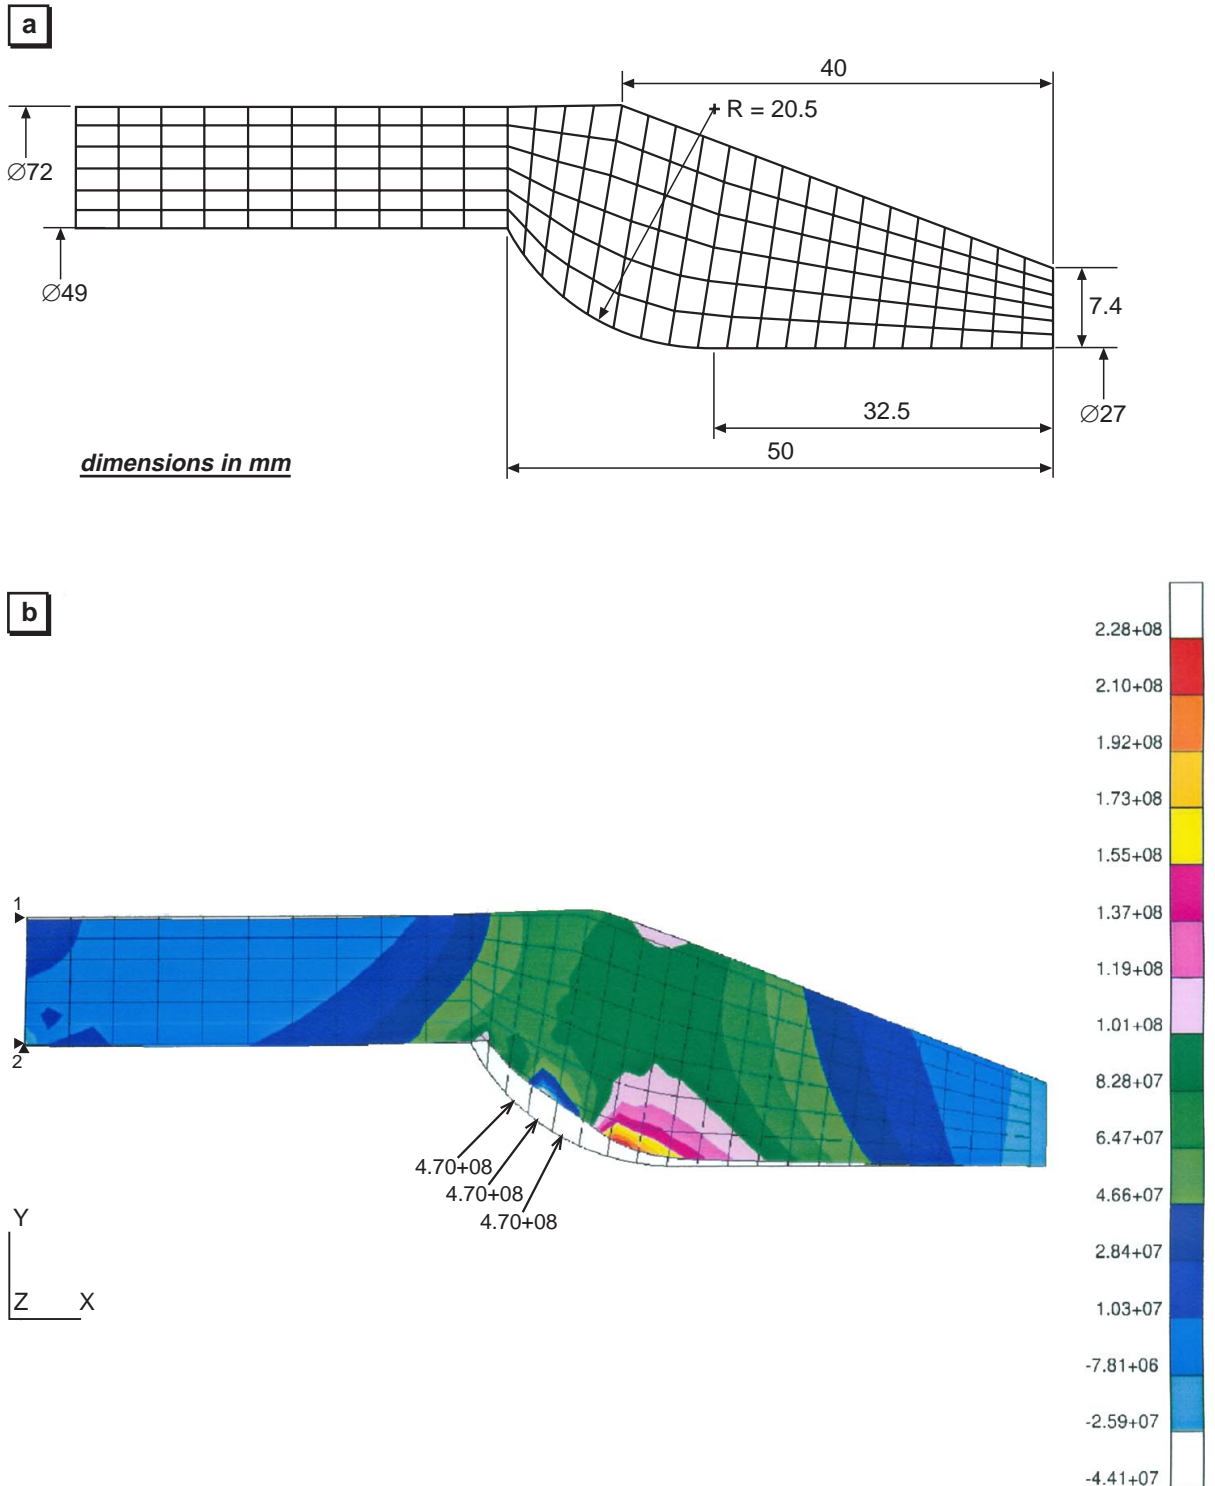
Figure 9a shows the shape and dimensions for the finite element mesh, which was a two-dimensional axisymmetric model using 8 node quadrilateral elements. The model was fixed in the longitudinal and radial directions, as indicated by the arrowheads at 1 and 2 in figure 9b. This figure also gives the surface pressure, 470 MPa, applied to three element faces, and the analysis results. The surface pressure was derived by assuming that the seated rod end was loaded to 107 kN and made contact with the connector over an annular area of width 2.7 mm. The material properties required for the stress analysis were the Young's modulus (E) and Poisson's ratio ( $\nu$ ) of 17-4 PH steel: the values selected were  $E = 197 \text{ GPa}$  and  $\nu = 0.272$ .<sup>[4]</sup>

In figure 9b the connector deflection with respect to the undistorted mesh is greatly exaggerated for clarity (note that this deflection has nothing to do with the local indent of the internal shoulder, shown in figure 3a, which was due to post-fracture secondary damage). Figure 9b shows a peak tensile stress of 228 MPa (red colour) close to the assumed contact area. Comparing figure 9b with figures 3a and 3b shows that the predicted position of the peak tensile stress agrees with the location of the black initial regions. Thus this stress analysis, which is straightforward, indicates that the tensile stresses required for stress corrosion cracking are a direct consequence of the load transfer between the seated rod end and connector.

Fig. 9 (a) Finite element mesh representing part of an intact connector with the same overall dimensions as the fractured connector 1; (b) Uniform circumferential stress distribution for the connector sustaining a surface pressure of 470 MPa, as though loaded by a seated rod end with a loading of 107 kN
