NLR-TP-2002-289

Material-based failure analysis of a helicopter rotor hub

Revised edition

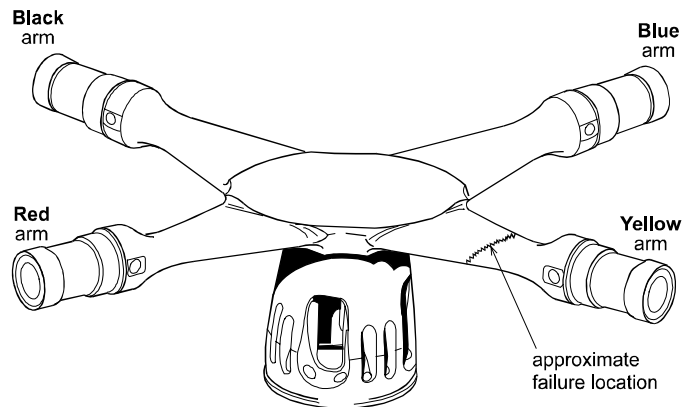
On 10 November, 1998, a Royal Netherlands Navy (RNLN) Lynx helicopter lost a rotor blade during preparation for take-off. The blade loss was due to failure of a rotor hub arm. Figure 1 shows the failure schematically. It occurred in the "yellow" arm of the rotor hub, a monolithic Ti-6Al-4V titanium alloy forging, across an elliptical plain section. Figure 2 is an overview of the outboard fracture surface of the failure. Concentric semi-circular ring markings, so-called "beach markings", on the fracture surface indicated fatigue failure beginning from the arrowed location. This was on the upper surface of the rotor hub arm, towards the trailing edge.

Fig. 1 Failure location in the monolithic rotor hub, a Ti-6Al-4V forging

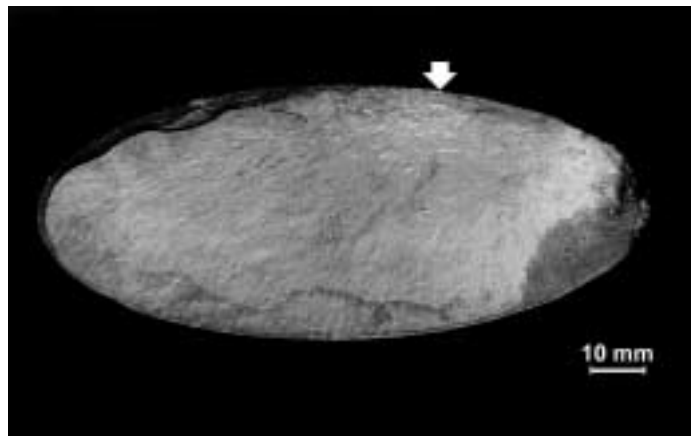
The failure analysis included a check to see whether one of the blind reference holes could have been at the same location as the fatigue origin in the failed yellow arm, see figure 2. It was concluded that this was improbable [2].

Fig. 2 Macro photograph of the yellow arm outboard fracture surface. The failure origin is arrowed

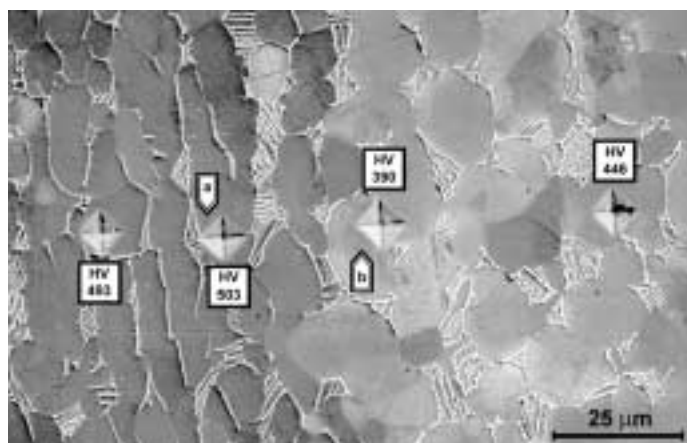
Precision sectioning of *one* of the fracture surfaces, at and near the fatigue origin, was done to check the microstructural condition. This was normal, consisting of primary α and transformed β , with some bands of elongated α grains. Figure 3 is an example metallograph showing part of a band of elongated α next to more equiaxed primary α . This example also shows where checks were made for differences in primary α hardnesses and in-depth *relative* oxygen contents, using Auger Electron Spectroscopy (AES). The elongated primary α tended to have higher hardness than the equiaxed primary α , but the in-depth oxygen contents were the same [4]. Thus the smaller effective grain size of the elongated primary α was most probably the reason for its higher hardness.

The AES measurements also showed that nitrogen was not detectable within the equipment limits [4]. In view of this and the above results, it was concluded that there was no evidence for excessively hard and high-interstitial content α phase in the microstructure, and hence no indication of a fatigue-initiating metallurgical defect (see Costa *et al.* [5]).

Fig. 3 SEM micrograph near the M323 fatigue origin, showing the $\alpha + \beta$ microstructure, microhardness (HV) measurements in primary α grains, and locations (a, b) analysed for oxygen content using Auger Electron Spectroscopy (AES)

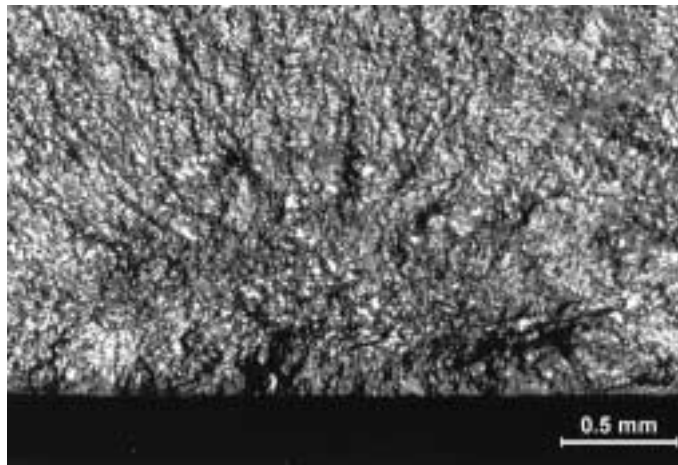
The starting point for this section of the paper is the fracture topography at the fatigue origin of the M323 yellow arm service failure. Figure 4 gives a mesoscopic view of the fatigue origin on the inboard fracture surface. This is *optical* fractography, which is often better at showing mesoscopic features than SEM fractography. In the case of figure 4 there is a change in fracture surface roughness, visible as a transition from dark to light grey.

Of more importance in the present context is the fracture roughness transition boundary, visible in figures 4 and 5 for the service failure, and also found for the full-scale test failure [2]. Figure 6 shows that the crack sizes at each fracture topography change were smaller for the full-scale test. This difference is consistent with the full-scale fatigue stress levels being generally higher than those for the service failure. Table 3 shows the full-scale fatigue stress levels at the fatigue origin in rotor hub arm 4C, which failed after approximately 7×10^5 cycles, representing 175 flying hours [8]: this was evidently an accelerated test.

Fig. 4 Mesofractograph of the fatigue origin on the inboard fracture surface of the M323 service failure, showing a change in roughness (dark to light grey)

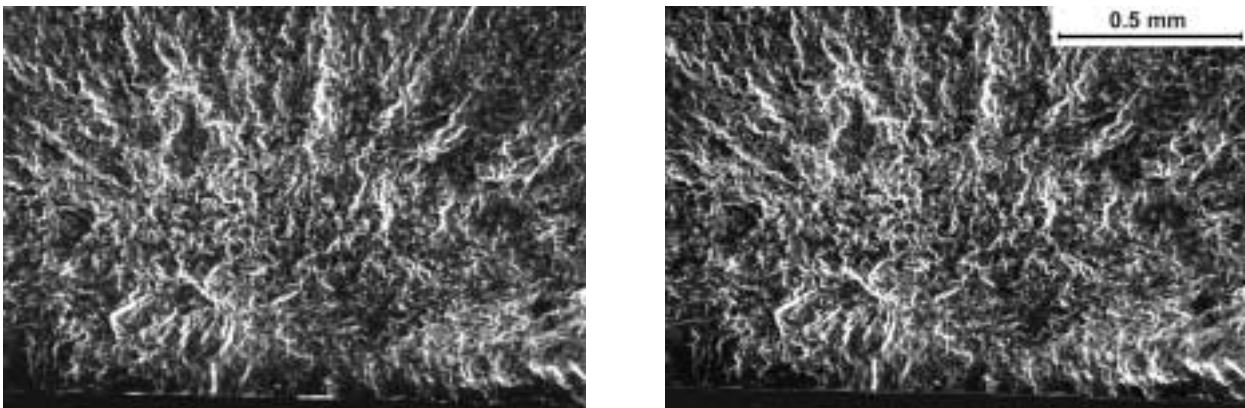
Similar changes in fracture topography were observed for the fatigue origins of the M6 full-scale and M323 specimen test failures. These changes were mapped using combinations of optical and SEM fractography over the magnification range $30\times - 3000\times$. Stereo pair SEM fractography was particularly useful in defining the boundaries between the changes in fracture topography: figure 5 is an example, showing the same area as in figure 4.

Fig. 5 Stereo pair SEM mesofractographs of the fatigue origin on the inboard fracture of the M323 service failure: y-axis tilt ± 5 , some vertical foreshortening due to x-axis tilt for better visibility of topography changes

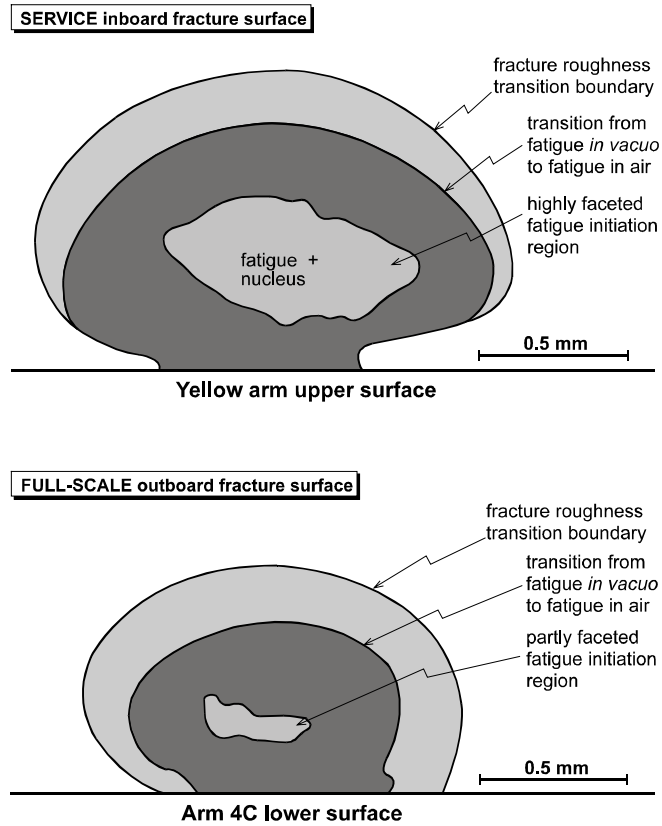
Figure 6 compares schematics of the fatigue origin areas of the service and full-scale test failures. Fatigue nucleation was subsurface owing to surface shot peening (though titanium alloys can show naturally-occurring subsurface fatigue origins at very long lives). Thus the fatigue cracks grew initially in vacuo. When the cracks broke through to the outer surfaces there was a subtle but definite change in fracture topography, namely that the fatigue facets produced in air were more sharply defined than those produced in vacuo. Figure 7 gives an example of this difference, whereby it should be noted that the SEM magnification for the facet produced in air is twice that for the facet produced in vacuo.

At the fracture roughness transition boundary the crack depths, a , were 1.02 mm for the M323 failure and 0.78 mm for the M6 failure, see figure 6. Substituting these values in equation (3) gives

Fig. 6 Schematics of the fatigue origin areas of the M323 service and M6 full-scale test failures

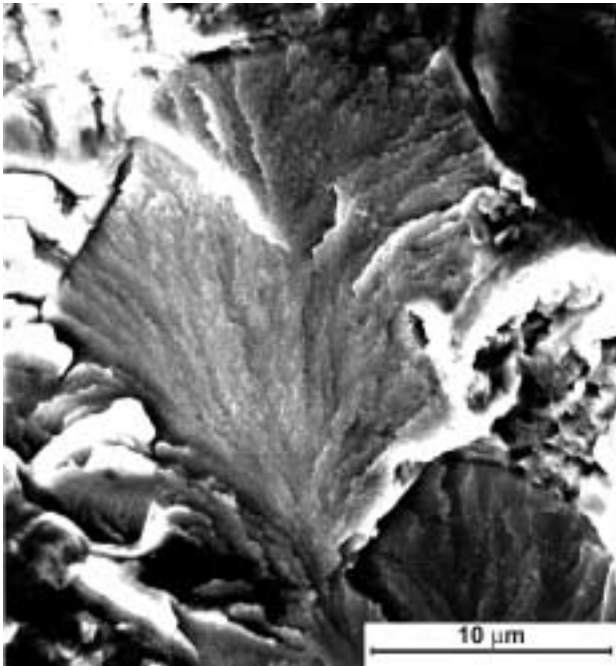
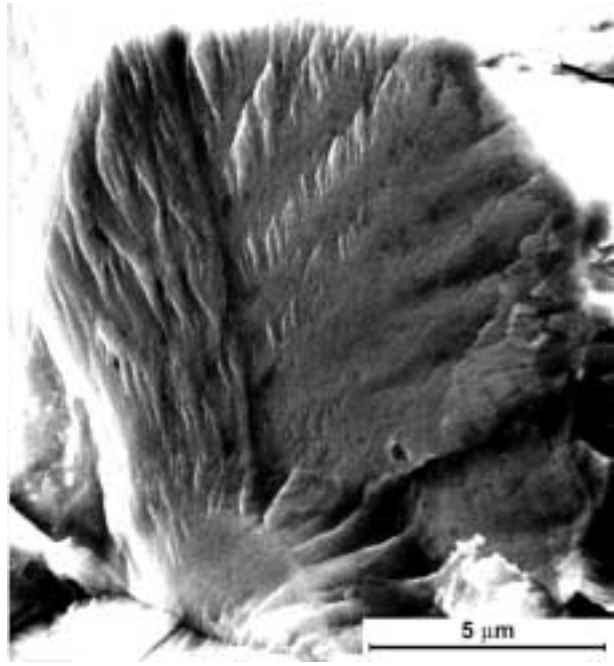
Fatigue *in vacuo*

Fatigue in air

Fig. 7 Microfractographic differences between fatigue facets produced in vacuo and in air
These details are SEM fractographs of the fatigue origin area of the M323 service failure

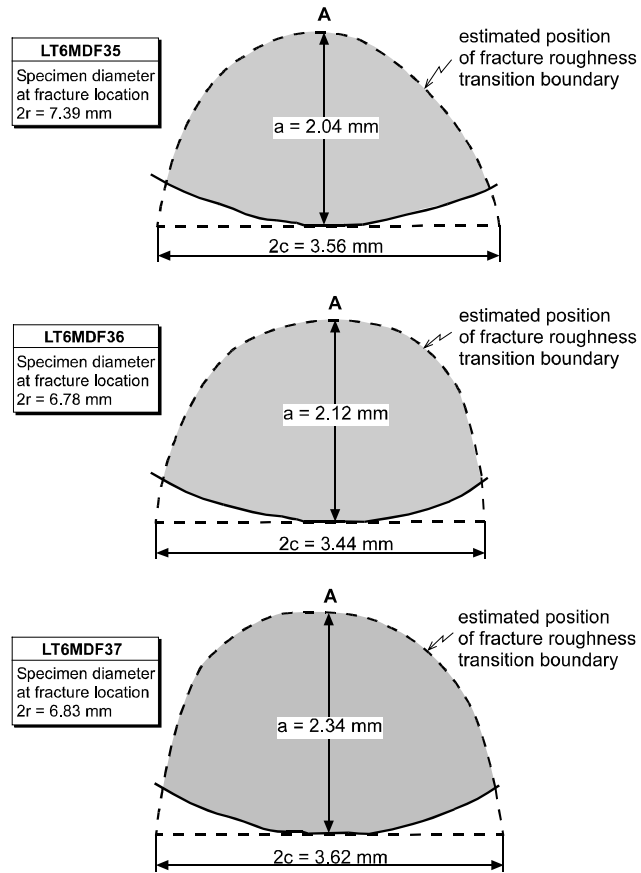
Figure 8 shows schematics of the fatigue origin areas of the specimens. The fracture roughness transition boundaries were visible, but details within these boundaries were largely obscured by fretting debris and hammering of the fracture surfaces as a consequence of fully reversed stressing ($R = -1$). This behaviour was not observed for the M323 service failure and M6 full-scale test failure. In turn, this indicates that in *both* cases the local R value was much less negative than $R = -1$. Thus it is possible that the M323 fatigue origin R value was similar to that for the M6 fatigue origin, as mentioned with respect to the Method (1) modified estimates.

Fig. 8 Schematics of the fatigue origin areas of the three failed specimens LT6MDF35-37. Dimensions were obtained from SEM fractographs
