Unravelling corrosion degradation of aged aircraft components protected by chromate-based coatings

A.J. Cornet^{a,b,*}, A.M. Homborg^{a,c}, P.R. Anusuyadevi^a, L. 't Hoen-Velterop^d, J.M.C. Mol^a

<https://doi.org/10.1016/j.engfailanal.2024.108070>

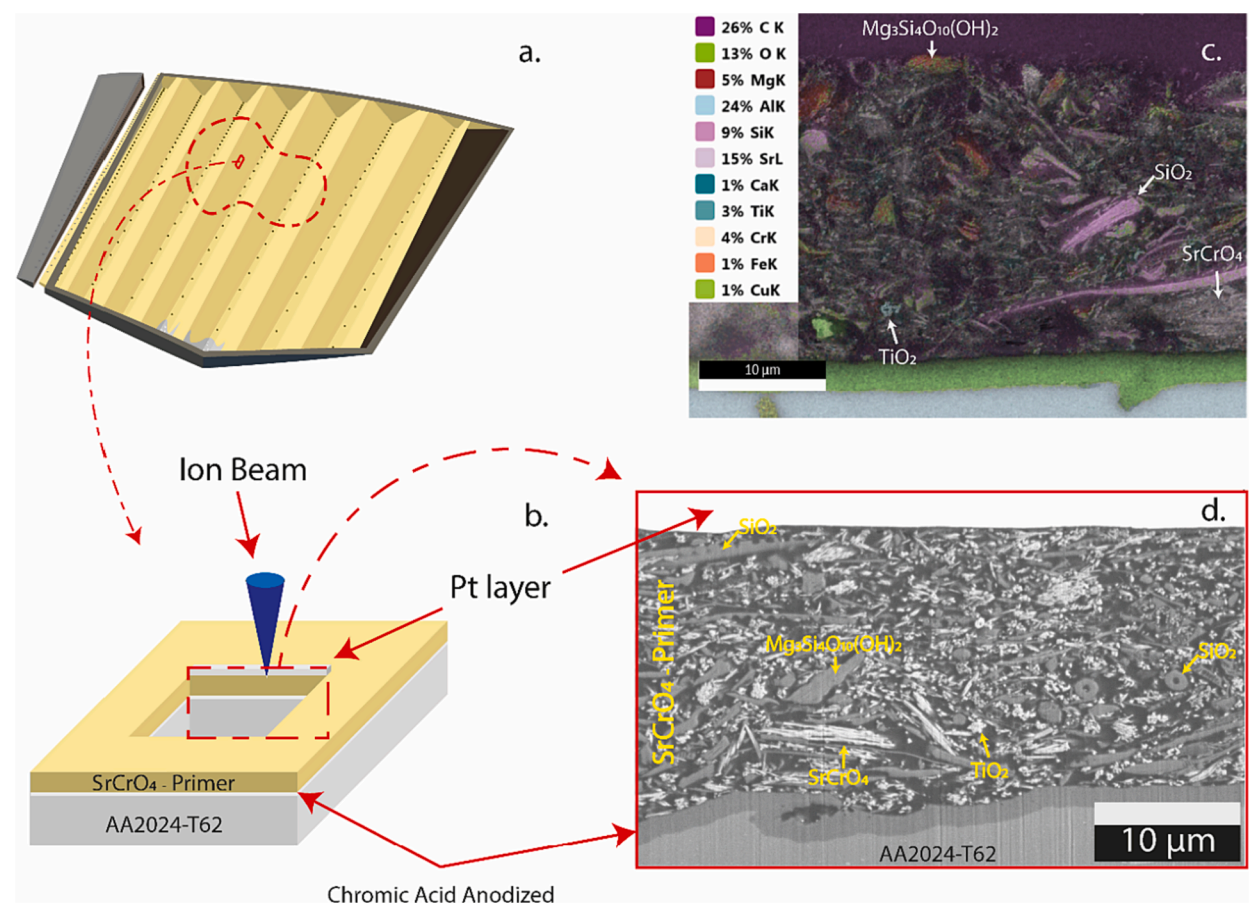
EDX was used to further analyse the elemental composition of different particles present in the coating. The EDX image shown in Fig. 2c reveals the presence of talc particles ($Mg_3Si_4O_{10}(OH)_2$), diatoms (as SiO_2), titanium oxide (TiO_2) and strontium chromate ($SrCrO_4$). Notably, the intact coating exhibited an almost pristine condition, with no observed pores, except in specific instances where pores were found around a scratch in the top layer of the primer. This observation implies a limited exposure to electrolytes, as particle leaching would typically occur under such conditions [35]. These small levels of electrolyte exposure could be attributed to the design of drain holes in the aircraft part, facilitating the easy exit of moisture and thereby potentially playing an important role in the corrosion protection. This analysis of the undisturbed coating area indicates that the hexavalent chromium coatings provided excellent corrosion protection in the featureless plain field areas of the aircraft components under investigation.

Fig. 2. Cross-sectional view of an intact coating achieved through FIB milling: (a) sample location within the overall aircraft part studied; (b) FIB-milling preparation method; (c) cross-sectional EDX mapping image; (d) cross-sectional BSE microscopic image.

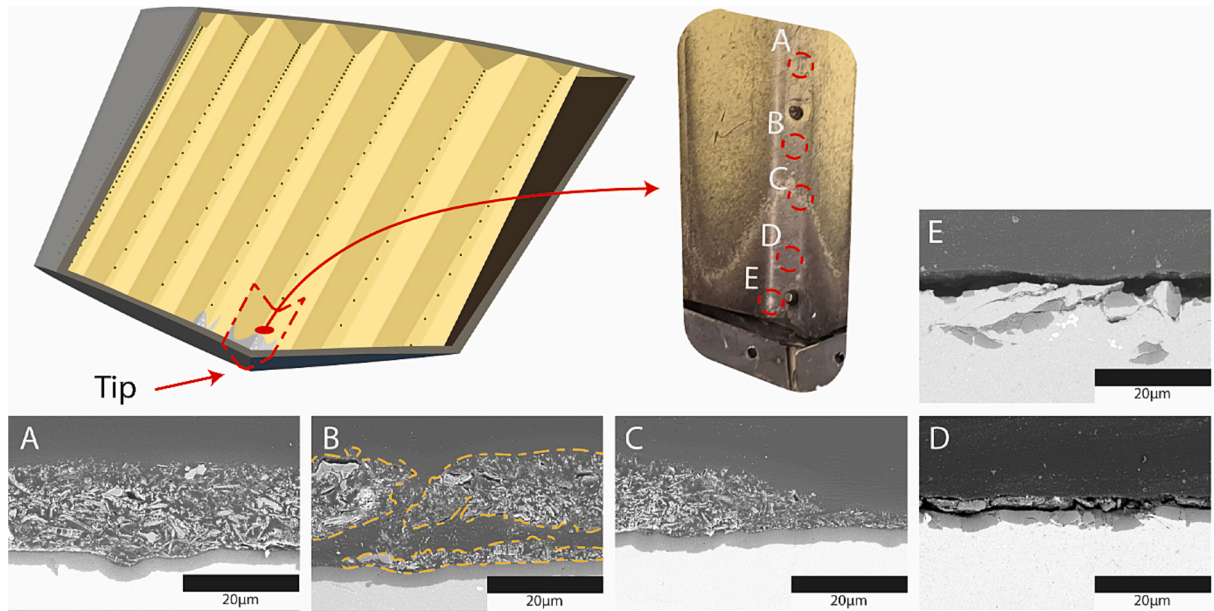
In this section, the eroded areas at the tip of the aluminium structural aircraft parts are investigated. Through visual examination, cross sections were scrutinized using SEM, ranging from the intact parts of the coating to severely damaged regions. This is depicted in Fig. 3. Interestingly, these findings indicate that despite the damage extending down to the bare metal “area E”, no apparent signs of corrosion are evident.

Fig. 3. SEM cross-sectional images illustrating distinct degradation stages observed in eroded areas at the tip: (a) intact coating; (b) adhesive and cohesive failure; (c) coating partly eroded; (d) only anodized layer intact; (e) local erosion down to bare metal.

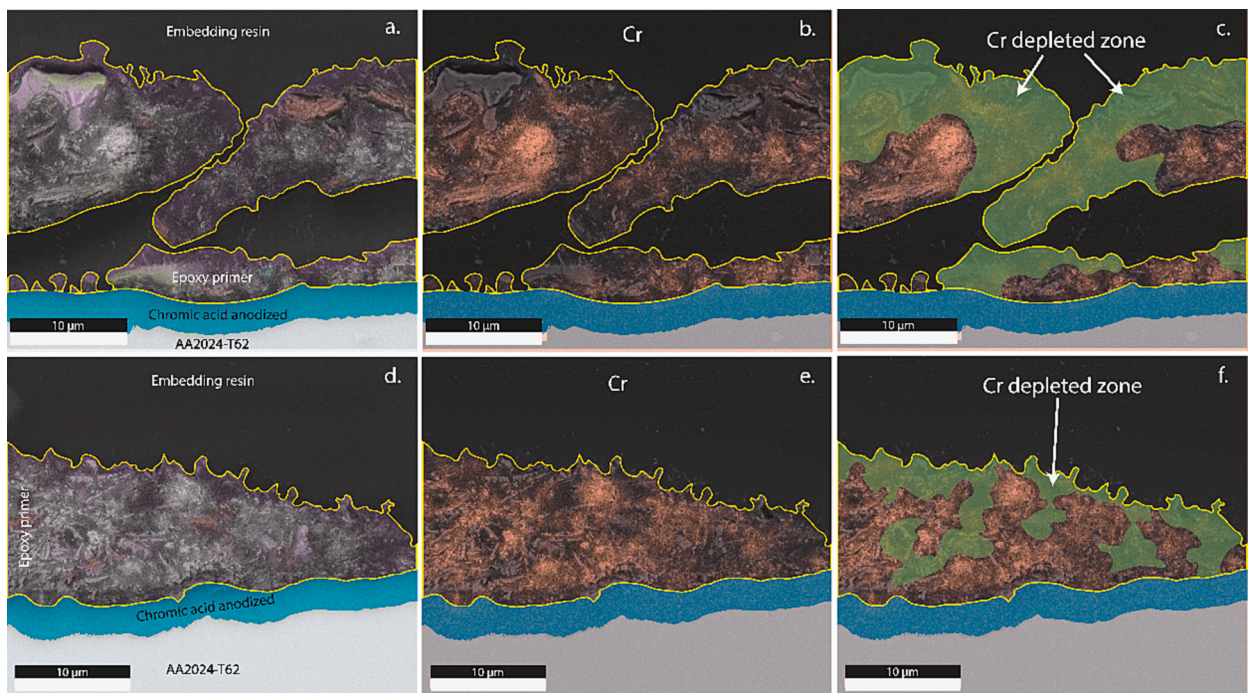
In order to elucidate the reasons behind this lack of corrosion, EDX images were acquired and analysed, specifically in areas (B) and (C) as shown in Fig. 3. The resulting EDX images are presented in Fig. 4. Analysis of these images revealed a notable presence of chromium remaining within the coating. However, some chromium is leached out as observed in Fig. 4c and 4f. This finding, including the findings of the intact coating, implies relatively dry conditions during service, despite periodic humid cycling and extended rainy periods during its service life under conditions where humidity levels exceed 90 % for over a week. These conditions might have induced minor moisture ingress into the coating, which triggered the leaching of chromate around the damaged area at the tip.

Fig. 4. SEM-EDX images revealing the coating conditions in eroded areas: (a) exhibiting adhesive and cohesive failure, accompanied by its corresponding image (b) illustrating chromium distribution; (c) revealing the chromium-depleted zone; (d) showcasing the coating erosion interface, along with its corresponding image (e) highlighting chromium distribution and in (f) the chromium-depleted zone.

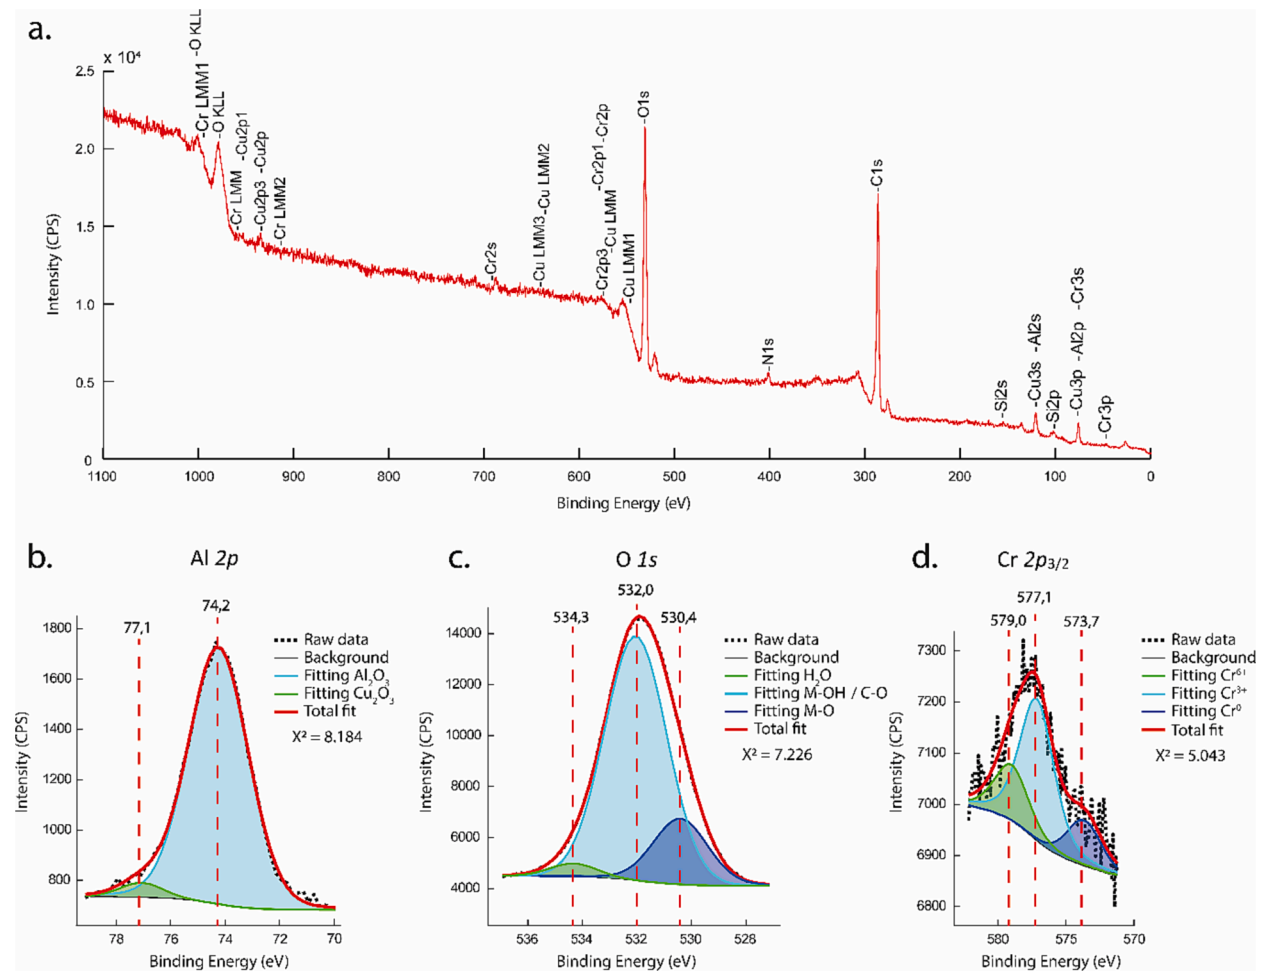
The high-resolution spectra, depicted in Fig. 5, reveals distinctive peaks corresponding to the elements of aluminium (Al 2p), oxygen (O 1s) and chromium (Cr 2p_{3/2}). Fitting and analysis of the obtained spectra provides valuable insights. The aluminium spectrum (Fig. 5b) indicates the primary presence of aluminium- and copper-oxide, confirming the presence of the aluminium alloy

Fig. 5. XPS survey spectrum (a), including fitted outcomes in the high resolution spectra, obtained from the region at the tip of the investigated aircraft component, elucidating the elements (b) aluminium, (c) oxygen, and (d) chromium.

The fitted oxygen spectrum (Fig. 5c) reveals the presence of H₂O, metal hydroxides (e.g., aluminium and chromium hydroxides), and metal oxides [37,39–41]. The heightened concentration of aluminium oxide is attributed to the damaged anodized oxide layer as observed in the bare aluminium surfaces (Fig. 3e). The presence of metal hydroxide bonds can be ascribed to the corrosion of the aluminium alloy and the sealing treatment after anodizing, both resulting in aluminium hydroxide. The metal hydroxide bonds can further be attributed to chromium hydroxide, as indicated by the distinctive chromium peak in the Cr 2p_{3/2} spectrum, as depicted in Fig. 5d.

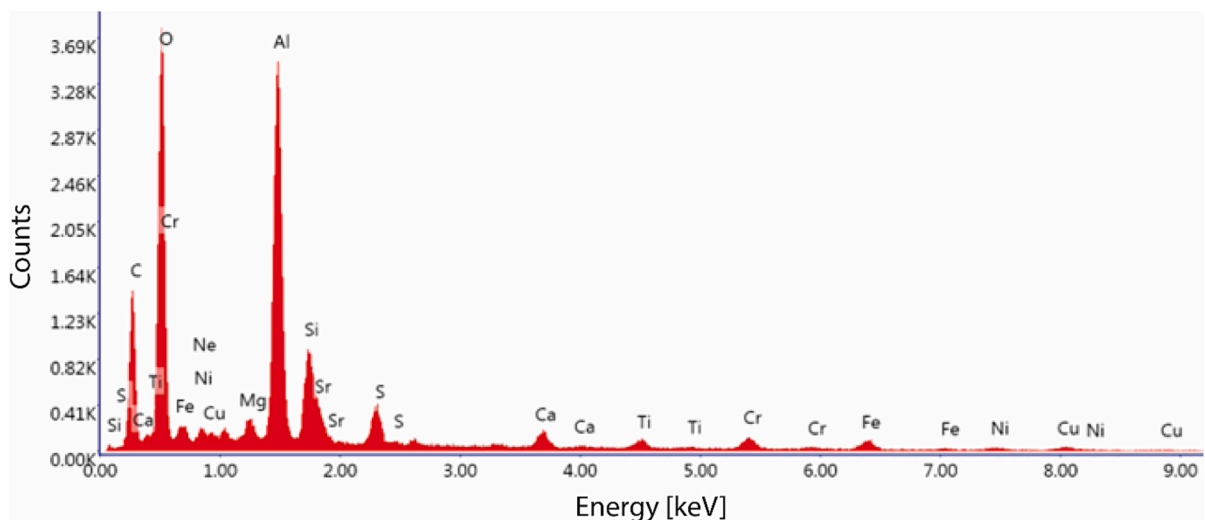
Continuing the investigation, the grey deposited dust atop the eroded areas was also investigated. The EDX analysis of the grey deposited dust clearly unveiled its predominant composition, arising from identifiable coating particles marked by the presence of C, Si, and Sr. Furthermore, traces of sealant, characterized by S and Ca, were identified, along with traces of stainless steel, distinguished by the presence of Fe, Ni, and Cr. These elements were discerned within the deposited dust, alongside aluminium oxide originating

Fig. 6. EDX analysis of grey deposited dust discovered in the eroded areas of the aircraft component.
