NLR-TP-98139

## **Impact damage prediction and failure analysis of heavily loaded, blade-stiffened composite wing panels**

J.F.M. Wiggeraad, X. Zhang\* and G.A.O. Davies\*\*

Division:	Structures and Materials
Issued:	17 March 1998
Classification of title:	Unclassified

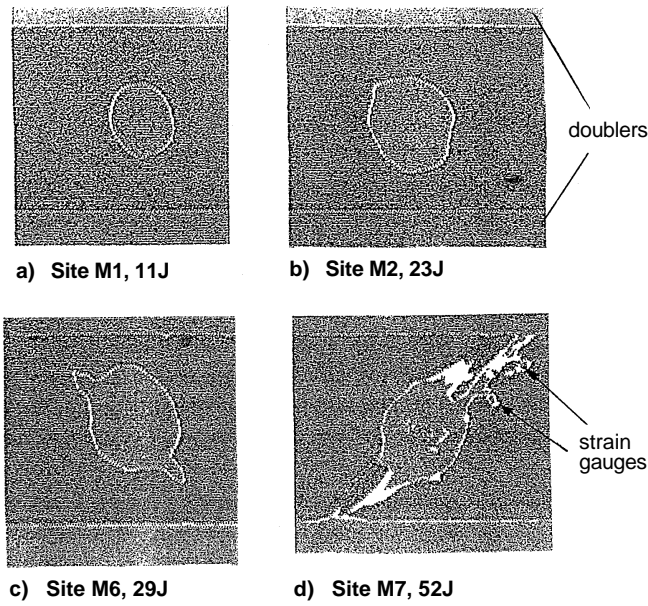
Fig. 4 C-scan pictures for impact tests on base skin of panel D

splitting was confined to a few layers and precipitated delamination at the adjacent interface. This separate form of delamination can be seen as the extra elongation in figures 4c and d, and were excluded in the measurement of the interior shear-driven delamination areas. Figure 5 presents the 3D image of test M2 previously shown in figure 4b by the conventional C-scan in terms of the total damage envelope. The ANDSCAN has the advantage of determining the depth of each delamination damage as figure 5 shows the damaged layers up to 2.86 mm in depth from the impact surface. The overlapping ‘peanut’ shapes are reasonably clear in this picture, but any damage will shield the area below in this “*time-of-flight*” mode. The extensive reflection below a depth of 2.86 mm are from the back surface of the plate and the edge of the inclined doubler face.

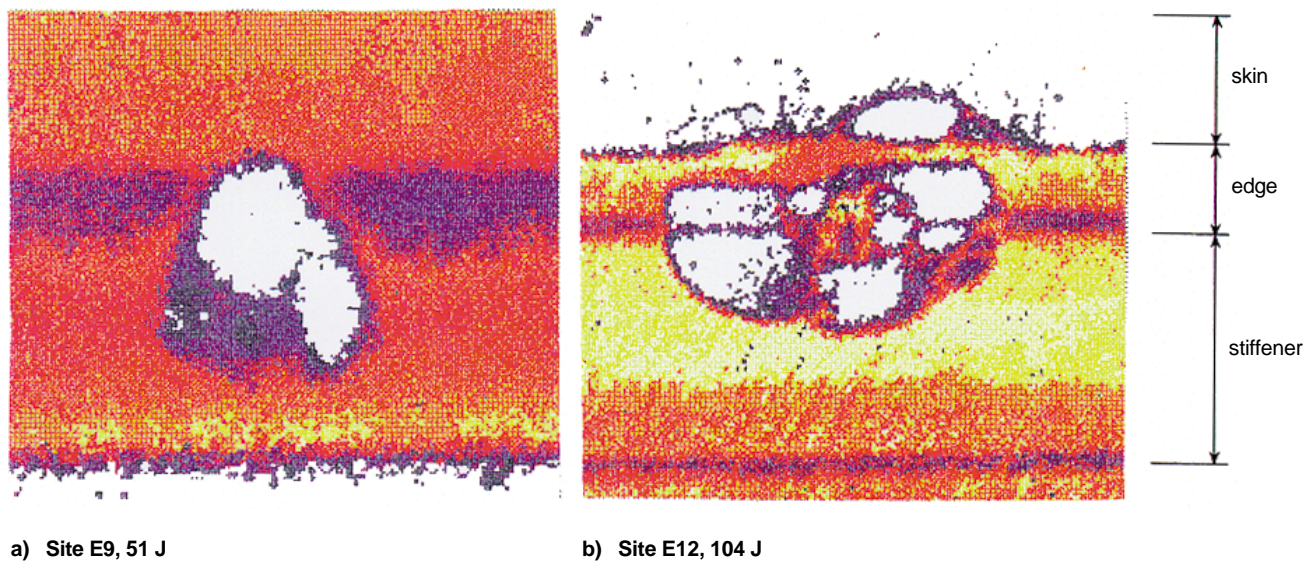
Fig. 7 C-scan maps showing progressive damage for edge impact tests (panel D)

were impacted at four locations with increasing energies. The resulting damage areas were very similar for each panel at same energy levels despite the difference in the doubler sublaminae. Therefore, only the results of panel D are discussed here. The progressive damage development with increasing impact energy was monitored by C-scan. Firstly, at the lowest energy of all, 30 J at site E8 (figure 3), no significant delamination was found, but some surface damage within the first 1.1 mm from the impacted face was detected. The second test was over site E9 with 51 J. The damage area was about  $270\text{mm}^2$  as shown in figure 7a. At site E11 with 74 J the damage area was increased to  $2800\text{mm}^2$ , and finally at the highest energy of 104 J at site E12, the damage area was about  $4000\text{mm}^2$ , figure 7b. For the highest energy test, the back face matrix cracking was observed by eye extending to the basic skin. These C-scans also showed internal delamination of the same limited extent as for the basic skin tests, but the pattern is clearly more complex as we would expect in the tapered region where lamina were being phased out continuously from the stiffener flange to the basic skin. The impact force histories in figure 8 for 51 J and 104 J show a characteristic shape which we recognise as evidence of damage. In an undamaged structure the response is virtually a sinusoidal fundamental mode signature, with occasionally a small higher harmonic component in complex configurations. The decay is identical to the rise. Any in-plane damage will lower the flexural stiffness, truncate the maximum force, and result in a longer decay. The effects are apparent in figure 8b.

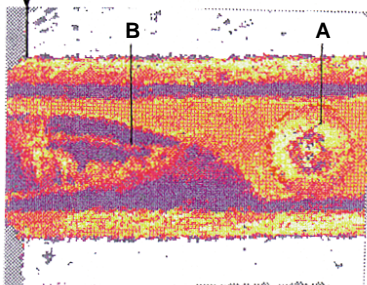
**impact site S1, 100 J**

**A:** delamination area = 1400 mm<sup>2</sup>

**B:** debonding between stiffener and doubler

Fig. 9 Andscan images for impact tests over stiffener centre (panel D)

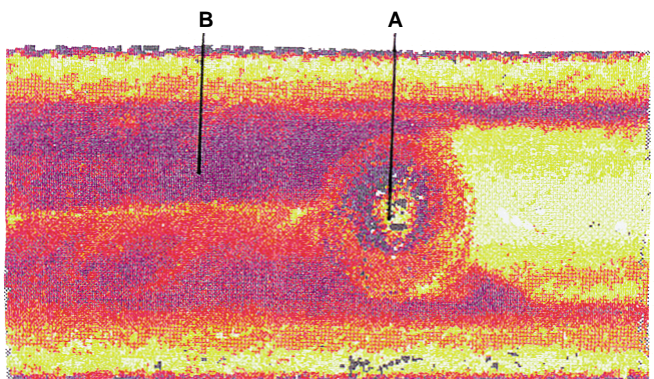
**impact site S5, 203 J**

**A:** delamination area = 2000 mm<sup>2</sup>

**B:** debonding between stiffener and doubler

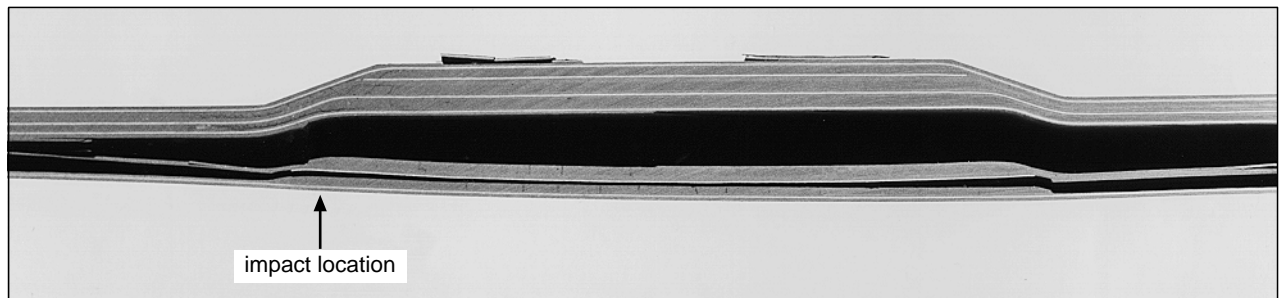
Fig. 18 Failure mode of panel A

To find an explanation for the different failure loads of the two panels, which were considered to be different only with respect to the fabrication effort that was involved but equivalent in strength, photographs were made of lateral cross sections near the fracture lines, shown in figures 18 and 19. The photographs show the skin/doubler section where the impact had taken place, with the stiffener missing. Apparently, the failure mechanism consisted of the subsequent buckling of several delaminated sublaminates, followed by the crippling of the skin and the collapse of the separated stiffeners. It can also be seen that the load drops in the load versus end-shortening curves (Fig. 18-19) may well have corresponded with the subsequent buckling of the delaminated sublaminates. Figure 18 shows that panel A had developed two thick sublaminates, while panel B (figure 19) had developed at least four thinner sublaminates. It was thought that the difference in thickness of the respective doubler laminates, 6 plies for panel A and 3 plies for panel B, was the reason for the different panel strength: thicker sublaminates buckle at higher loads than thinner sublaminates. The designs for panels C and D were subsequently defined on the basis of this conclusion: panel C with 6-ply doubler laminates and panel D with 3-ply doubler laminates. Note that panels C and D were made with thinner material plies than panels A and B (see table 1).

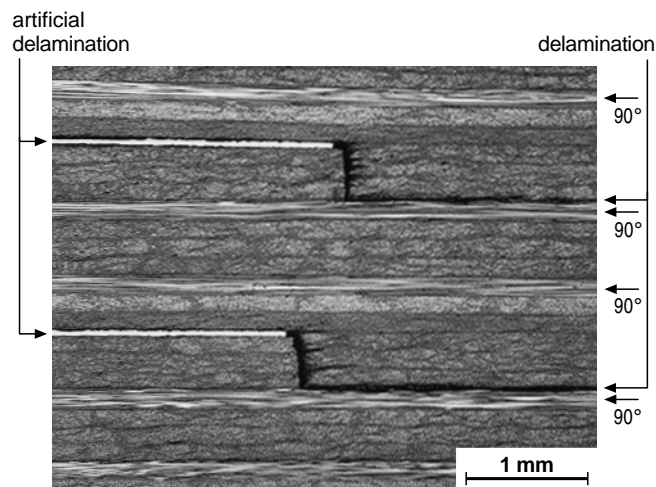
Fig. 21 Delamination growth from artificial delaminations towards 90-degree layers

When loaded in compression, stable delamination buckling and growth was observed before collapse for the first configuration (with the foils placed nearer to the surface). The delaminations of the second configuration (with the foils placed deeper inside the laminate) had not grown when the specimen fractured, which occurred at a location away from the artificial delaminations, but at approximately the same strain level (0.0060) as the first configuration. A similar specimen, impacted with 36 J at the location where the artificial delaminations were already present, also collapsed without stable damage growth. However, in this case strain gauges and an LVDT located at the impact site indicated a distinct nonlinear strain increase before failure, which was not observed elsewhere on the specimen.

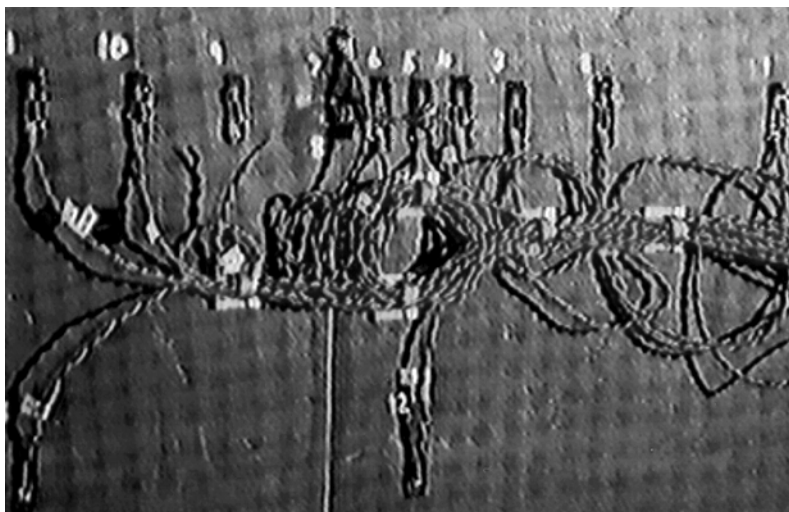
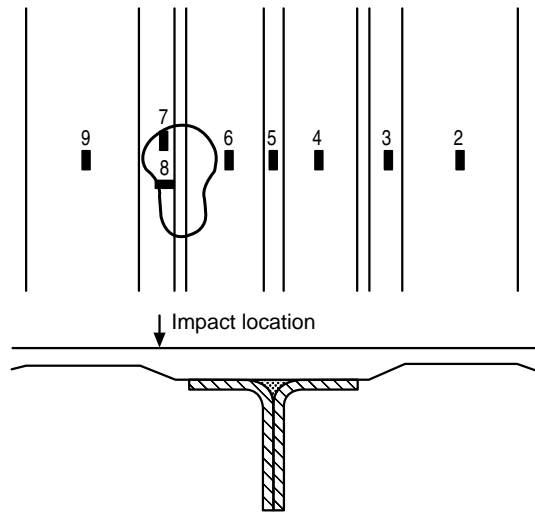
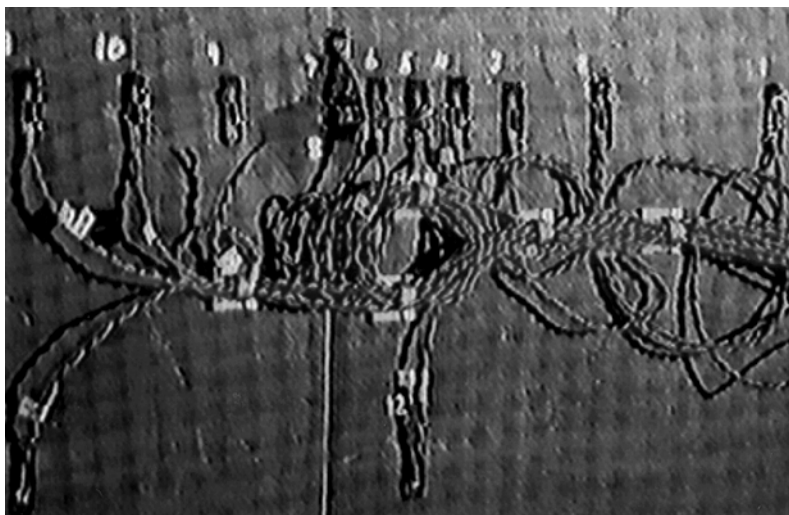
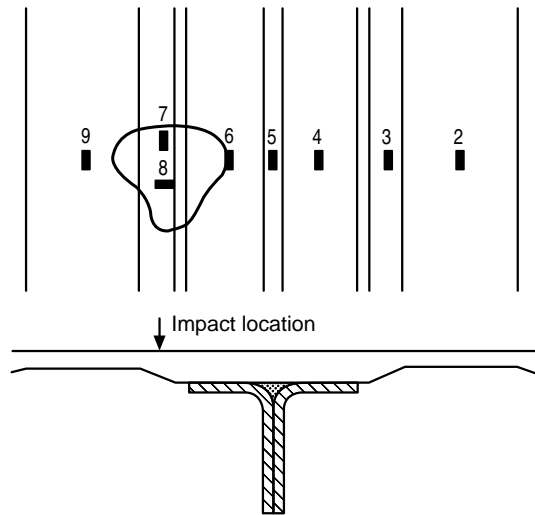
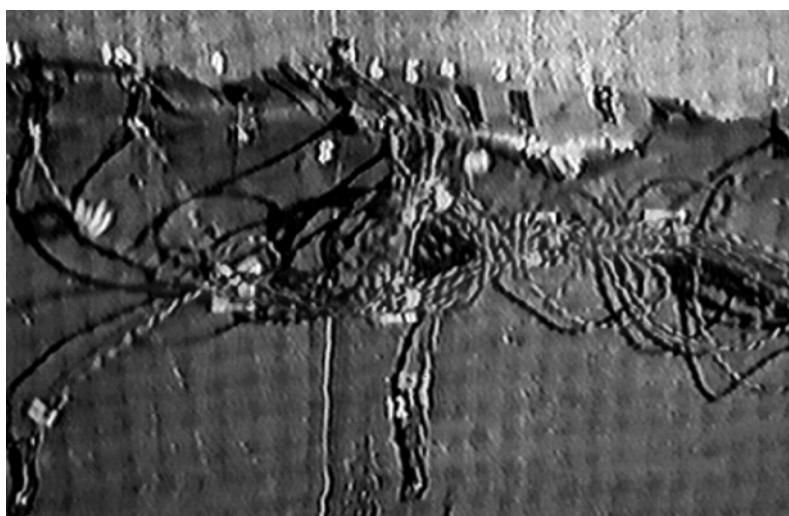
Fig. 23 Sublaminate buckling and collapse of panel C

The final collapse of panel C was accompanied by the unstable buckling of a sublaminate at the damage site, as observed with the video camera. In figure 23 this phenomenon is shown on three subsequent photographs taken by the video camera at 25 images per second, hence, the images are separated by 0.04 seconds. The first shape of the buckle is a peanut shape with the major axis in the longitudinal direction. In the second photograph, the upper part of the buckle has developed two lobes, one on either side in the lateral direction. The third photograph shows total fracture upon the complete extension of the lobes to the sides of the panel. The shape of the buckled delamination was not the often assumed ellipse growing in a self similar pattern. It is

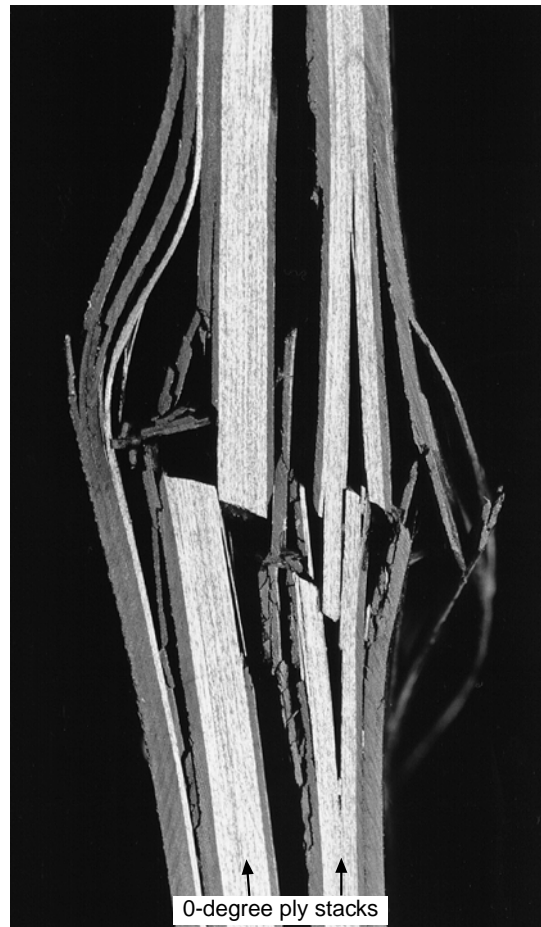
Fig. 24 Non-symmetric deformation due to collapse of 0-degree ply stacks (Ref. 16)

also not obvious that it is the buckling of the outer sublaminates that initiated the final failure. It is more likely that one or more 0-degree ply stacks collapsed due to out of plane bending, one part sliding past the other, thereby prying off the outer 45-degree plies in a non-symmetric manner. Such behaviour was observed in more detail [16] on a similar, 0-degree dominated laminate. Figure 24 shows a photograph of a cross section of the laminate of Ref. 16, taken in the longitudinal (loading) direction. The white layers are 0-degree plies in this photograph.

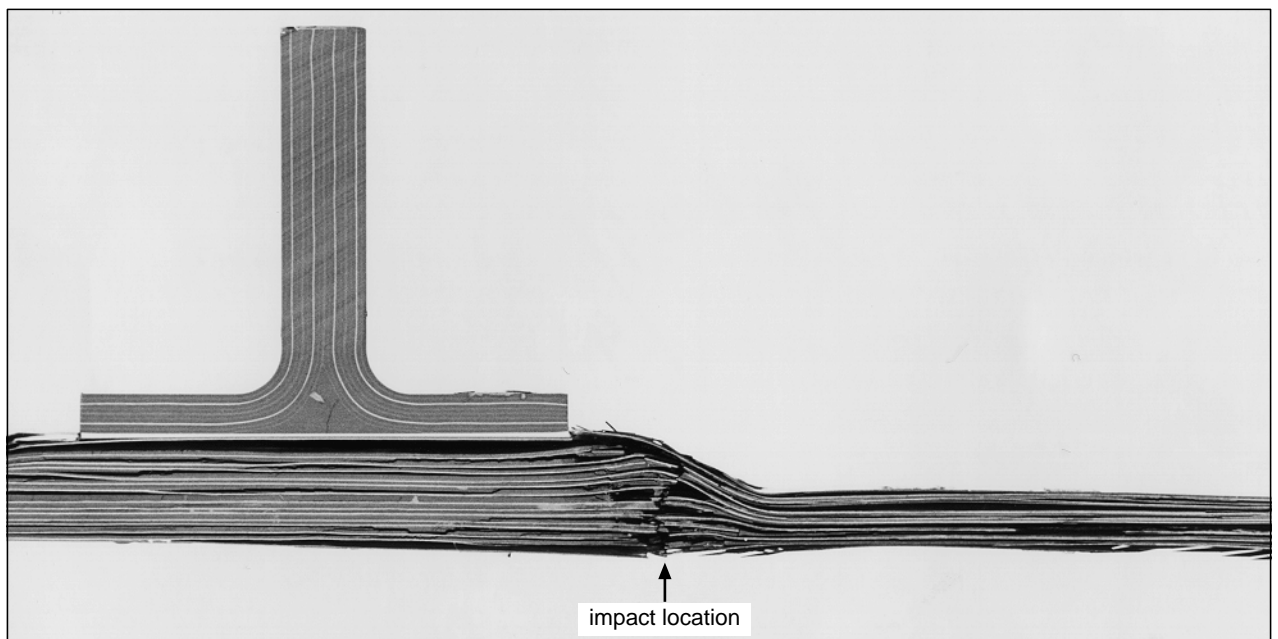
Fig. 25 Post-mortem view of panel C

A post-mortem view of panel C after it failed in compression is shown in figure 25. The cross section is taken close to the fracture line. It is clear that many thin sublaminates with a low buckling resistance were formed by the delaminations, all of which followed the 90-degree plies (which are the white lines in the photograph). The fact that panel C had relatively thick doubler laminates did not result in a high failure load. Instead, the presence of the many 90-degree layers (19% of all plies in the doubler region were 90-degree plies, versus only 10% for panels A and B), and their dispersal (see table 2) resulted in many thin 3-ply and 5-ply sublaminates, each containing no more than three 0-degree plies, which could buckle out at relatively low loads. Instead, panel D with thinner doubler laminates might have failed at a higher load. Its 90-degree plies were grouped in pairs, which resulted in a doubler region containing only 11% 90-degree ply interfaces (see table 2). The 8-ply sublaminates, formed by the major delaminations which again followed the 90-degree plies, were much thicker than those of panel C. Each sublaminates contained six 0-degree plies and would have buckled at a much higher load. A post-mortem view of panel D is shown in figure 26a. Panel D had been loaded in compression, but not up to failure, and no growth of the C-scan damage area was detected afterwards. The panel was dissected through the impact site. The location of the larger impact induced delaminations of panel D are more clearly shown in figure 26b, on a photograph taken under u.v. light, in which the delaminations, impregnated with a penetrating fluid, show up as white lines. Comparison of figures 26a and 26b shows that the large delaminations are adjacent to the 90-degree plies.

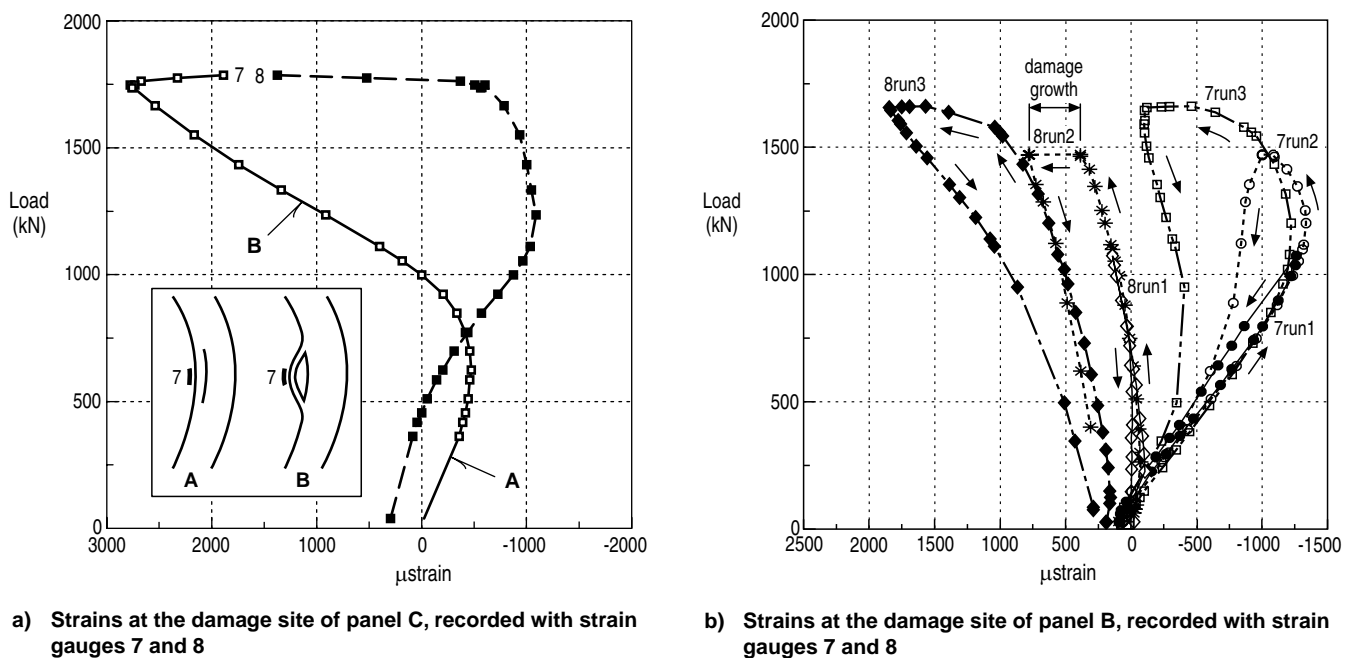
Fig. 32 Strains at damage location

A closer view of the behaviour of the damaged region is shown in figure 32. Strain gauges 7 and 8 are located on top of the damaged site, in the longitudinal and lateral panel directions, respectively. Figure 32a shows that the damage in panel C propagates extensively during the last stable load steps, which are the load steps corresponding to the non-linear part of the load versus end-shortening curve in figure 27a, but before the unstable buckling shown in figure 23 took place. In particular, the lateral strain gauge 8 shows a large change in strain at hardly any change in load. This effect is shown even more clearly in figure 32b, in which the loading and unloading

curves are shown for strain gauges 7 and 8 for all three test runs of panel D. The longitudinal strain gauge 7 indicates a reversible bending of the outer sublaminate, but lateral strain gauge 8 shows a non-reversible strain increase during the second and third test run, indicating damage growth in the lateral direction.
