# Hybrid inspection method using 3 dimensional scanning, lock-in thermography and laser shearography

H.P. Jansen<sup>1\*</sup>, D.J. Platenkamp<sup>2</sup> and J.S Hwang<sup>3</sup>

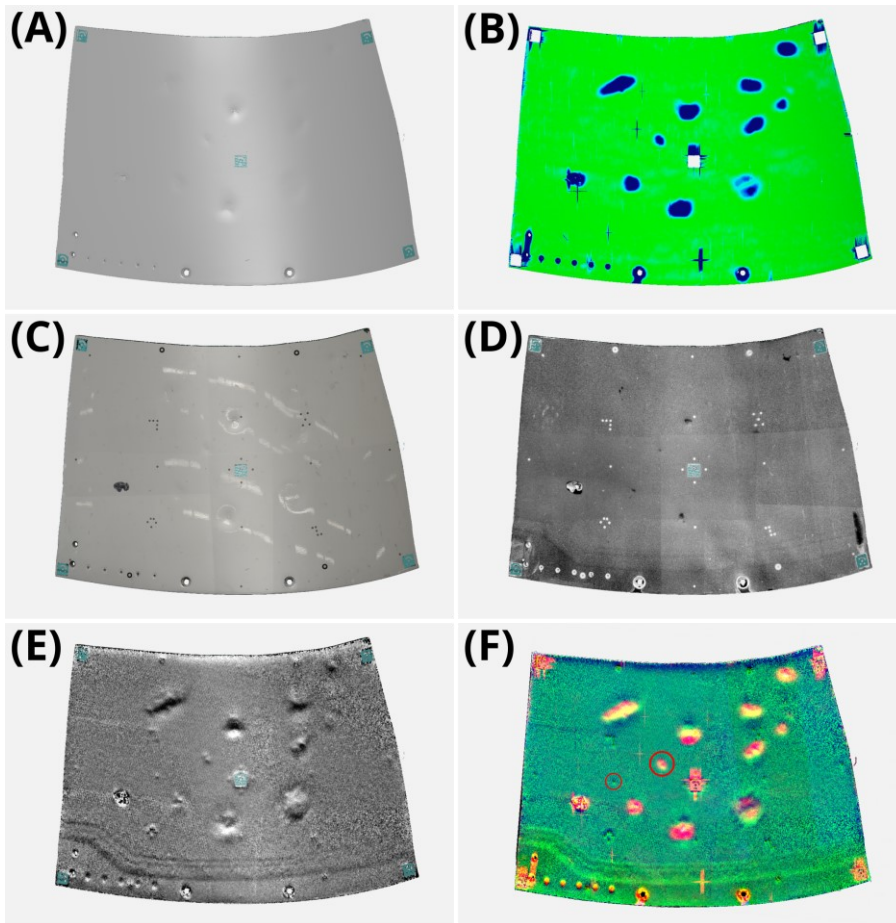
The three aforementioned NDI techniques are applied on a radome of an aircraft. The aircraft flew through a hail storm, resulting into impact damage on the part of the radome. The radome is made of a GFRP external skin with a 1.1 mm thickness and GFRP internal skin of 0.8 mm thickness, in between a Nomex honeycomb core with cell size of about 3 mm and a height of 6.3 mm. The specimen has a size of approximately 450x665x22 mm. First the entire radome is scanned using the ATOS5 scanner with a measuring volume of 320x240x240 mm, resulting in a point spacing of 0.068 mm and an accuracy of about 0.02 mm. The reference markers placed on top of the radome have a size of respectively 3 mm and 6 mm. A total of 61 3D measurements were done to capture the entire specimen, if only the front side is needed a total of 14 scans would be sufficient. Scanning can also be performed with a larger measuring volume of 1000x750x750 mm, requiring only a single scan of a couple of seconds with the consequence of losing point spacing and accuracy (0.20 mm point spacing and accuracy of about 0.05mm) The resulting surface mesh is shown in Fig. 1(A), showing dents on the surface. For better visibility of the dents a surface defect map can be constructed as shown in Fig. 1(B). Scaling starts at green at 0.0 mm, dark blue regions have a dent depth of 0.07 mm or above. A total of 11 dents can be seen on the surface.

Only external geometric effects are captured by the 3D scanner, and no information on the damage inside of the skin, skin-honeycomb interface and honeycomb can be extracted from the data. Therefore thermographic and shearographic inspections are also performed on the front side of this specimen, which is the side that would be accessible in a Maintenance Repair and Overhaul (MRO) environment. For the thermographic inspection, the front side of the panel is divided into 4 areas. The FOV of the infrared camera is 365 x 300 mm, resulting in a resolution of 0.58 mm/ pixel. The inspections were done at four different lock-in frequencies: 0.50, 0.20, 0.10 and 0.05 Hz. Fig. 1(D) shows the mapped thermographic phase images at 0.10 Hz. Small difference in greyscale values between the separate images can be seen as straight bands on the model. The reference markers are visible as white spots on the thermographic images which have been used for the mapping of data. Damage in the GFRP skin can be seen as black spots on the image. Not all dents that have been found using 3D scanning show damage inside of the skin. The damage found with the thermography inspection is the cracking of the skin and not all dent locations show this cracking. Cracking of the skin can result in water ingress of the radome and it is therefore an important defect that needs to be found.

Shearographic inspection has also been performed in a similar manner as the thermographic inspection, resulting in roughly the same FOV but with a higher resolution of 0.15 mm/pixel. The unwrapped phase information of the shearographic measurement is exported to an image and the results can be mapped on the surface as shown in Fig. 1(E). For an undamaged radome, a uniform image is expected. This is not the case and multiple damages can be seen on the radome, corresponding to the locations where a dent is visible from the 3D scan. Using shearography the gradient of the out-of-plane deformation under stress induced by the halogen lamps can be detected. This difference in out-of-plane movement is caused by defects that alter the stiffness of the panel. In this case it is probably caused by damage inside of the honeycomb, or a debond between the GFRP skin and the honeycomb.

**Fig. 1** Results of the radome (A) Surface mesh, (B) Dent map, (C) Mapped photographs, (D) IRT 0.200 Hz, (E) Shearography, (F) Fusion of data, red channel dent map, green channel shearography, blue channel IRT 0.200 Hz

All NDI data is mapped on the same surface mesh allowing for data fusion and a compiled image. Fig. 1(F) shows the data in a compiled image, where the surface dent map is expressed in the red channel, shearographic data in the green channel and the thermographic data at 0.20 Hz in the blue channel. When there is a defect in all data types the area will be white. This can be seen in some of the dents in the centre, where there is also damage in the skin which is detected by thermography. Areas that are yellow contain a defect in both the surface defect map and the shearographic data.

be difficult to distinguish. In the fused image, the reference marker is immediately identifiable as it appears green while the small dents appear red and yellow (see red circles in the image),

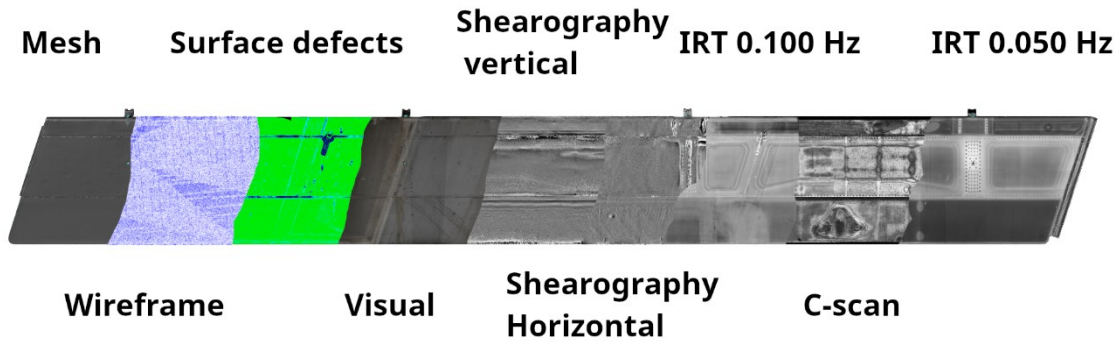
Additionally, a part of the flap was also scanned by traditional ultrasonic C-scanning in squirter pulse-echo mode using a single transducer of 19 mm with a nominal frequency of 5 MHz. All data from all experiments have been mapped on top of the 3D mesh, resulting in a single file containing all the inspection data. Results from the bottom side of the flap are partially shown in Fig. 2.

*Fig. 2 Results of the mapped data of the 747-400 flap showing the bottom side. From left to right, mesh, wireframe, surface defects, visual images, shearography vertical, shearography horizontal, IRT 0.100 Hz, C-scan and IRT 0.050Hz*
