NLR-TP-2026-008 | February 2026

# Failure/accident investigation

Lecture notes

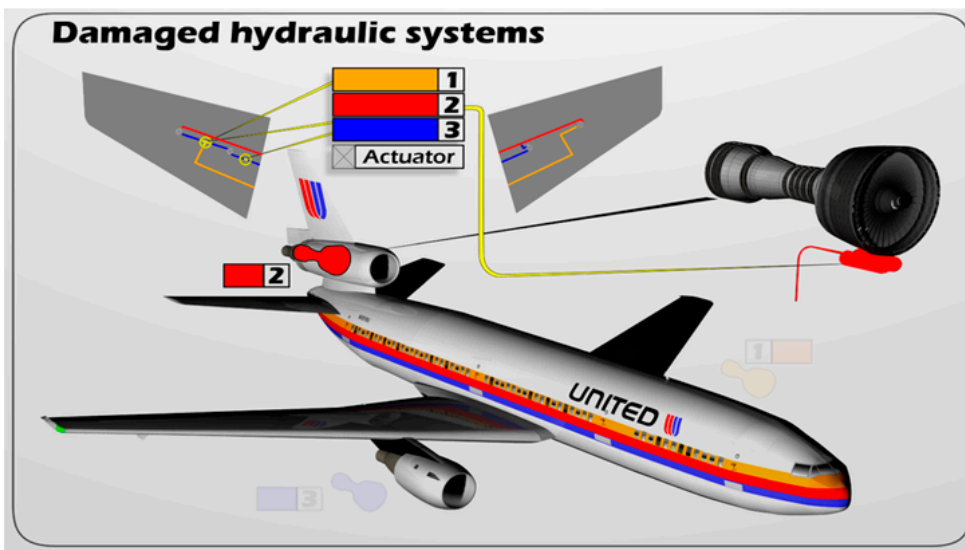
Sioux City, Iowa, 9 July 1989, uncontained fan disk failure

Uncontained -in flight- failure of the fan disk of the engine of a DC 10.

The high-speed debris exiting the engine penetrated the hydraulic lines of all three independent hydraulic systems in the tail wing.

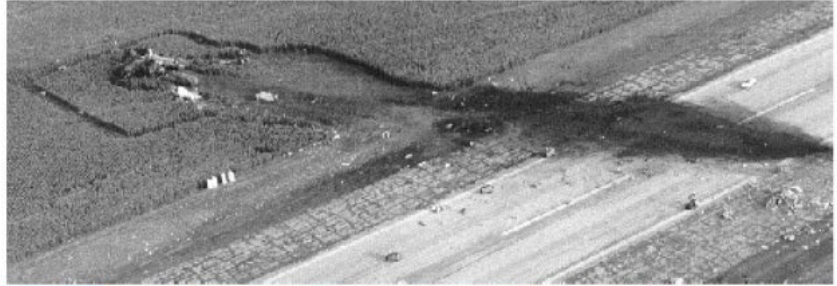
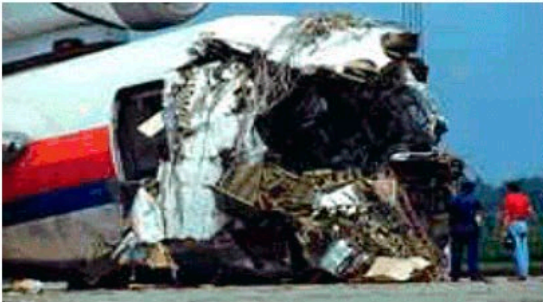
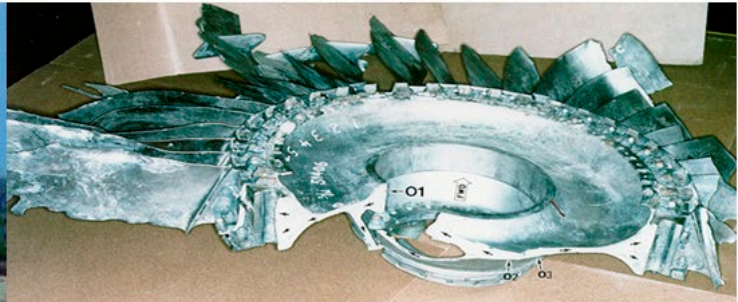
A defect that went undetected in a titanium fan disk was responsible for the failure of the disk.

Fan disk had 16.899 cycles; safe life was 18.000 cycles

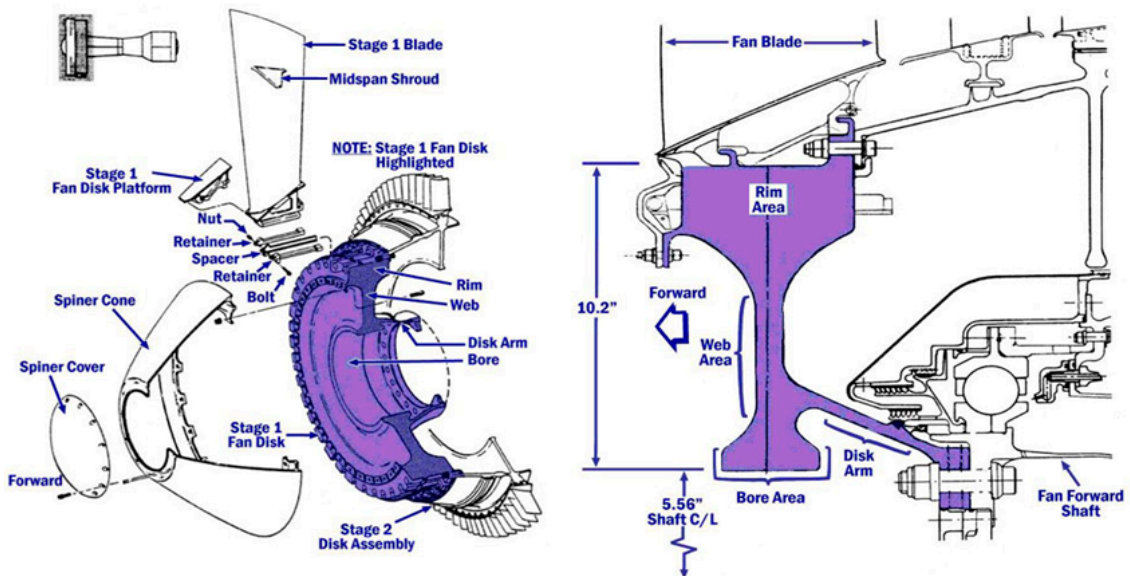
### CF-6 Fan Assembly Showing Fan Disk

**Fatigue crack originated at a hard  $\alpha$  defect present after manufacture**

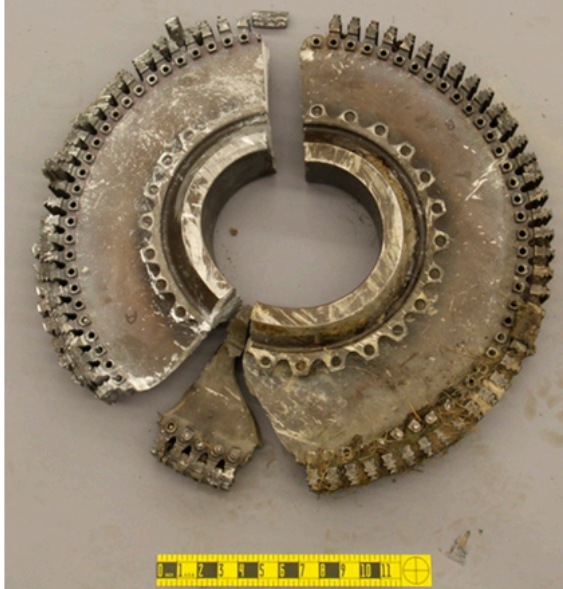
### Recovered stage 2 HPT disk pieces

As a result of the uncontained engine failure, a fuel leak occurred, which resulted in a fire under the right wing.

The right engine stage 2 high pressure turbine disk fractured into at least 4 pieces. One piece went through the inboard section of the right wing, over the fuselage and into a UPS warehouse facility (location A).

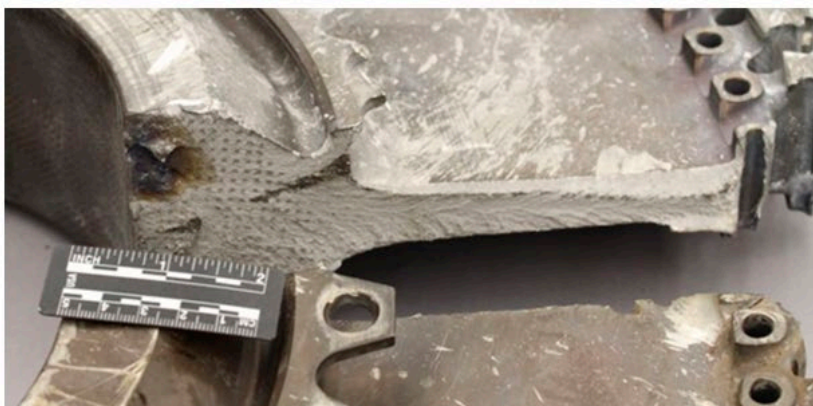
### Fatigue crack location on a disk fracture surface

- Engine and wing debris were found at far-off locations.
- The majority of the stage 2 disk was recovered.
- One of the fractures exhibited features consistent with fatigue cracking initiating at an internal inclusion in the hub's inner bore.

The disk had 10,984 cycles and had a life limit of 15,000 cycles.

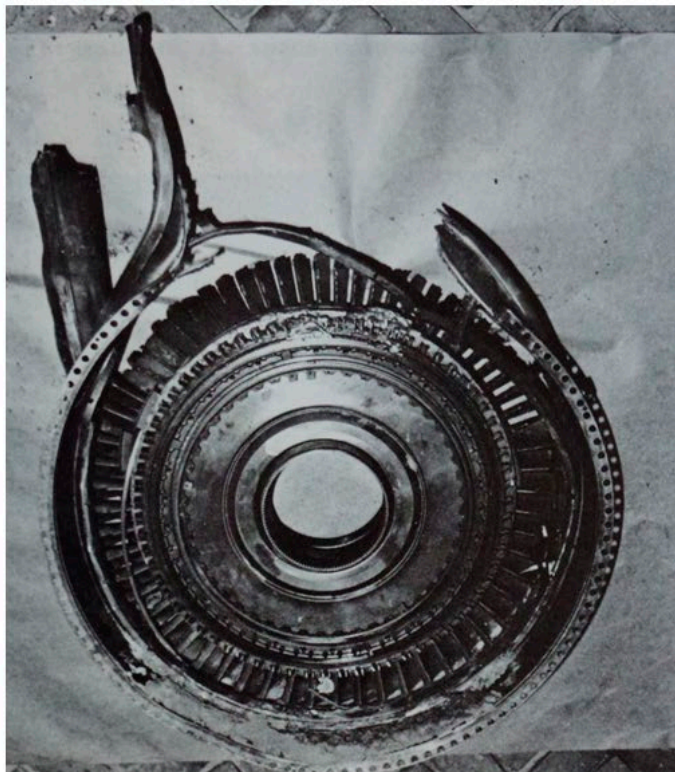
After disassembly of the engine, it turned out that the inlet of the turbine was heavily damaged. Broken 1<sup>st</sup> stage turbine blades are clearly visible; 2<sup>nd</sup> stage relatively undamaged.

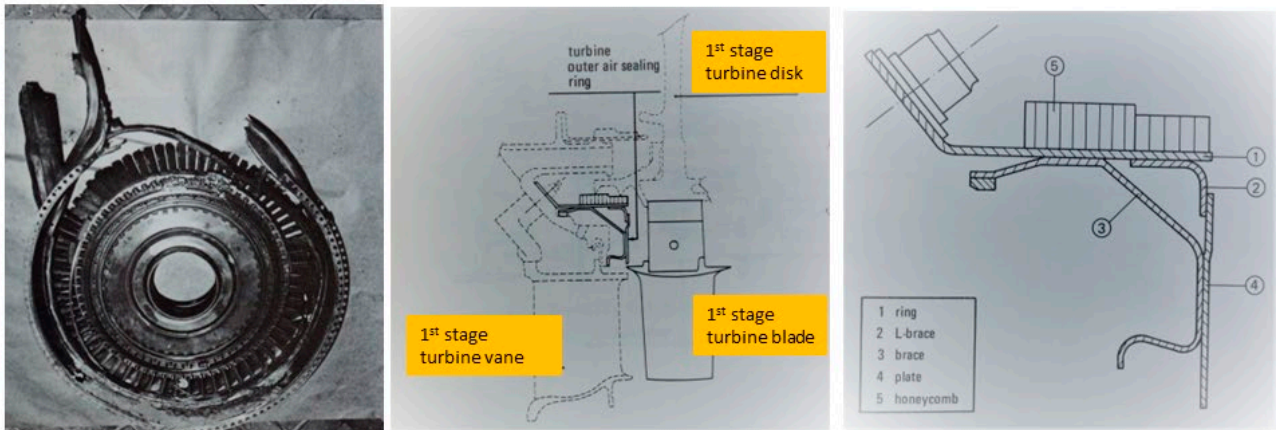
# Brazing joint failure

Turbine sealing ring failed by braze joint failure between ring 1 and part 2 and 3.  
 Cause: oxide layer build up during Ni-plating prior to brazing (NLR MP 87037, presented at BVM symposium, Wageningen, 1986)

- Production process was interrupted between application of Ni-strike and Ni-plate (production fault)
- Formation of extremely thin oxide layer between Ni-strike and Ni-plate
- Lower Co-alloy ring sheared off from upper ring (because of internal hot gas pressure) and cut all first stage turbine blades.

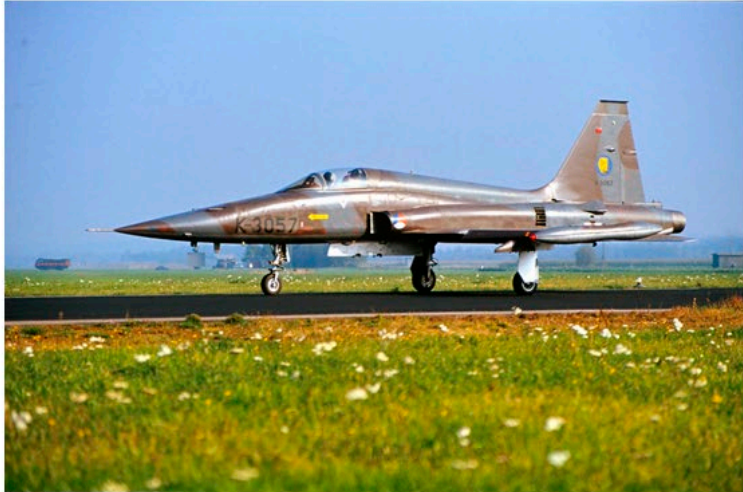
**Cause: compressor drive shaft cracking**

**Fatigue failure in drive shaft; but: calculated stresses at that location were much too low to cause fatigue cracking.**

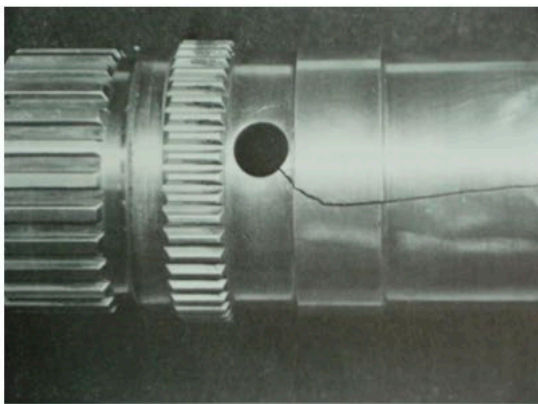
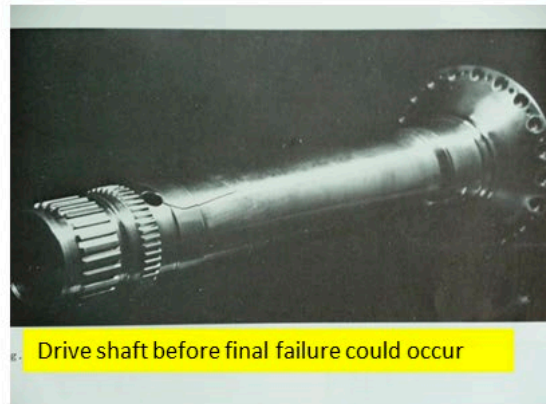
- 20% thicker shaft
- 100% thicker shaft
- **But: this did not work; even more failures occurred.**

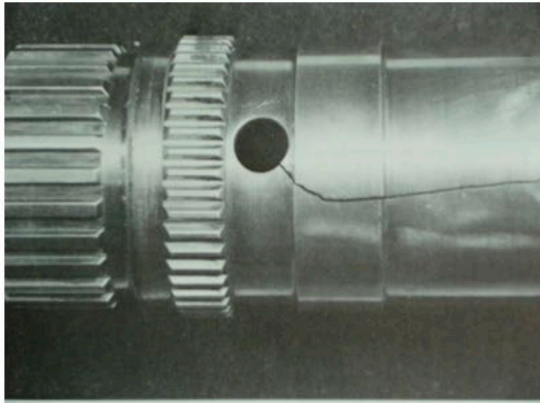
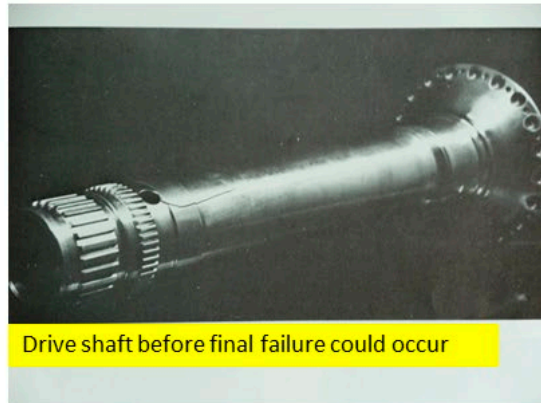
## Fatigue failure in drive shaft

After extensive and expensive in-flight measurements on instrumented engine, done by Netherlands Air Force/NLR, it became clear that rumble in afterburner (with same frequency as torsion frequency of shaft) caused high torsional stresses at vent hole

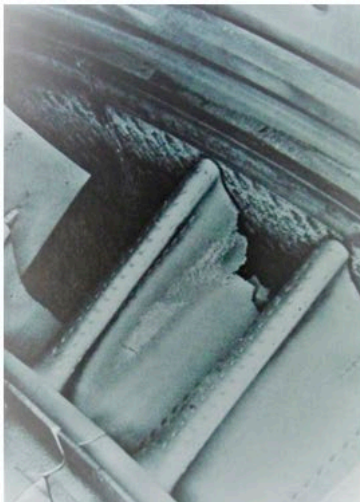
Broken and damaged 1<sup>st</sup> stage turbine blades in civil aircraft engine

- ceramic core shift during casting leading to thin leading edge convex walls
- acid stripping of old coating during repair: leading to cooling hole enlargement
- reduced internal blade pressure (total airflow restricted); ineffective cooling

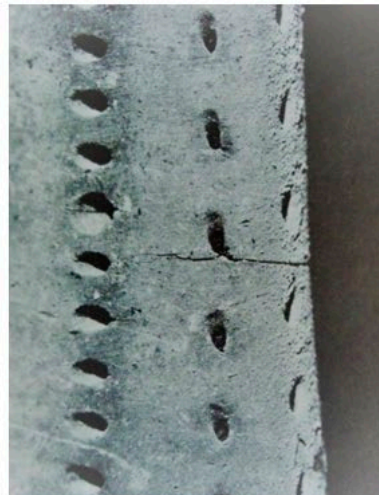
Detail of crack formation in leading edge of 1<sup>st</sup> stage turbine blade

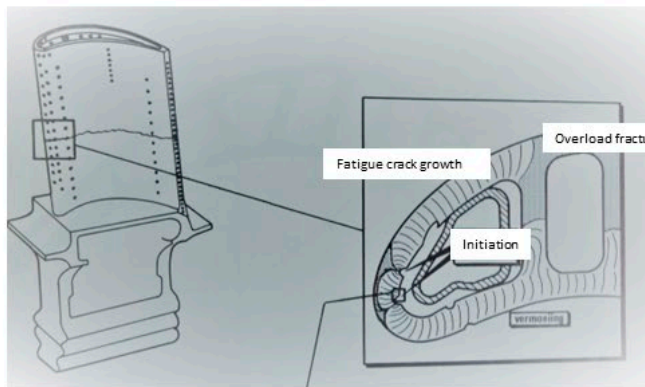
Crack initiation, fatigue crack growth and overload fracture

## Increased stresses resulted in LCF crack initiation and blade failure by HCF

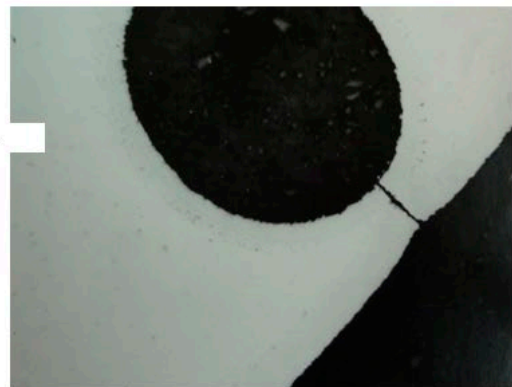
Crack initiation at location where film cooling hole intersects blade wall

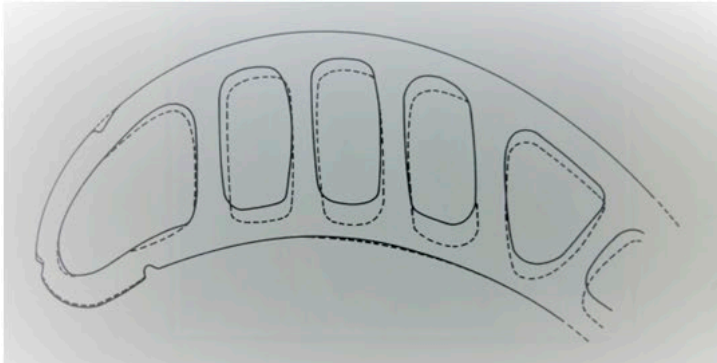
Shift in location of internal cooling circuit for 2 different blades

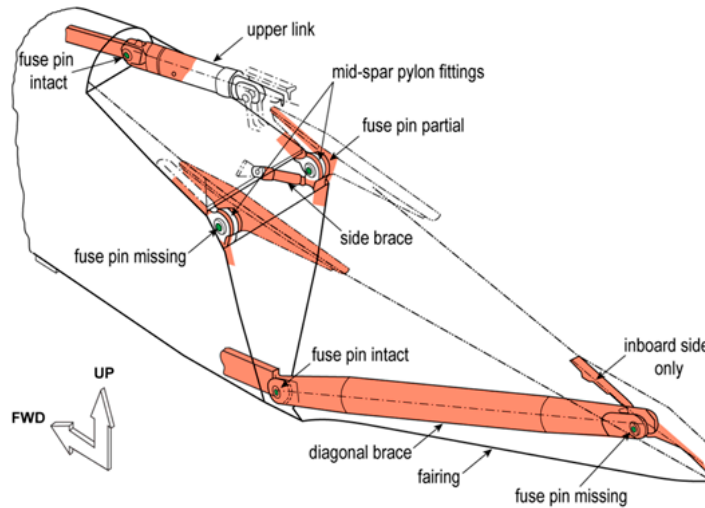
## Recovered components from engine 3 pylon-to-wing connections

The design and certification of the B 747 pylon was found to be inadequate to provide the required level of safety. Furthermore, the system to ensure structural integrity by inspection failed.

This ultimately caused - probably initiated by fatigue in the inboard midspar fuse-pin - the n°3 pylon and engine to separate from the wing in such a way that the n°4 pylon and engine were torn off, part of the leading edge of the wing was damaged and the **use of several systems was lost or limited**.

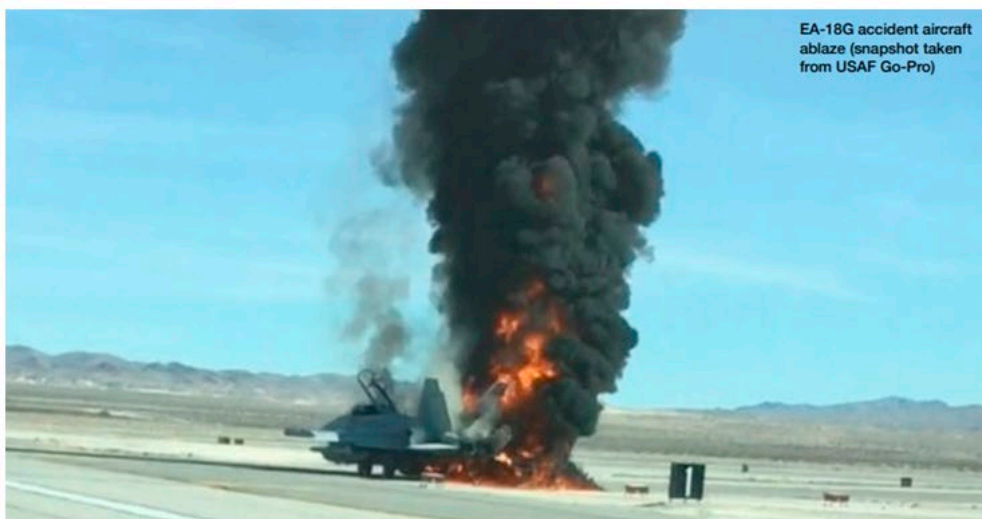
**The aircraft experienced an uncontained F414 engine fan disc failure during the latter stages of its take-off roll at Nellis AFB.**

**The righthand engine failed; uncontained material from that engine caused the simultaneous failure of the lefthand engine and a fierce fuel/airframe fire.**

EA-18G accident aircraft ablaze (snapshot taken from USAF Go-Pro)

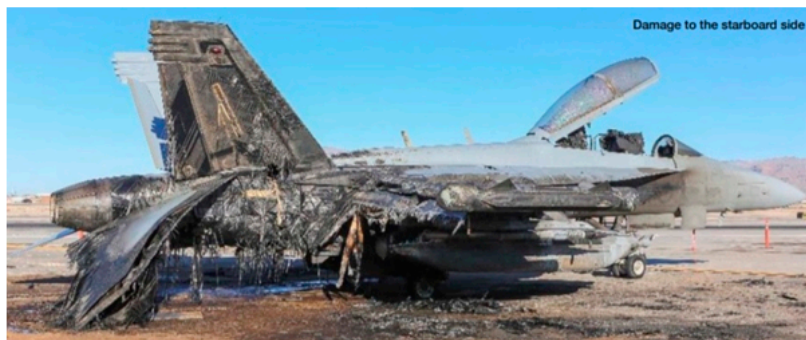
### Cause of failure: uncontained Ti fan disc failure

The uncontained failure of the 1st stage fan disc was considered to be an unusual event by metallurgists. Subsequent discussions with the OEM sub-contractor responsible for producing the 1st stage fan disc forgings revealed that they had previously experienced three cracked forgings during manufacture, affirming the conclusion that the failure of A46-311 engine component was introduced during the forging process.
