NLR-TP-98013

Non destructive investigation of the condition of gas turbine blades

H.J. Kolkman and G.A. Kool

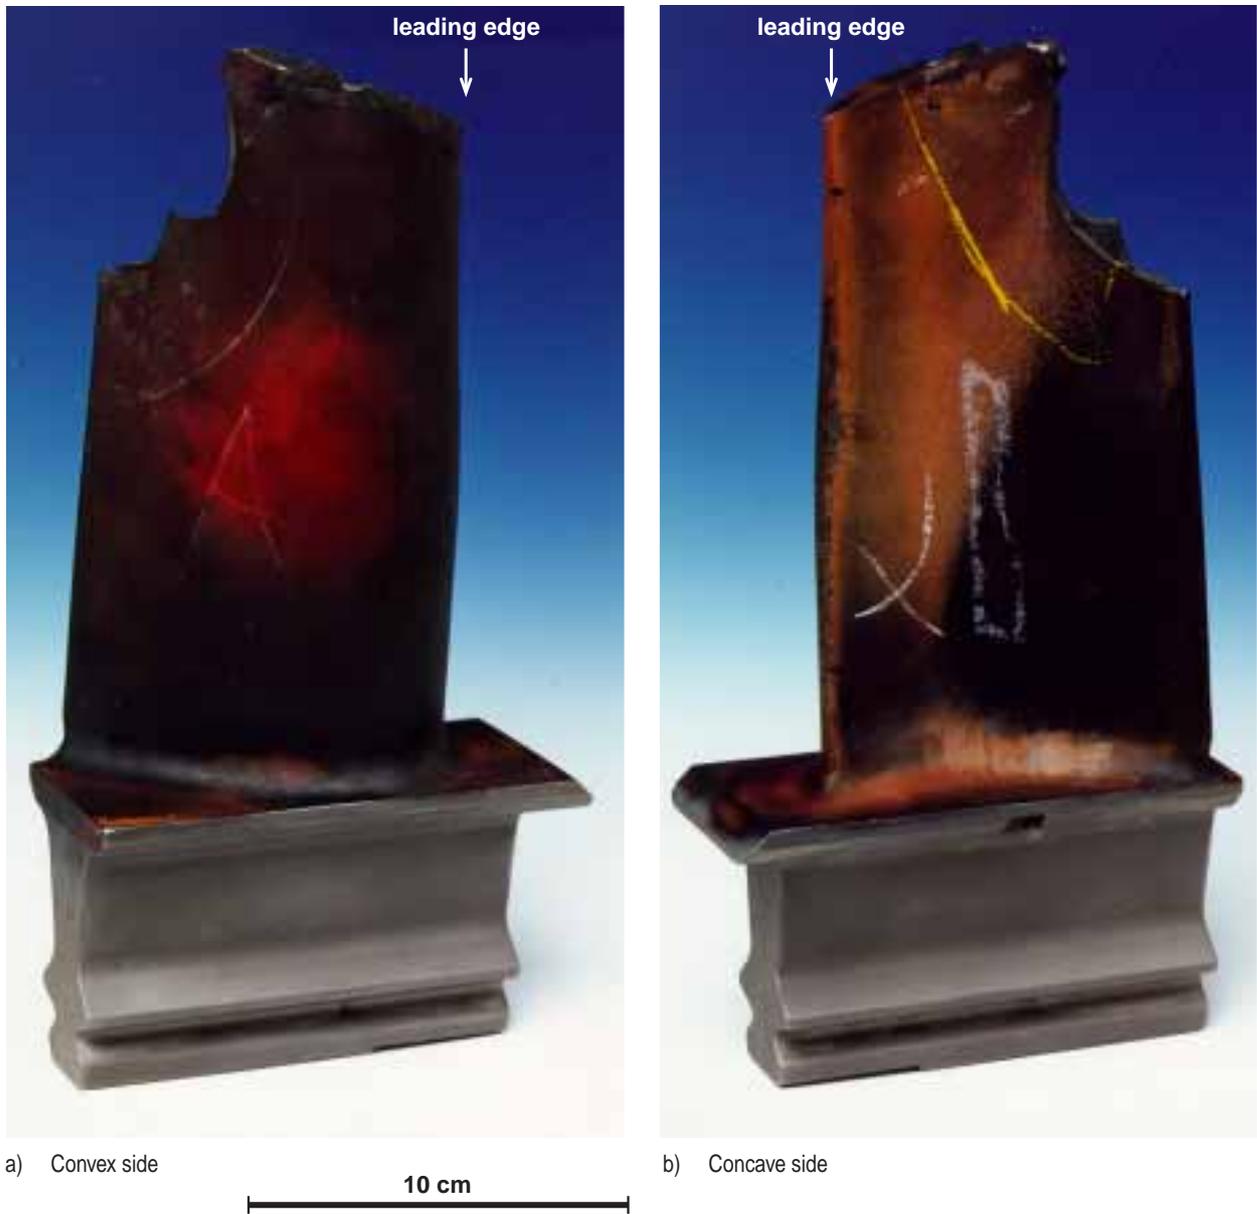
Fig. 1 shows a first stage gas turbine blade (bucket) after $\approx 15,000$ service hours and 1600 starts. Apparently a part of the tip has been removed by FOD (Foreign Object Damage). From a technical point of view repair is feasible. This can be done by building up the tip by welding followed by reprofiling and recoating. A certain decrease of the mechanical properties of the repaired area is acceptable, since the service stresses (mainly caused by centrifugal loading) are relatively low in the tip. Whether repair is economically attractive depends on the remaining

A serviced first stage turbine blade (Fig. 1) was made available by Stadtwerke München via Elbar. The blade was coated with a chromium diffusion layer; the substrate was IN 738. The blade had been in service for 15,329 h. The turbine inlet temperature was 920 °C. For the sake of clearness, all results presented here refer to this blade, but the procedures adopted was successfully applied to other blade and blade materials (such as the superalloy GTD 111). The blade was cut up in several pieces for destructive and non destructive investigation.

The γ' spheres at the leading edge at midspan have coarsened slightly (as compared with the root). It follows from this coarsening (Table 1) and the aforementioned service life that the rate constant $K(T)$ in eq. (1) is $0.12 \text{ nm s}^{-1/3}$. The lowest value found for IN 738 in the literature was 0.37 for 750 °C in [7]. Hence the service temperature for the blade shown in Fig. 1 was lower than 750 °C. This can be regarded as a very low temperature.

Fig. 1 Macrographs of the first stage gas turbine blade investigated.

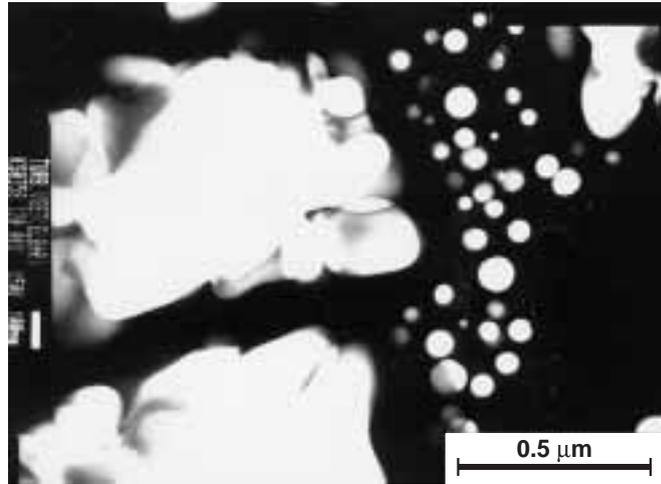
In order to provide reference data for the NDI methods, TEM (Transmission Electron Microscopy) of thin foils was applied. As exemplified in Fig. 4, the dark field technique provides sharp black and white micrographs that are very suitable for γ' sphere size measurements. Draw-backs are the time-consuming preparation of thin foils and of course the destructive nature of the technique.

Fig. 4 Destructive investigation: dark field TEM micrograph of thin foil taken from IN 738 blade root. Note the relatively coarse γ' cuboids on the left-hand side and the fine γ' spheres on the right-hand side.

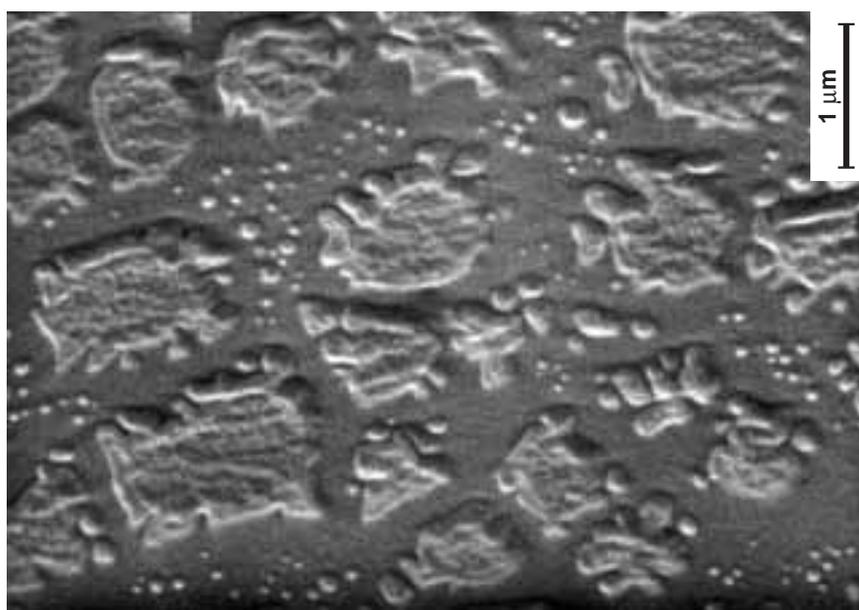
- c) single-stage replica investigated by means of SEM
- c) einstufiger Oberflächenabdruck beobachtet mit REM

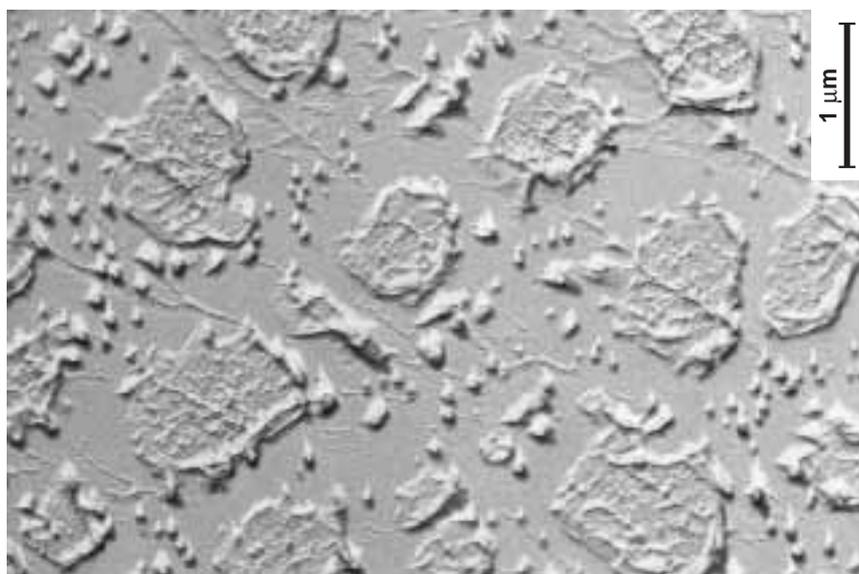
- b) two stage replica investigated by means of TEM
(shadow direction from left to right)
- b) zweistufiger Oberflächenabdruck beobachtet mit TEM
(Beschattungsrichtung von links nach rechts)

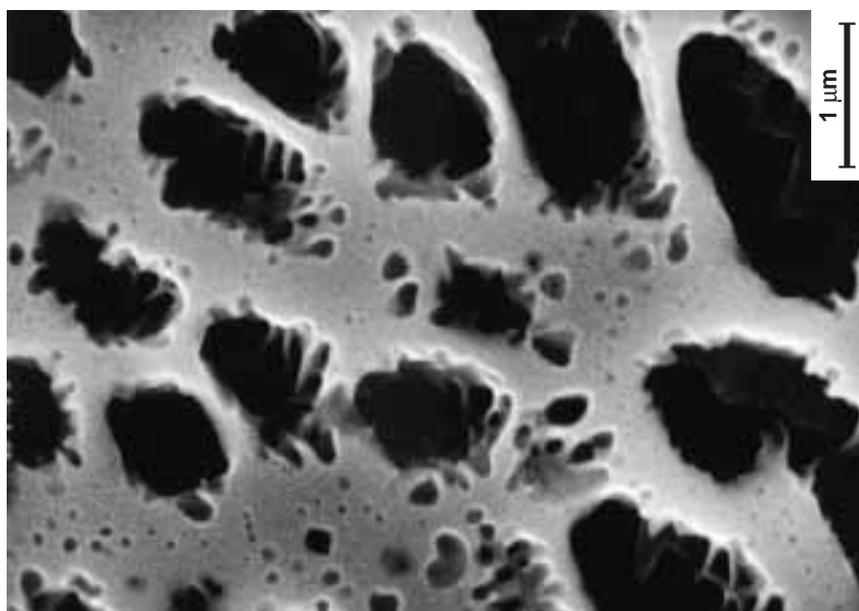
The other NDI methods produced satisfactory micrographs as exemplified in Fig. 6. The SEM technique is well-known. One of the SEM's used has a specimen room that can accommodate a blade as shown in Fig. 1. Nevertheless direct SEM observation (Fig. 6a) of complete blades in SEM gives problems with specimen manipulation and hence cannot be regarded as a practical method.

- a) direct SEM observation of etched surface
- a) direkte REM Beobachtung einer geätzten Oberfläche

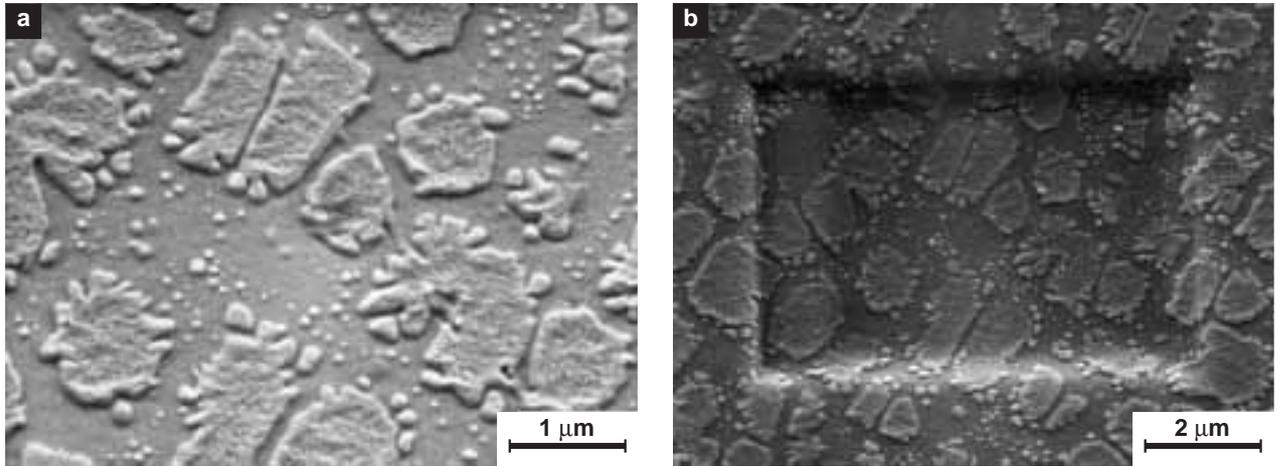
The main problem with single-stage replicas turned out to be heating (and consequently deformation) of the replica during SEM observation. An example is shown in Fig. 7. This problem was overcome by:

Fig. 7 SEM micrograph of single-stage replica. During photographing at high magnification (figure 7a) the illuminated area was deformed by heating up the electron beam as seen at lower magnification in figure 7b.

- * Focusing and correcting for astigmatism at another location than where the micrograph was made.
This is not a serious draw-back since the γ' distribution should be more or less the same everywhere.
- * A delicate combination of the thickness of the layer sputtered for electrical conductivity, the accelerating voltage and the beam current.

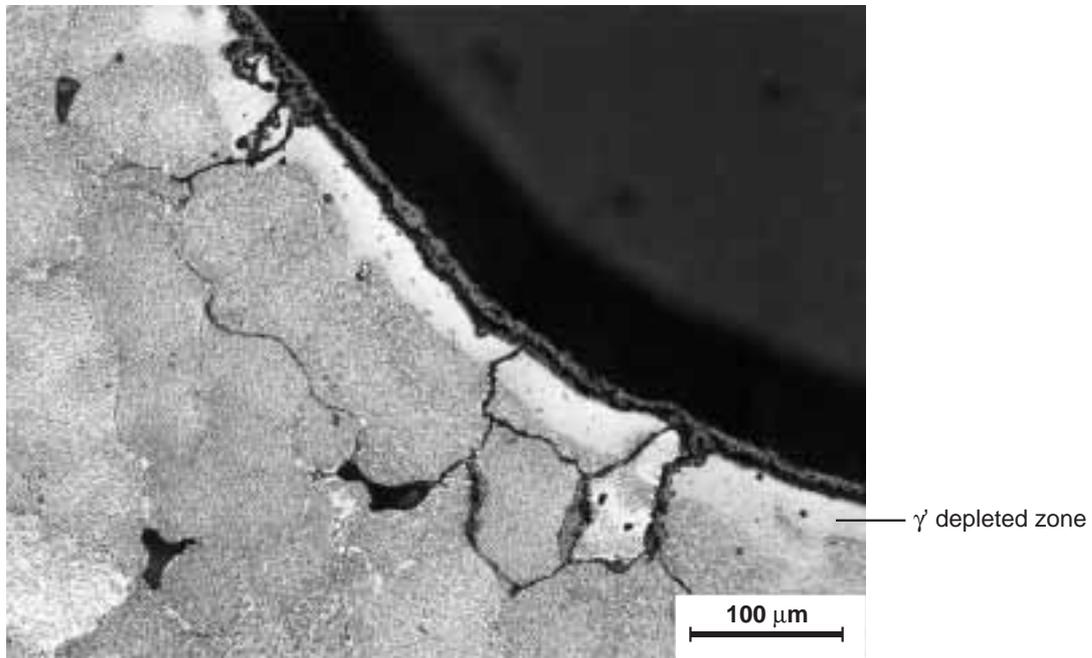
locations per blade. In the next phase of the project the residual lives will be determined. Despite the aforementioned low service temperature the internal surfaces of the hollow blade exhibited severe degradation, see Fig. 8. Therefore a following project will be devoted to internal coating.

Fig. 8 Optical micrograph of the (uncoated) internal surface of the blade shown in figure 1. Note the corrosion layer, the γ' depleted zone and the intergranular cracks. In contrast to this degradation, the external surface was protected well by the coating.
