NLR-TP-99408

Corrosion and fatigue assessment of aircraft pressure cabin longitudinal lap splices

This paper has been prepared for publication in the proceedings of the 5th International Aerospace Corrosion Control Symposium, 3-5 November, 1999, Amsterdam.

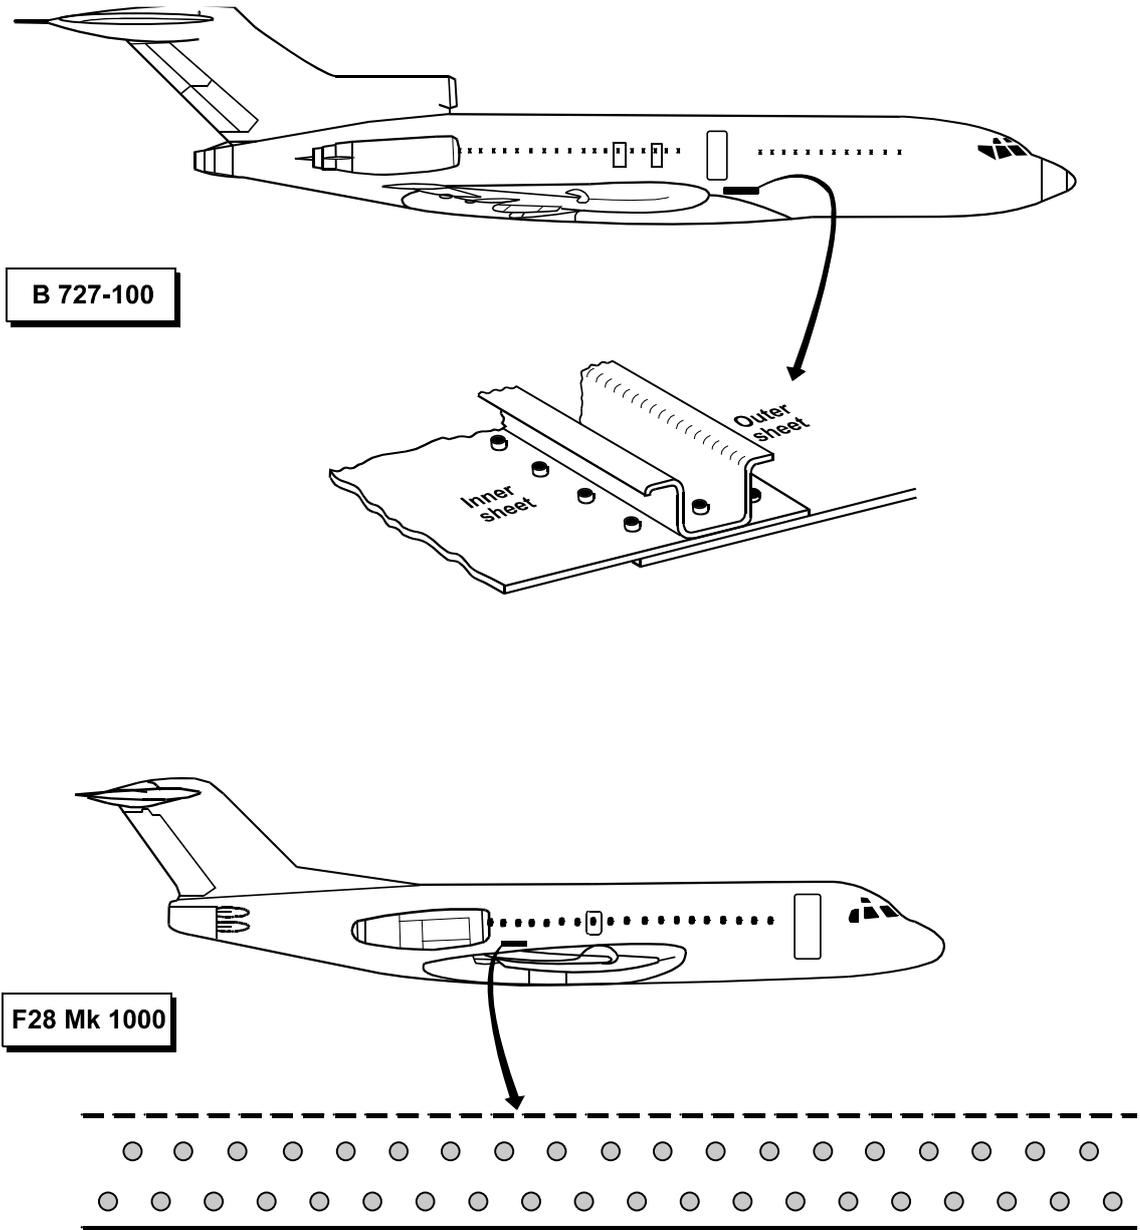
The F28-1000 lap splice sample was a strip 165 cm long containing about 200 rivets. The sample had been removed from the location shown in figure 1, owing to excessive *externally* visible corrosion. This had previously led to the lap splice outer sheet being “cleaned up” to a depth of about 0.25 mm, reducing the sheet thickness from 1.2 mm, figure 3, to less than 1 mm. The lap splice was disassembled and examined by the NLR for cracks. The procedure is given in table 3.

Fig. 1 Positions of the corroded lap splices

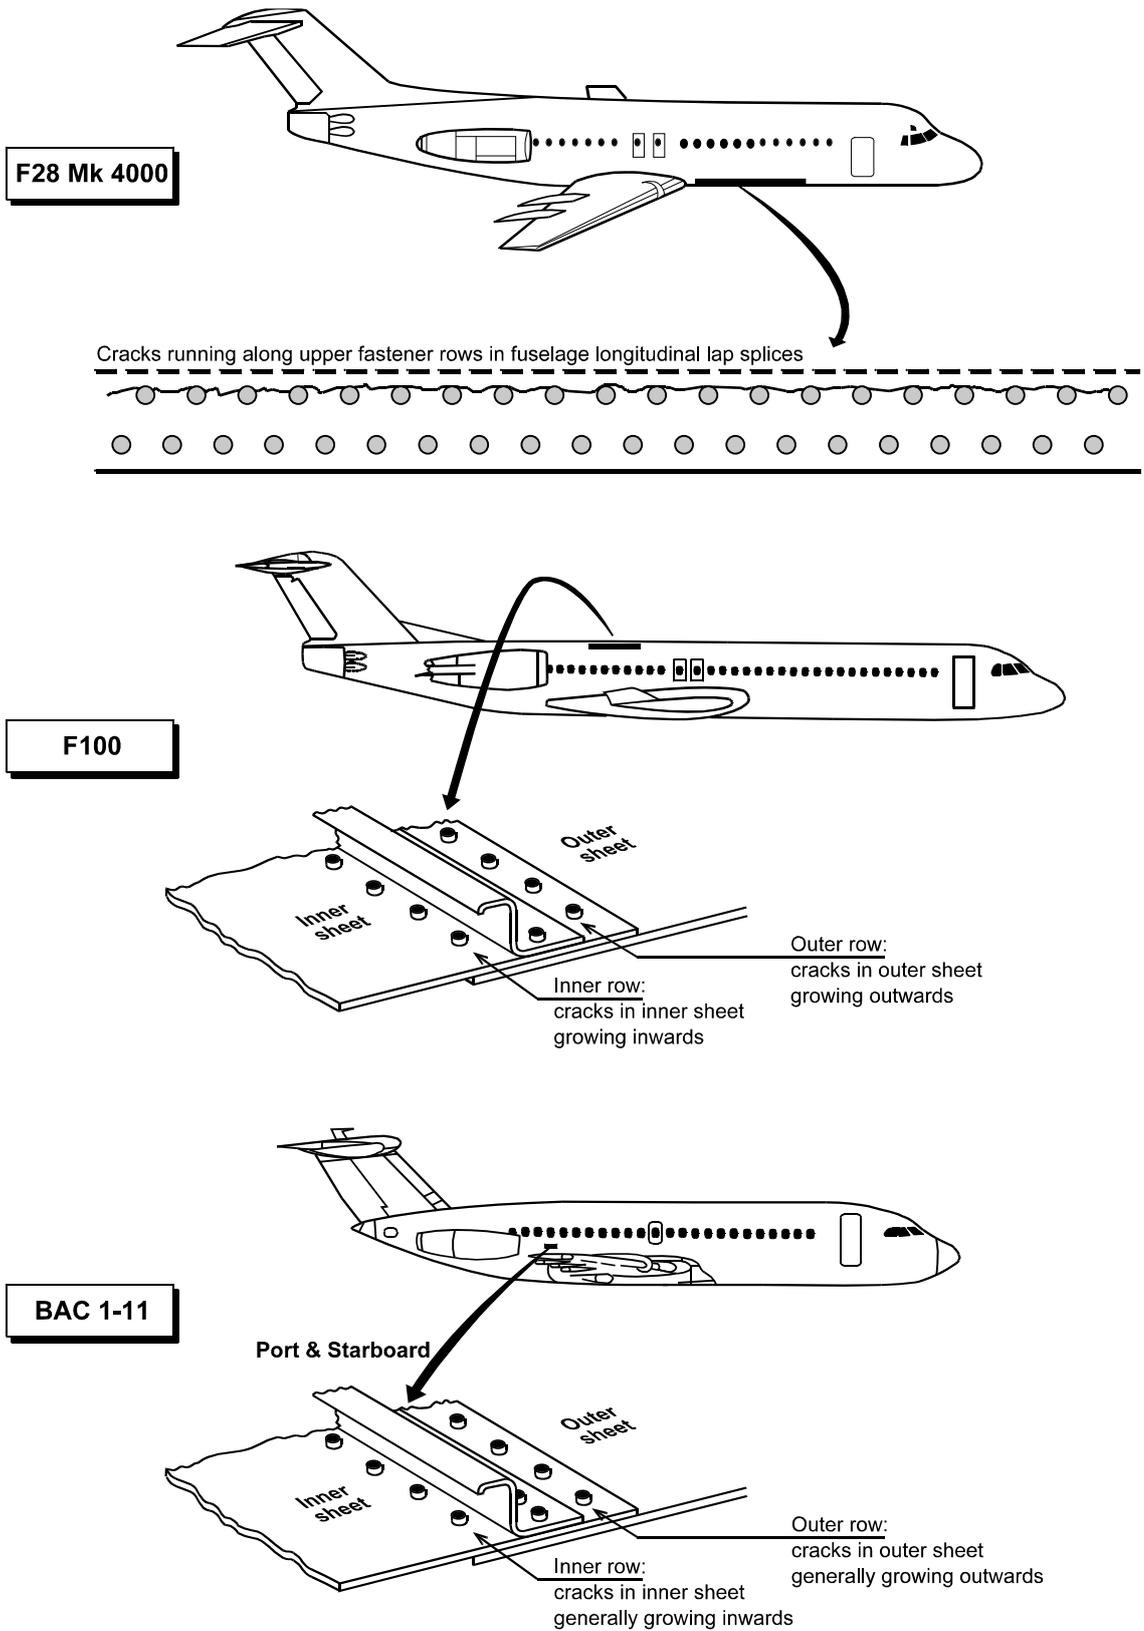
Fatigue assessment was to determine the MSD locations, any environmental (corrosion) influences on fatigue crack initiation and growth, crack initiation lives and early crack growth rates. The F28-4000, F100 and BAC 1-11 lap splice samples were macroscopically examined before being disassembled. As expected (6), the most MSD-susceptible rivet row in each sample was the upper one in the outer sheet. However, other rivet rows were also susceptible, notably the lower one in the inner sheet, see figure 2.

Fig. 2 Positions of the MSD fatigue cracked lap splices

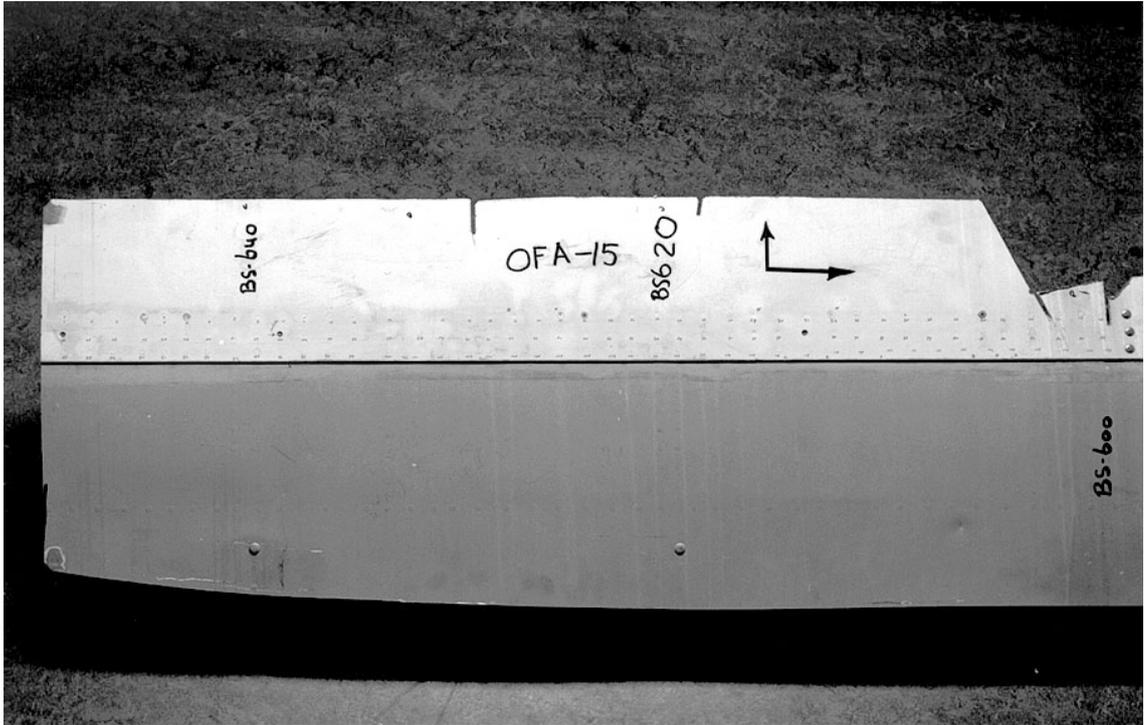
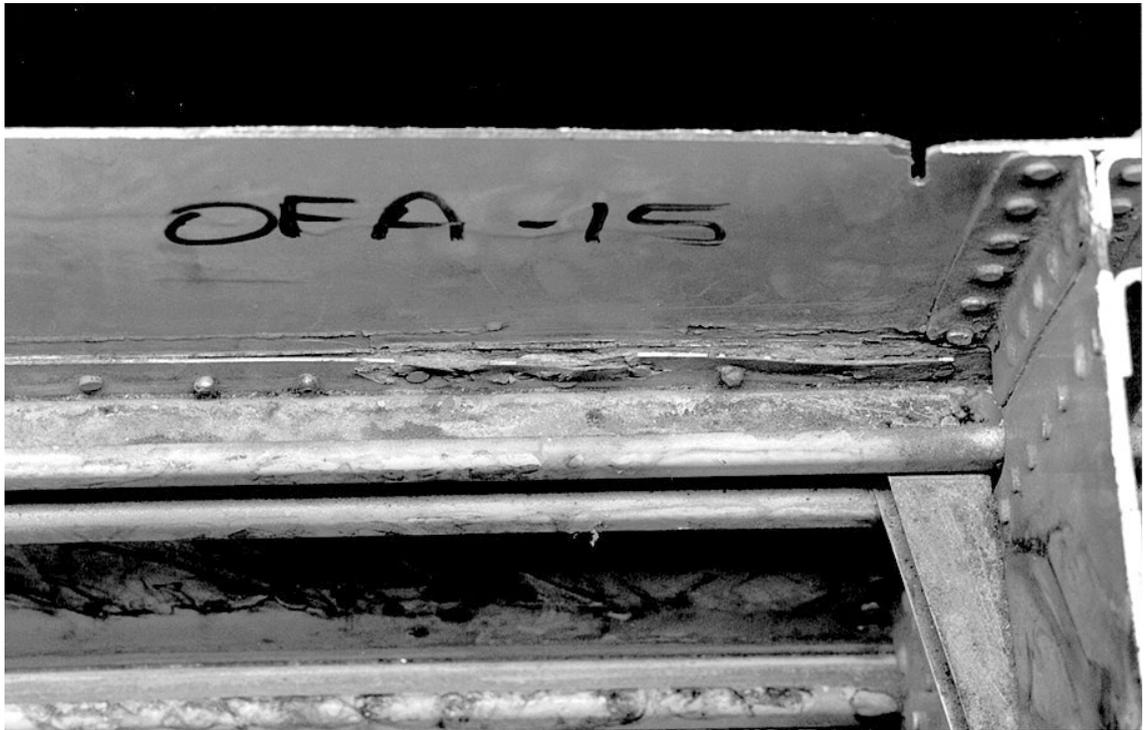
The B 727-100 lap splice sample was provided by the Institute for Aerospace Research (IAR) in Ottawa, Canada. The sample was one of several taken from aircraft inspected with the D Sight Aircraft Inspection System (DAIS) (2). Figure 4 gives an external overview of the sample and a detail of the *internally* visible corrosion. The corrosion appeared to be concentrated along the upper side of the lap splice/stiffener connection, but the DAIS showed that corrosion-induced “pillowing” was present throughout the lap splice, figure 5.

Fig. 4 Overview of the B 727-100 lap splice sample and detail of the internally visible corrosion along the upper side of the lap splice/stiffener connection

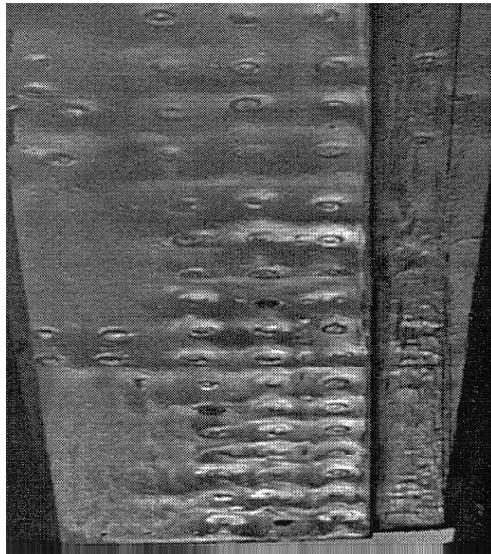
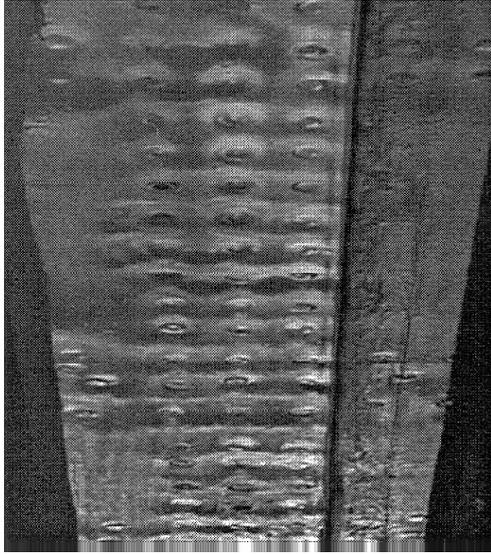
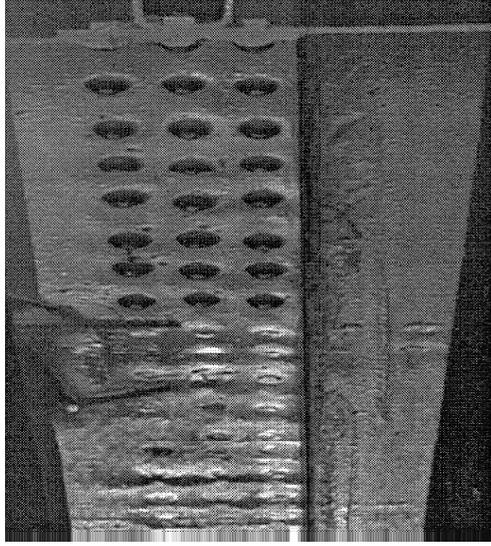
- (3) Only the severest cracking, along the upper rivet row (with one exception), was detected by X-ray radiography and eddy current non-destructive inspections.
- (4) Comparison of figure 5 with figures 7-9 seems to indicate that the DAIS is more sensitive to detecting severe corrosion than eddy current. Cracks due to severe corrosion were found just forward of BS640 and outside the area of severe corrosion determined visually and by eddy current, while the left-hand DAIS image in figure 5 clearly shows corrosion pillowing just forward of BS640.

Fig. 5 DAIS imaging of corrosion-induced pilling of the B 727-100 lap splice: images courtesy of the IAR. BS = Body Station

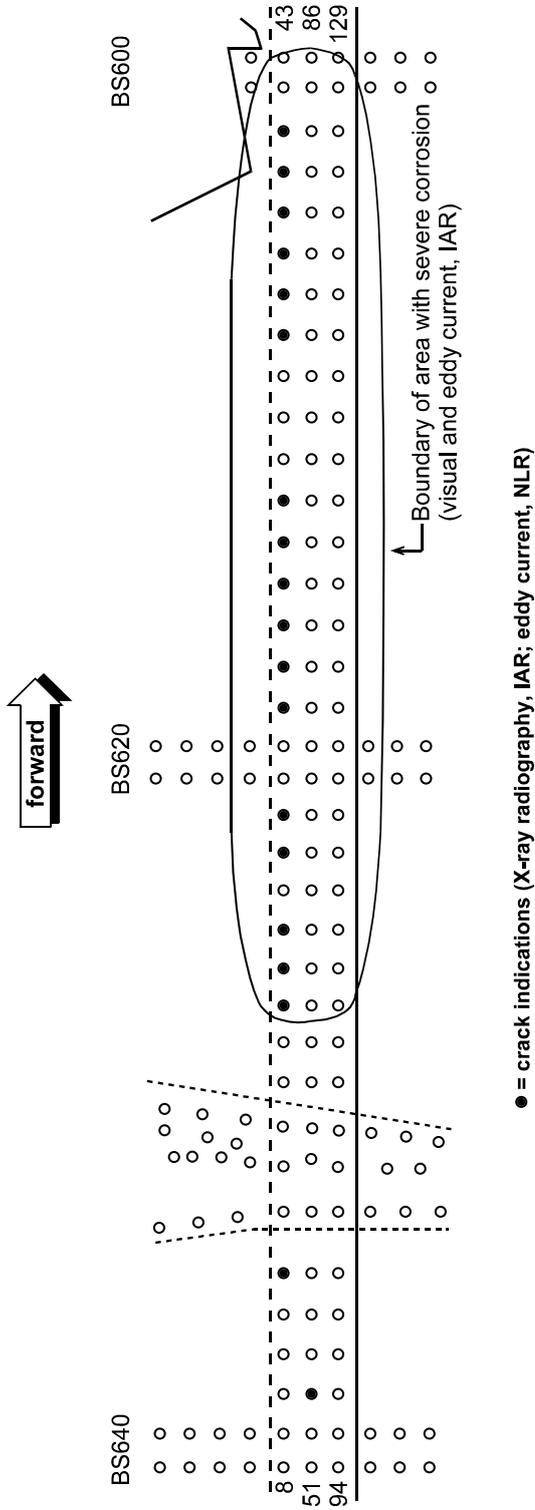
severely corroded area and any cracking associated with rivet locations along the lap splice. The severe corrosion was found to be in a well-defined area covering all three rivet rows of the lap splice. However, the crack indications were almost all confined to the upper rivet row: only two indications were outside the severely corroded area.

Fig. 6 Schematic of the results of the B 727-100 lap splice non-destructive inspections to determine (a) the severely corroded area, and (b) any cracking associated with rivet locations along the lap splice. The numbers at both ends of each rivet row indicate the chosen sequence of rivet numbering. BS = Body Station

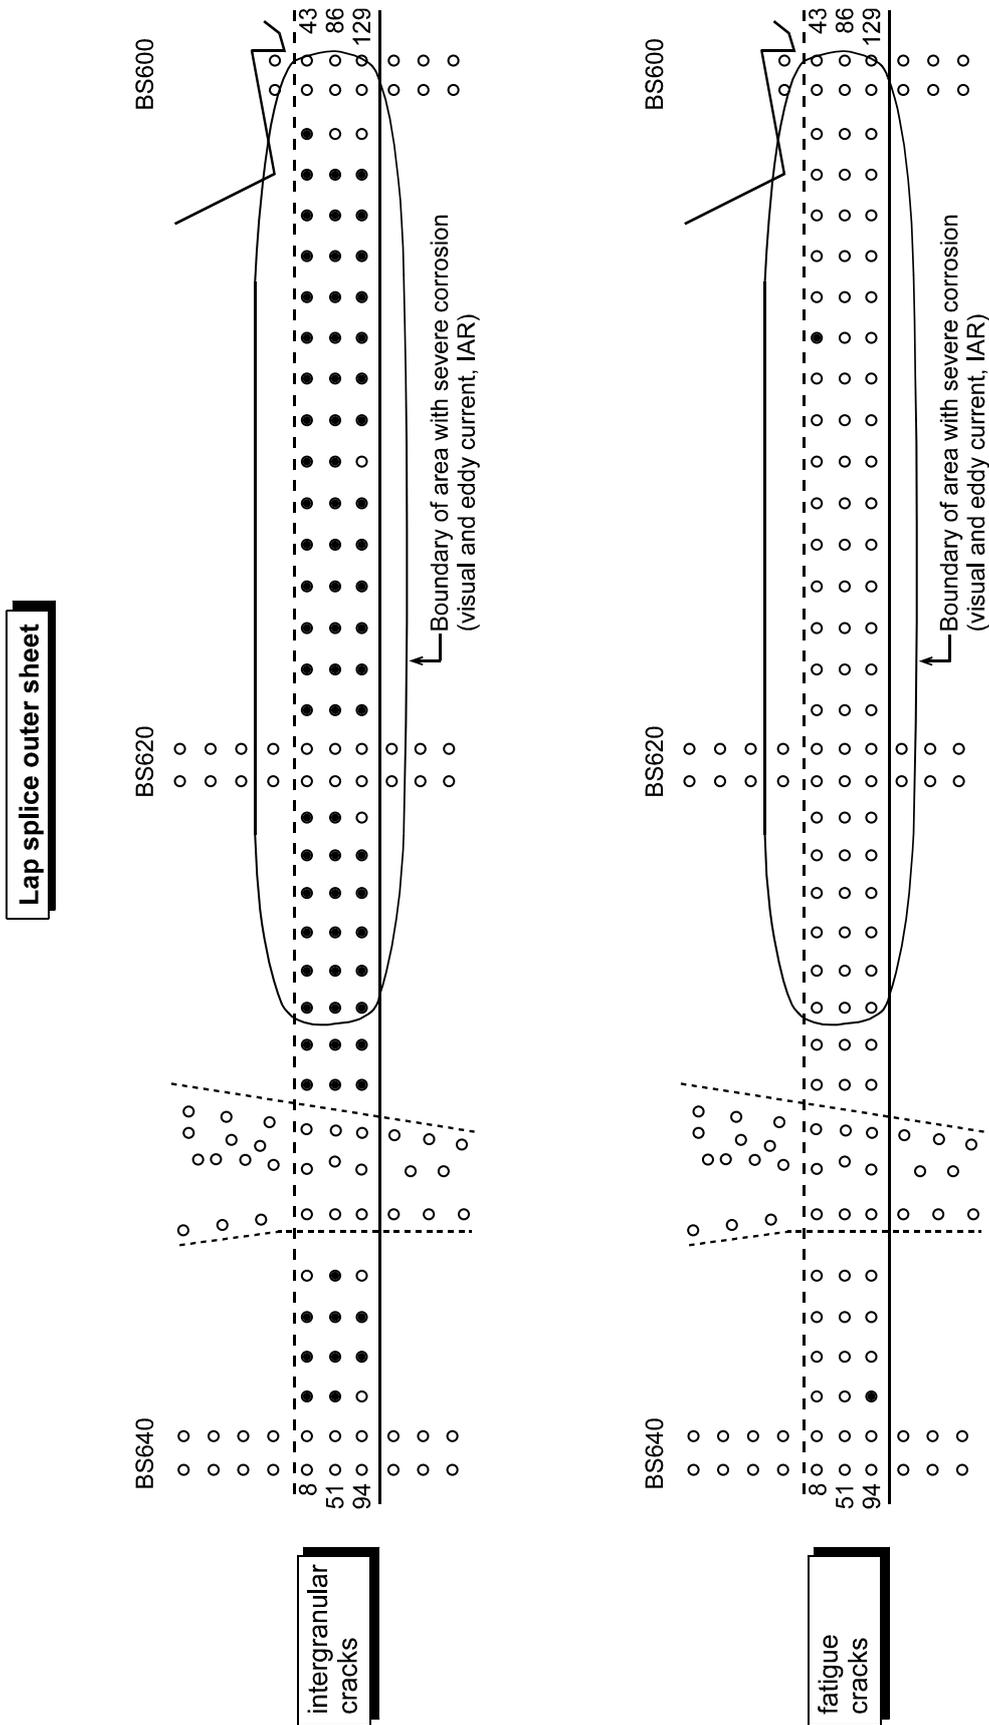
Figures 7 and 8 show the types and locations of cracks found in the outer and inner sheets of the lap splice (no cracks were found in the stringer base) and figure 9 compares the results of disassembly with those of non-destructive inspection. There are four main points to note:

- (1) Almost 95 % of the cracking, in terms of crack locations, was intergranular owing to exfoliation corrosion and stress corrosion, the latter especially as corrosion products built up between the sheets to cause locally high stresses (5). Some of the larger intergranular cracks were associated with small, secondary fatigue cracks. These usually initiated from intergranular cracking, but sometimes occurred directly from rivet holes, without any evidence of fatigue initiation due to local corrosion (pitting). Figure 10 shows examples of these associations.
- (2) The rivet hole locations determined to be only fatigue cracked showed no evidence of fatigue initiation due to local corrosion (pitting). These cracks will be discussed further in the FATIGUE section of this paper.

Fig. 7 Schematic of the results of the B 727-100 lap splice disassembly and examination for the outer sheet. BS = Body Station

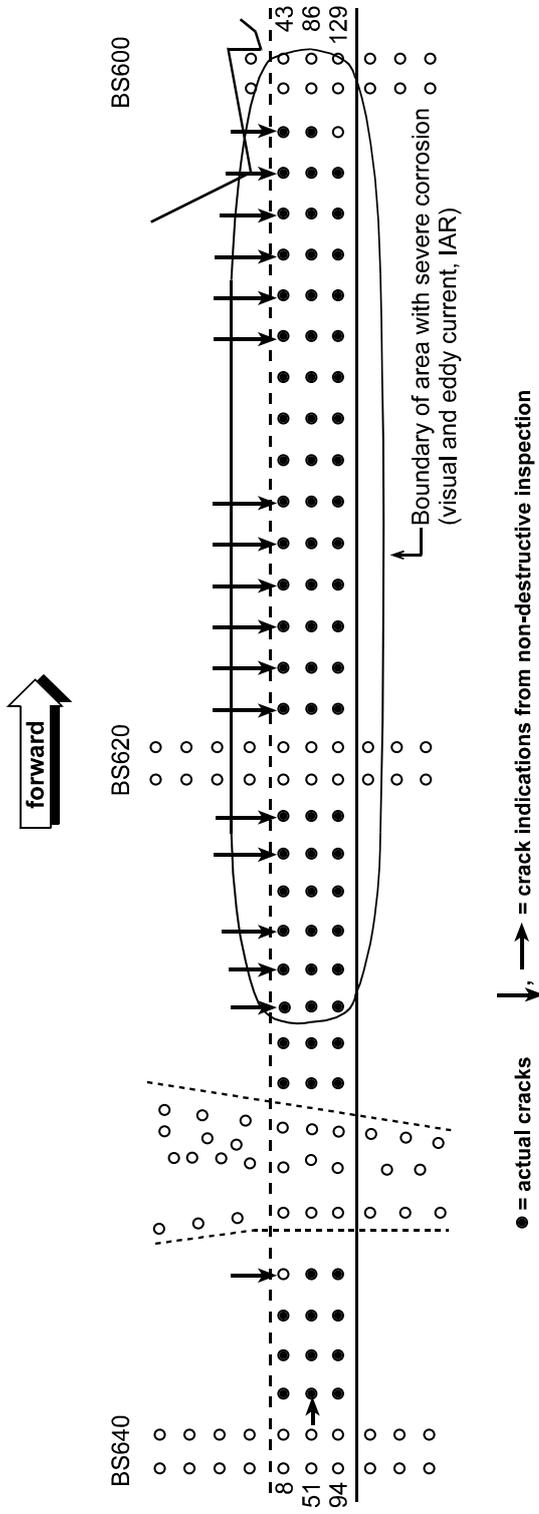
Fig. 9 Schematic comparison of the results of the B 727-100 lap splice disassembly and examination for cracks and the crack indications from non-destructive inspection. BS = Body Station

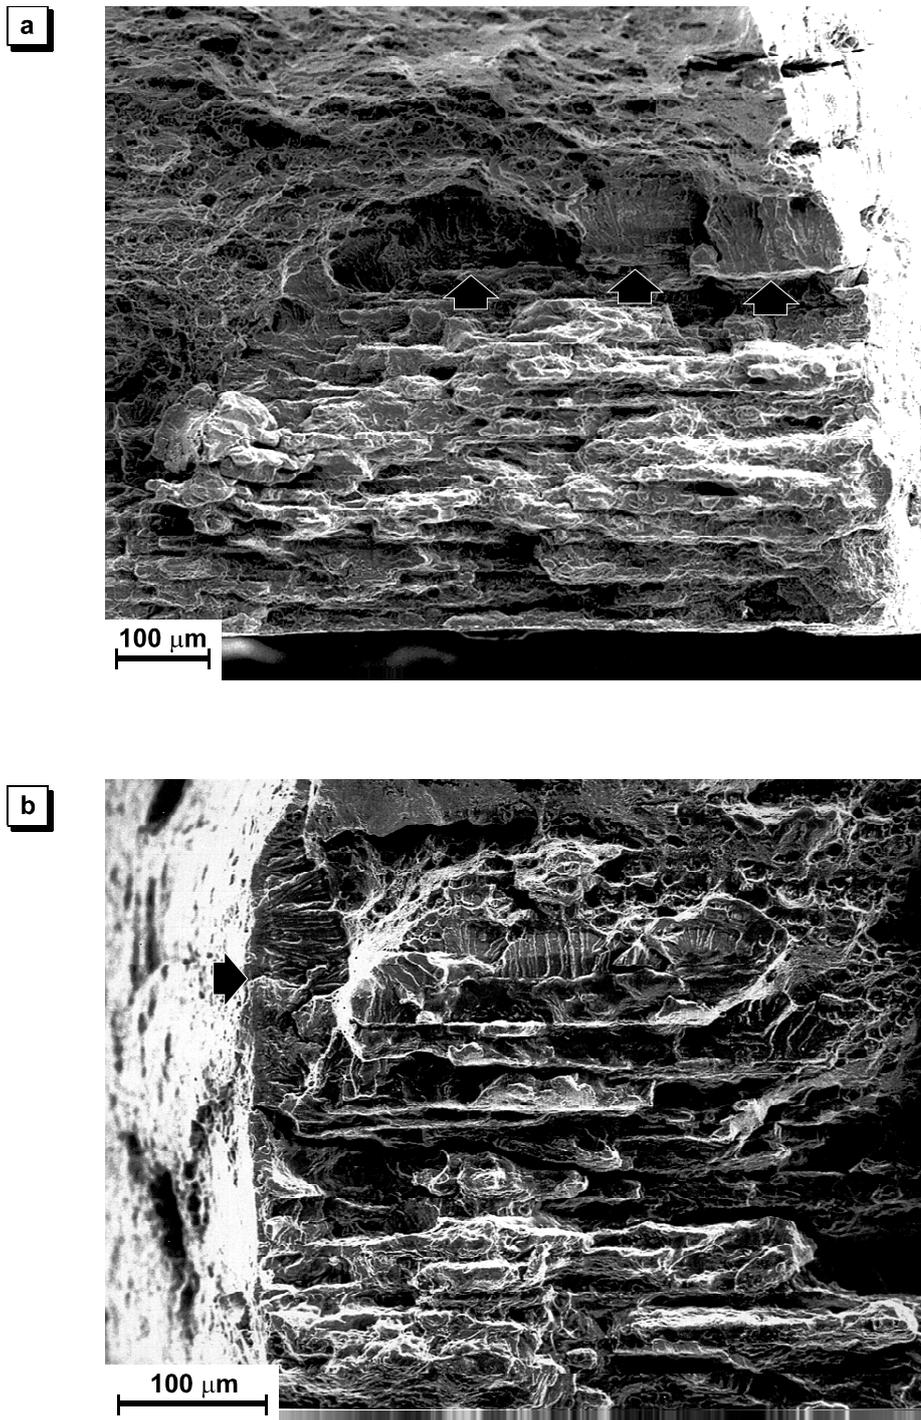
Fig. 10 Intergranular cracks with secondary fatigue cracks initiating (a) from intergranular cracking and (b) from a rivet hole: Boeing 727-100 lap splice outer sheet. Arrows point to fatigue cracks and their growth directions

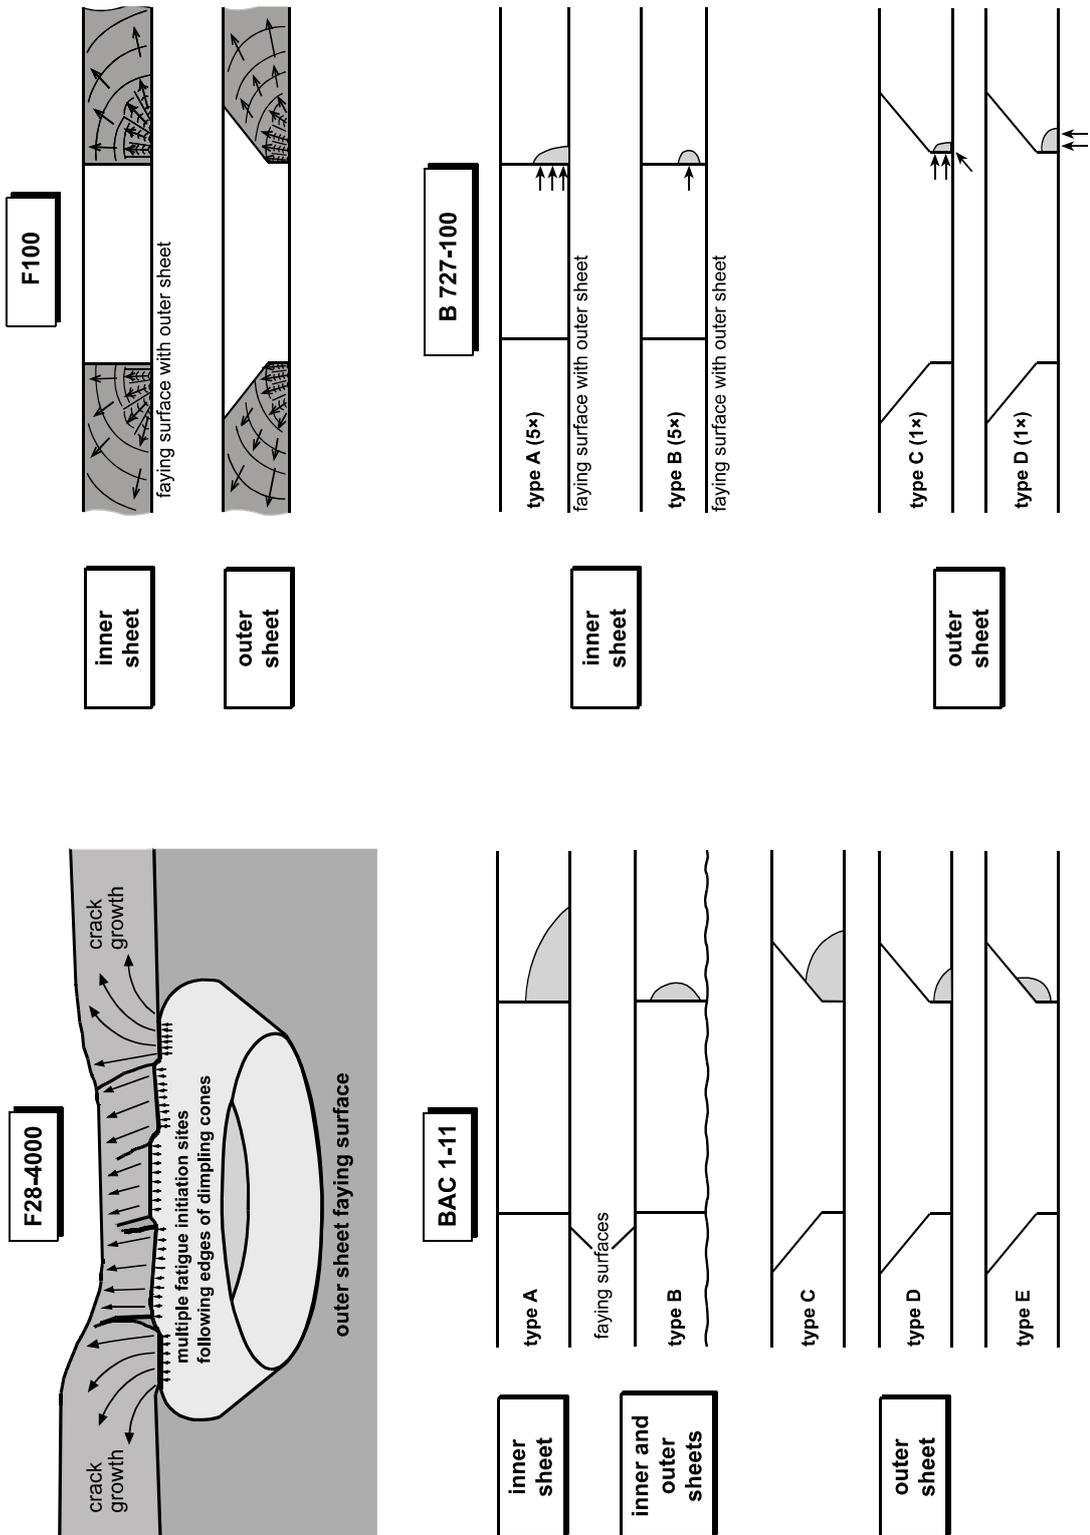
Figure 11 shows the characteristic MSD fatigue crack locations and shapes in the F28-4000, F100 and BAC 1-11 lap splice samples. These will be discussed separately, followed by a summary.

- (1) F28-4000 service aircraft: The total lengths of MSD were 530 mm and 330 mm for aircraft [1] and [2] respectively. The fatigue cracks initiated at numerous sites along the faying surface edges of the outer sheet dimpling cones, see figures 3 and 11. The cracks were mechanically induced: there was no evidence that corrosion played a role in initiation. The large number of initiation sites (many cracks initiating at each dimpling cone) suggests that fatigue cracking began soon after the aircraft entered service.

- (2) F100 full-scale test (indoors): The MSD extended over several frame bays having poor adhesive bond quality. The fatigue cracks initiated from the faying surfaces, mostly at multiple sites close to the rivet holes, see figure 11. There was no evidence of corrosion, as expected from a test indoors.

- (3) BAC 1-11 service aircraft: Two sections, port and starboard, of lap splices suspected to contain MSD were disassembled and the rivet holes *carefully* opened up (4). The MSD was found along about 500 mm of the lap splices. The fatigue cracks initiated at a variety of locations, see figure 11, though mainly at faying surfaces close to the rivet holes (types A, C and D). There was no evidence that corrosion played a role in initiation.

Figure 11 also shows the secondary fatigue crack locations and shapes in the B 727-100 cracked lap splice. Twelve small fatigue cracks were found at seven rivet hole locations, see figures 7 and 8. As mentioned earlier, these cracks showed no evidence of fatigue initiation due to local corrosion (pitting). Ten of the cracks, types A and B in figure 11, occurred inside the rivet holes

Fig. 11 MSD and secondary (Boeing 727-100) fatigue crack locations and shapes in the cracked lap splices

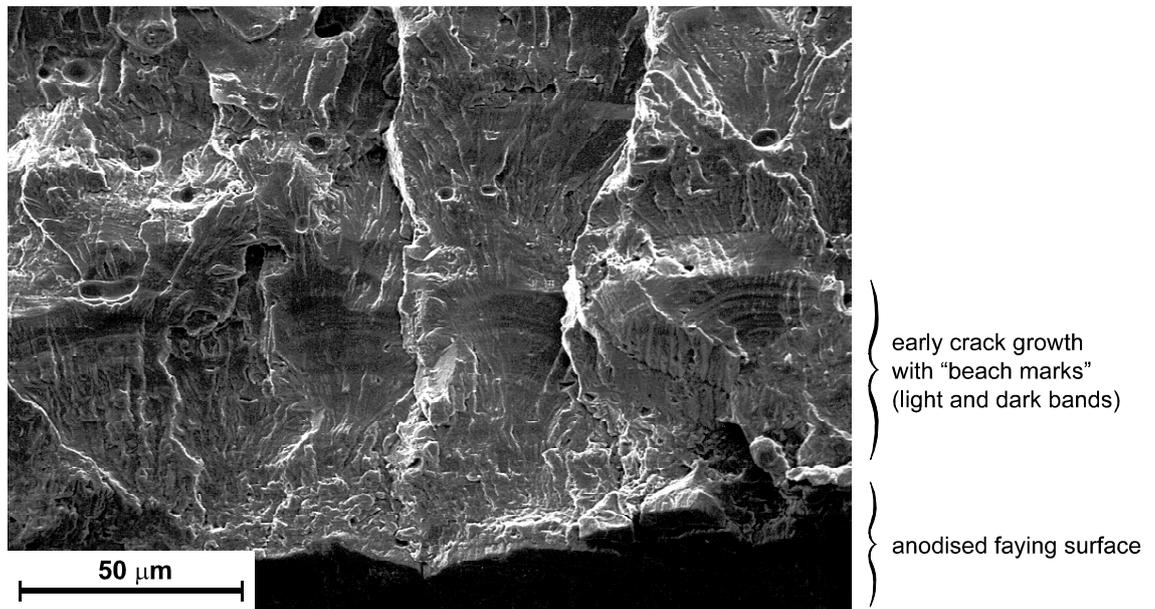
- (1) Figure 12 shows a particularly clear example of fracture surface “beach marks”. These sometimes occurred during early MSD crack growth in the F28-4000 and BAC 1-11 lap splices, and were usually present on the secondary fatigue fracture surfaces from the B 727-100 lap splice. The beach marks could well indicate periodic changes in the local environment (10). At least for the F28-4000 aircraft, it is certain that the beach marks were *not* due to variable amplitude loading, since the pressure cabins of these aircraft were subjected to the maximum pressure differential in each flight. Also the lap splice sample position, see figure 2, would not have been sensitive to gust loads.

Fig. 12 Multiple site MSD fatigue initiation and early crack growth in an F28-4000 lap splice

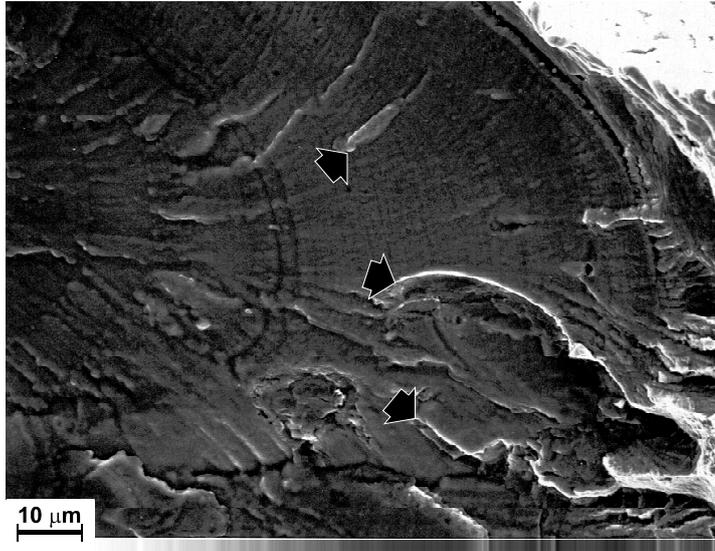
- (2) Figure 14 shows a secondary fatigue fracture surface from the B 727-100 lap splice, with special features (arrowed) similar to those found – albeit more abundantly – for corrosion fatigue at low stress intensities, figure 15.

By comparison with data in Ref. (9) the special features of secondary fatigue fracture in the B 727-100 lap splice suggest crack growth rates below 10^{-8} m/cycle. However, the fatigue striation spacings for the crack shown in figure 14 appeared (rather vaguely, owing to corrosion) to be more than $0.1 \mu\text{m}$, implying crack growth rates above 10^{-7} m/cycle. The reality of this “discrepancy” has not yet been checked, but it is much less important than the determination of early MSD crack growth rates.

Fig. 14 Secondary fatigue crack early growth in the B 727-100 lap splice. Arrows point to narrow elliptical and semi-elliptical features with major axes in the local crack growth direction
