Failure analysis of metallic materials: a short course

NLR-TP-2010-550

February 2011

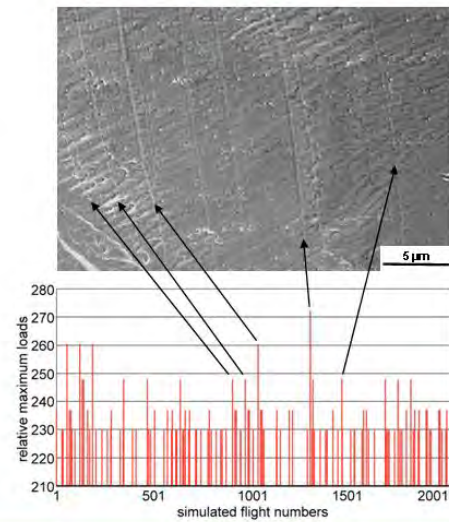
- Severe flight marker bands in window frame: aluminium alloy 7175-T73

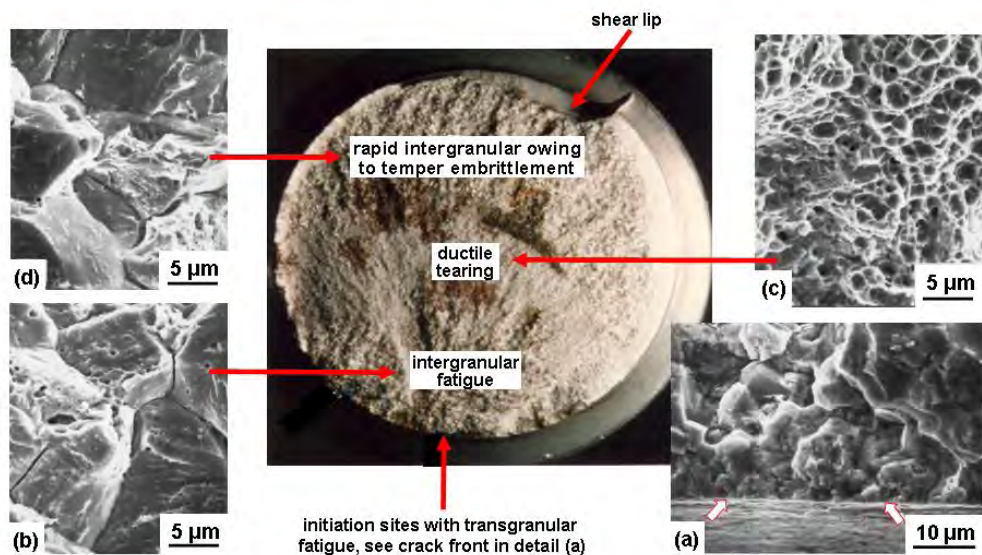
Cautionary Notes – IV: Combinations of fracture modes possible *(~ 8 mm diameter bolt made from tempered martensitic steel)*

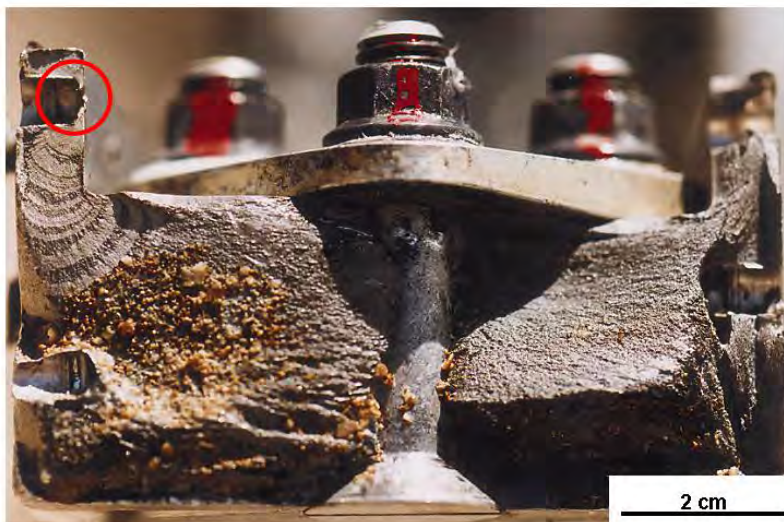
Inboard fracture surfaces of lower spar boom, aluminium alloy 7075-T6

Fatigue crack from (very) badly drilled fastener hole

Note fracture surface progression markings. These are important for **Quantitative Fractography (QF)** measurements of crack growth

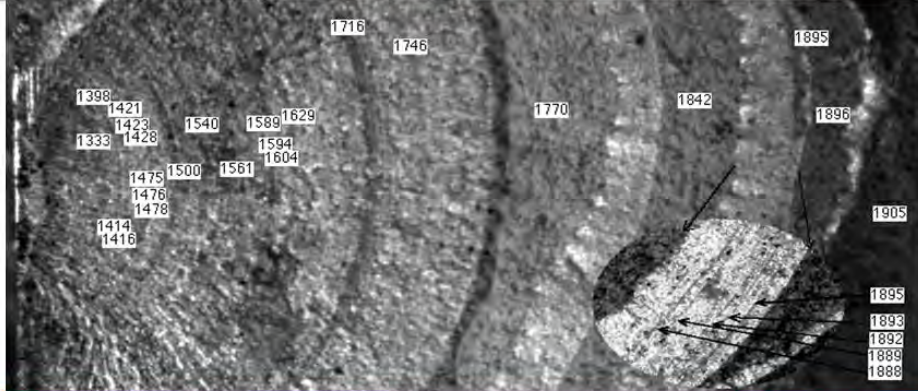
Growth of a *right wing* spar boom fatigue crack, tracked by correlating progression markings with G-meter data

● QF had to account for the complication of tensile crack extensions (darker grey areas) due to peak manoeuvre loads. These show up better optically compared to SEM fractographs

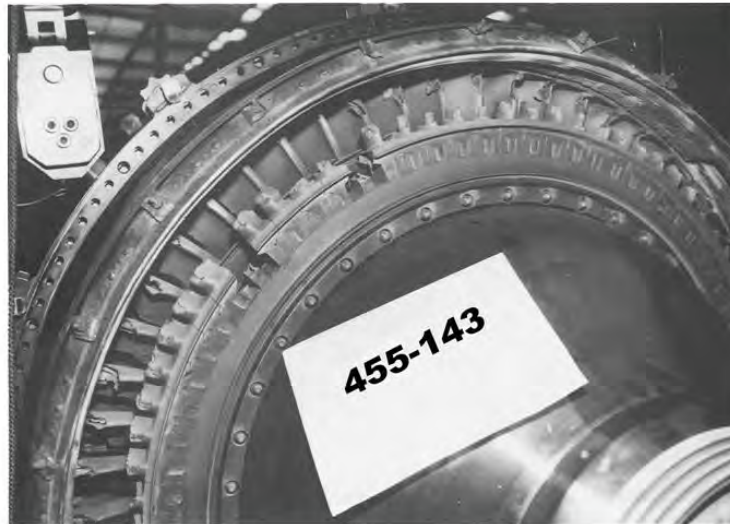
Example failure: engine 455-143, 17-05-1978

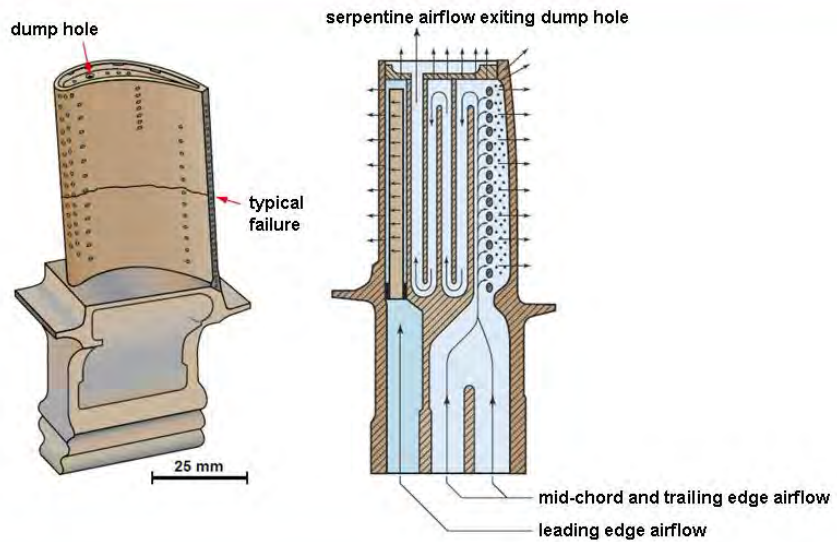
Schematics of typical blade failure and the internal cooling: cast René 80 nickel-base superalloy with a nickel aluminide coating

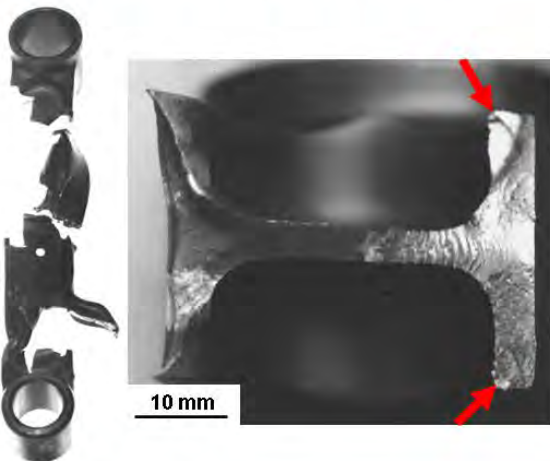
- Several engines failed with only one broken link rod and no fatigue

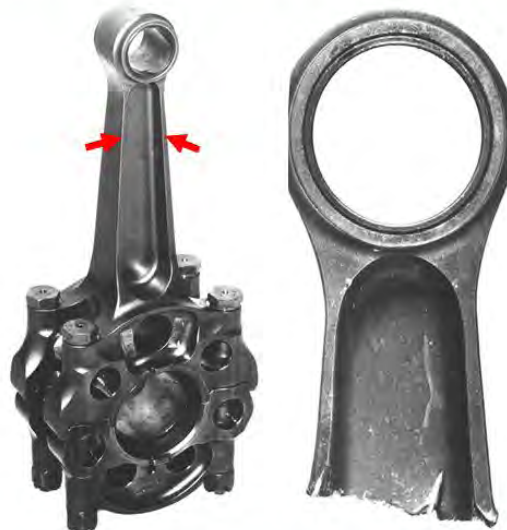
- One engine failure caused by fatigue of a master rod
- Progression markings indicated that fatigue cracking began after overhaul only 25 service hours earlier
- No associated failures of piston pins or wrist pins

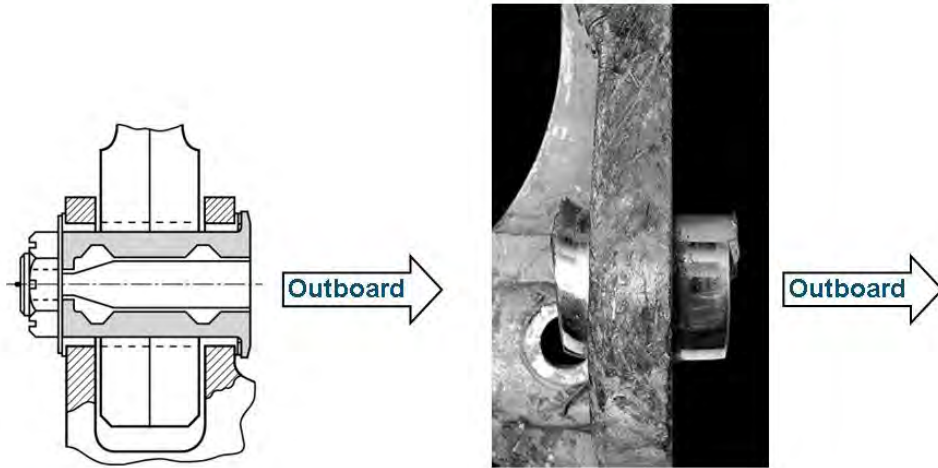
Engine 3 outboard mid-spar fuse pin schematic and remnant: medium-strength steel 4330M (126-139 ksi)

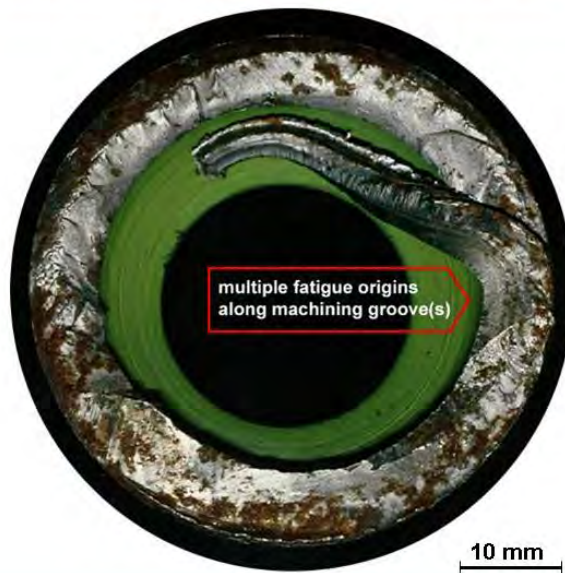
Engine 3 outboard mid-spar fuse pin outer fracture surface: medium-strength steel 4330M (126-139 ksi)

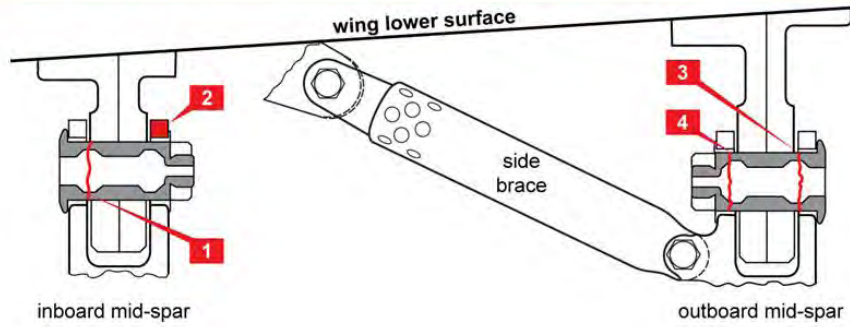
Most probable separation sequence for engine 3 and pylon

- **Inboard failure**
 - (1) Fatigue + overload of fuse pin inner thin-walled location
 - (2) Overload of outer lug
- **Outboard failure**
 - (3) Overload of already fatigue cracked fuse pin outer thin-walled location
 - (4) Overload of fuse pin inner thin-walled location

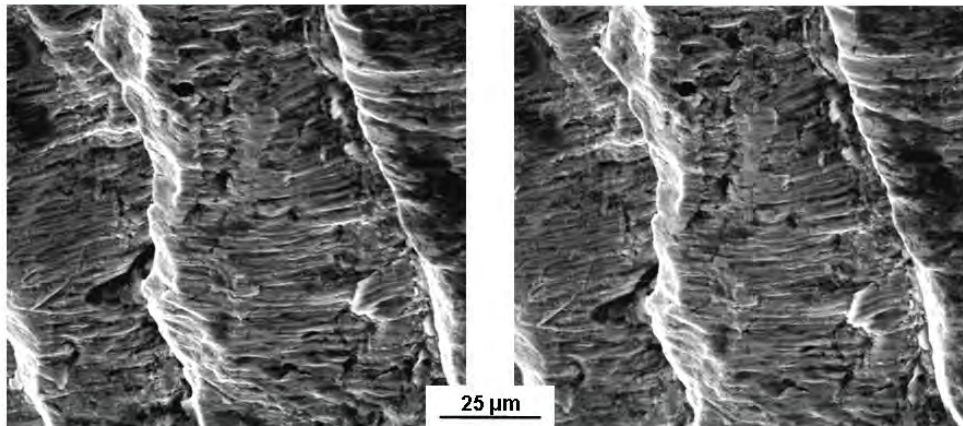
- Stereo pair SEM fractographs of rubbed and smeared fatigue striations with spacings suggesting crack growth rates greater than 1 $\mu\text{m}/\text{cycle}$

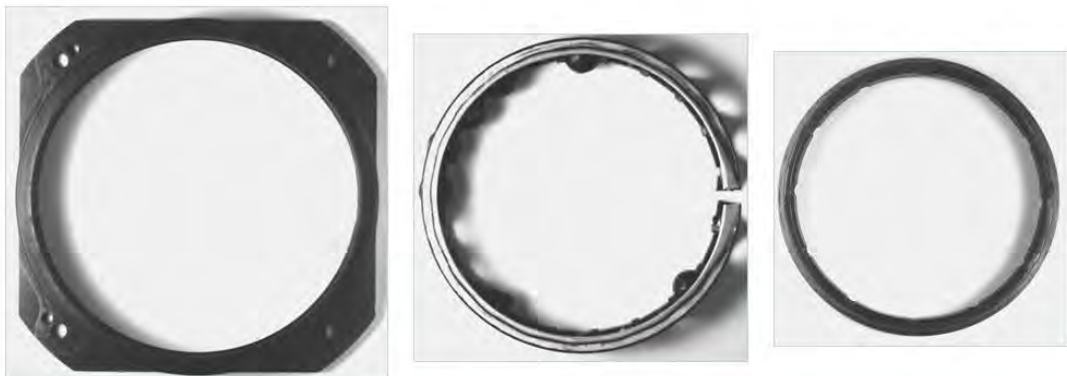
- 5095 hrs (6425 engine starts) since new and 530 hrs (585 engine starts) since overhaul
- Cage failure resulted in contact with the outer race and overheating

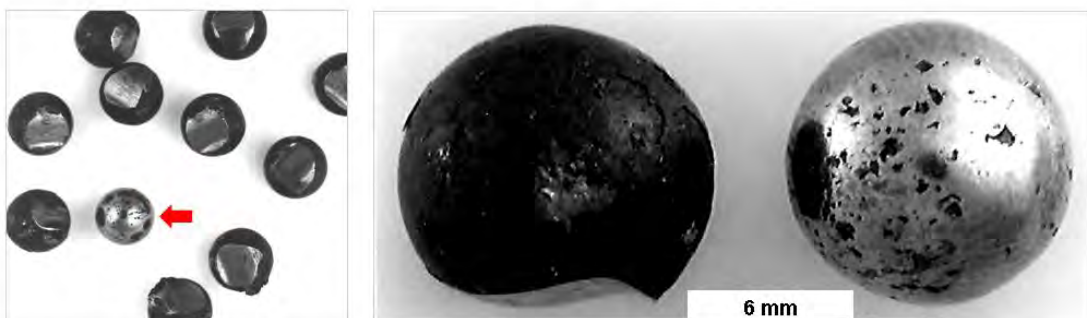
Disassembled bearing – II: ball bearings, M 50 steel

- 19 of the 20 balls were damaged by overheating, deformation, wear and cracking
- One ball was relatively undamaged and about 1 mm undersize

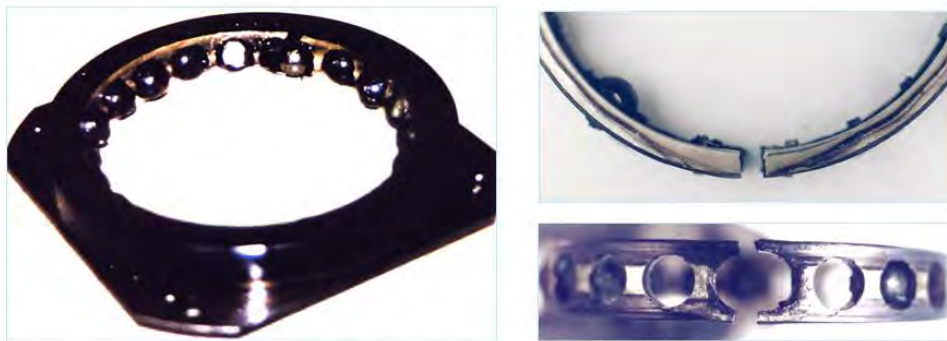
Cage failure details – I: macroscopic observations

- The ball pocket at the cage failure position was considerably elongated
- This pocket had contained the undersized ball

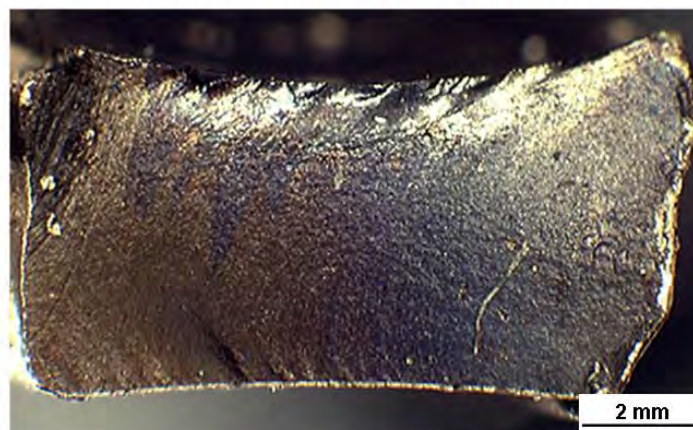
Cage failure details – I: optical fractographic overview

- The cage failed by high cycle – low stress fatigue
- Progression markings suggested engine starts

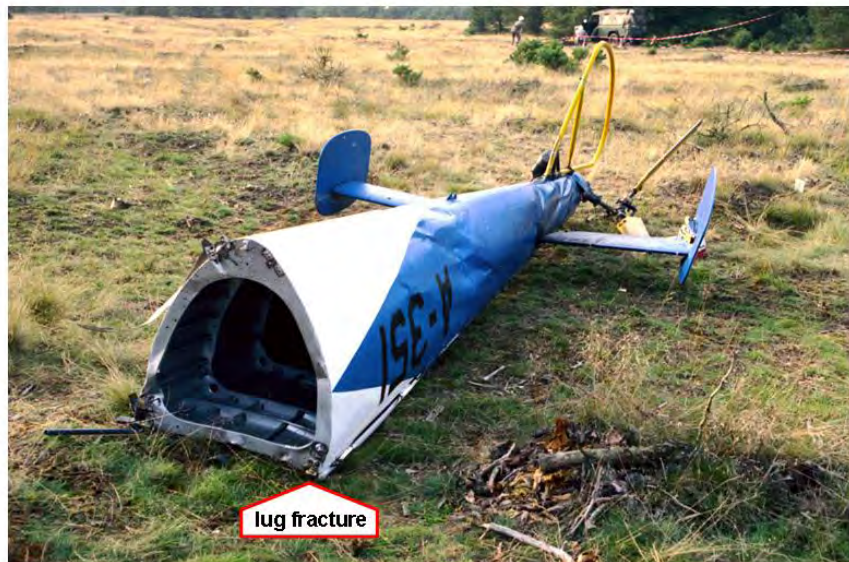
A-351 tail after in-flight separation

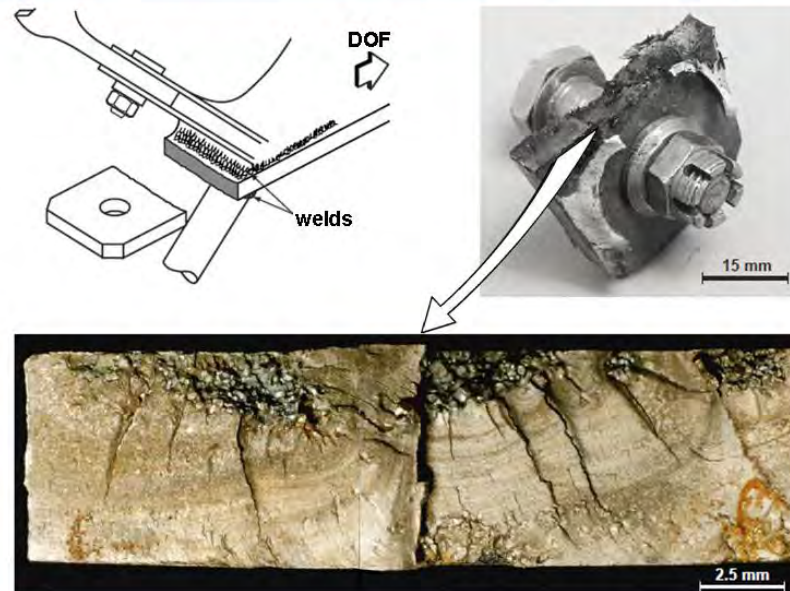
Lug fracture: medium-carbon steel plate, 01-10-1990

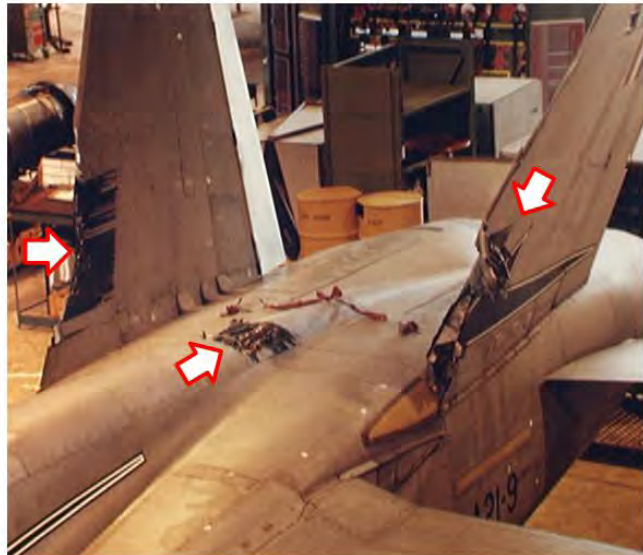
- **RH trailing edge flap (TEF) lost during manoeuvre**
- **Substantial additional damage to aircraft:**
 - flap shroud lost
 - leading edges of vertical tails broken off
 - holes punched in dorsal deck, LH TEF and LH horizontal stabilizer
- **Safety-of-flight matter: high landing speed required**

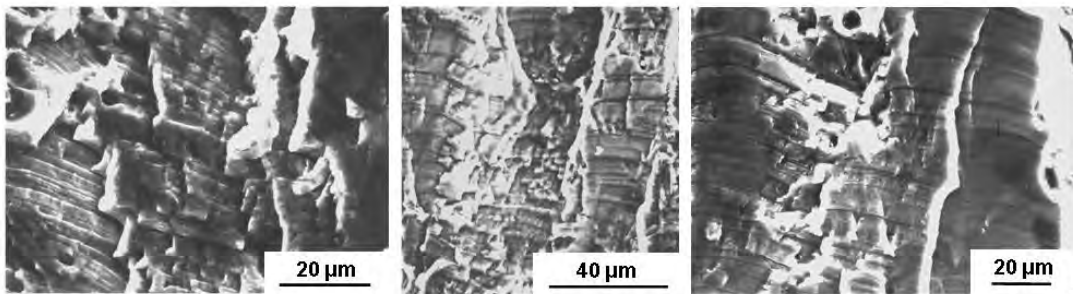
- Well-defined progression markings evident on the fatigue fracture surface

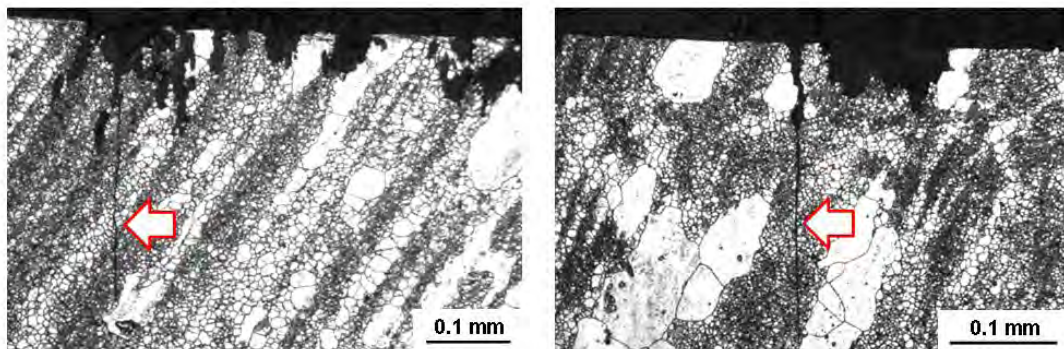
Optical metallographs of secondary fatigue cracks initiating from corrosion pits on the A21-015 TEF hinge lug

- Corrosion pit growth influenced by fatigue: probable corrosion fatigue to crack depths ~ 0.1 mm. Arrows point to fatigue cracks

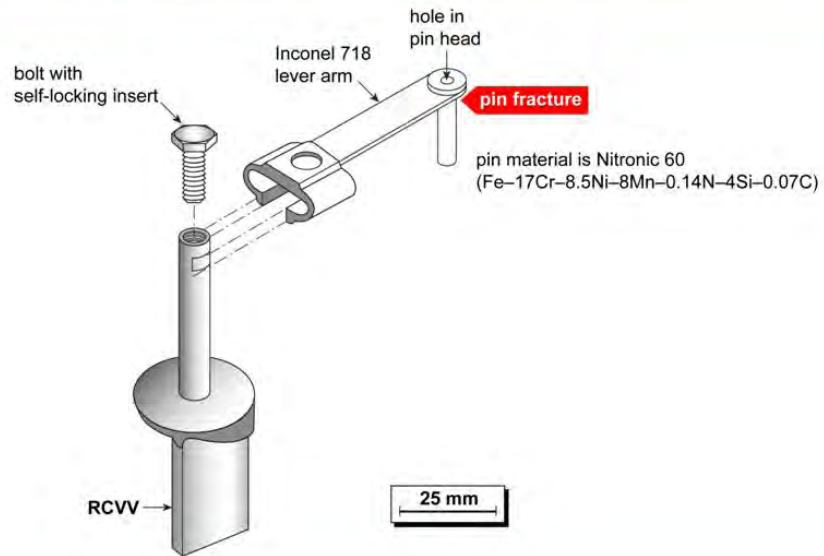
Rear Compressor Variable Vane (RCVV) lever arm assembly: malfunction due to pin fracture

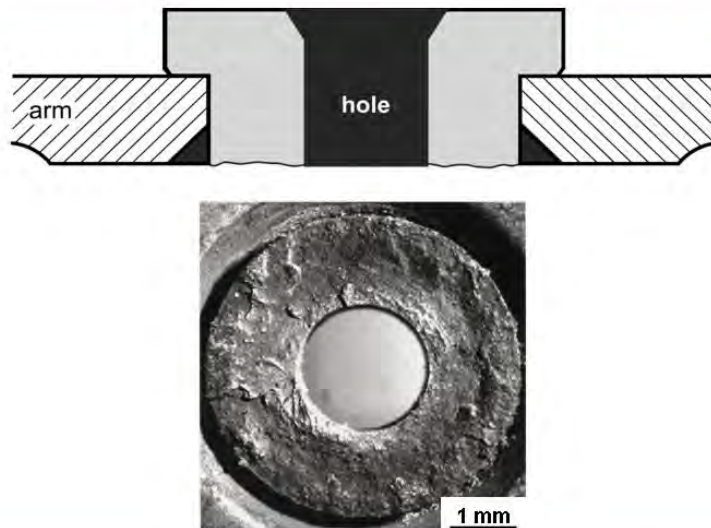
As-received fracture surface of lever arm pin

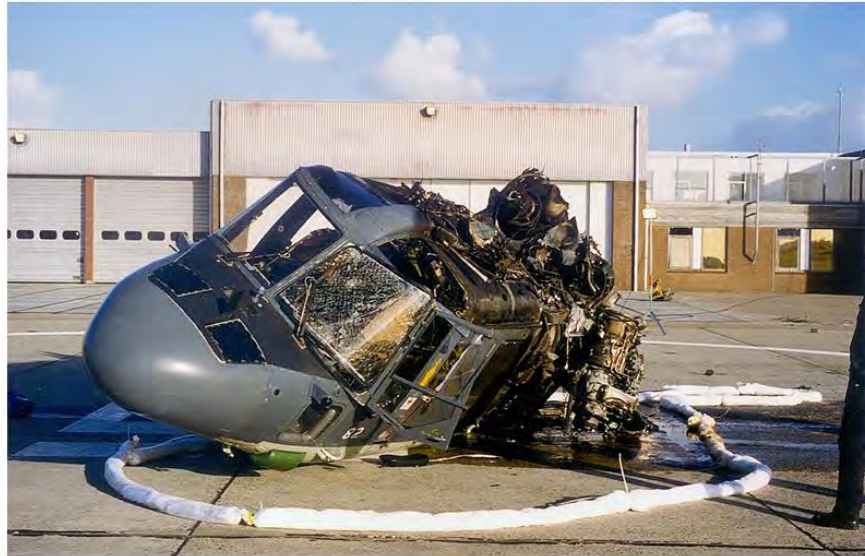
Lynx-282 airframe wreckage after rotor hub failure

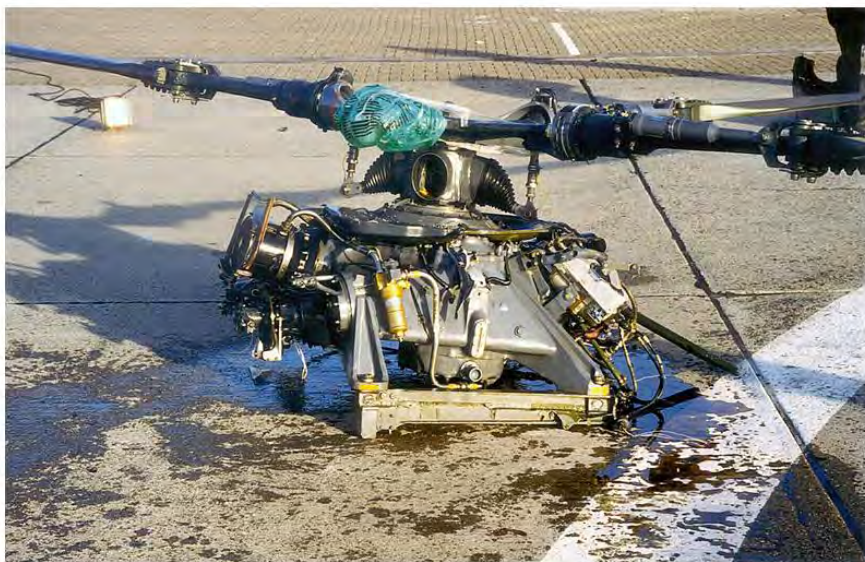
Lynx-282 rotor hub wreckage

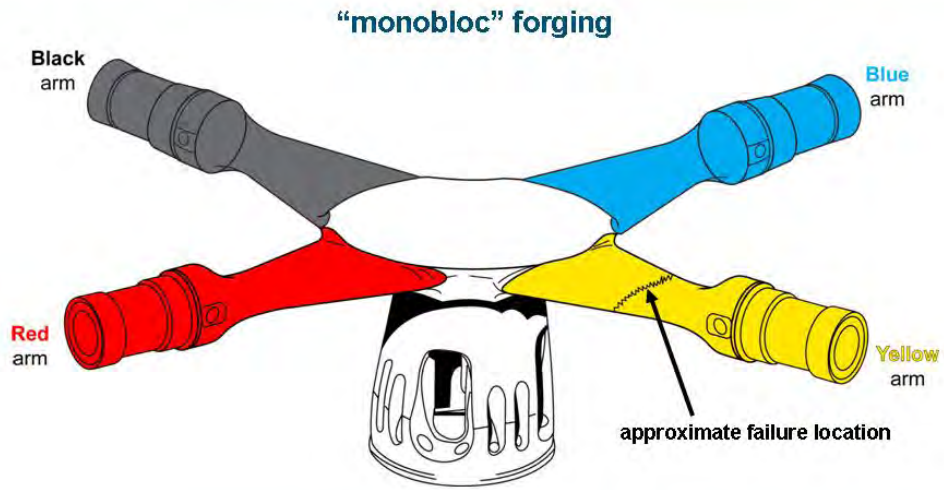
Schematic of rotor hub failure: Ti-6Al-4V ($\alpha + \beta$) processed titanium alloy forging

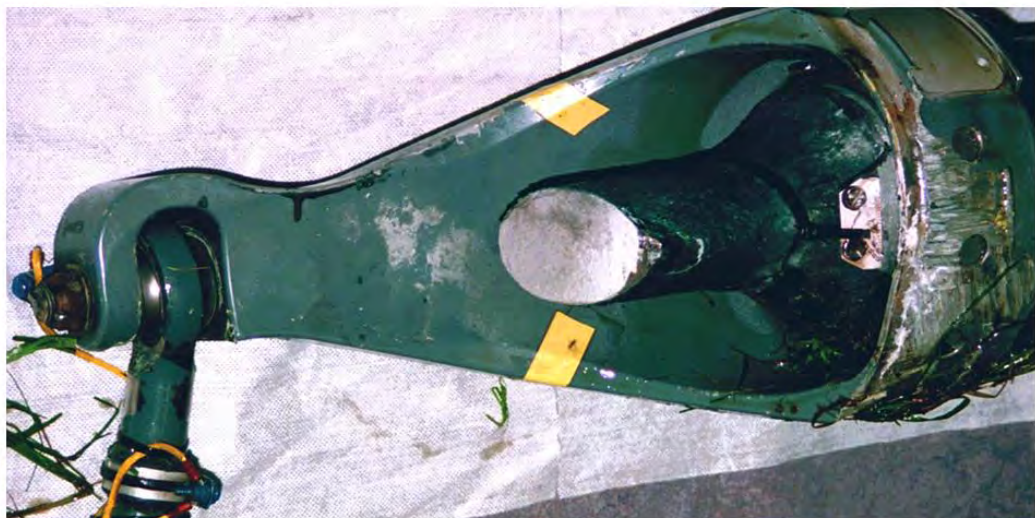
Outboard fracture surface of the "yellow" arm *in situ*

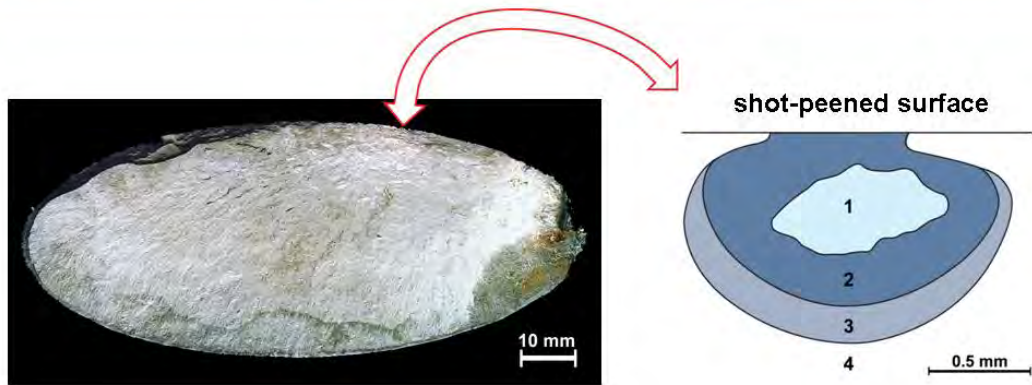
Outboard fracture surface with schematic of fatigue initiation area

- phases of the yellow arm fatigue life:
 - 1 – highly faceted sub-surface fatigue initiation *in vacuo*
 - 2 – rough early crack growth *in vacuo*
 - 3 – rough early crack growth in air
 - 4 – less rough crack growth in air

- **Physical cause: too-high dynamic stresses → fatigue**
- **Contributing cause: inadequate fatigue design analysis**
- **Remedial action: new design rotor hub**
 - non-“monobloc” bolted-on arms
 - Ti-10V-2Fe-3Al β titanium alloy replacing Ti-6Al-4V
