NLR-TP-2001-273

## **Practical investigation of aircraft pressure cabin MSD and corrosion**

This report is based on a paper held at the 5<sup>th</sup> Joint NASA/FAA/DoD Conference on Aging Aircraft, HYATT-Orlando, Florida, September 2001.

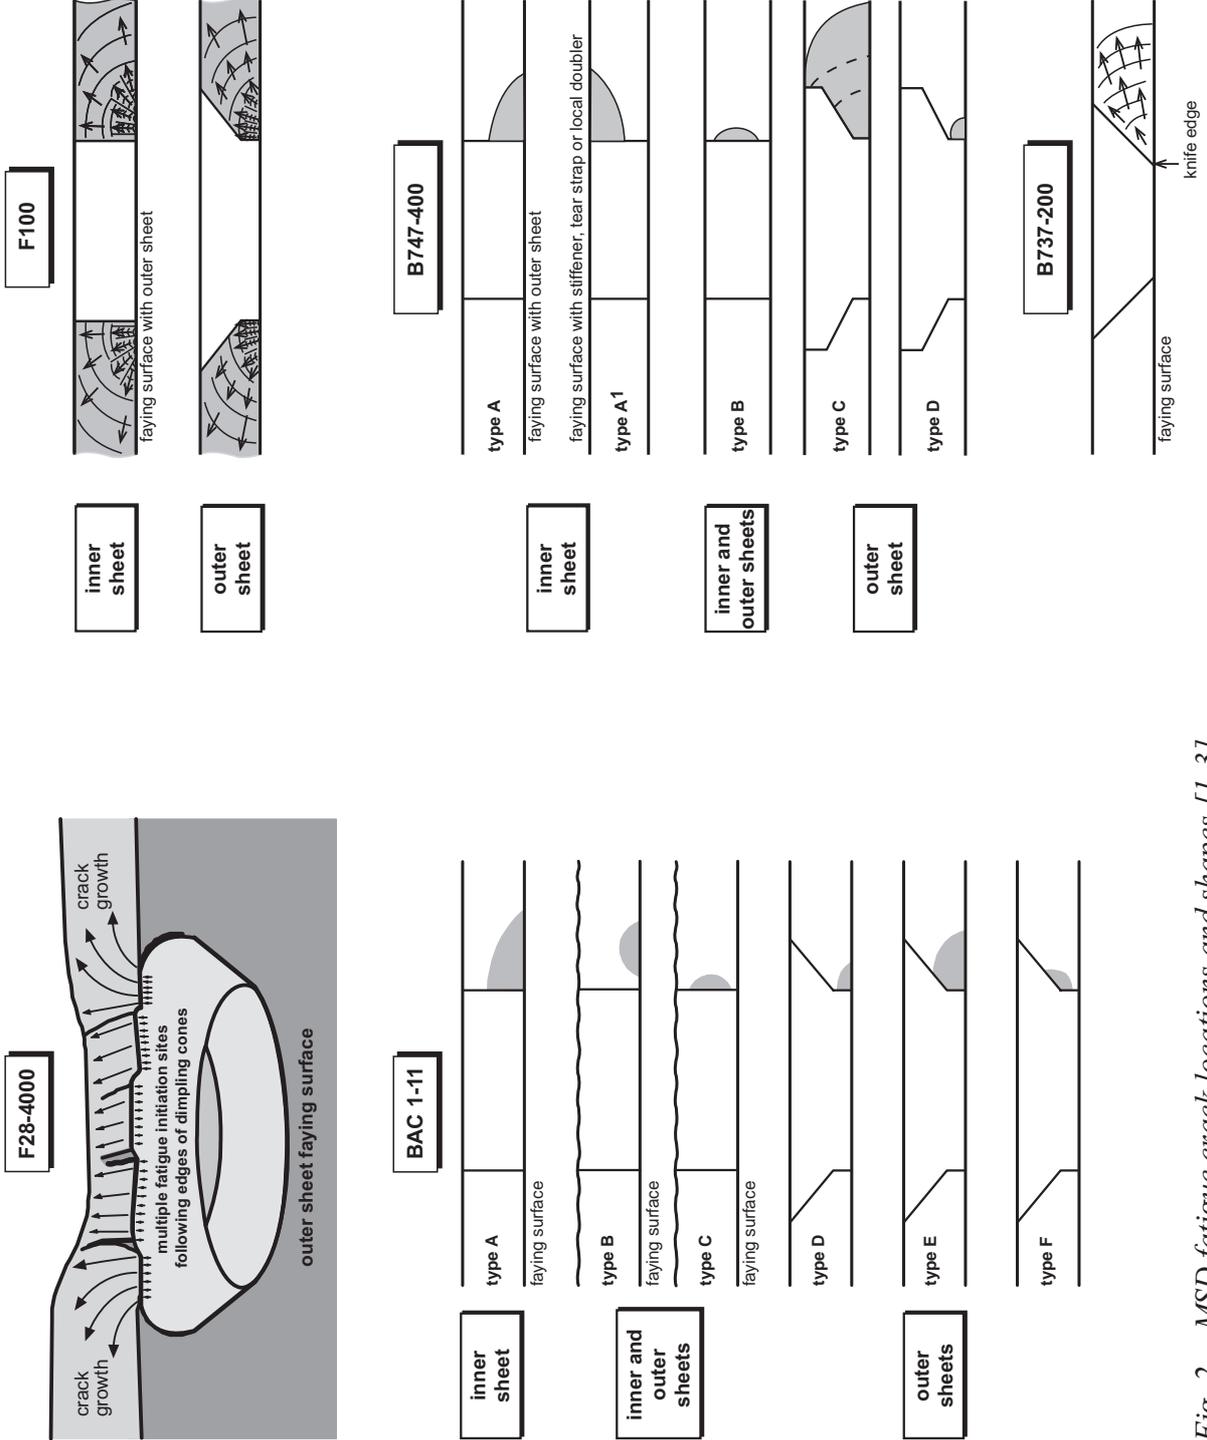
Fig. 2 MSD fatigue crack locations and shapes [1-3]

Figure 2 shows the characteristic MSD fatigue crack locations and shapes. The F28-4000 dimpled lap splices and B737-200 “knife-edged” lap splices are uncustomary. Bearing this in mind, the most representative fatigue initiation sites were at faying surfaces near or at rivet hole corners. This means the faying surface condition (cladding, anodising, priming, interfay sealant, adhesive bonding) and rivet hole corner quality are very important. Also, fretting must play a role, if not always in crack initiation, then probably soon after and during early crack growth [4].

Another very important point, with reference to service aircraft, is no evidence that corrosion was directly involved in crack initiation [1, 3], i.e. corrosion pitting is not responsible for initiating MSD fatigue cracks in lap splices using 2024-T3 Alclad skins.

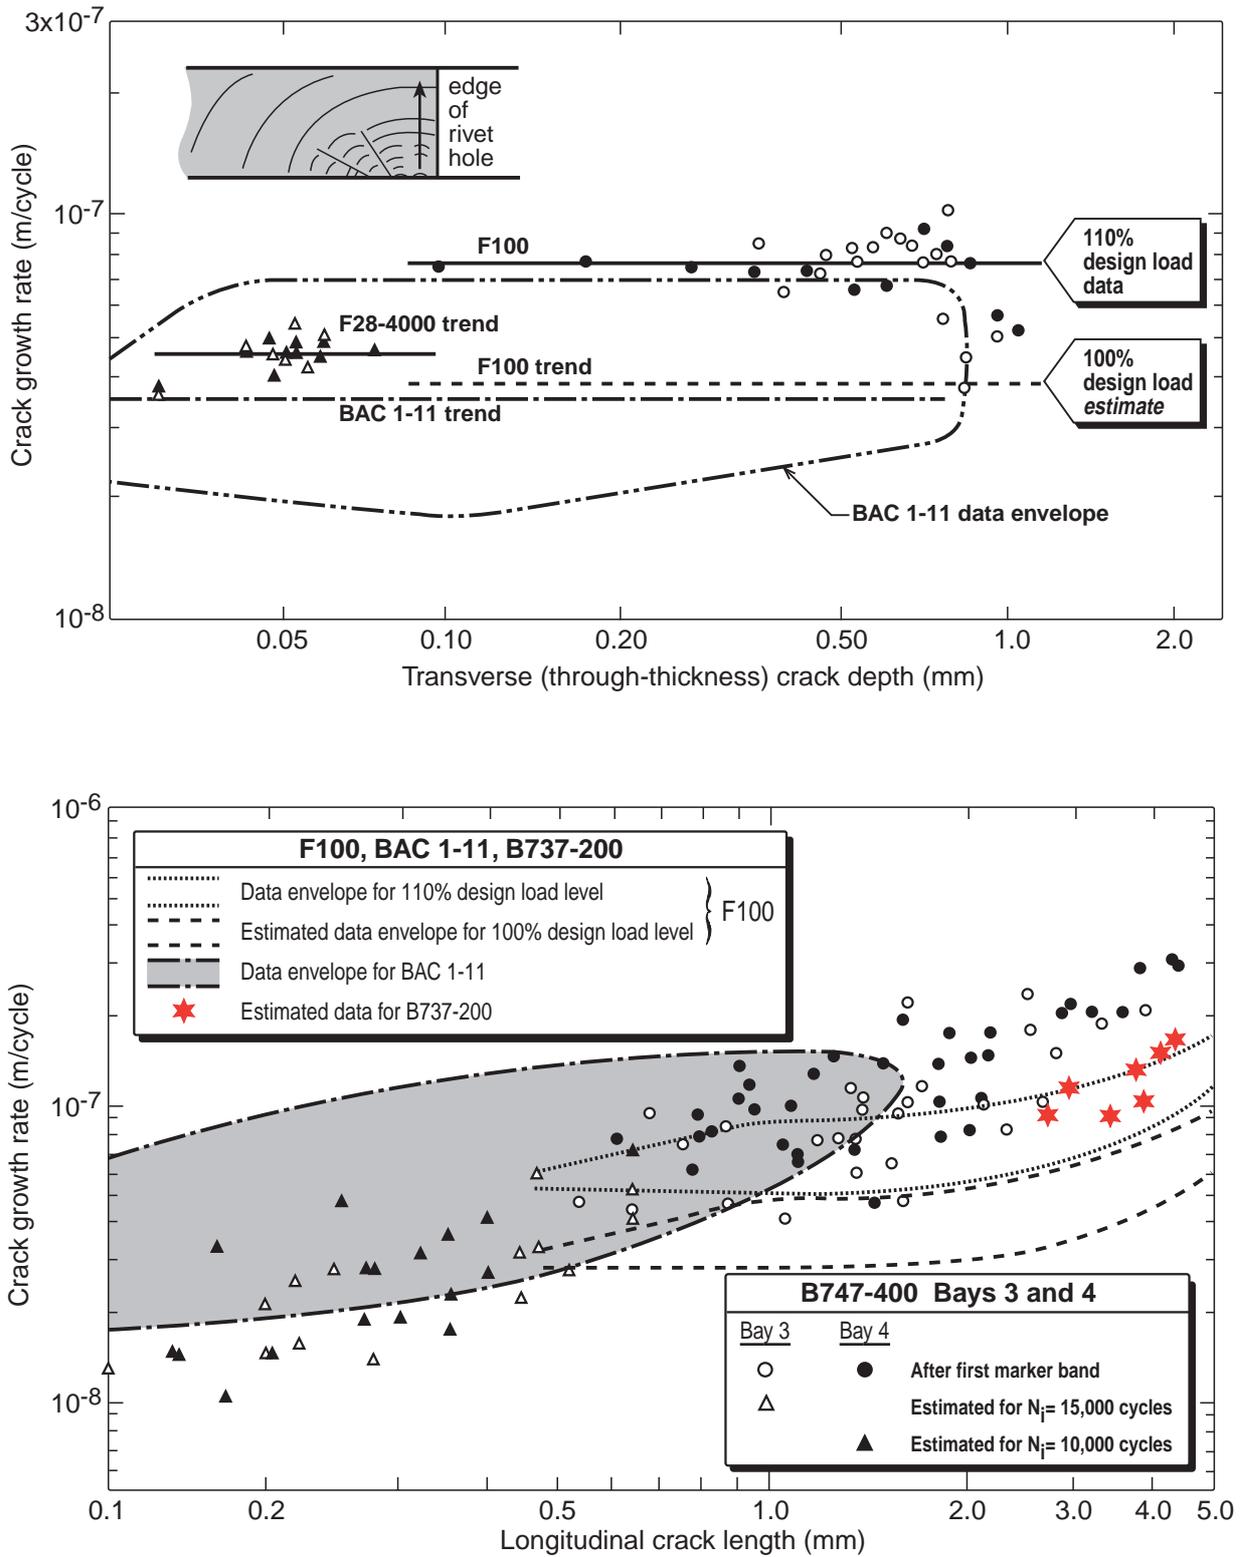
Fig. 3 Summary of transverse (through-thickness) and longitudinal early MSD fatigue crack growth rates [1, 2]. The F100 estimates were derived from the factor  $(100/110)^{7.1}$ , where 7.1 is the "Paris Law" exponent in the same crack growth rate regime [9]

Figure 3 summarises the data, which were obtained fractographically *from different sources*: F28-4000, Wanhill (NLR); F100, Eijkhout [6] and Vermeulen (NLR); BAC 1-11, Hattenberg (NLR); B747-400, Piascik and Willard [2]; B737-200, Anon (Boeing) [3]. The data show the following important features:

- (1) All crack growth rates were above  $10^{-8}$  m/cycle.
- (2) The transverse (through-thickness) crack growth rates were, on average, fairly constant and remarkably similar.
- (3) The longitudinal crack growth rates were also remarkably similar, considering the different aircraft types and lap splice configurations, figure 1.

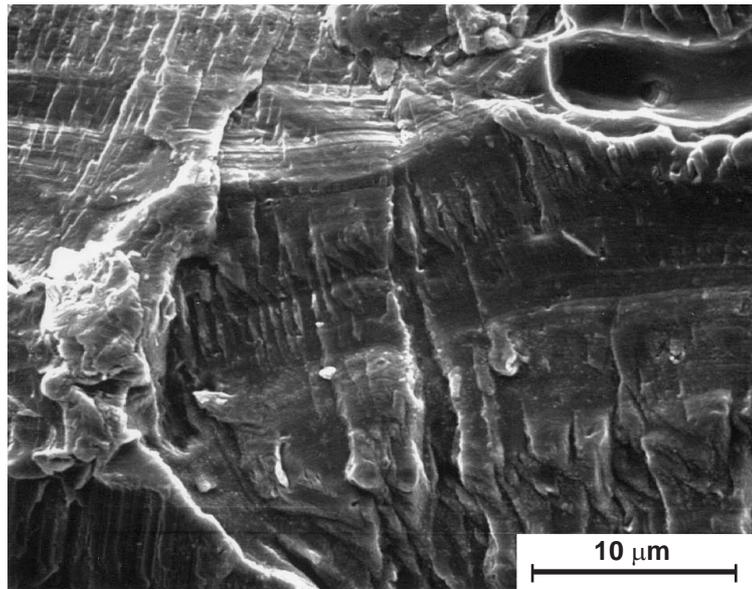
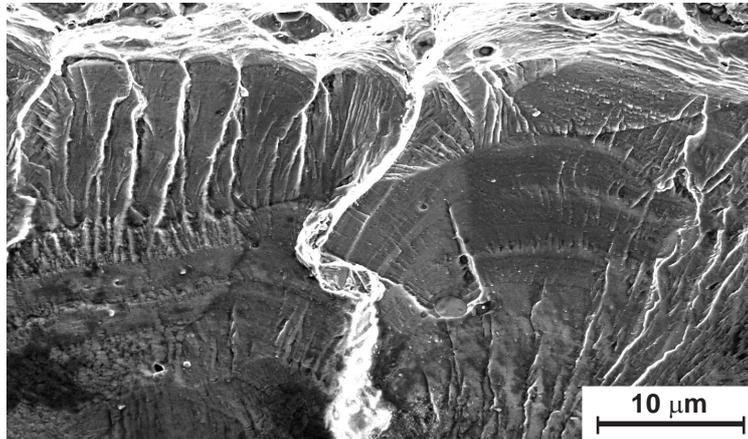
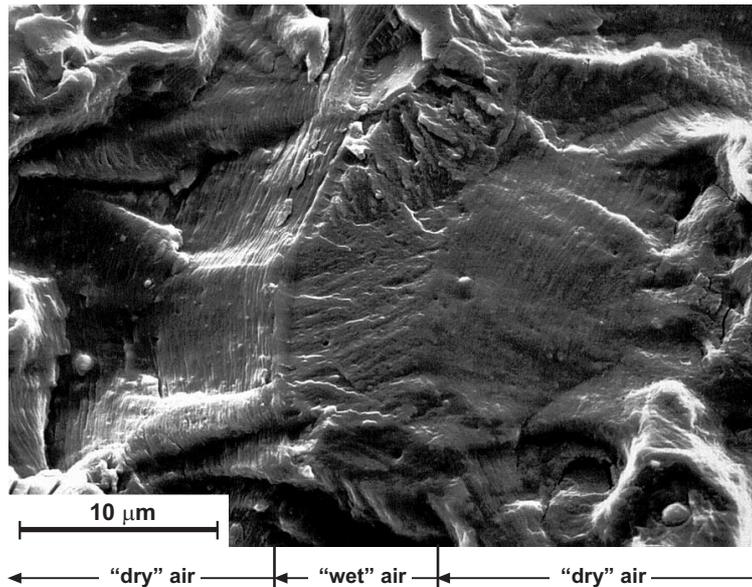
Fig. 4 Examples of “beach marks” for early MSD fatigue crack growth in service aircraft and similar topographical changes produced by very low cycle frequency tests in “dry” and “wet” air in the same crack growth rate regime [10]

Of more interest are any effects during early MSD fatigue crack growth. Some fracture surfaces showed crystallographic-looking “beach marks” similar to topographical changes produced by very low cycle frequency tests in “dry” and “wet” air, e.g. figure 4. Thus the “beach marks” could indicate periodic changes in the local environment during early MSD fatigue crack growth (and also secondary fatigue crack growth [1]). Be that as it may, it is presently unknown whether the local environmental conditions have significant effects on early fatigue crack growth rates in the lap splices. More work needs to be done, and the NLR is pursuing and persevering with very low frequency tests in “dry” and “wet” air in the crack growth rate regime  $10^{-8} - 10^{-7}$  m/cycle.

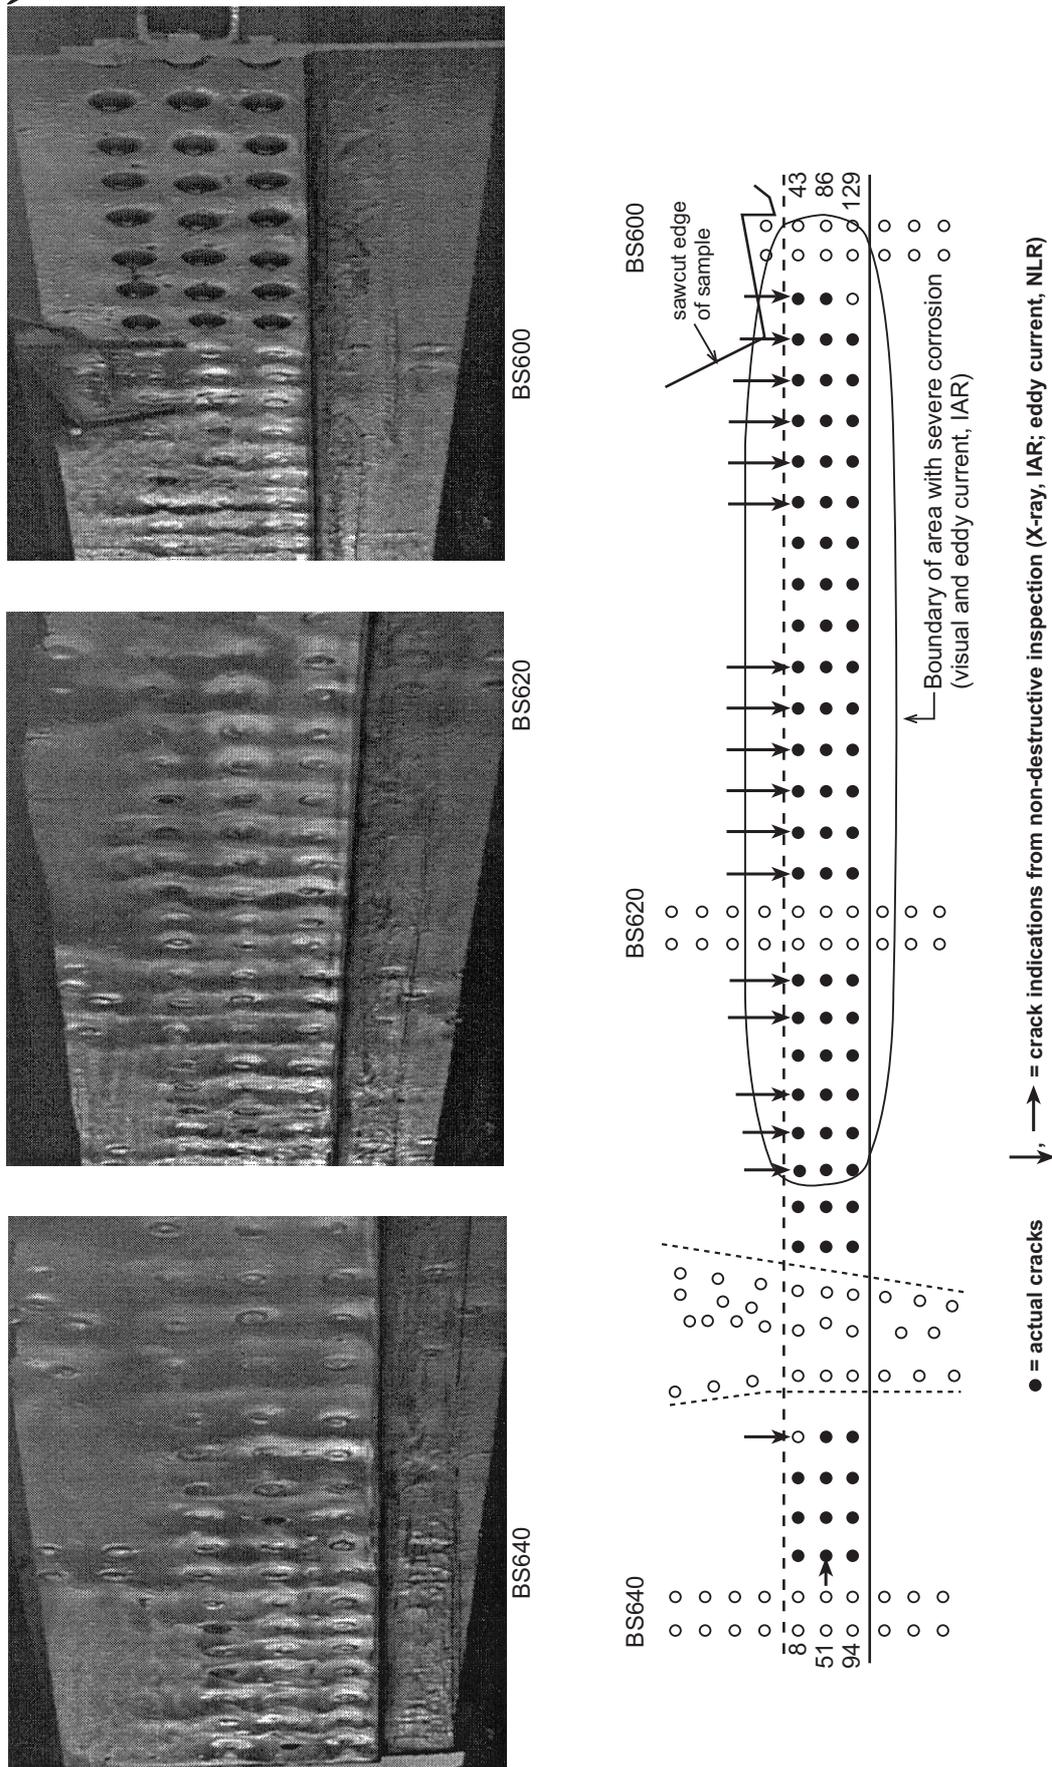
Fig. 5 DAIS imaging of corrosion-induced pilloving of the B727-100 lap splice (IAR) and schematic comparison of cracks found by non-destructive inspection (IAR, NLR) and lap splice disassembly (NLR): DAIS = D Sight Aircraft Inspection System, an enhanced optical method

The B727-100 internally corroded lap splice was non-destructively inspected by the Institute for Aerospace Research (IAR), Ottawa, before shipping to the NLR for inspection and disassembly. Figure 5 summarises the results. Disassembly showed that only the severest cracks, nearly 95 % of which were due to intergranular corrosion and stress corrosion, were previously detected by inspections. Also, the DAIS imaging detected severe corrosion better than eddy current, since the BS640 position was found to be severely corroded after disassembly, and this had not been indicated by eddy current.

- (8) Disassembly of the B727-100 lap splice showed only the severest corrosion cracking had been previously detected by X-ray and eddy current non-destructive inspections. The enhanced optical non-destructive inspection technique DAIS was more sensitive to detecting the presence of severe corrosion than eddy current.
