Fractography-based estimation of fatigue crack "initiation" and growth lives in aircraft components

NLR-TP-2006-184

R.J.H. Wanhill
T. Hattenberg

December 2006

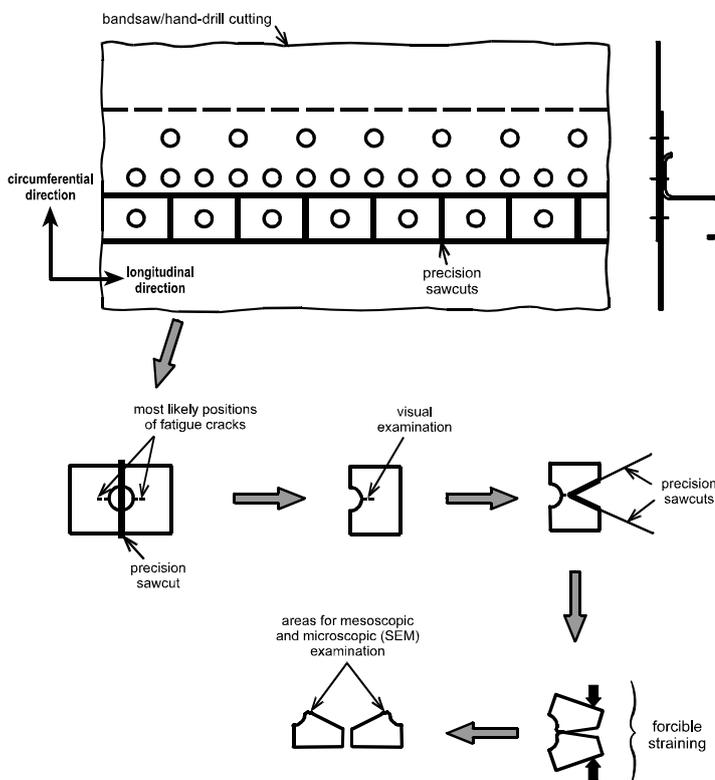
Figure 2 Illustration of opening up cracks: MSD fatigue in pressure cabin longitudinal lap splices (Wanhill et al. 2001)^[7]

After teardown and NDI (Platenkamp *et al.* 2005)^[18], the largest fastener hole crack in either window frame was forcibly opened, as illustrated in figure 2, and fractographically analysed to check for spectrum "readability".

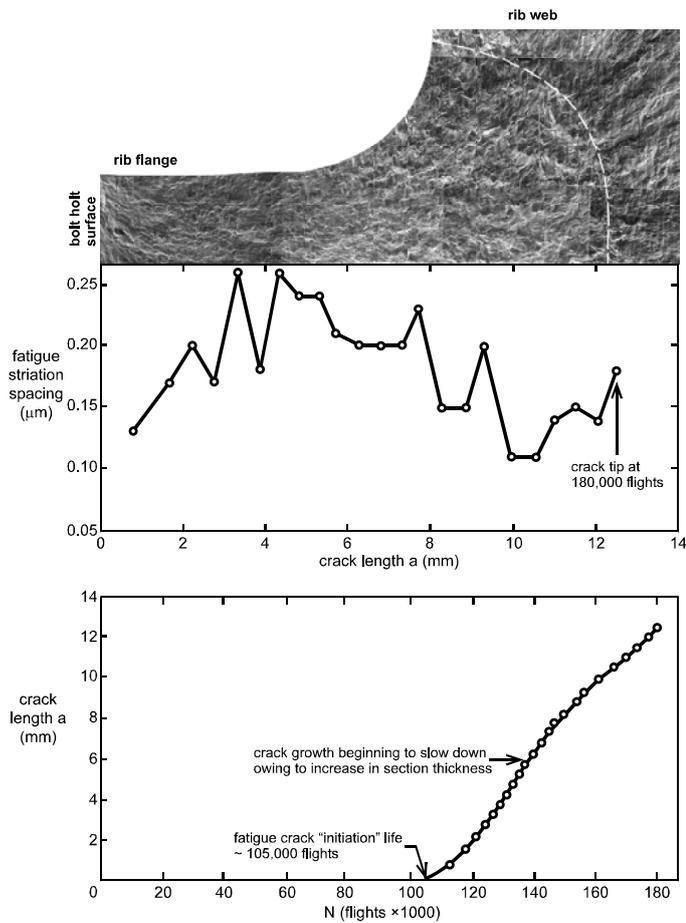
Figure 6 Striation-based analysis of crack growth from a bolt hole in a vertical stabilizer rib (Hattenberg and Vlieger 1993)^[9]

The macrofractograph in figure 6 shows a fatigue crack in a vertical stabilizer rib from a full-scale test. The crack initiated and grew from a bolt hole during 180,000 simulated flights of *effectively* constant amplitude loading, whereby one cycle equalled one flight.

Fatigue striation spacings (one striation = one simulated flight) were measured along a near-surface crack path and are plotted in the upper diagram in figure 6. As such, these data look unpromising. However, the number of flights during crack growth can be estimated by taking the average striation spacing between each measurement interval, dividing this striation spacing into the interval, and adding up the numbers for each interval. The result is shown in the lower diagram.

The lower diagram in figure 6 gives an estimate of the overall crack growth behaviour. Despite the unpromising-looking striation measurements, the overall crack growth curve shows clearly that the crack slowed down when it started to grow into the web of the rib. Also, and more importantly, back-extrapolation indicates that a regular process of fatigue crack growth began from the bolt hole only after about 105,000 simulated flights. Thus the crack growth life was about 75,000 flights.

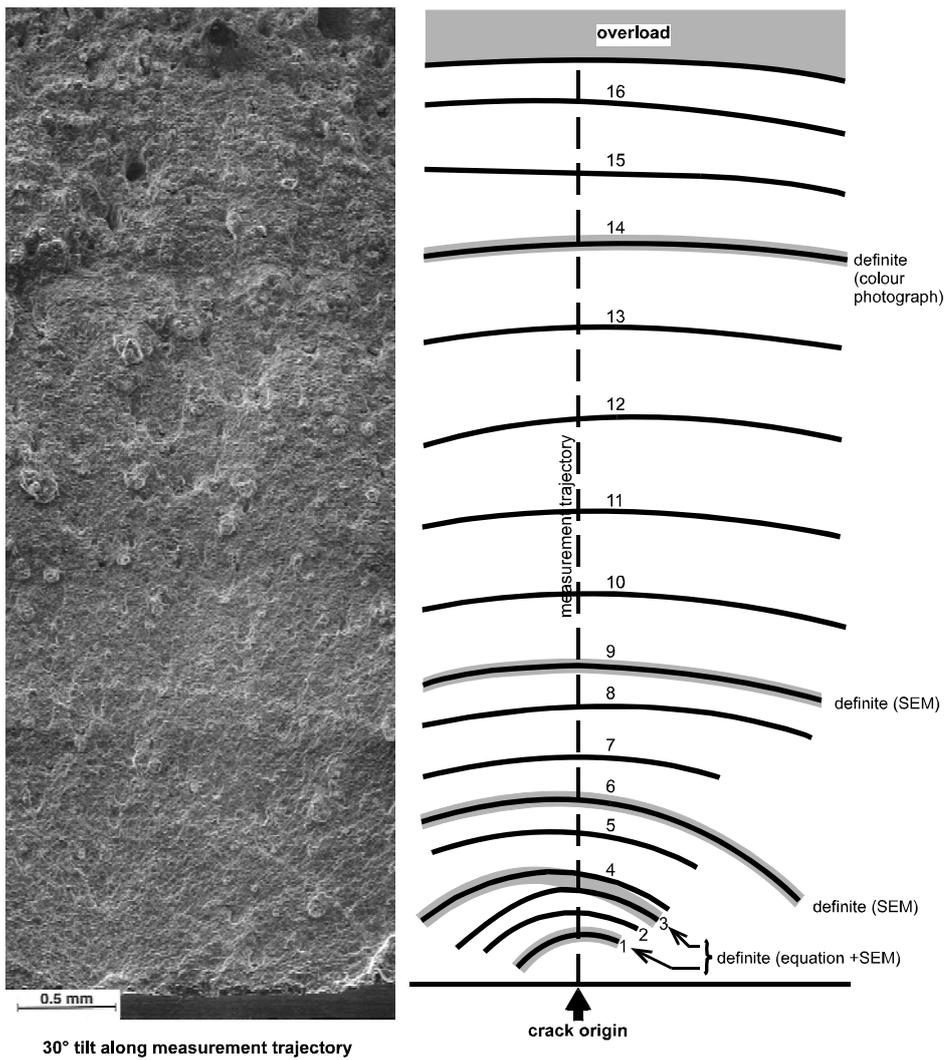
Figure 10 Low magnification SEM fractographic montage and marker band locations for a nickel-base superalloy (Inconel 718) specimen fatigue tested under constant amplitude + marker band loading at 600°C in air (Wanhill et al. 1996)^[12]

In fact, iterative checks comparing marker band locations and striation spacings can also be essential for discounting features initially thought to be marker bands. Figure 10 gives a notable example. This shows a high temperature fatigue fracture surface which had poorly visible marker bands, though the last one could be detected by a change in oxidation interference colours. On the other hand, fatigue striations were readily measurable and enabled checking not only actual marker bands (1, 3+4, 6, 9 and 14), but also discounting many apparent ones.¹

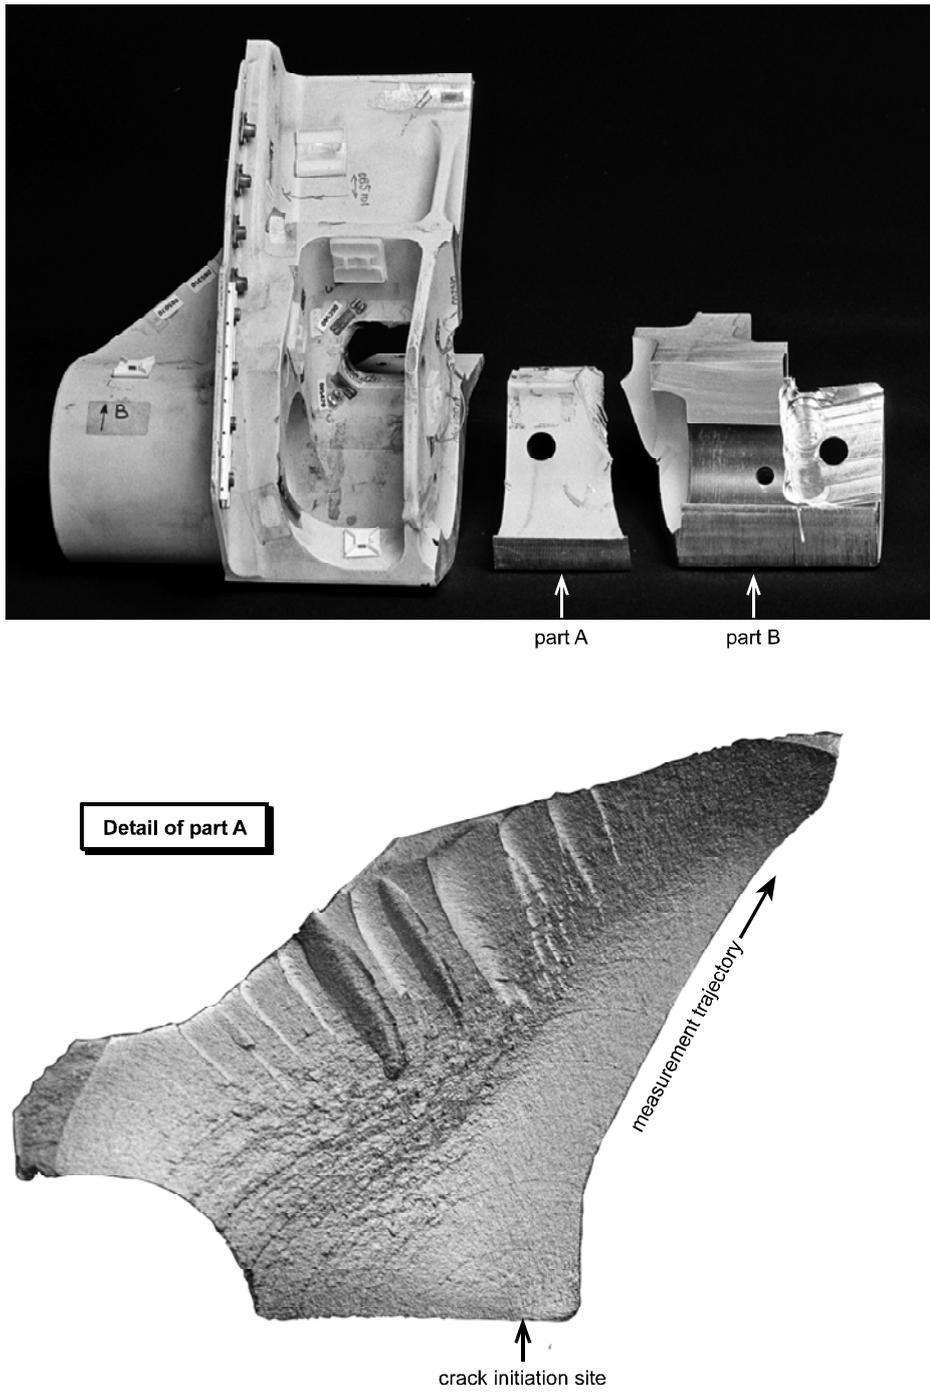
Figure 11 Overview and macroscopic fractograph of the fatigue fracture surface of a crack in a vertical stabilizer main hinge fitting (Hattenberg 1994)^[17]

Figures 11 – 13 illustrate the macroscopic to microscopic fractographic analysis of fatigue cracking under flight simulation loading that was developed to provide excellent fracture surface "readability" without unduly compromising the spectrum characteristics. The fatigue 'striation' pattern in figure 12 is due to the four severest flights in each block of 5000 simulated flights: the position of the severest flight, type A, is clearly recognisable. Figure 13 shows that this pattern could be traced back to a crack size of only 20 μ m.

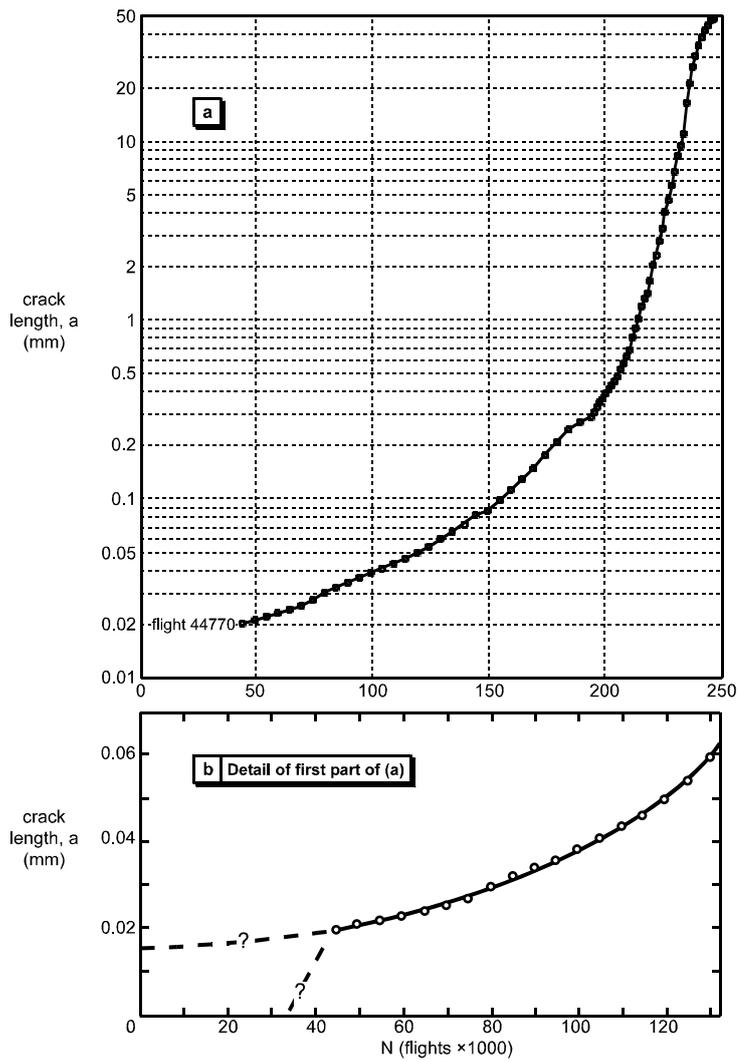
Figure 13 "Striation" pattern analysis of fatigue crack growth in a vertical stabilizer main hinge fitting (Hattenberg 1994)^[17]

Note that back-extrapolation of the a *versus* N curve in figure 13b is uncertain. There was no initial defect with a size of 15 μ m. Instead it appeared that fatigue initiated in a single grain, possibly resulting in a crack only after many thousands of simulated flights. Be that as it may, a crack detectable by Non-Destructive Inspection (NDI) would have been much longer and well along the crack growth curve shown in figure 13a.

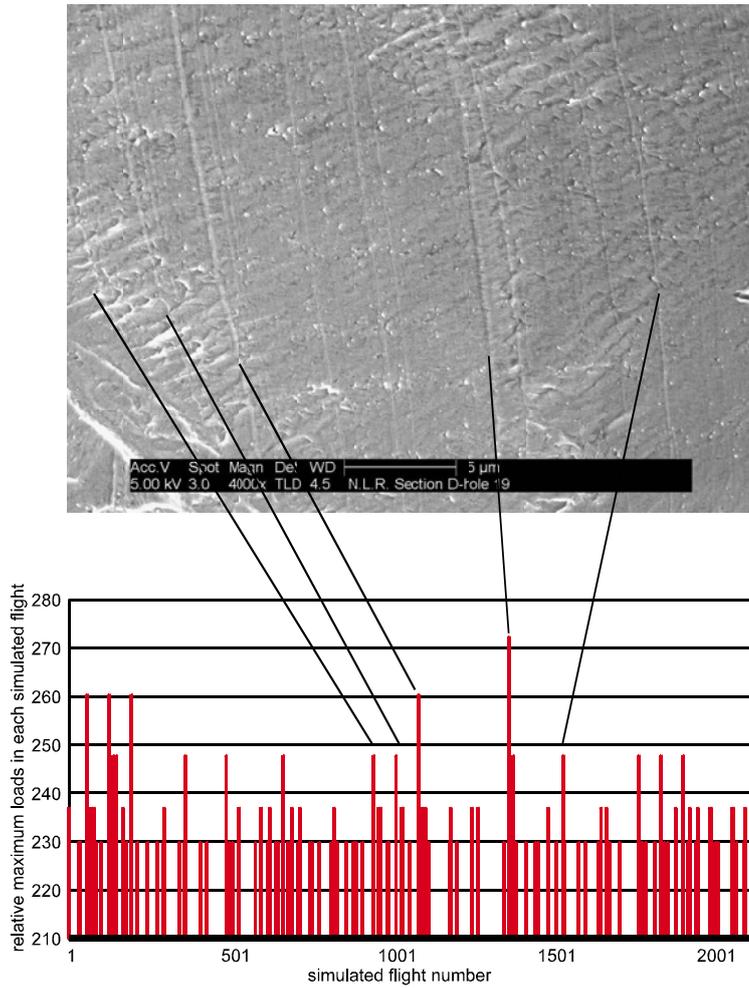
Figure 15 Example of fractographic identification of severe simulated flights in the MLB fatigue load spectrum, using the largest window frame crack

Figure 15 gives an example of detecting the simulated flights, notably the severest flight types A, B and C. Despite the complexity of the spectrum, the "readability" was excellent, enabling crack growth to be traced back from 1.68mm at the end of the test to less than 0.2mm. This was necessary to obtain:

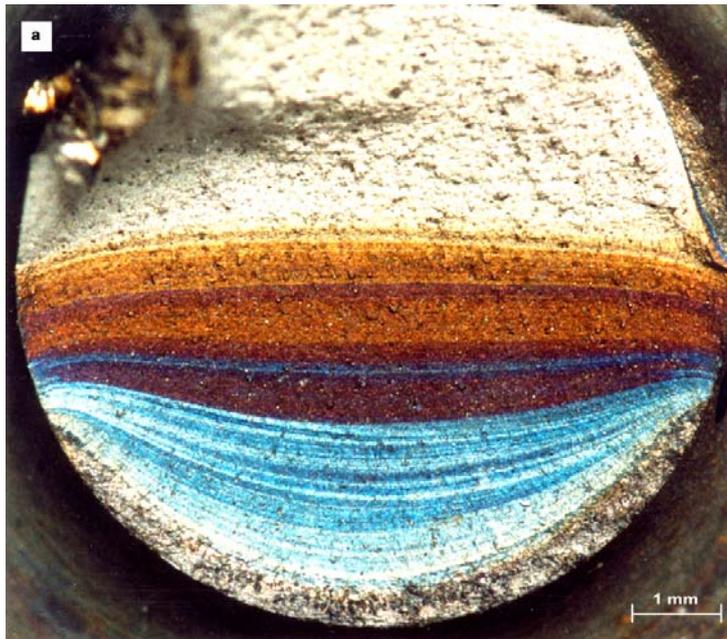
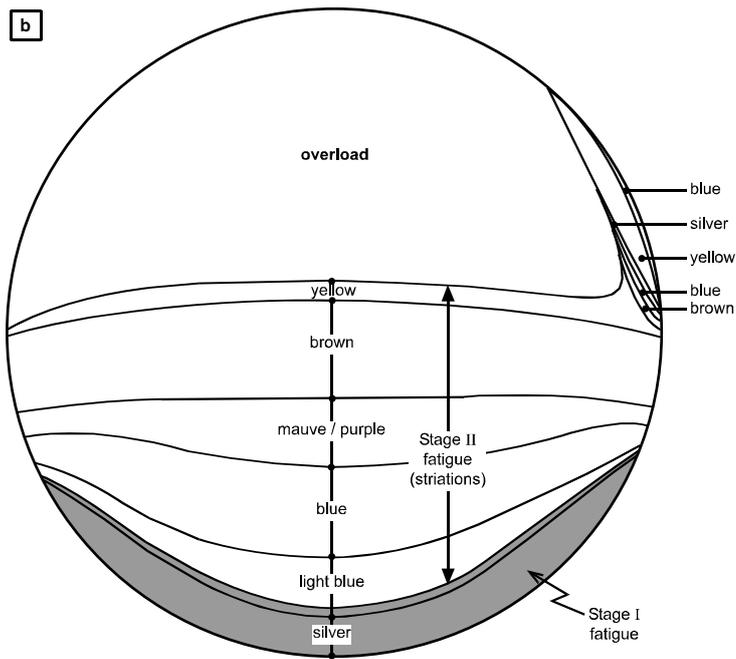
Figure 19 Macro photograph and schematic of the fracture surface of the broken rod

The second is an in-flight failure of an air supply manifold support rod from a military jet engine. This failure was particularly interesting owing to the diagnostic assistance of oxidation interference colours on the fatigue fracture surfaces.

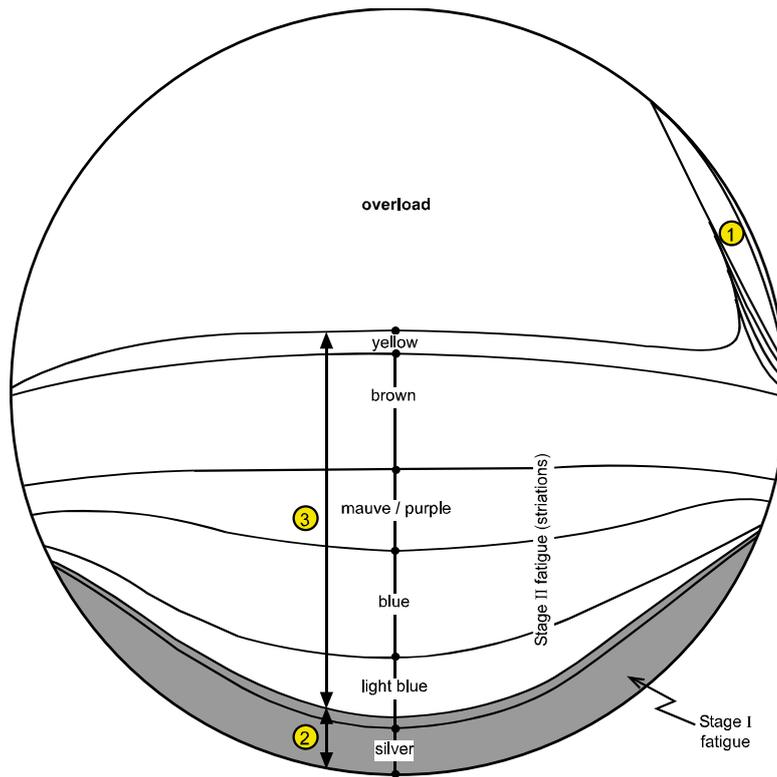
Figure 21 Interpretation of the relation between service history and fatigue fracture areas for the broken rod

Service history	Intervals		Fatigue fracture areas
	Operating hours	Flights	
0 → 1st maintenance rod rotation	410.9	257	①
1st → 2nd maintenance no rod rotation	761.5	326	②
2nd maintenance → failure	143.5	57	③
