NLR TECHNICAL PUBLICATION

TP 96047 U

FAILURE AND CRACKING OF INCONEL 718 AIR SUPPLY
MANIFOLD SUPPORT RODS

- A service-related contribution to IEPG TA 31 -

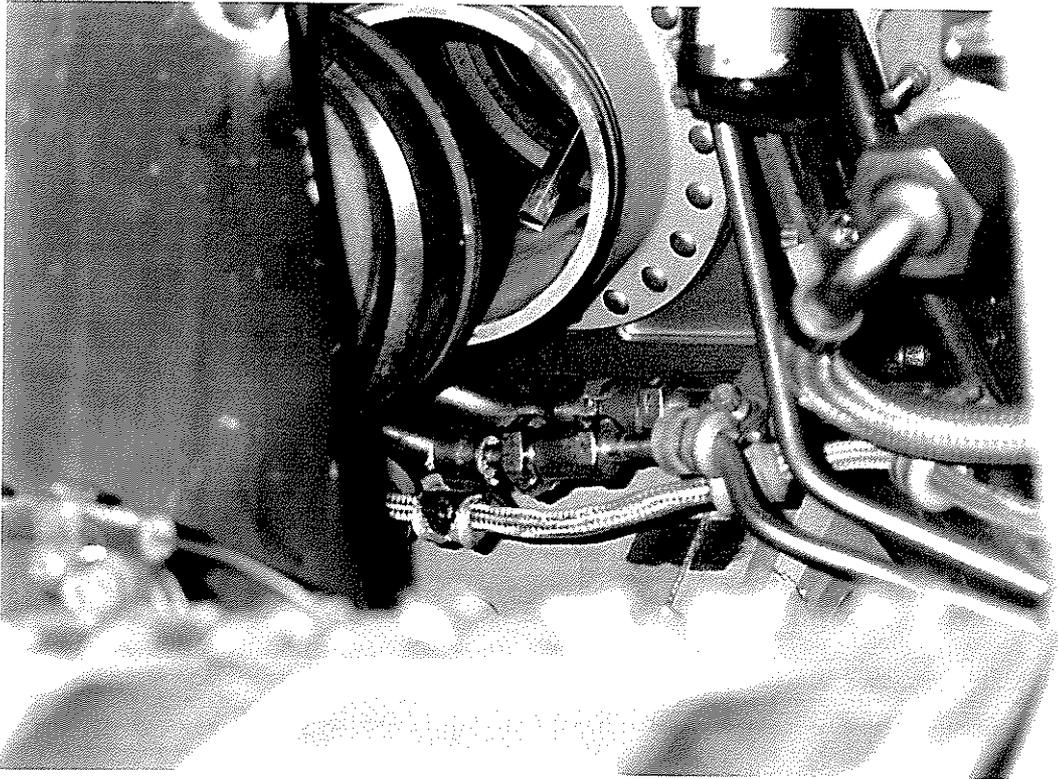
Figure 1 shows the broken rod *in situ*. Normally the rod held together two expansion sleeves connecting the engine's diffuser case air supply tube with the bleed air supply manifold. Fracture of the rod resulted in separation of the expansion sleeves, visible in figure 1, and impingement of hot bleed air on the surrounding airframe.

Fig. 1 The broken air supply manifold support rod *in situ*

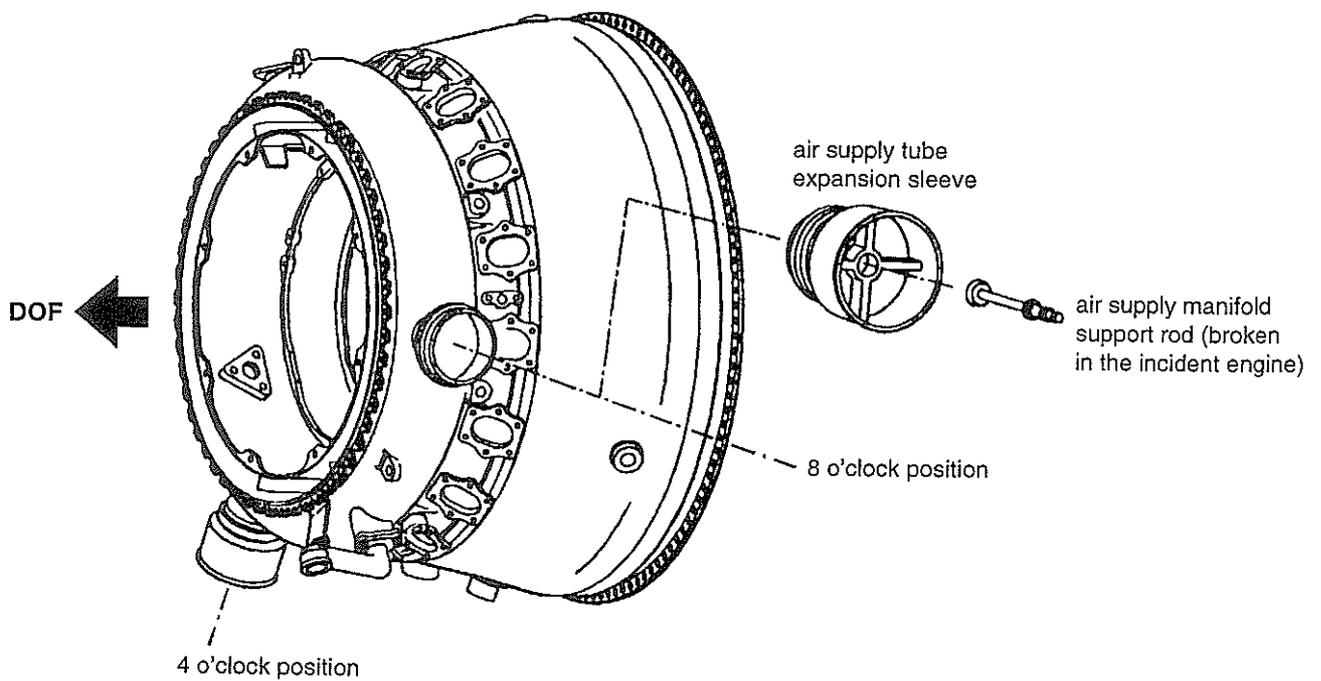
Figure 2 shows where the broken rod was located with respect to the diffuser case, namely at the 8 o'clock position looking in the direction of flight (DOF). A second, unbroken rod was located at the 4 o'clock position. Figure 3 gives a full-size sketch of an air supply manifold support rod and also shows the location of fracture in the broken rod.

Fig. 2 Diffuser case and details of one air supply tube expansion sleeve and manifold support rod (8 o'clock position relative to the DOF)

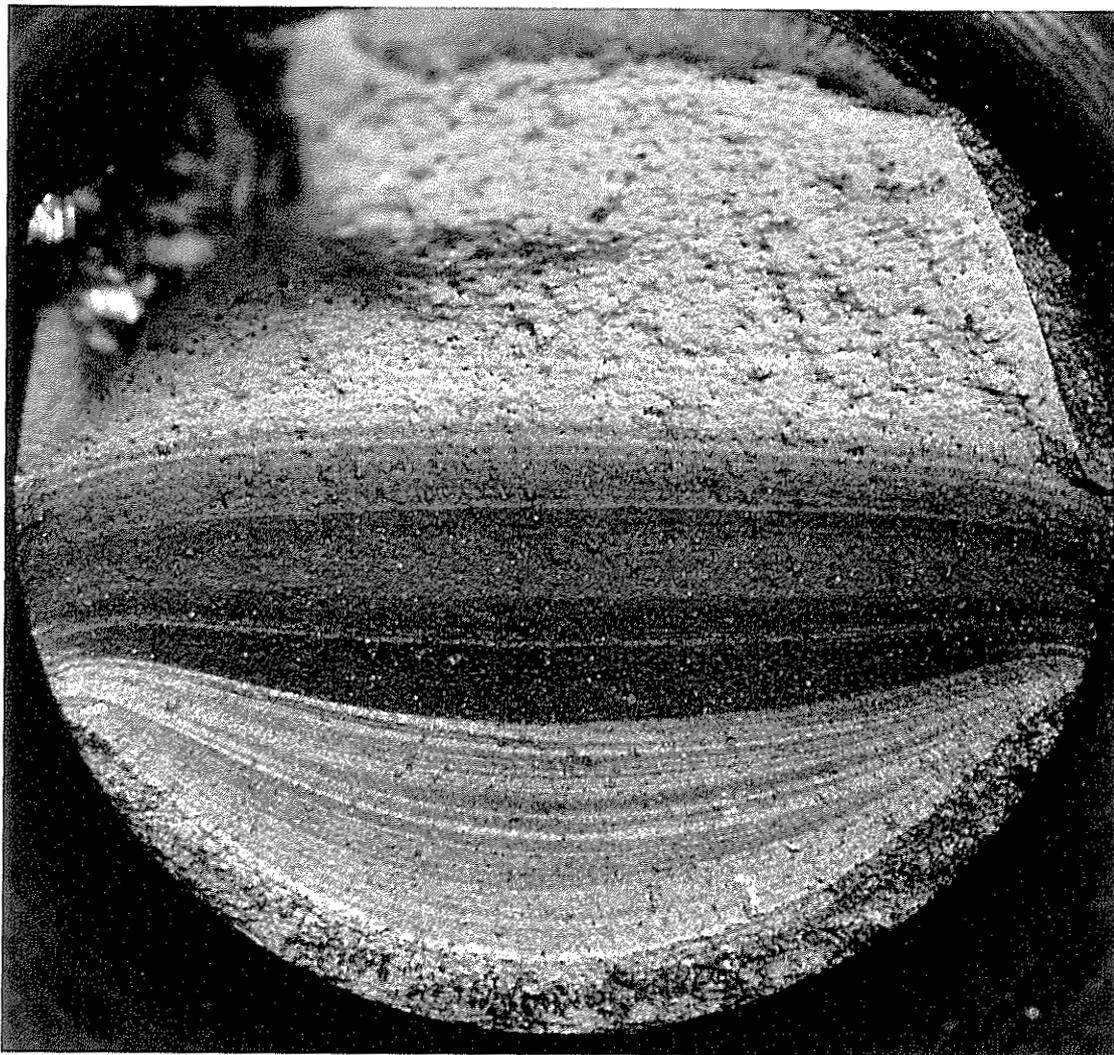
Figure 4 shows the as-received macroscopic appearance of the fracture surface of the broken rod end. Figure 5 is a schematic of the broad divisions of interference colours and fatigue fracture characteristics. There are two main locations of fatigue initiation and crack growth. The older fatigue area, which shows 2nd order interference colours, see section 8, is centred on the 2 o'clock position as viewed in figures 4 and 5. The more recent and main crack, which shows 1st order interference colours, see section 8, is centred on the 6 o'clock position. The shapes of the early crack fronts are diagnostic for fatigue controlled by bending stresses rather than axial stresses. Evidence for this is given in subsection 3.5.1.

*Fig. 4 Macro photograph of the as-received fracture surface of the broken rod end.
Magnification x18*

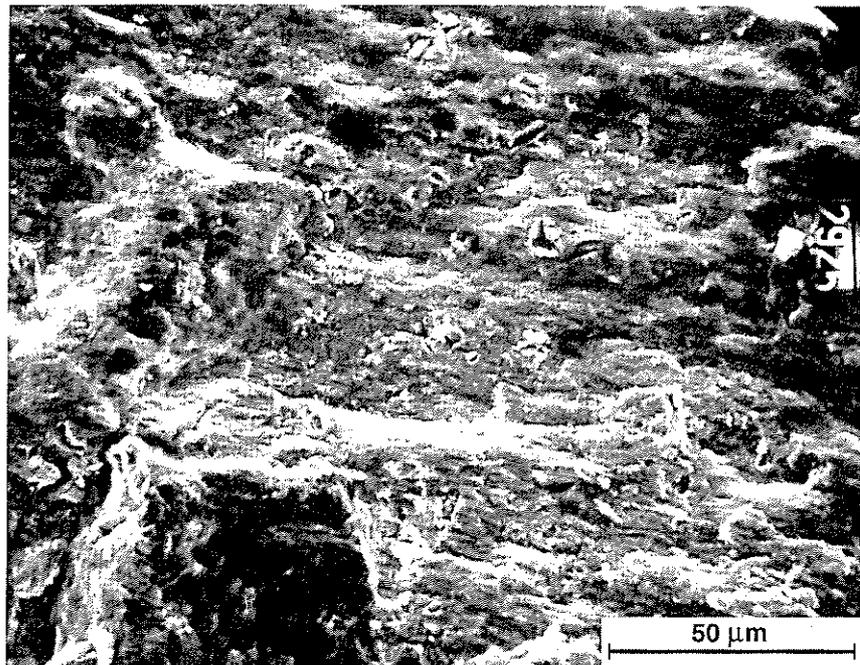
Figure 5 indicates that the main crack initiated by Stage I fatigue. In fact, this is inferred from the rough fracture topography, figure 6, and observation of similar topographies on less oxidised fatigue fracture surfaces of a broken-open rod (NLR code A) from another engine, see subsection 3.4.2, and also the fatigue fracture surfaces of LCF specimens from the IEPG TA 31 programme, see subsection 3.5.2.

Fig. 6 SEM fractograph of initiation area of the main crack in the broken rod end

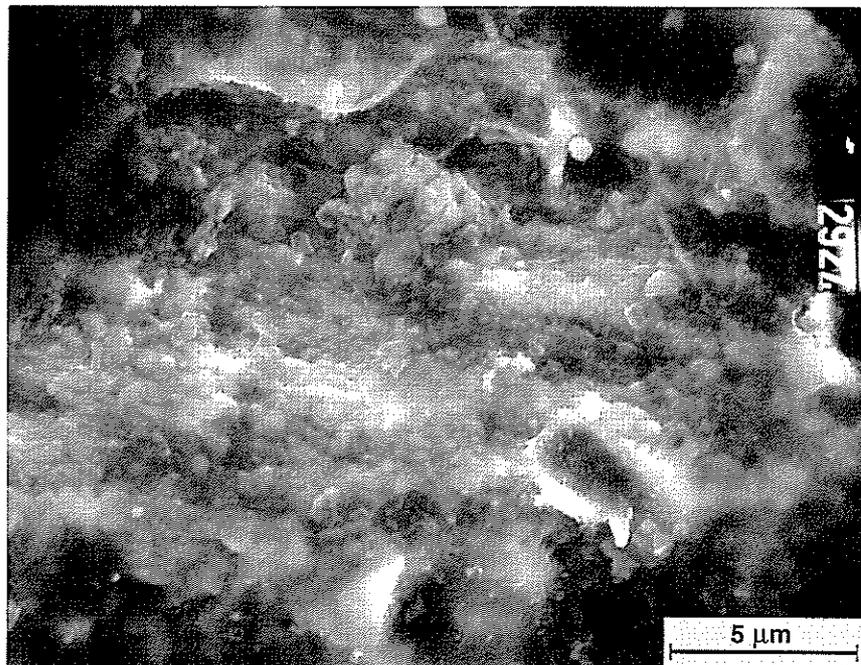
The need for inferring Stage I fatigue for the broken rod end is severe oxidation of the initial silver-coloured fracture surface of the main crack, figure 7. It should be noted that Stage I fatigue is common in precipitation-strengthened nickel-base superalloys, like Inconel 718, and occurs in both LCF and high cycle fatigue (Ref. 4).

Fig. 7 Detail of figure 6, showing severe oxidation

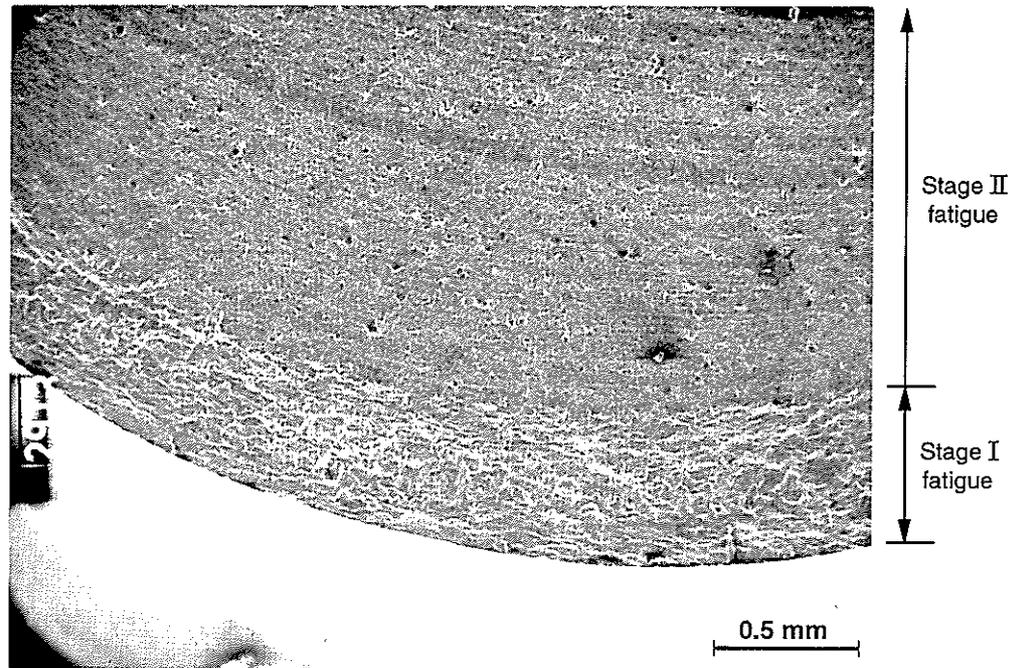
Figure 8 shows the Stage I → Stage II fatigue transition at low magnification in the Scanning Electron Microscope (SEM). The change in fracture topography is evident, and "beach marks" representing positions of the Stage II fatigue crack front are also visible. Figure 9 is a detail of the Stage II fracture surface, showing fatigue striations.

Fig. 8 SEM fractograph of Stage I → Stage II fatigue transition in the broken rod end

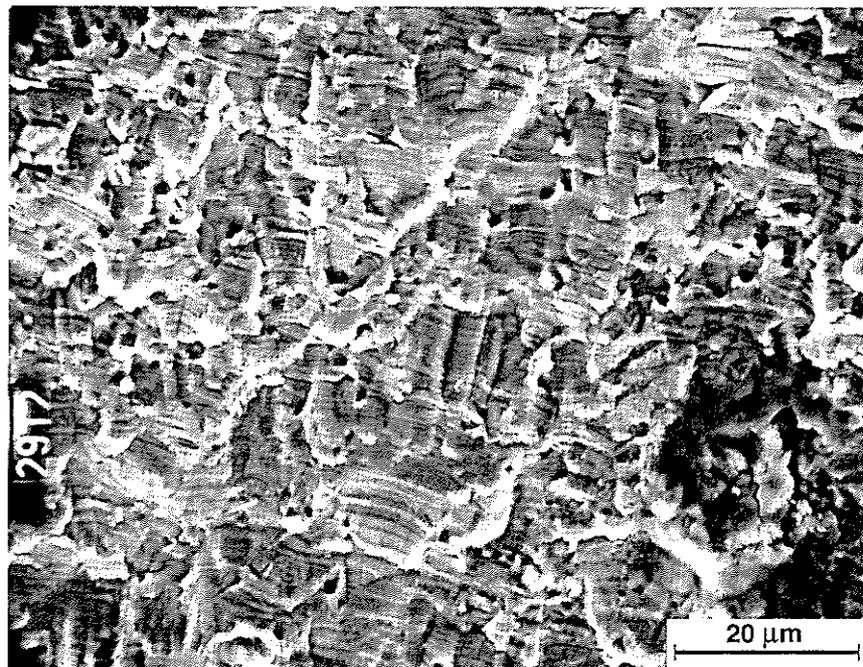
Fig. 9 Detail of figure 8 in the Stage II area, showing fatigue striations

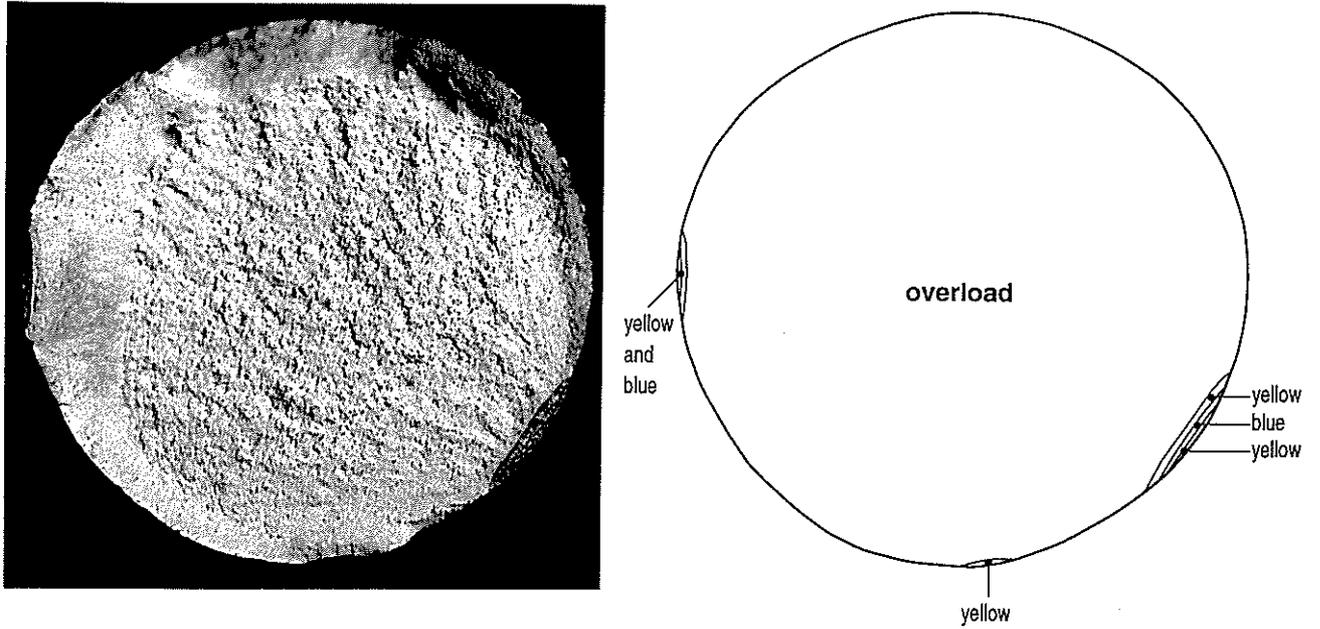
Figure 12 shows the macroscopic appearance of the fracture surface of the broken-open spherical rod end, together with a schematic of interference colours on the fatigue fracture surfaces. The shapes of the broken-open fatigue cracks suggest their initiation and growth were controlled by bending stresses. All the cracks show 2nd order interference colours, see section 8.

Fig. 12 Macrofractograph and schematic of the fracture surface of the broken-open spherical rod end (NLR code S) from the incident engine

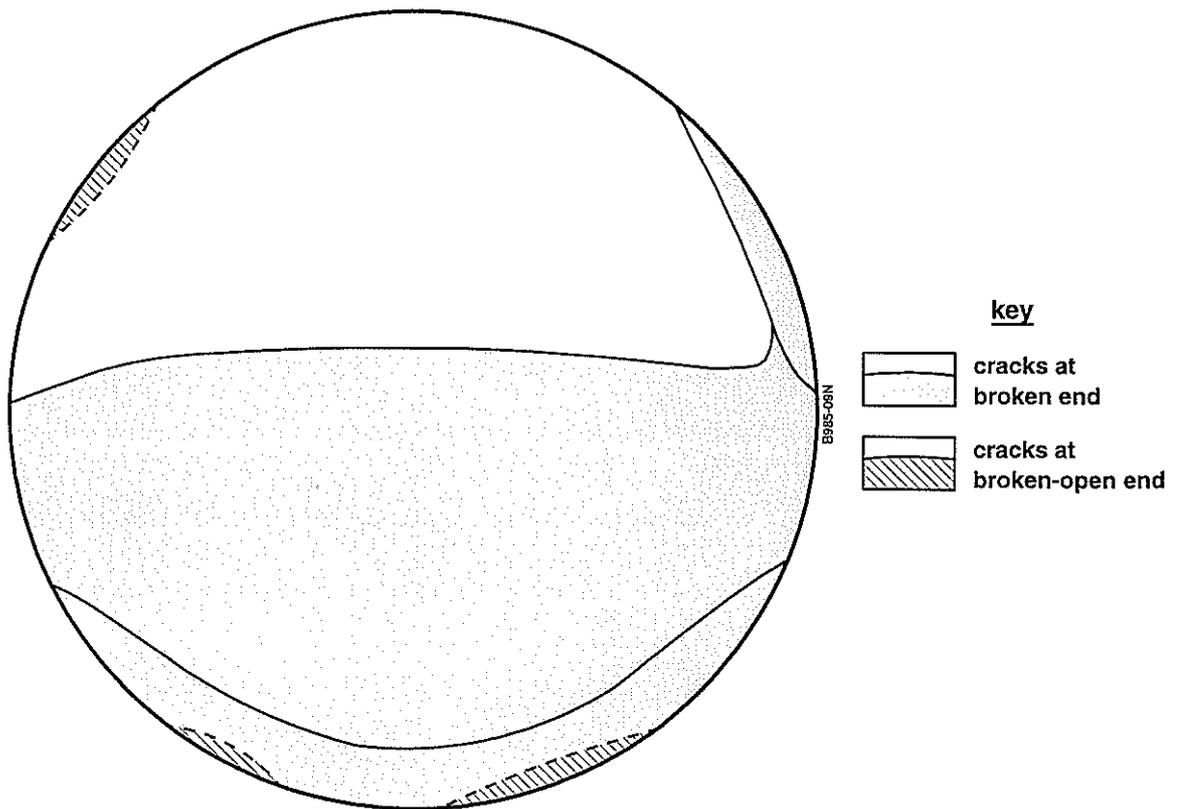
Figure 13 shows the relative positions, viewed in the outboard direction, of the cracks in the broken/broken-open parts of the rod. There is some correlation, notably between the main crack at the broken end and two of the cracks in the broken-open end. If anything, this correlation indicates that tensile bending stresses at and near the 6 o'clock position in figure 13 may have been responsible for initiating these cracks.

Fig. 13 Relative positions, viewed in the outboard direction, of the cracks in the broken/broken-open rod (NLR code S) from the incident engine

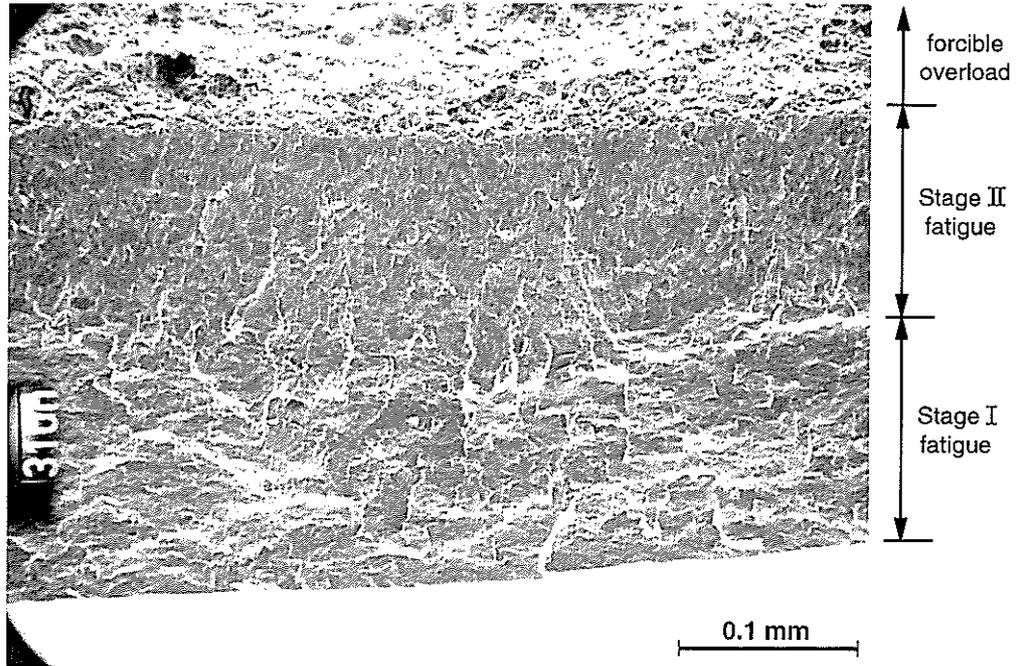
The fatigue fracture surfaces were considerably oxidised. Stage I → Stage II fatigue transitions were inferred from a change in fracture topography similar to that observed for a broken-open rod from another engine, see subsection 3.4.2. An example of this transition, for the crack at the 4 o'clock position of figure 12, is given in figure 14; and figure 15 is a detail of the Stage II area, showing oxidised fatigue striations.

Fig. 14 SEM fractograph of Stage I → Stage II fatigue transition in the broken-open spherical rod end (NLR code S) from the incident engine

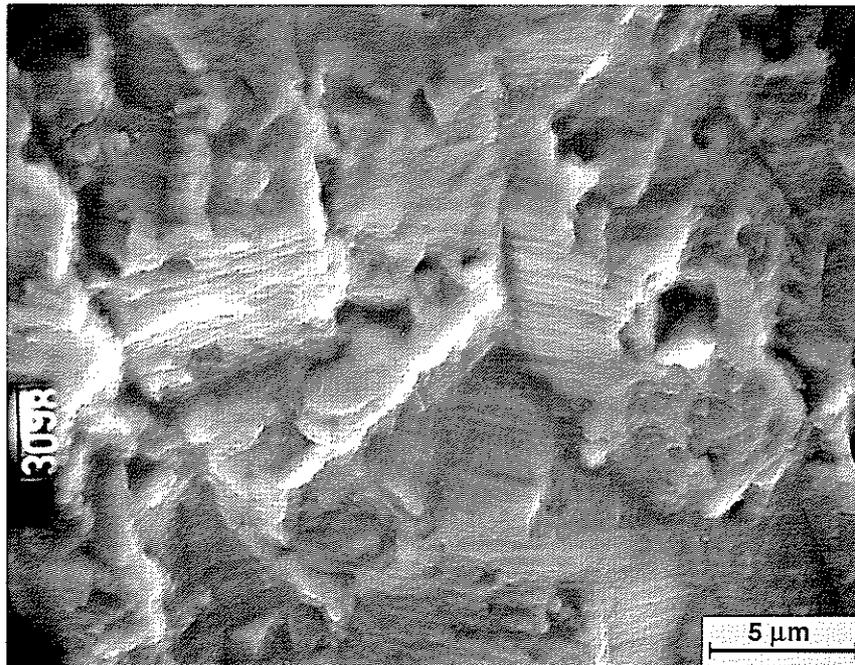
Fig. 15 Detail of figure 14 in the Stage II area just beyond Stage I

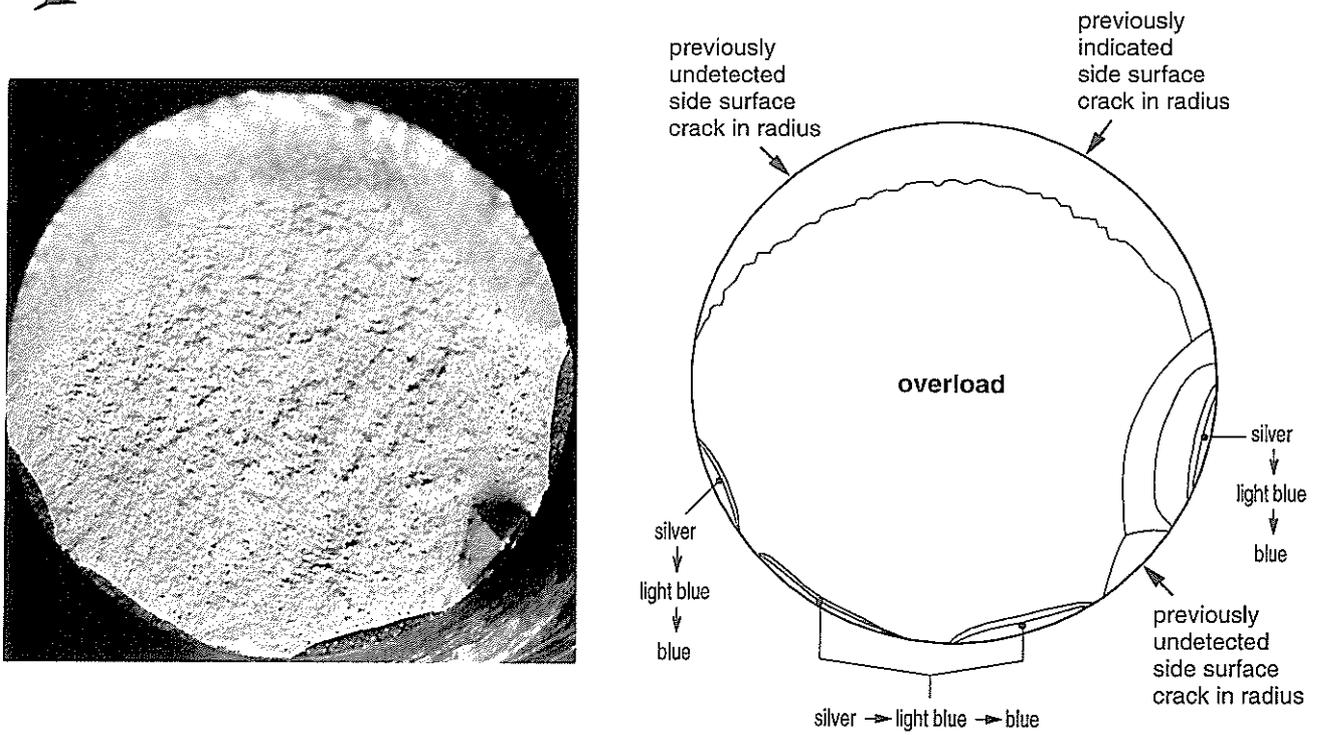
Figure 16 shows the macroscopic appearance of the fracture surface of the broken-open spherical rod end, together with a schematic of interference colours on the fatigue fracture surfaces and the locations of the side surface cracks. The shapes of the broken-open fatigue cracks suggest their initiation and growth were controlled by bending stresses. They are, however, fairly evenly distributed around the circumference of the fracture surface.

Fig. 16 Macrofractograph and schematic of the fracture surface of the broken-open rod (NLR code S_1) from the incident engine

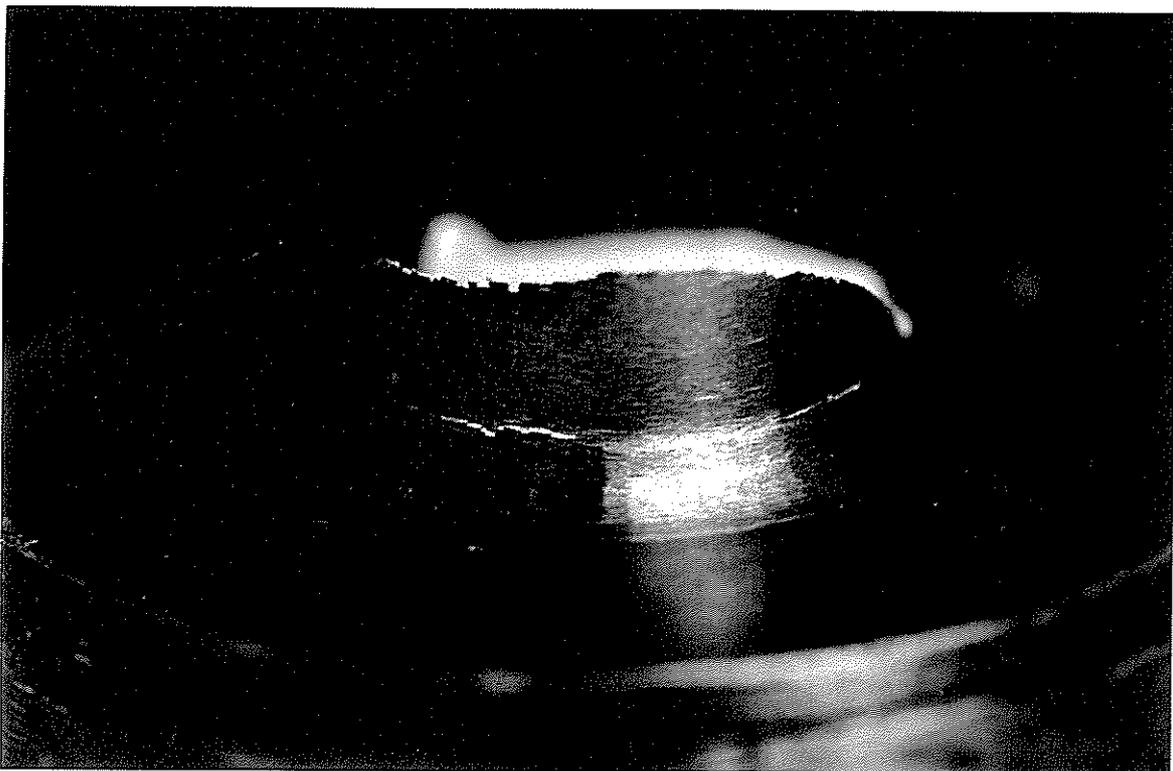
Figure 17 shows two of the side surface cracks, which had been partly opened-up by the forcible overload: the left-hand crack in figure 17 had been indicated by fluorescent penetrant inspection before the rod was pulled in tension. The cracks were exactly at an abrupt change in the mod radius.

Fig. 17 Two of the partly opened cracks in the broken-open rod (NLR code S_1) from the incident engine

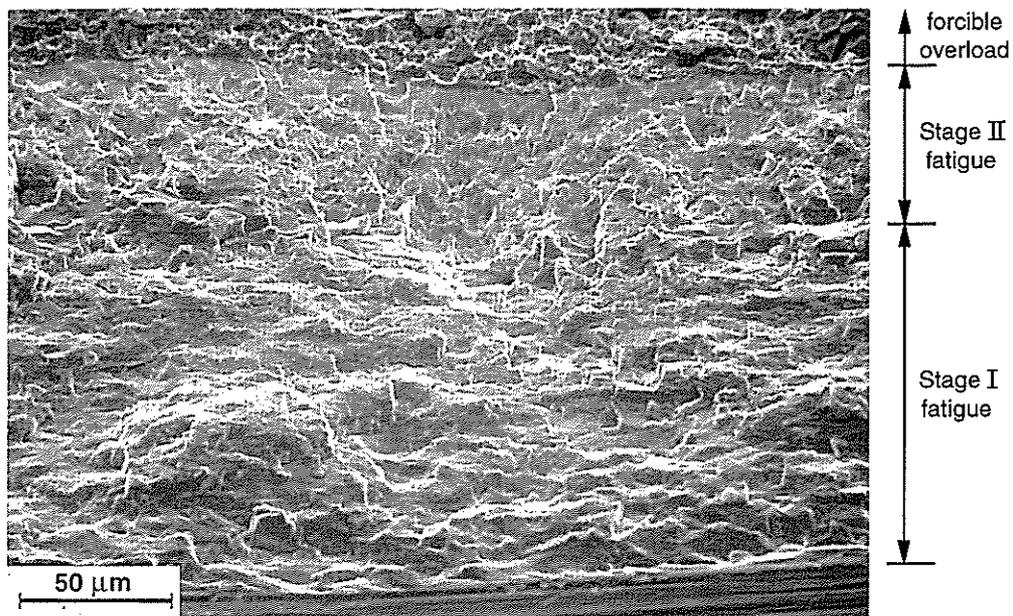
Fig. 18 SEM fractograph of Stage I → Stage II fatigue transition in the broken-open spherical rod end (NLR code S₁) from the incident engine

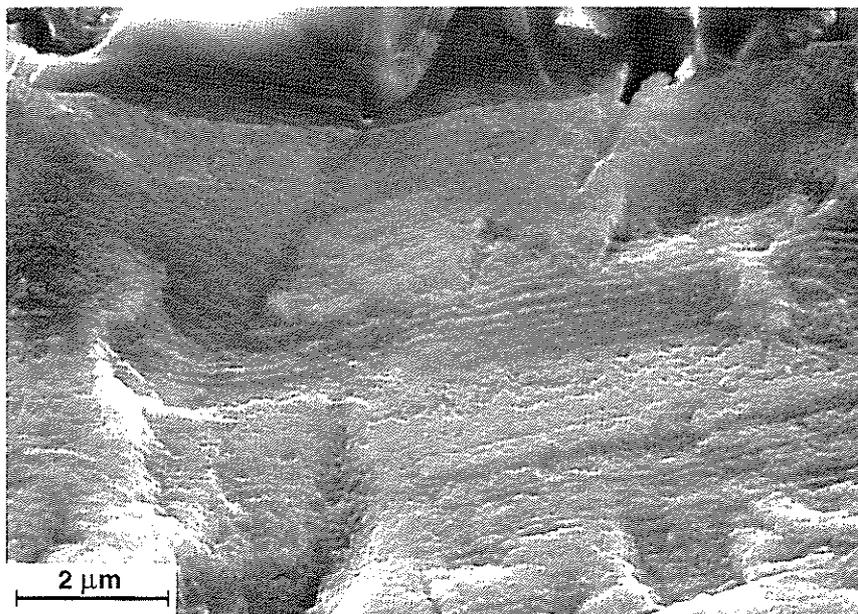
Fig. 19 Much-oxidised fatigue striations for one of the cracks in the broken-open spherical rod end (NLR code S₁) from the incident engine

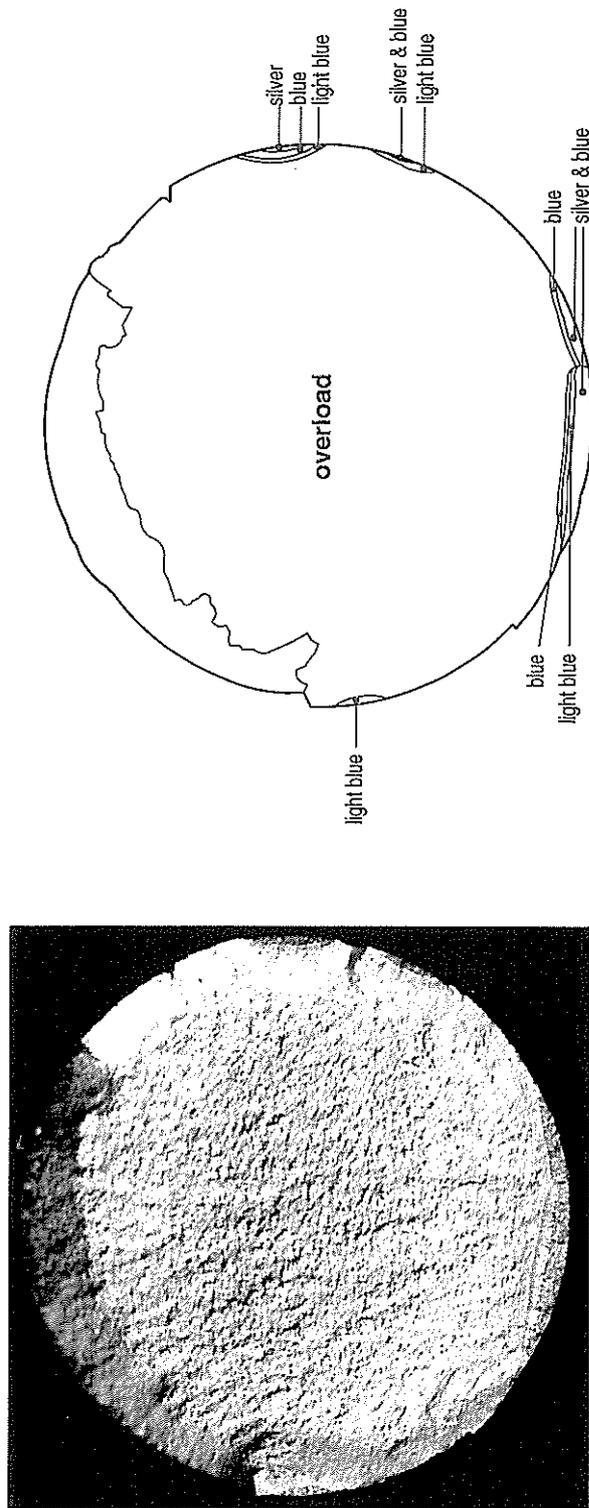
Figure 20 shows the macroscopic appearance of the fracture surface of the broken-open spherical rod end, together with a schematic of the interference colours and fracture characteristics. The rod fractured over all the indicated cracks. The shapes of the broken-open fatigue cracks suggest their initiation and growth were controlled by bending stresses.

Fig. 20 Macrofractograph and schematic of the fracture surface of a broken-open rod (NLR code A)

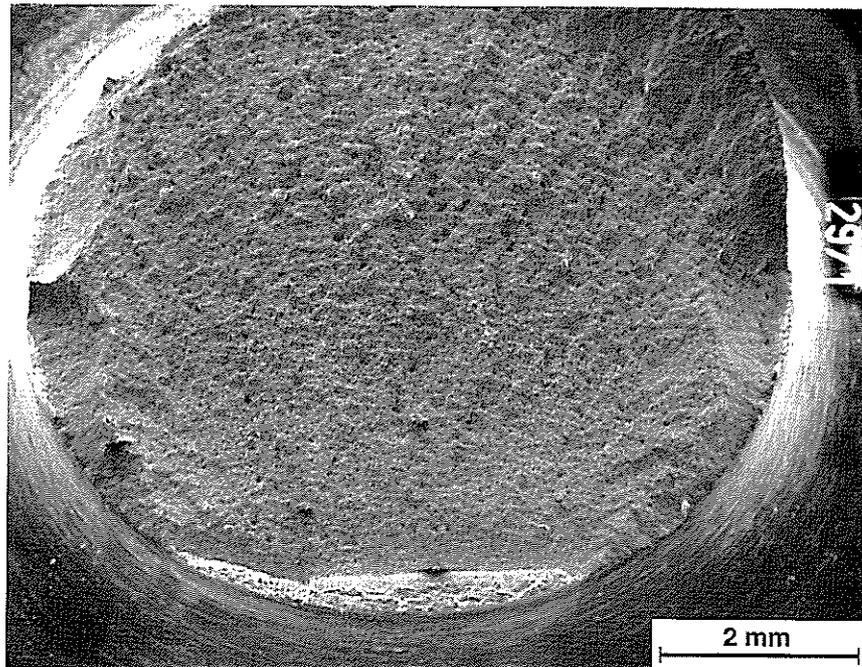
Figure 21 is a low magnification SEM fractograph of the broken-open spherical rod end: this is the mating fracture surface to that shown in figure 20. The main crack at the 6 o'clock position in figures 20 and 21 showed a change in fracture topography corresponding to the Stage I → Stage II fatigue transition. However, as in the case of the rods from the incident engine, the occurrence of Stage I fatigue is inferred from the rough fracture topography, since the initial cracked area was severely oxidised, figure 22.

Fig. 21 Low magnification SEM fractograph of a broken-open spherical rod end (NLR code A); see also figure 20, which shows the mating fracture surface

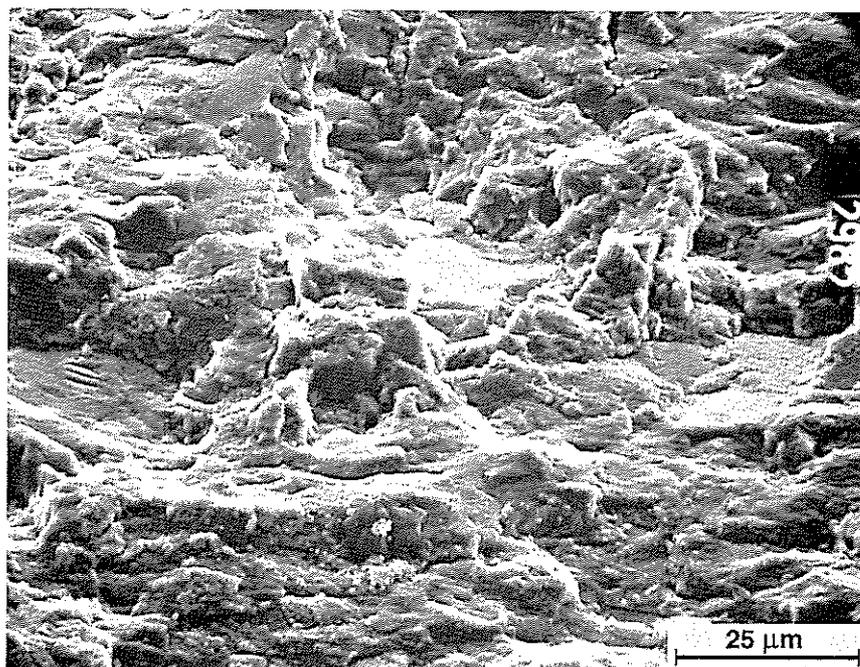
Fig. 22 Detail of initiation area of main crack in figure 21, showing severe oxidation

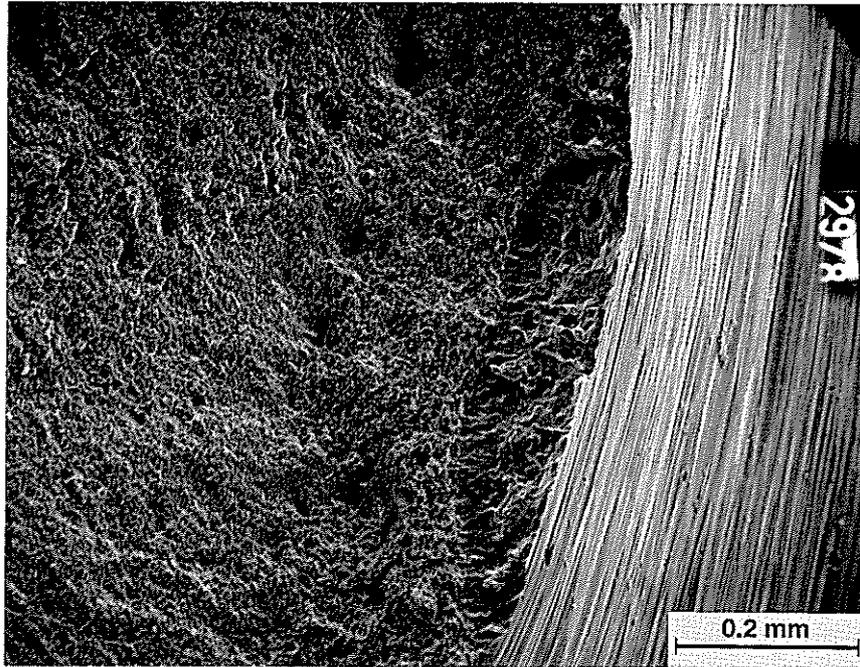
On the other hand, the crack at the 3 o'clock position in figure 21 was less oxidised (this crack is at the 9 o'clock position in Fig. 20). Figures 23 and 24 give details of this crack, including the Stage I → Stage II fatigue transition. The characteristics of Stage I fatigue are most clearly seen at the centre of figure 24, namely flat and crystallographically ridged facets: see also subsection 3.5.2. The characteristics of Stage II fatigue were fatigue striations. Examples are given in figure 25.

Fig. 23 SEM fractograph of crack at 3 o'clock position in figure 21

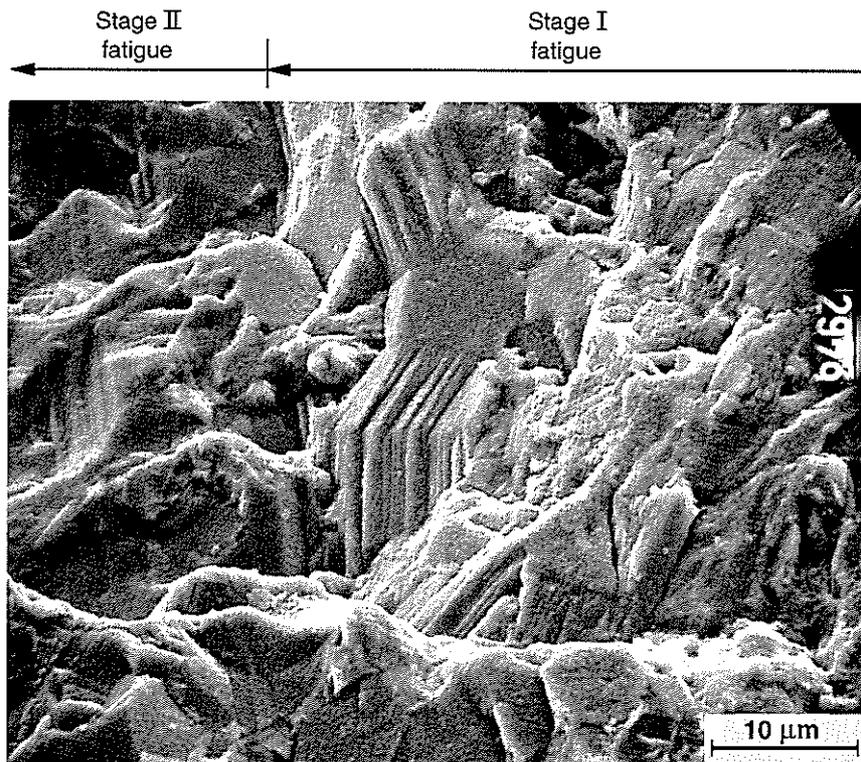
Fig. 24 Detail of figure 23, showing Stage I → Stage II fatigue transition

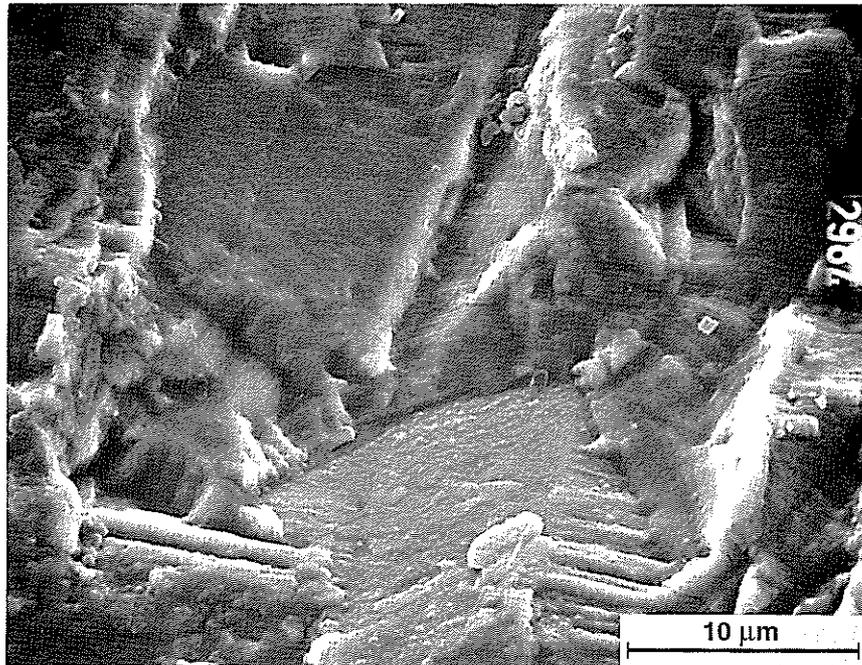
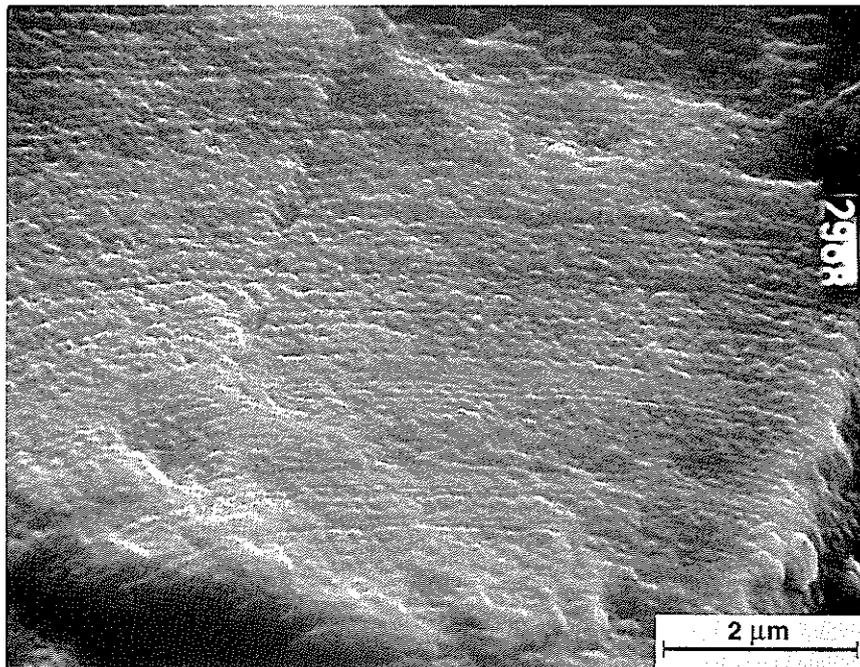
Fig. 25 Fatigue striations at the beginning of Stage II fatigue for the crack at the 6 o'clock position in figures 20 and 21

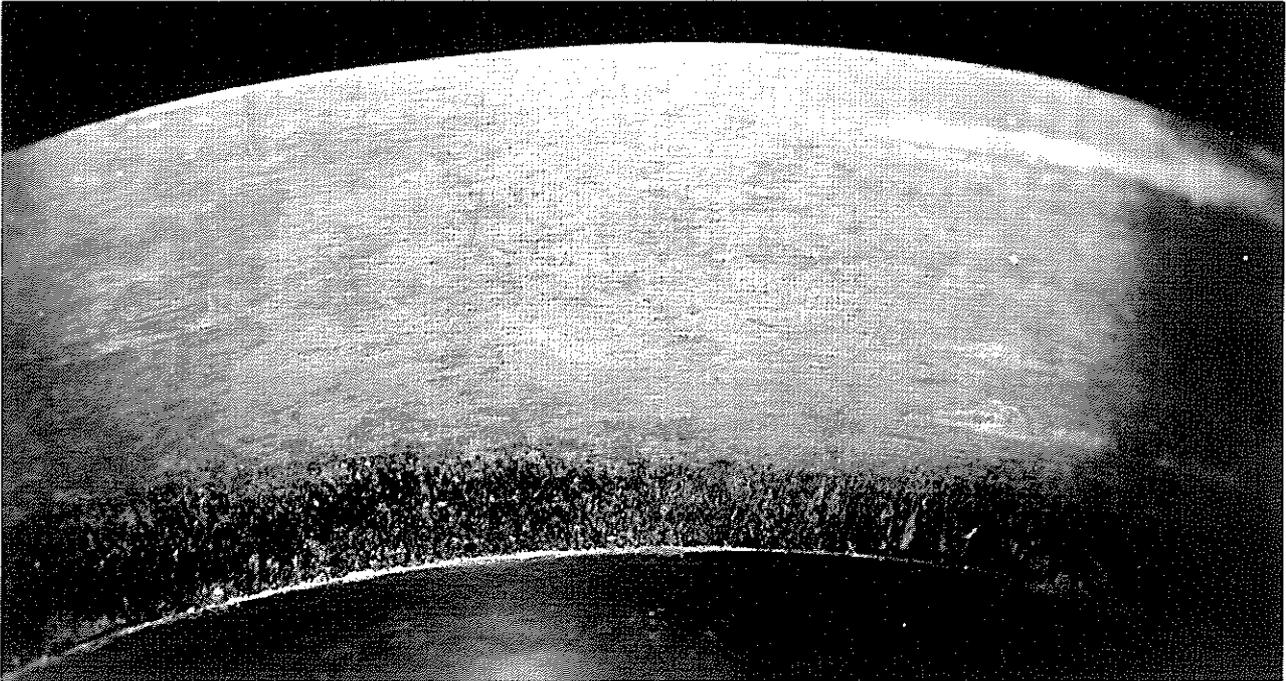
Fig. 36 Local fretting on the spherical rod end of the broken rod from the incident engine (NLR code S)

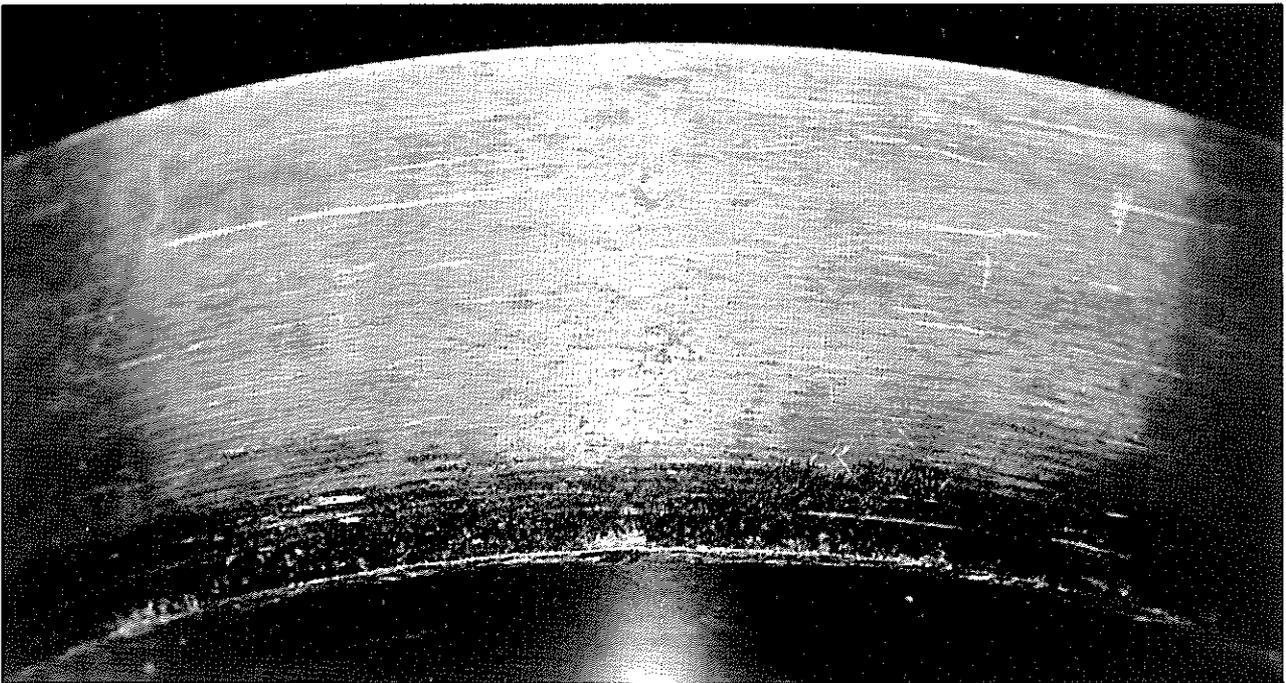
Fig. 37 Local fretting on the spherical rod end of the broken-open rod from the incident engine (NLR code S₁)

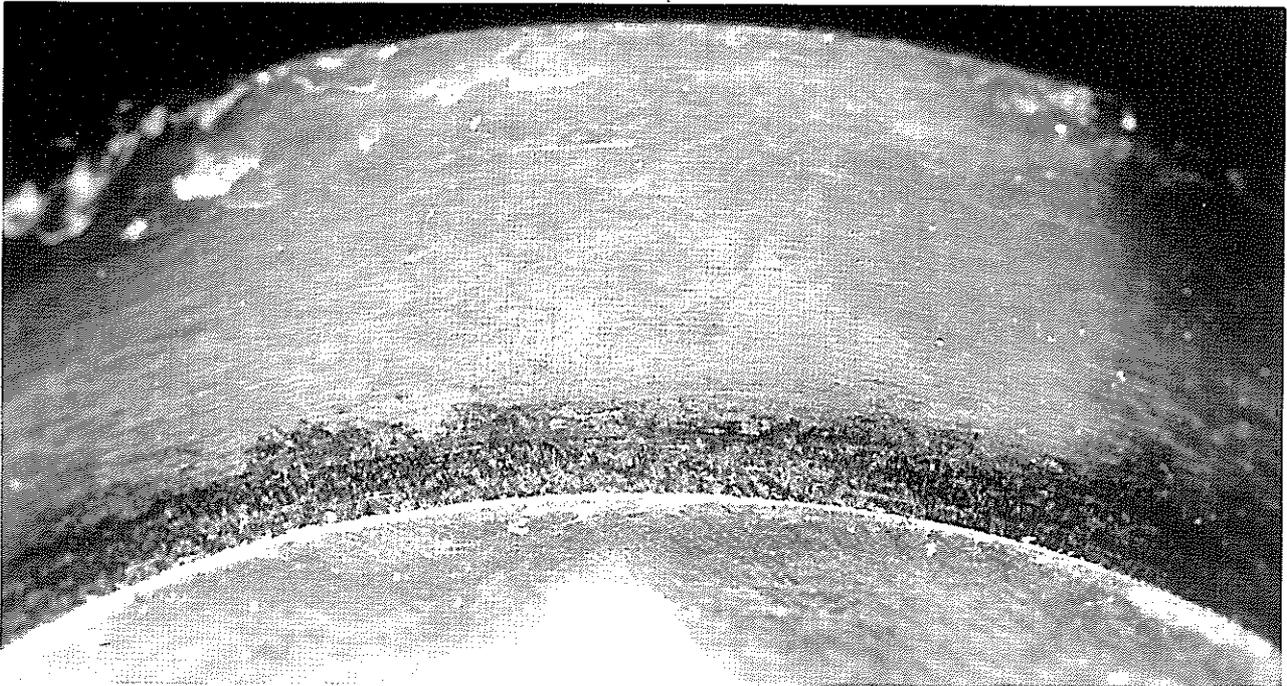
Fig. 38 Local fretting on the spherical rod end of a broken-open rod (NLR code A)

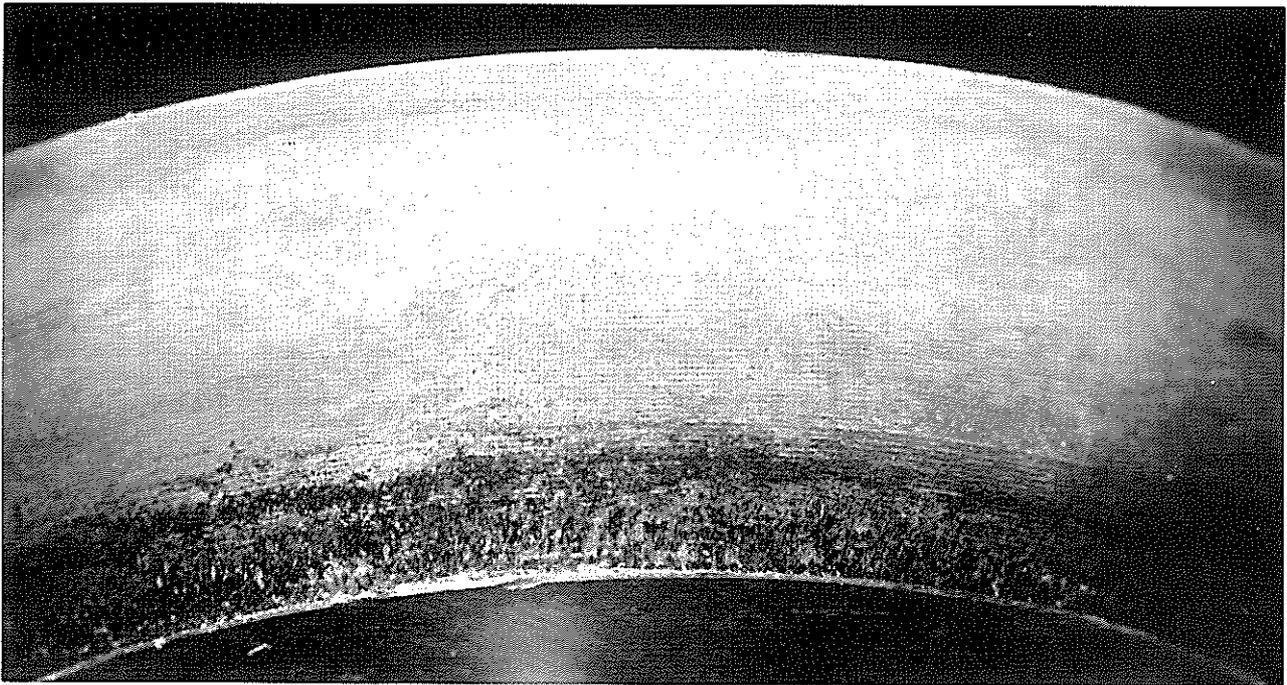
Fig. 39 Local fretting on the spherical rod end of an uncracked rod (NLR code D)
