NLR TECHNICAL PUBLICATION

TP 96047 U

FAILURE AND CRACKING OF INCONEL 718 AIR SUPPLY
MANIFOLD SUPPORT RODS

- A service-related contribution to IEPG TA 31 -

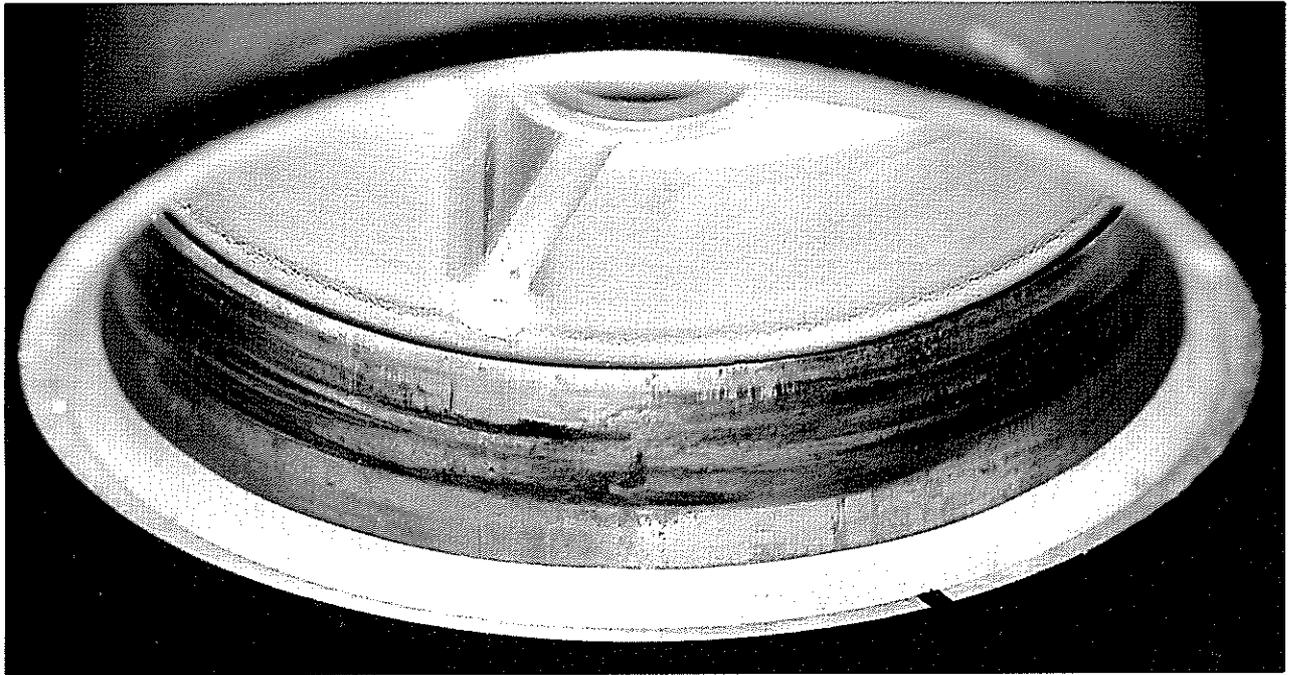
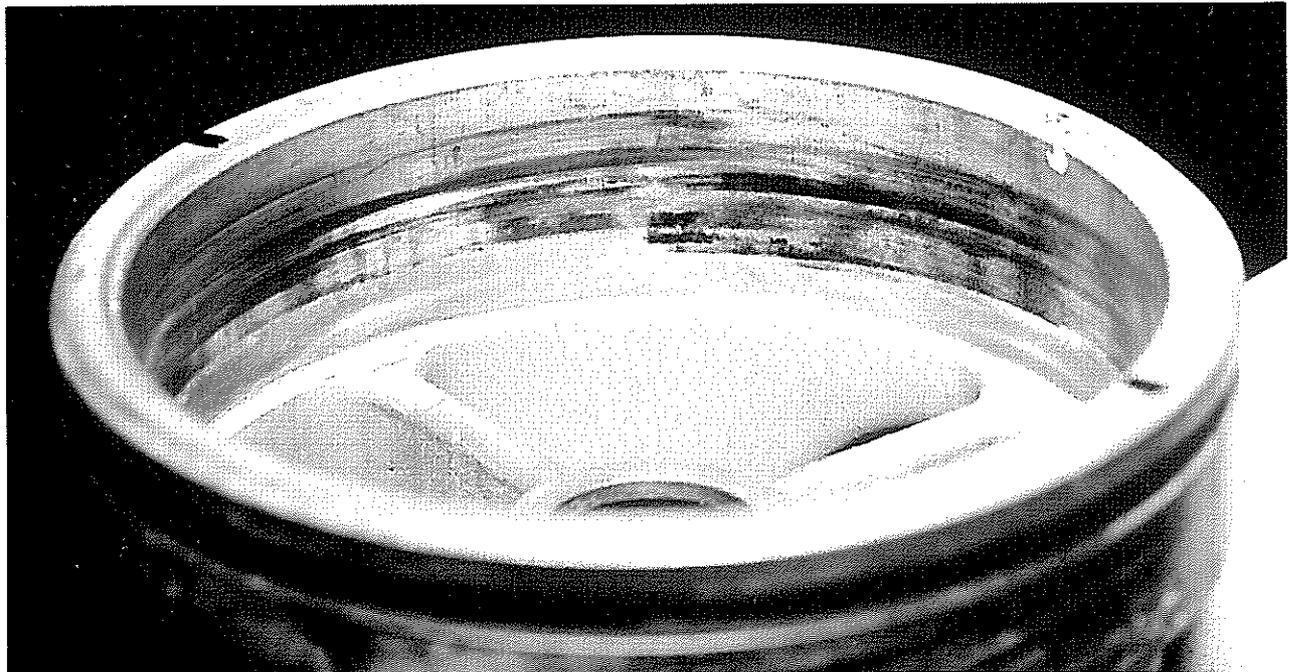
Fig. 41 Grooves on the inside ring surfaces of the air supply tube expansion sleeves from the 8 o'clock position on the incident engine
