Multi-domain contactless NDI approach: Data fusion of structural light scanning with thermography and shearography

H. Patrick Jansen, Arnoud F. Bosch, D. Jacco Platenkamp
 Royal Netherlands Aerospace Centre (NLR), Netherlands, patrick.jansen@nlr.nl

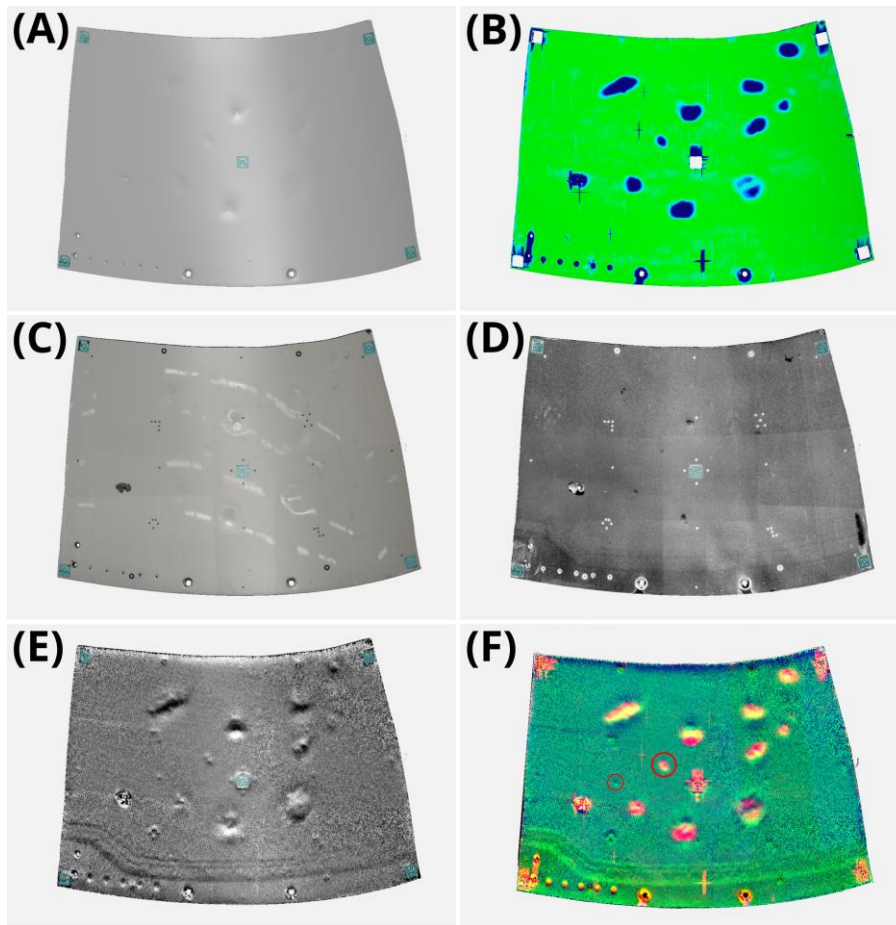
Figure 1. Results of the radome (A) Surface mesh, (B) Dent map, (C) Mapped photographs, (D) IRT 0.200 Hz, (E) Shearography, (F) Fusion of data, red channel dent map, green channel shearography, blue channel IRT 0.200 Hz

320x240x240 mm, resulting in a point spacing of 0.068 mm and an accuracy of about 0.02 mm. The reference markers placed on top of the radome have a size of respectively 3 mm and 6 mm. A total of 61 3D measurements were done to capture the entire specimen, if only the front side is needed a total of 14 scans would be sufficient. Scanning can also be performed with a larger measuring volume of 1000x750x750 mm, requiring only a single scan of a couple of seconds with the consequence of losing point spacing and accuracy (0.20 mm point spacing and accuracy of about 0.05mm) The resulting surface mesh is shown in **Figure 1 (A)**, showing dents on the surface. For better visibility of the dents a surface defect map can be constructed as shown in **Figure 1 (B)**. Scaling starts at green at 0.0 mm, dark blue regions have a dent depth of 0.07 mm or above. A total of 11 dents can be seen on the surface.

Only external geometric effects are captured by the 3D scanner, and no information on the damage inside of the skin, skin-honeycomb interface and honeycomb can be extracted from the data. Therefore thermographic and shearographic inspections are also performed on the front side of this specimen, which is the side that would be accessible in a Maintenance Repair and Overhaul (MRO) environment. For the thermographic inspection, the front side of the panel is divided into 4 areas. The FOV of the infrared camera is 365 x 300 mm, resulting in a resolution of 0.58 mm/ pixel. The inspections were done at four different lock-in frequencies: 0.50, 0.20, 0.10 and 0.05 Hz. **Figure 1 (D)** shows the mapped thermographic phase images at 0.10 Hz. Small difference in greyscale values between the separate images can be seen as straight bands on the model. The reference markers are visible as white spots on the thermographic images which have been used for the mapping of data. Damage in the GFRP skin can be seen as black spots on the image. Not all dents that have been found using 3D scanning show damage inside of the skin. The damage found with the thermography inspection is the cracking of the skin and not all dent locations show this cracking. Cracking of the skin can result in water ingress of the radome and it is therefore an important defect that needs to be found.

Shearographic inspection has also been performed in a similar manner as the thermographic inspection, resulting in roughly the same FOV but with a higher resolution of 0.15 mm/pixel. The unwrapped phase information of the shearographic measurement is exported to an image and the results can be mapped on the surface as shown in **Figure 1 (E)**. For an undamaged radome, a uniform image is expected. This is not the case and multiple damages can be seen on the radome, corresponding to the locations where a dent is visible from the 3D scan. Using shearography the gradient of the out-of-plane deformation under stress induced by the halogen lamps can be detected. This difference in out-of-plane movement is caused by defects that alter the stiffness of the panel. In this case it is probably caused by damage inside of the honeycomb, or a debond between the GFRP skin and the honeycomb.

All NDI data is mapped on the same surface mesh allowing for data fusion and a compiled image. *Figure 1 (F)* shows the data in a compiled image, where the surface dent map is expressed in the red channel, shearographic data in the green channel and the thermographic data at 0.20 Hz in the blue channel. When there is a defect in all data types the area will be white. This can be seen in some of the dents in the centre, where there is also damage in the skin which is detected by thermography. Areas that are yellow contain a defect in both the surface defect map and the shearographic data.

Using images produced by data fusion for NDI makes the classification of defects easier as certain indications will be visible in one technique and invisible in another. For example, using this technique the reference markers that produce a signal in the thermographic and shearographic inspection can be filtered out since they do not appear in the defect map. And, while the response in the shearographic data between a small dent and a reference marker can be difficult to distinguish. In the fused image, the reference marker is immediately identifiable as it appears green while the small dents appear red and yellow (see red circles in the image),

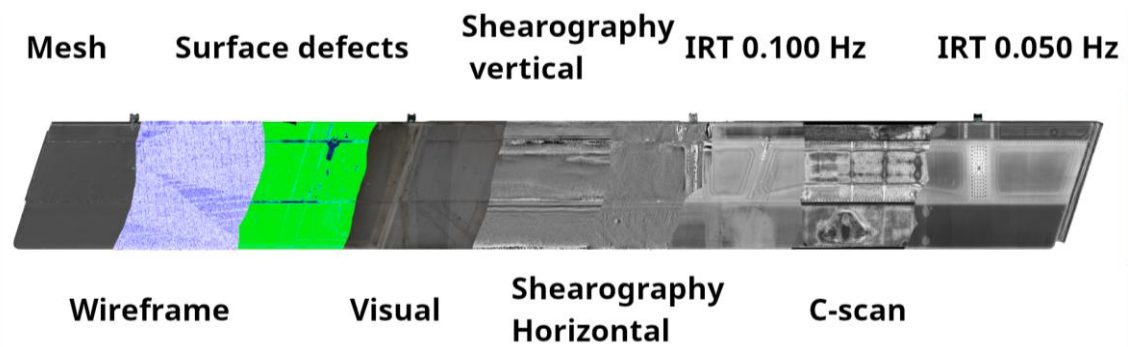
Figure 2. Results of the mapped data of the 747-400 flap showing the bottom side. From left to right, mesh, wireframe, surface defects, visual images, shearography vertical, shearography horizontal, IRT 0.100 Hz, C-scan and IRT 0.050Hz

Additionally, a part of the flap was also scanned by traditional ultrasonic C-scanning in squirter pulse-echo mode using a single transducer of 19 mm with a nominal frequency of 5 MHz. All data from all experiments have been mapped on top of the 3D mesh, resulting in a single file containing all the inspection data. Results from the bottom side of the flap are partially shown in **Figure 2**.
