NLR TP 96719

Fatigue and Fracture in an Aircraft Engine Pylon

R.J.H. Wanhill and A. Oldersma

FATIGUE AND FRACTURE IN AN AIRCRAFT ENGINE PYLON

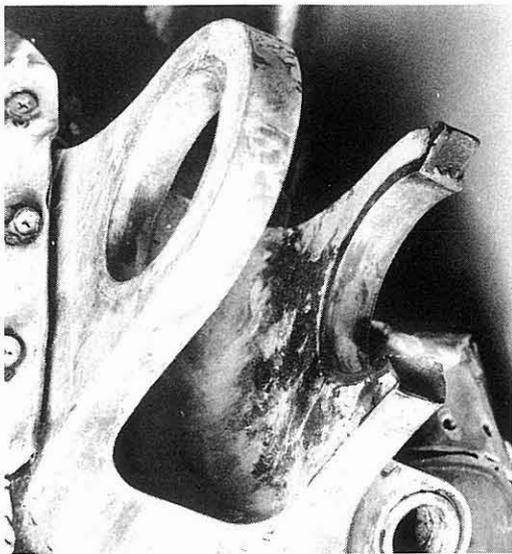
a inboard

Figure 2 shows the mid-spar pylon fittings. Each has two lugs that had been connected via fuse pins to two male lugs on each mid-spar wing fitting. The lugs on the outboard pylon fitting were unbroken but had witness marks indicative of scraping, as did the base of the throat between the lugs (Wanhill 1992, Nash 1993a). However, the outer lug of the inboard pylon fitting was broken. Detailed examination by the NLR showed that this lug had failed by a combination of tensile and bending overload (Wanhill 1992). This was confirmed by Boeing (Nash 1993a). Also, in contrast to the outboard pylon fitting, the base of the throat between the lugs of the inboard pylon fitting was undamaged (Wanhill 1992). From these results two main conclusions were drawn:

- (1) The missing inboard mid-spar fuse pin must have failed such that the outer lug of the inboard mid-spar pylon fitting took all the load at this connection. Only thus is it possible to explain overload failure of the lug by tension and bending (Netherlands Aviation Safety Board 1994).
- (2) During failure of the inboard mid-spar connection the male lugs of the wing fitting moved outward from the throat of the lugs on the pylon fitting. On the other hand, failure of the outboard mid-spar connection resulted in the male lugs of the wing fitting moving into the throat of the lugs on the pylon fitting, thereby producing witness marks.

Figure 2 The lugs of the mid-spar pylon fittings.

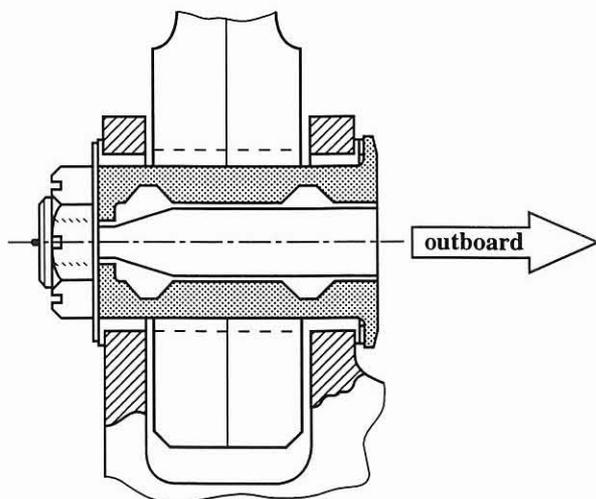
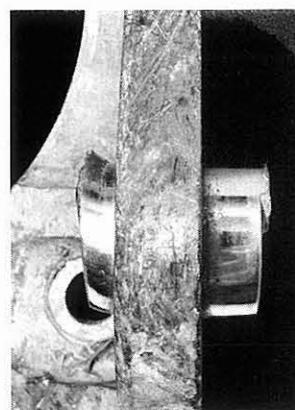
Figure 3 Schematic and remnant of the outboard mid-spar fuse pin.

Figure 3 shows a schematic of the outboard mid-spar connection with a cross-section of the intact fuse pin, and also the as-recovered fuse pin remnant, still in one of the male lugs of the wing fitting. The fuse pin broke at the thin-walled locations shown in cross-section in figure 3a. On the inboard side the fuse pin failed by shear overload, but on the outboard side it failed by fatigue followed by shear overload.

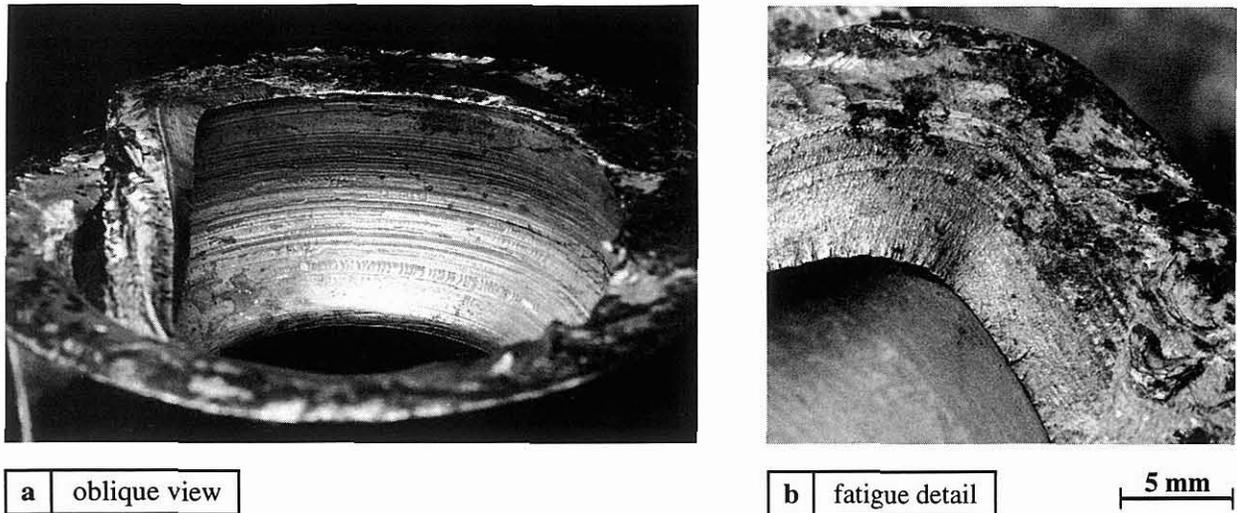
Figure 4 Outboard fracture surface of the outboard mid-spar fuse pin.

Figure 4 gives two macroscopic views of the outboard fracture surface of the fuse pin. The partially separated sliver in figure 4a contains a fatigue crack originally parallel to the coarse machining grooves on the inside wall of the fuse pin. Figure 4b is a detail of the fatigue crack, which initiated at multiple origins along one or more machining grooves and progressed to at least

half the wall thickness before overload (Oldersma & Wanhill 1993, Nash 1993a).

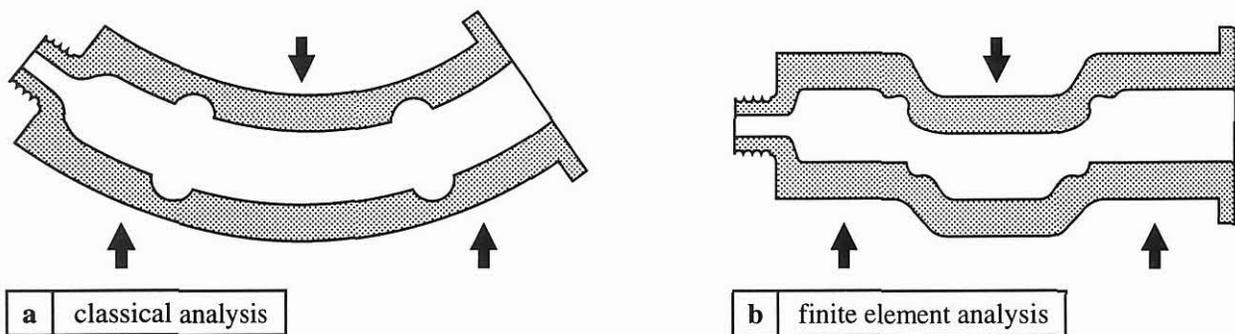
Figure 5 Fuse pin bending under service loads.

The stresses causing fatigue crack initiation were due to fuse pin bending. Boeing did both a classical and finite element analysis of fuse pin bending, the results of which are shown schematically in figure 5. Boeing concluded that fuse pins undergo crankshaft deflections, leading to much higher local stresses, in the thin-walled locations, than those estimated by classical 3-point bending analysis.

Summarising, in our opinion there has not been a definitive interpretation of the fatigue fracture surface of the outboard mid-spar fuse pin. However, Boeing's analysis of fuse pin bending indicates high local stresses (the crankshafting illustrated in figure 5) and thus would appear to support Technion's interpretation that the markings in figure 6 represent true striations.

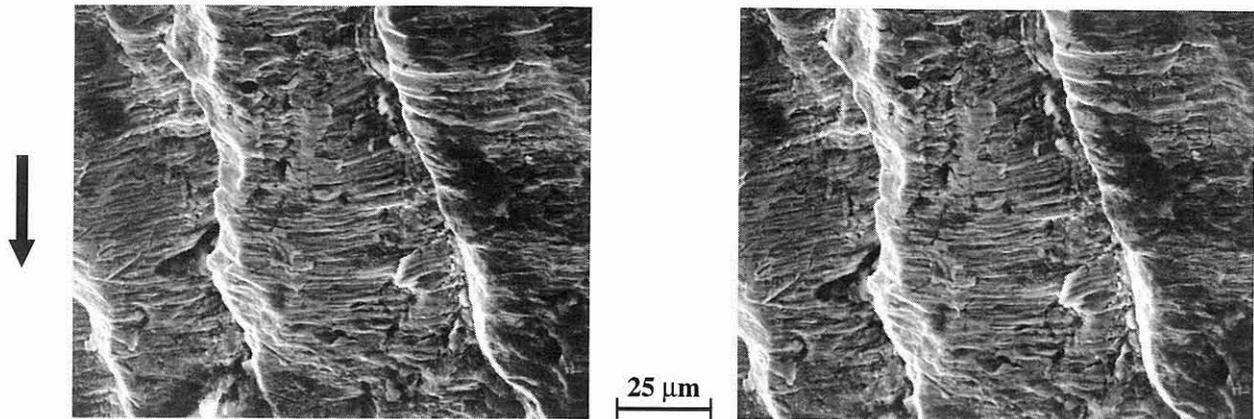
Figure 6 Stereo-pair fractographs of fatigue in the outboard mid-spar fuse pin (Oldersma & Wanhill 1993).

- (1) The NLR was able to examine the fatigue fracture for only a short time. We found much of the fracture surface to be severely damaged, most probably due to rubbing of the mating fracture surfaces during shear overload. However, a patch of partially rubbed and damaged fatigue "striations" was observed at a depth of 2.2 mm from the inside wall, figure 6. The spacings of the "striations" were greater than 10^{-3} mm, which would appear to indicate a high fatigue crack growth rate and hence high local stresses in the fuse pin.
- (2) Boeing conducted an extensive investigation of the fatigue fracture (Nash 1993b). They concluded that the "striations" illustrated in figure 6 represent flight-by-flight markings, and that fine striations were present between such markings. This implies that fatigue crack growth rates were much lower than would be inferred from the NLR's examination.

- (3) Technion commented on the NLR and Boeing investigations and also conducted fatigue tests on fuse pins (McEvily & Berkovitz 1993). They found fine parallel deformation markings, which did not represent load cycles, between large fatigue striations. They concluded that the "striations" illustrated in figure 6 are true cycle-by-cycle striations.

The RLD requested the NLR to comment. From the Technion results and those of others (Laird 1967, Hertzberg 1967) we concluded that since parallel deformation lines occur between striations with spacings greater than 10^{-3} mm, it is entirely possible that markings like those in figure 6 are true striations. On the other hand, the evidence presented by Boeing, though unconvincing, was no more than one would expect for minor load cycles between flight-by-flight markings on high strength steel fracture surfaces (Wanhill 1985).

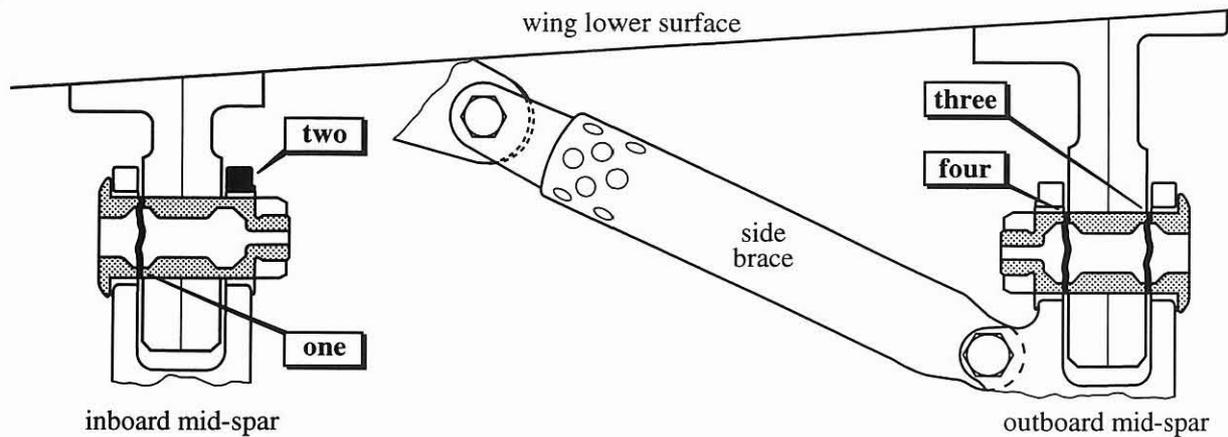
Figure 7 Probable sequence of separation of the #3 engine pylon from the right wing.

The Netherlands Aviation Safety Board considered several scenarios for separation of the #3 engine and pylon from the right wing. Figure 7 shows the most probable sequence of events, described as follows:

- (1) Gradual failure by fatigue and then overload failure of the inboard mid-spar fuse pin at the inboard thin-walled location.
- (2) Overload failure of the outer lug of the inboard mid-spar pylon fitting.
- (3) Overload failure of the outboard mid-spar fuse pin at the outboard thin-walled and fatigue-cracked location.
- (4) Overload failure of the outboard mid-spar fuse pin at the inboard thin-walled location.

The Board concluded that overload failure of the inboard mid-spar fuse pin and the subsequent overload failures all occurred during the last flight. This has subsequently been disputed because an
