Teardown of a GLARE window area from the Airbus MegaLiner Barrel fatigue test article

NLR-TP-2006-183

R.J.H. Wanhill
D.J. Platenkamp
T. Hattenberg
A.F. Bosch

April 2006

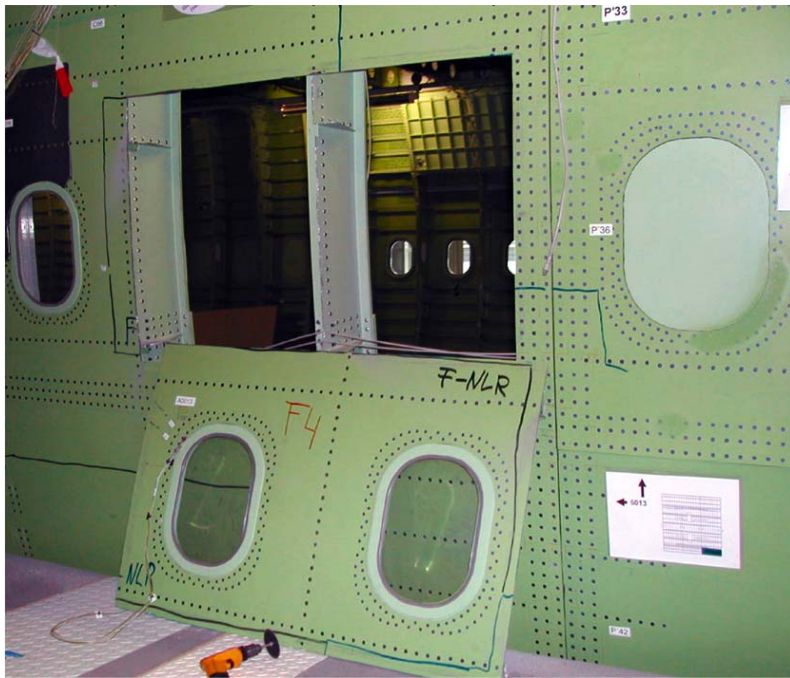
Figure 1 GLARE window area cut from the MLB

Figure 1 shows the GLARE window area shortly after its removal from the MLB. The window area has two identical windows, which are the A340 shape rather than the A380 elliptical shape. This difference is unimportant for the present work.

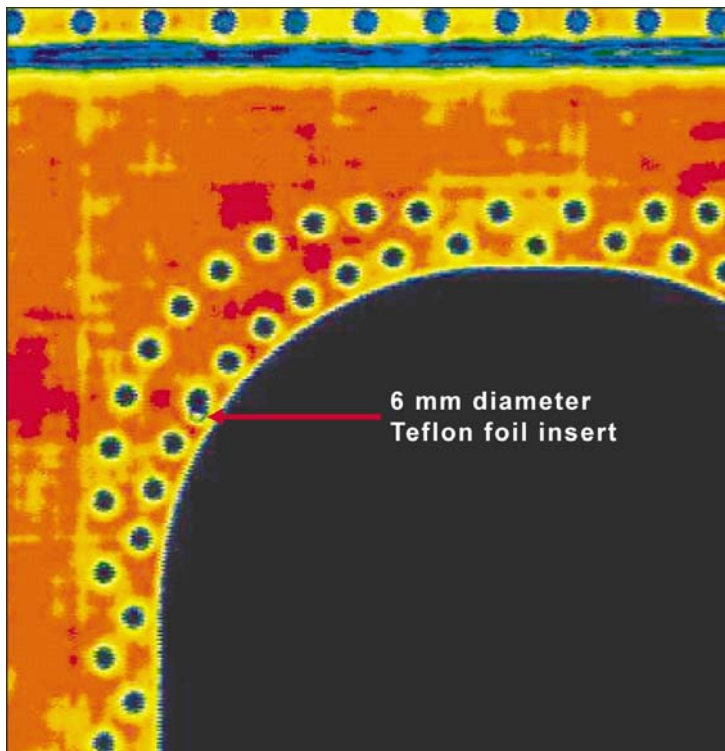
Figure 5 C-scan attenuation detection of the insert

The GLARE skin was C-scanned around the window cutouts. The 6mm diameter Teflon foil insert was readily detected by both attenuation and reflection measurements, for example figure 5. The measurements showed that the MLB fatigue test did not cause delamination growth from the insert.

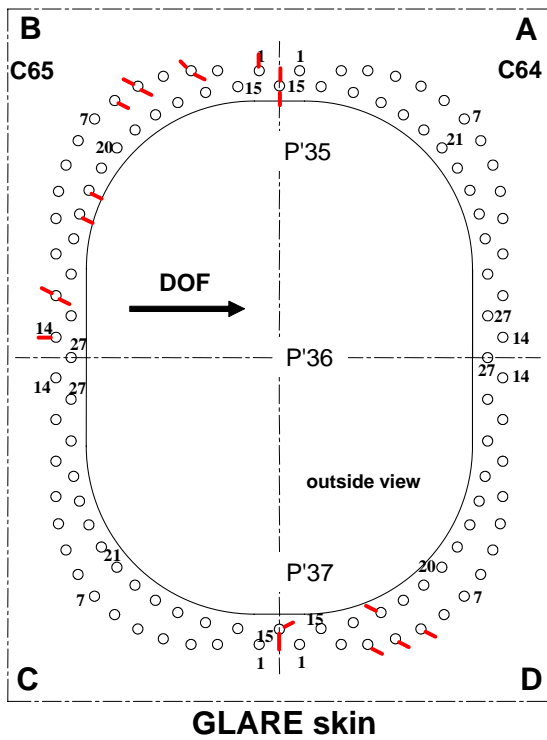
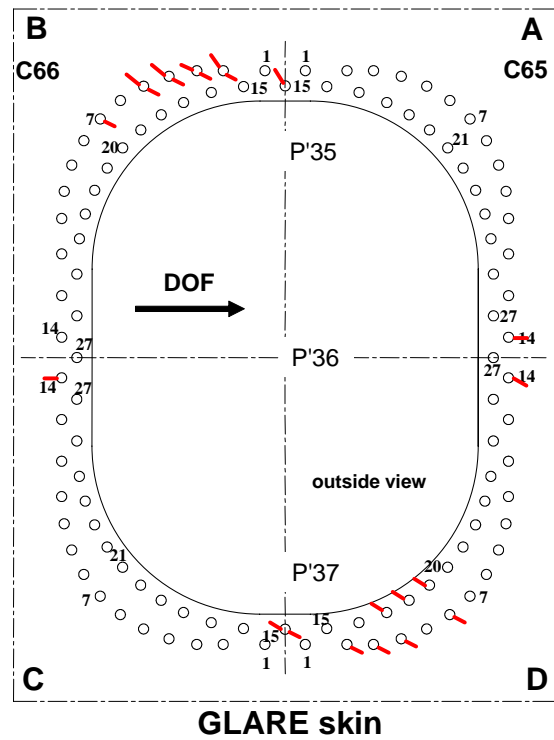
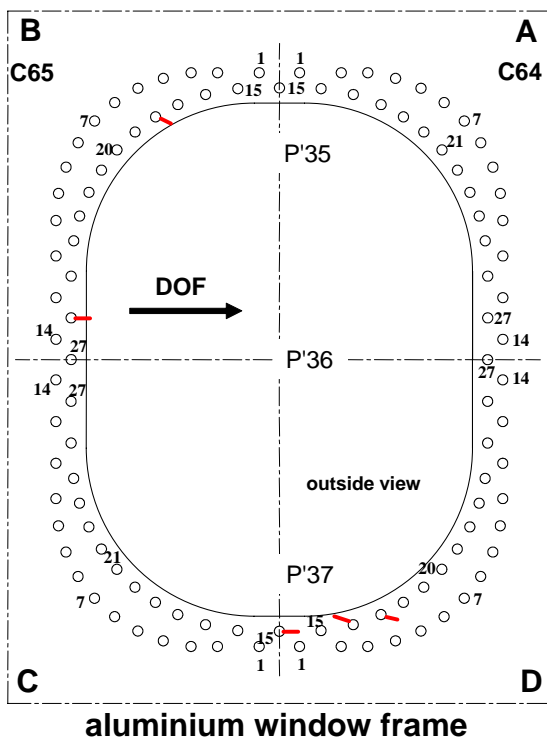
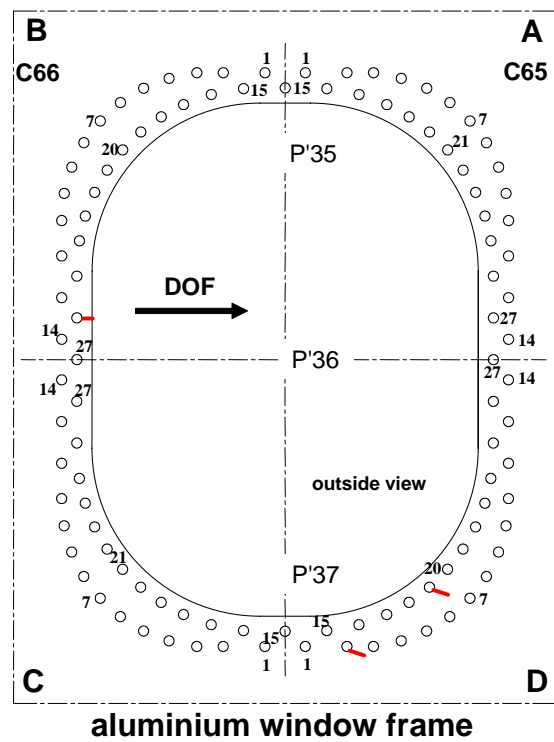
Figure 6 Overviews of the crack indications from eddy current rotor inspections of the fastener hole bores of the fully disassembled GLARE skin and aluminium window frames: **DOF** = Direction Of (simulated)

53 crack indications were obtained for the fastener hole bores in the partially assembled condition, and 49 indications in the fully disassembled condition. The crack indications were almost equally divided between the windows: figure 6 shows 19 and 22 indications for the GLARE skin around windows C64 – C65 and C65 – C66 respectively; and 5 and 3 indications for the corresponding aluminium alloy window frames.

Figure 6 also shows that most of the crack indications were in the **B** and **D** quadrants. These were the quadrants largely subjected to tensile shear loads during the MLB fatigue test.

Only two crack indications were obtained for the fastener hole countersinks in the GLARE skin: one at hole B6 for window C64 – C65, and the other at hole B4 for window C65 – C66 (see figure 6 for the hole locations). These indications were not confirmed by a pencil probe check, so any cracks would have to have been small: see subsection 7.3.

Note that the false calls came from fastener holes on the long axes of the windows (see figure 6). A likely explanation is that these holes were used as locators for attaching the aluminium window frames to the GLARE skin, and that this locator function led to hole damage sufficient to cause the NDI indications.

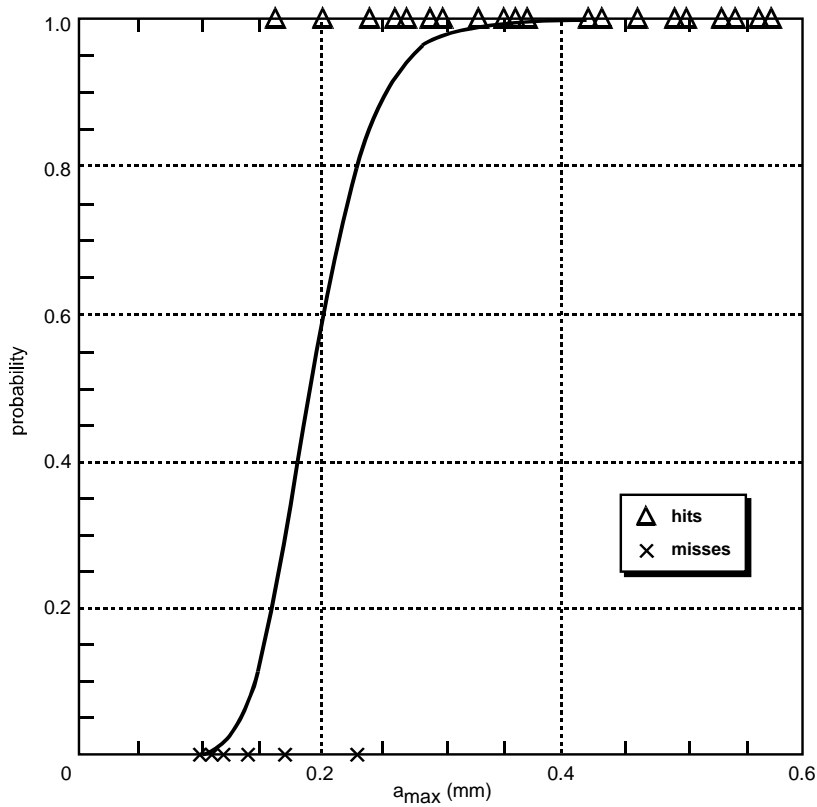
Figure 7 Mean POD curve for GLARE skin cracks

Figure 7 shows the mean (50% confidence) POD curve. For the often used 90% probability + 50% confidence level the detectable crack length is 0.25mm. This is an excellent result, owing to few misses and the relatively small sizes of the missed cracks: note that in subsection 7.1 it was stated that fractography verified the NDI crack indications for all fastener holes with maximum crack lengths ≥ 0.24 mm.

In practical terms this result shows that the NLR’s teardown NDI capability is excellent, and that most cracks in GLARE will be detected during teardown.

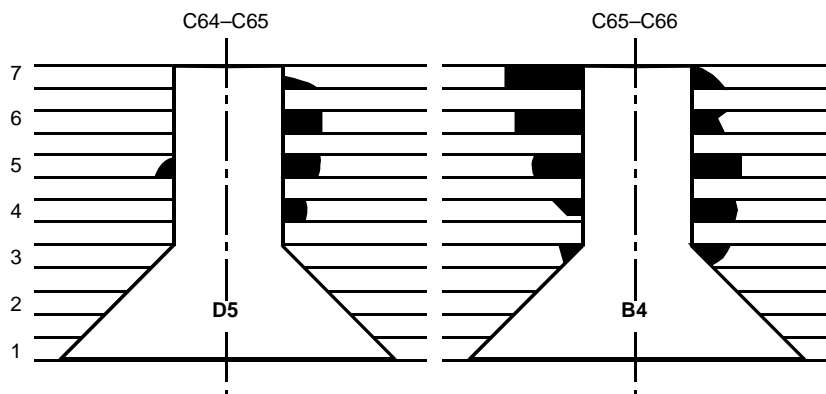
Figure 8 Examples of GLARE cracking patterns

Figure 8 gives examples of the cracking patterns in the aluminium layers of the GLARE skin. Most cracks were in the fastener hole bores. Only a few cracks grew from the countersinks, and then only in layer 3. The largest countersink crack is shown in figure 8: this had a length of 0.42mm.

Table 6 lists the layer positions of the largest cracks on both sides of each fastener hole. Most were in layer 5, like three of the four examples in figure 8.

The smaller cracks in figure 8 show that they began from one or both corners of an aluminium layer. This was also the case for all the other cracked fastener holes in the GLARE skin.

The patterns of cracking in the GLARE skin, illustrated in figure 8, showed that the smaller cracks (and presumably the larger ones also) all began at the corners of the aluminium layers. Thus the most likely causes of fatigue crack initiation, besides the severity of the applied MLB fatigue load spectrum, are the stress concentrations provided by these corners.

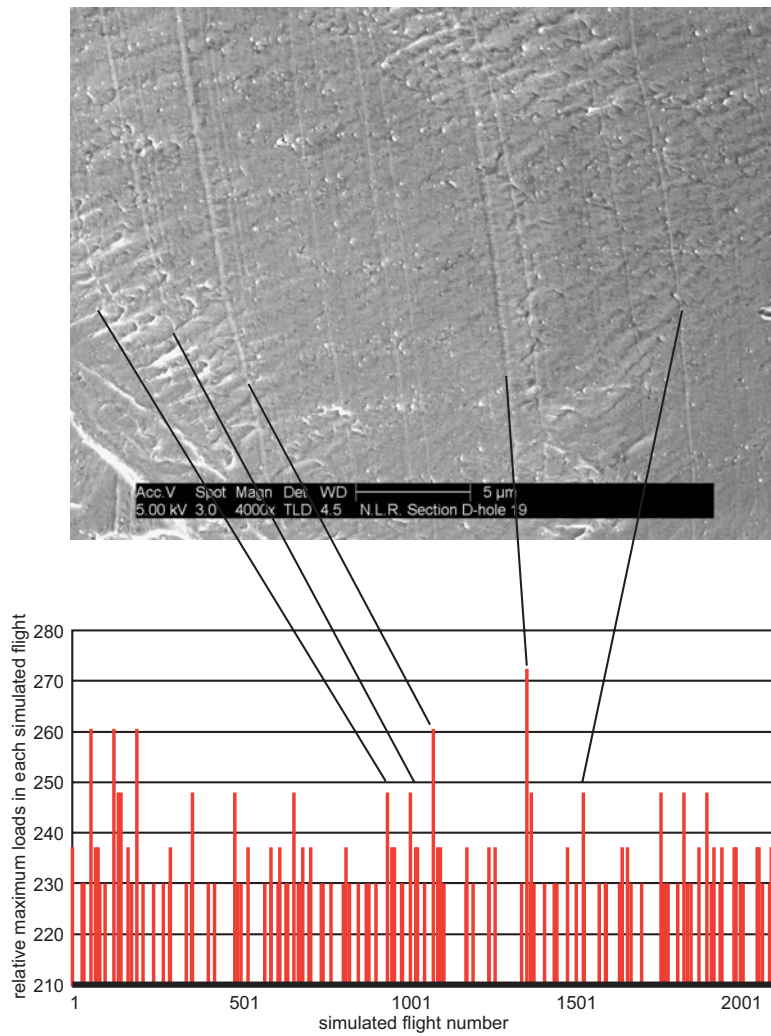
Figure 9 Example of fractographic identification of severe simulated flights from crack front markings due to peak loads

The largest crack in the aluminium window frames was at fastener hole D19 in window area C65 – C66, see tables 5 and 7. FEG-SEM fractography showed that fatigue fracture was a mixture of faceted and mainly continuum-mode areas. The continuum-mode areas contained evident crack front markings due to the peak loads in severe simulated flights.

Figure 9 gives an example of identifying the severe simulated flights, notably the severest flight types A, B and C. The crack front markings from these flights were mostly sufficient for tracing fatigue crack growth back to small crack lengths. However, the fainter crack front markings from D type flights helped in checking the numbering of B and C type flights. In general, the fractographic “readability” was excellent.

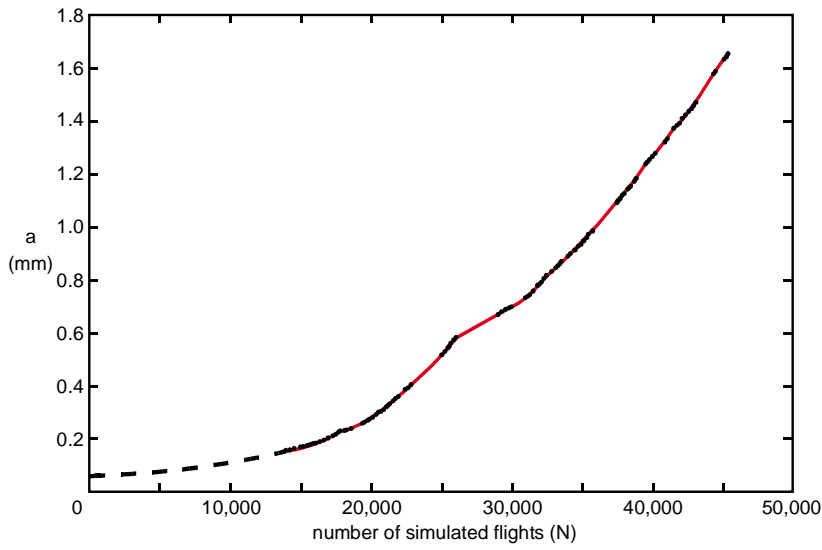
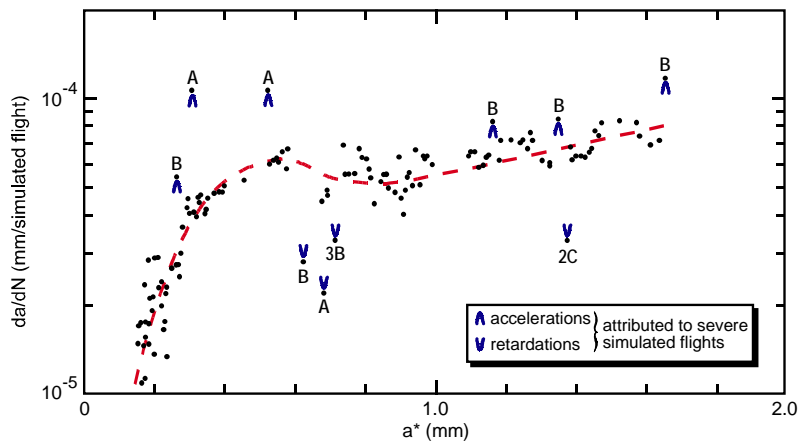
Figure 10 Crack growth curves for the largest fastener hole crack in either of the window frames. The material was die forged aluminium alloy 7175-T73

However, beginning at a crack length of 0.6mm there was a significant and persistent retardation of fatigue crack growth. This persistent retardation could be due to termination of the “short crack effect”. This effect is well known, and is generally attributed to a lack of fatigue crack closure in cracks smaller than about 0.5mm. Thus once the crack in the window frame grew beyond about 0.5mm, closure-induced retardation effects of peak loads in severe simulated flights would have become possible.

Back-extrapolation of the *a versus N* curve in figure 10a suggests that the fatigue “initiation” life was zero, and that there was an initial crack size of about 0.06mm.

In fact, the crack initiated from a fretting scar due to fastener movement against the bore of the fastener hole (Wanhill *et al.* 2006)^[6]. This explains the effectively zero fatigue “initiation” life and also the indication of an initial crack size, which was most probably due to the fretting scar.

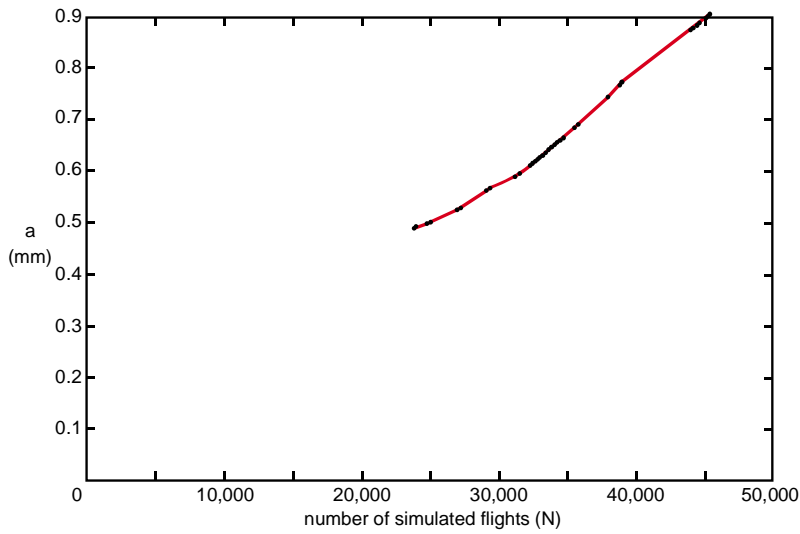
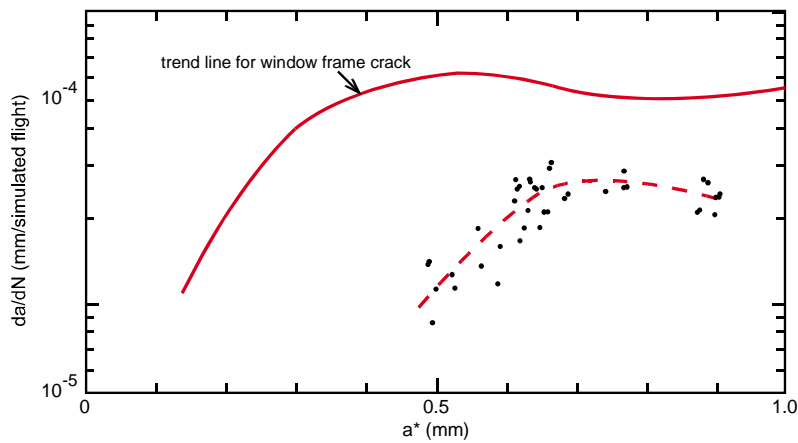
Figure 11 Crack growth curves for the largest “readable” fastener hole crack in an aluminium layer of the GLARE skin. The material was 0.3mm 2024-T3 sheet

The largest “readable” crack in any of the GLARE aluminium layers was at fastener hole B4 in window area C65 – C66. This crack was 0.91mm long, slightly less than a_{max} , see table 4. The largest crack in the GLARE aluminium layers at the same fastener hole as the largest window frame crack was at fastener hole D19 in window area C65 – C66, see table 7. This crack was only 0.42mm long.

Preliminary examination of these cracks showed that the initial 0.2mm was obscured by debris and sealant. This made fractographic analysis of the smaller crack impractical – there was simply too little fatigue fracture surface available.

Figures 11a and 11b present the crack growth curves. The data are limited, but sufficient to show that the “plateau” crack growth rates were about 50% of those in the aluminium window frame.
