NDI and teardown fractography of a GLARE window panel (F4) from the Airbus MegaLiner Barrel (MLB) fatigue test.

NLR-TP-2006-183

**Teardown of a GLARE window area from the Airbus MegaLiner Barrel
fatigue test article**

The MegaLiner Barrel (MLB) test was done to study the fatigue behaviour of a double-deck fuselage configuration. The test was part of the Airbus 380 development programme, and was discontinued after 45,402 simulated flights. The NLR is carrying out teardowns and supplemental fatigue tests of GLARE (GLASS REinforced aluminium laminate) panels from several key locations of the MLB. This paper describes the teardown of a GLARE window area. The teardown began with Non-Destructive Inspection (NDI), and was followed by fractographic investigation of the NDI-indicated cracks. The teardown had the following main objectives, which were largely achieved:

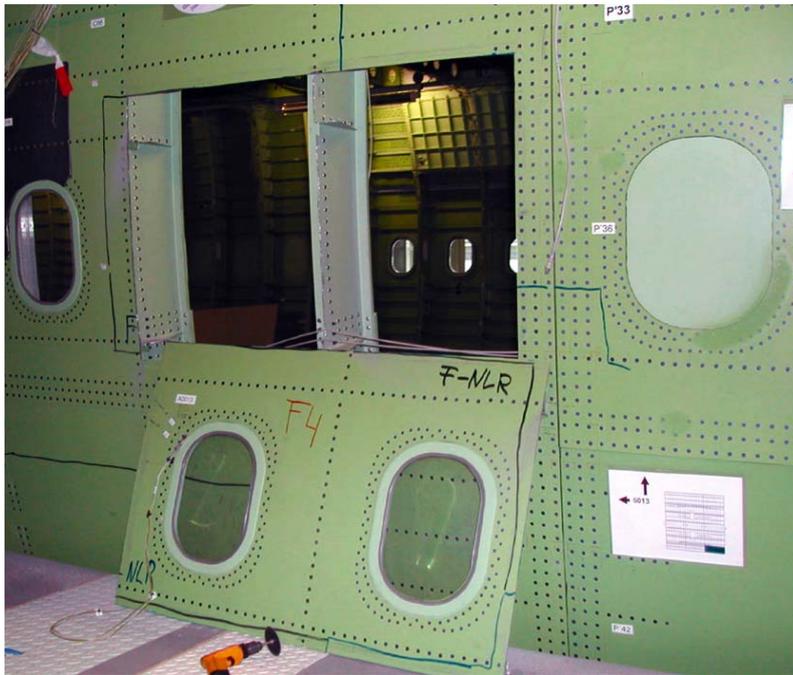
Figure 1 GLARE window area cut from the MLB

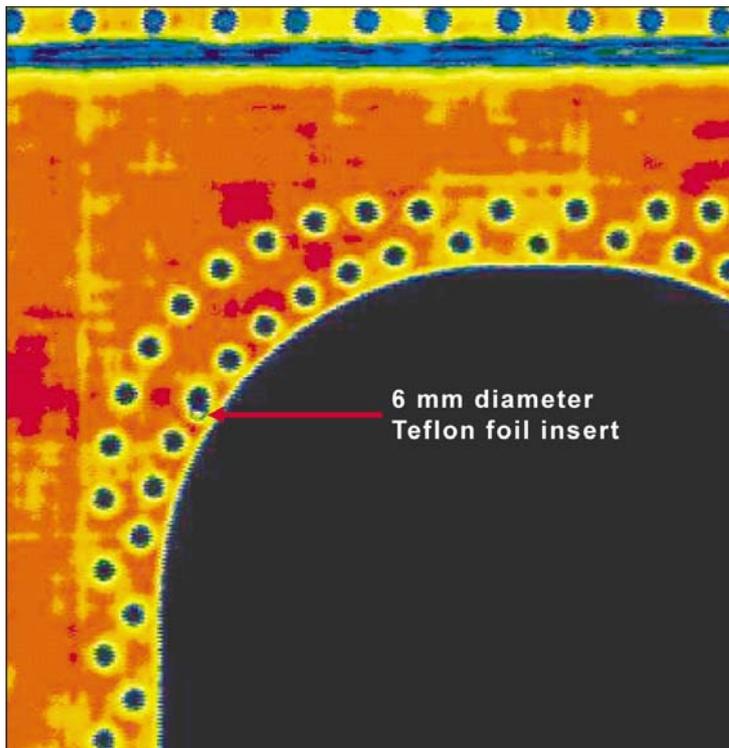
The GLARE skin was C-scanned around the window cutouts. The 6mm diameter Teflon foil insert was readily detected by both attenuation and reflection measurements, for example figure 5. The measurements showed that the MLB fatigue test did not cause delamination growth from the insert.

Figure 5 C-scan attenuation detection of the insert

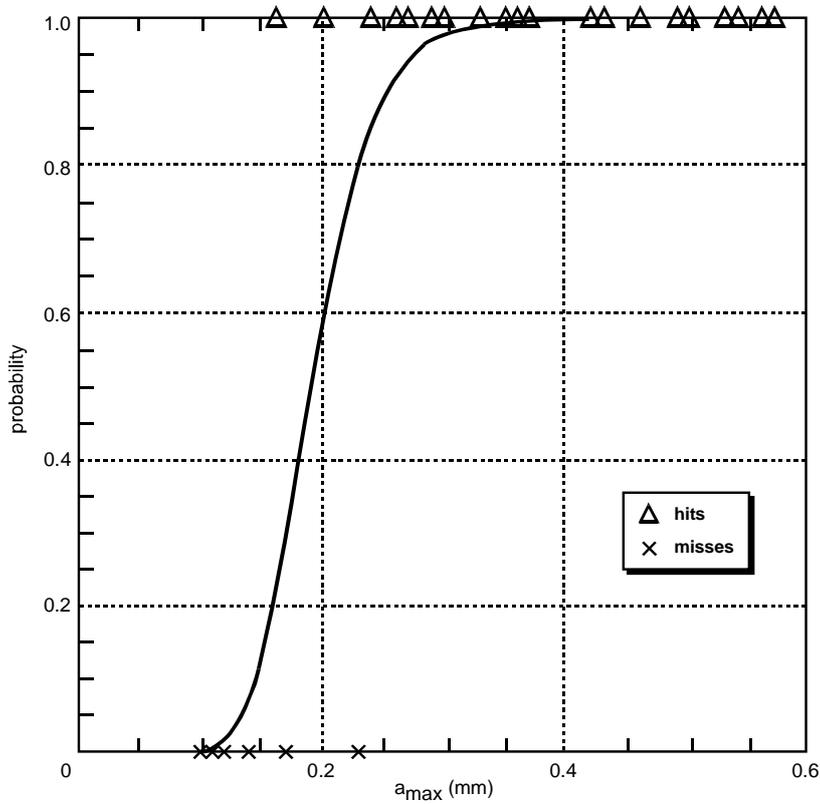
Figure 7 shows the mean (50% confidence) POD curve. For the often used 90% probability + 50% confidence level the detectable crack length is 0.25mm. This is an excellent result, owing to few misses and the relatively small sizes of the missed cracks: note that in subsection 7.1 it was stated that fractography verified the NDI crack indications for all fastener holes with maximum crack lengths ≥ 0.24 mm.

In practical terms this result shows that the NLR’s teardown NDI capability is excellent, and that most cracks in GLARE will be detected during teardown.

Figure 7 Mean POD curve for GLARE skin cracks

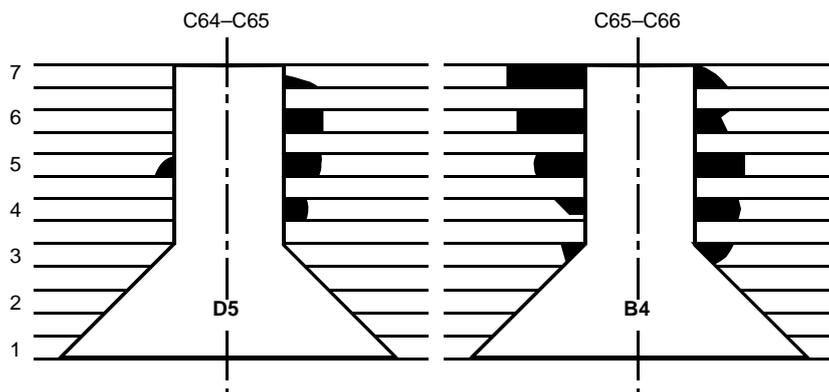
Figure 8 gives examples of the cracking patterns in the aluminium layers of the GLARE skin. Most cracks were in the fastener hole bores. Only a few cracks grew from the countersinks, and then only in layer 3. The largest countersink crack is shown in figure 8: this had a length of 0.42mm.

The smaller cracks in figure 8 show that they began from one or both corners of an aluminium layer. This was also the case for all the other cracked fastener holes in the GLARE skin.

The patterns of cracking in the GLARE skin, illustrated in figure 8, showed that the smaller cracks (and presumably the larger ones also) all began at the corners of the aluminium layers. Thus the most likely causes of fatigue crack initiation, besides the severity of the applied MLB fatigue load spectrum, are the stress concentrations provided by these corners.

On the other hand, this does not explain why many more cracks began in the fastener hole bores (layers 4 – 7) rather than in the countersinks (layers 1 – 3), where there are so-called “knife edges”. It is possible that local secondary bending favoured fatigue initiation in the fastener hole bores. Support for this hypothesis comes from the window frame cracks. These were all corner cracks with maximum depths along the fastener hole bores larger than a_{max} .

Figure 8 Examples of GLARE cracking patterns

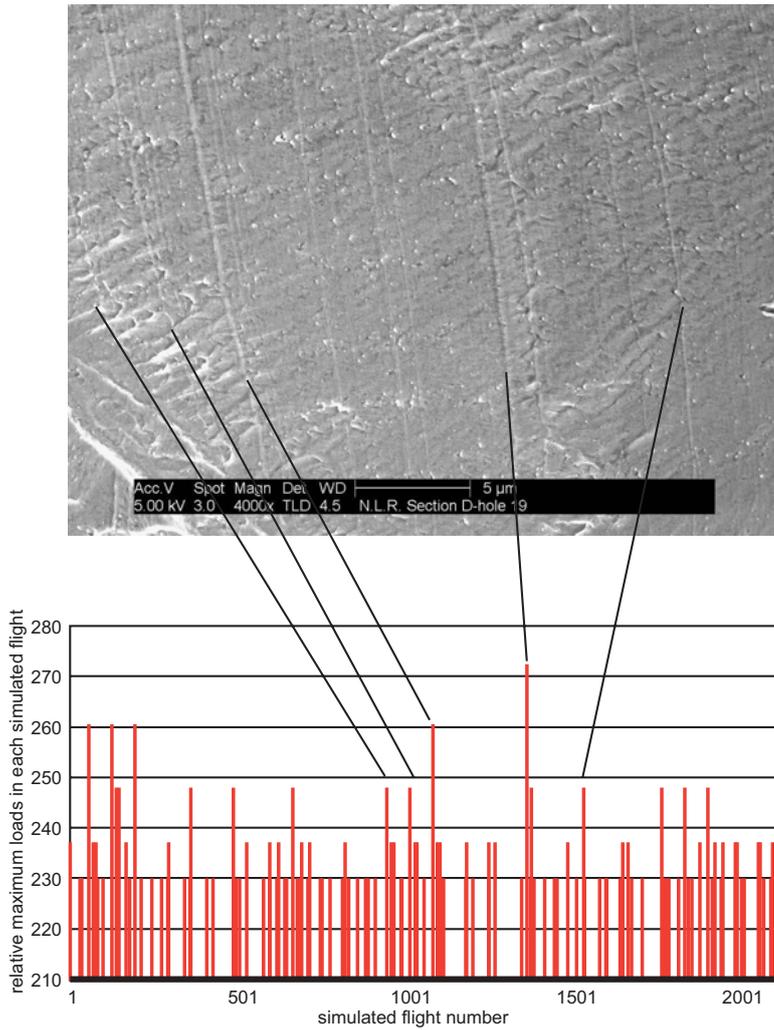
Figure 9 gives an example of identifying the severe simulated flights, notably the severest flight types A, B and C. The crack front markings from these flights were mostly sufficient for tracing fatigue crack growth back to small crack lengths. However, the fainter crack front markings from D type flights helped in checking the numbering of B and C type flights. In general, the fractographic “readability” was excellent.

Figure 9 Example of fractographic identification of severe simulated flights from crack front markings due to peak loads

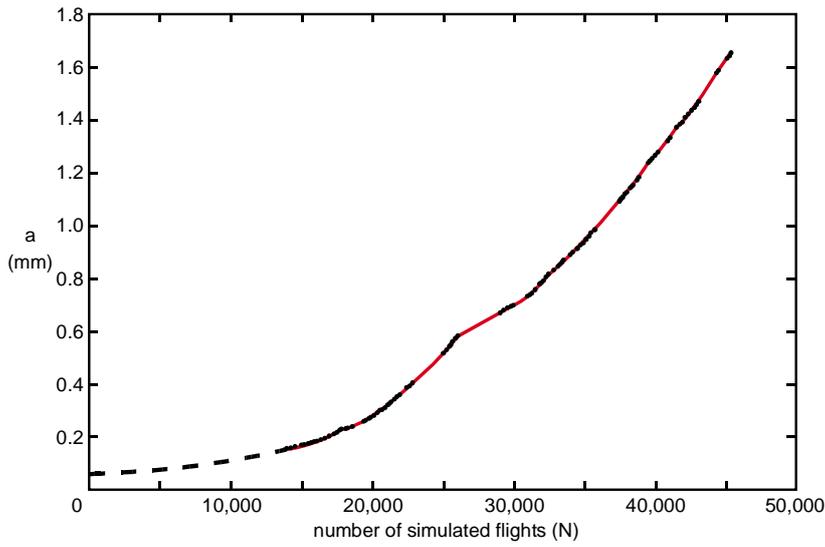
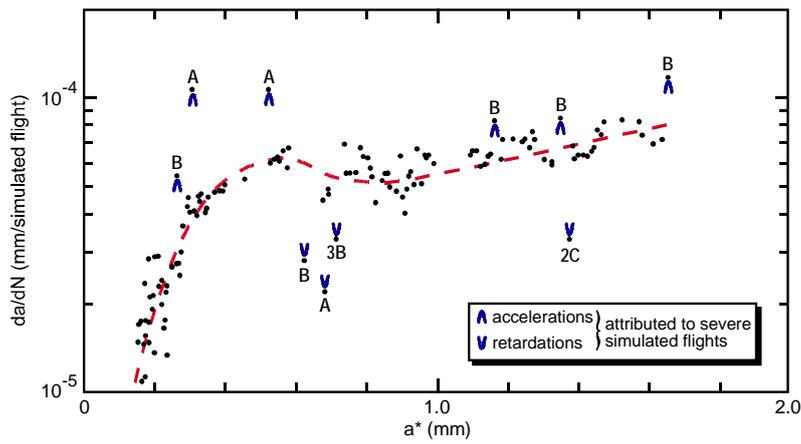
However, beginning at a crack length of 0.6mm there was a significant and persistent retardation of fatigue crack growth. This persistent retardation could be due to termination of the “short crack effect”. This effect is well known, and is generally attributed to a lack of fatigue crack closure in cracks smaller than about 0.5mm. Thus once the crack in the window frame grew beyond about 0.5mm, closure-induced retardation effects of peak loads in severe simulated flights would have become possible.

Back-extrapolation of the *a versus N* curve in figure 10a suggests that the fatigue “initiation” life was zero, and that there was an initial crack size of about 0.06mm.

In fact, the crack initiated from a fretting scar due to fastener movement against the bore of the fastener hole (Wanhill *et al.* 2006)^[6]. This explains the effectively zero fatigue “initiation” life and also the indication of an initial crack size, which was most probably due to the fretting scar.

Figure 10 Crack growth curves for the largest fastener hole crack in either of the window frames. The material was die forged aluminium alloy 7175-T73

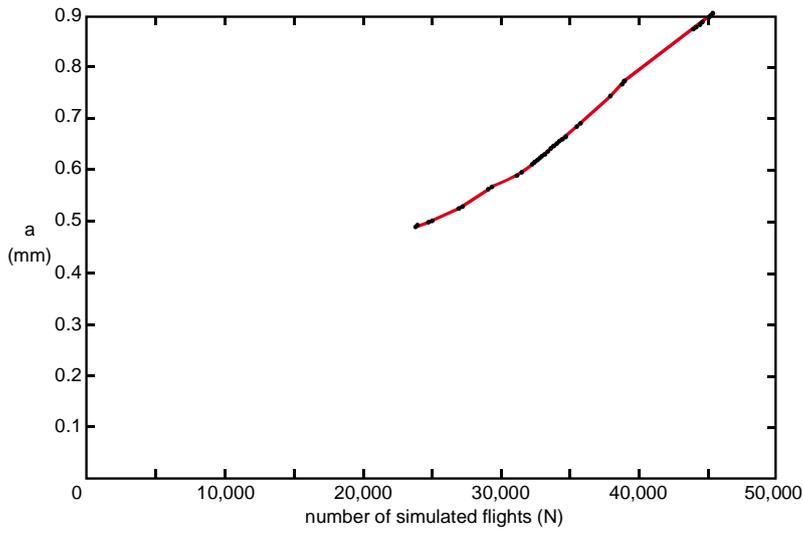
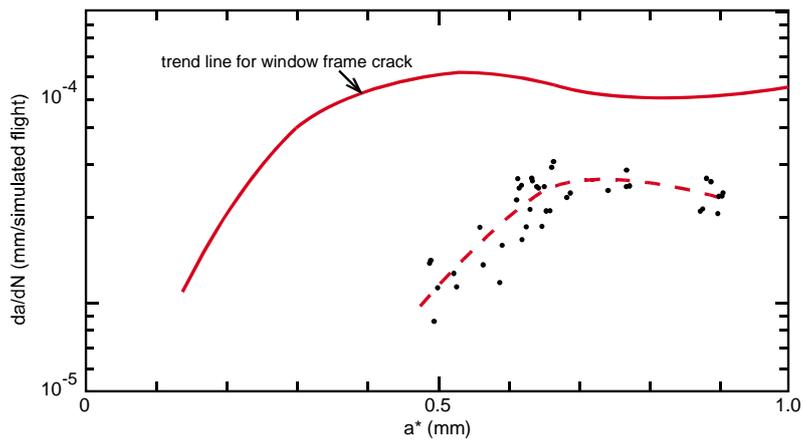
Figures 11a and 11b present the crack growth curves. The data are limited, but sufficient to show that the “plateau” crack growth rates were about 50% of those in the aluminium window frame.

The largest “readable” GLARE aluminium layer crack could not be traced back to less than 0.45mm, owing to ever more closely-spaced crack markers, making them impossible to resolve. This, and the limited data, made it unfeasible to estimate a fatigue “initiation” life. Nevertheless, it was evident that this crack grew significantly slower than the largest window frame crack.

Figure 11 Crack growth curves for the largest “readable” fastener hole crack in an aluminium layer of the GLARE skin. The material was 0.3mm 2024-T3 sheet
