NLR-TP-2002-048

## **Thermal testing of low porosity microcracked thermal barrier coatings**

M.F.J. Koolloos and M.J.W. Schouten\*

Customer: National Aerospace Laboratory NLR

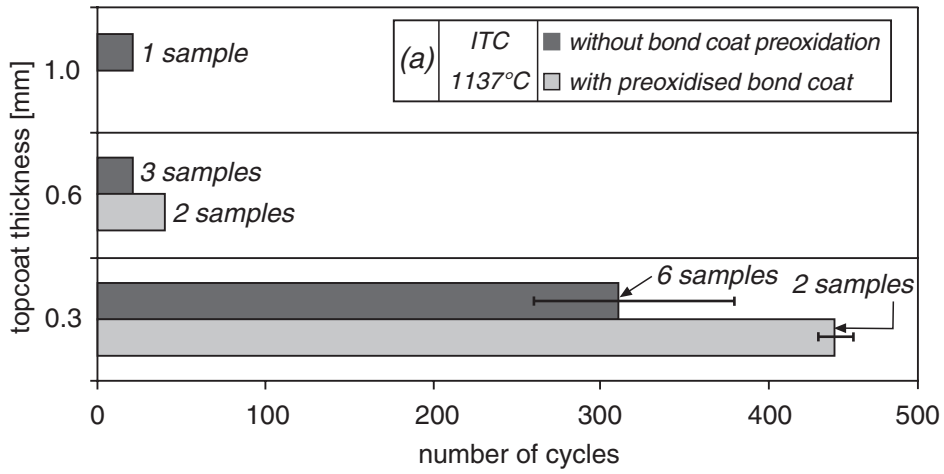
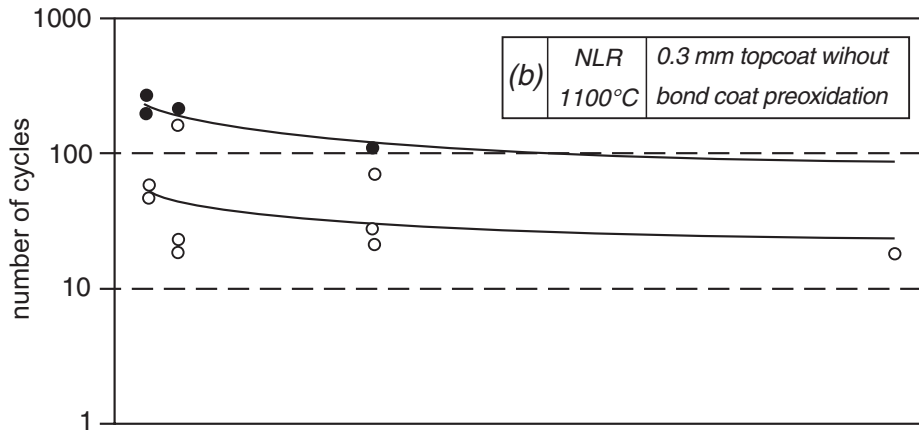
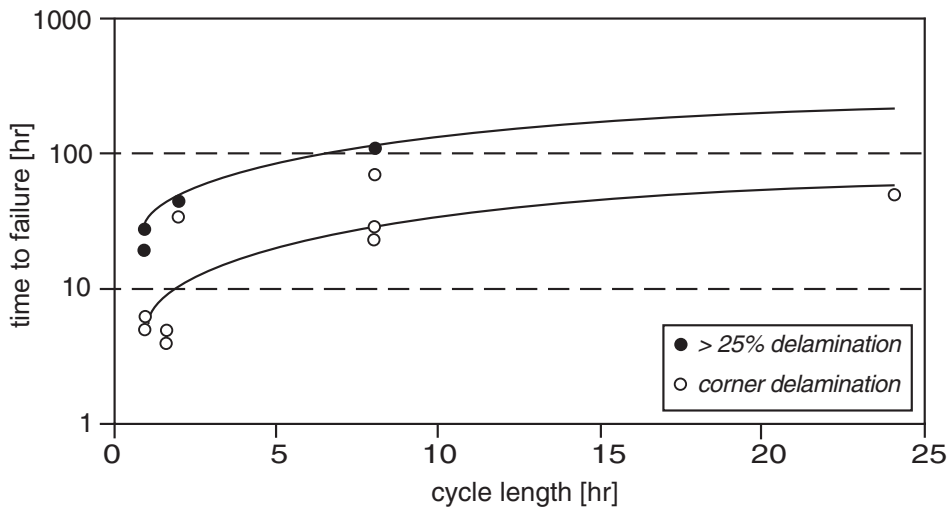
Fig. 3 1137°C and 1100°C furnace test results

Figure 3 presents the 1137 °C and 1100 °C furnace test results. The ITC tests, figure 3a, showed a dramatic effect of top coat thickness. The coatings with 0.3 mm top coats failed after an average of 310 cycles (without bond coat preoxidation) and 440 cycles (with preoxidised bond coat), while the coatings with 0.6 mm and 1.0 mm top coats all failed at 20-40 cycles. The results for coatings with 0.3 mm top coats show clearly that bond coat preoxidation is beneficial. However, there was essentially no difference between the two samples with bond coats preoxidised for 5 hr (450 cycles) and 10 hr (430 cycles).

The NLR furnace tests at 1100 °C, figure 3b, show that longer heating cycles reduce the number of cycles to failure but increase the time to failure, defined as greater than 25 % delamination of the top coat. Figure 3b also plots the cycles and times at which corner delamination first occurred. The trends are similar to those for greater than 25 % delamination, though at lesser number of cycles and times.

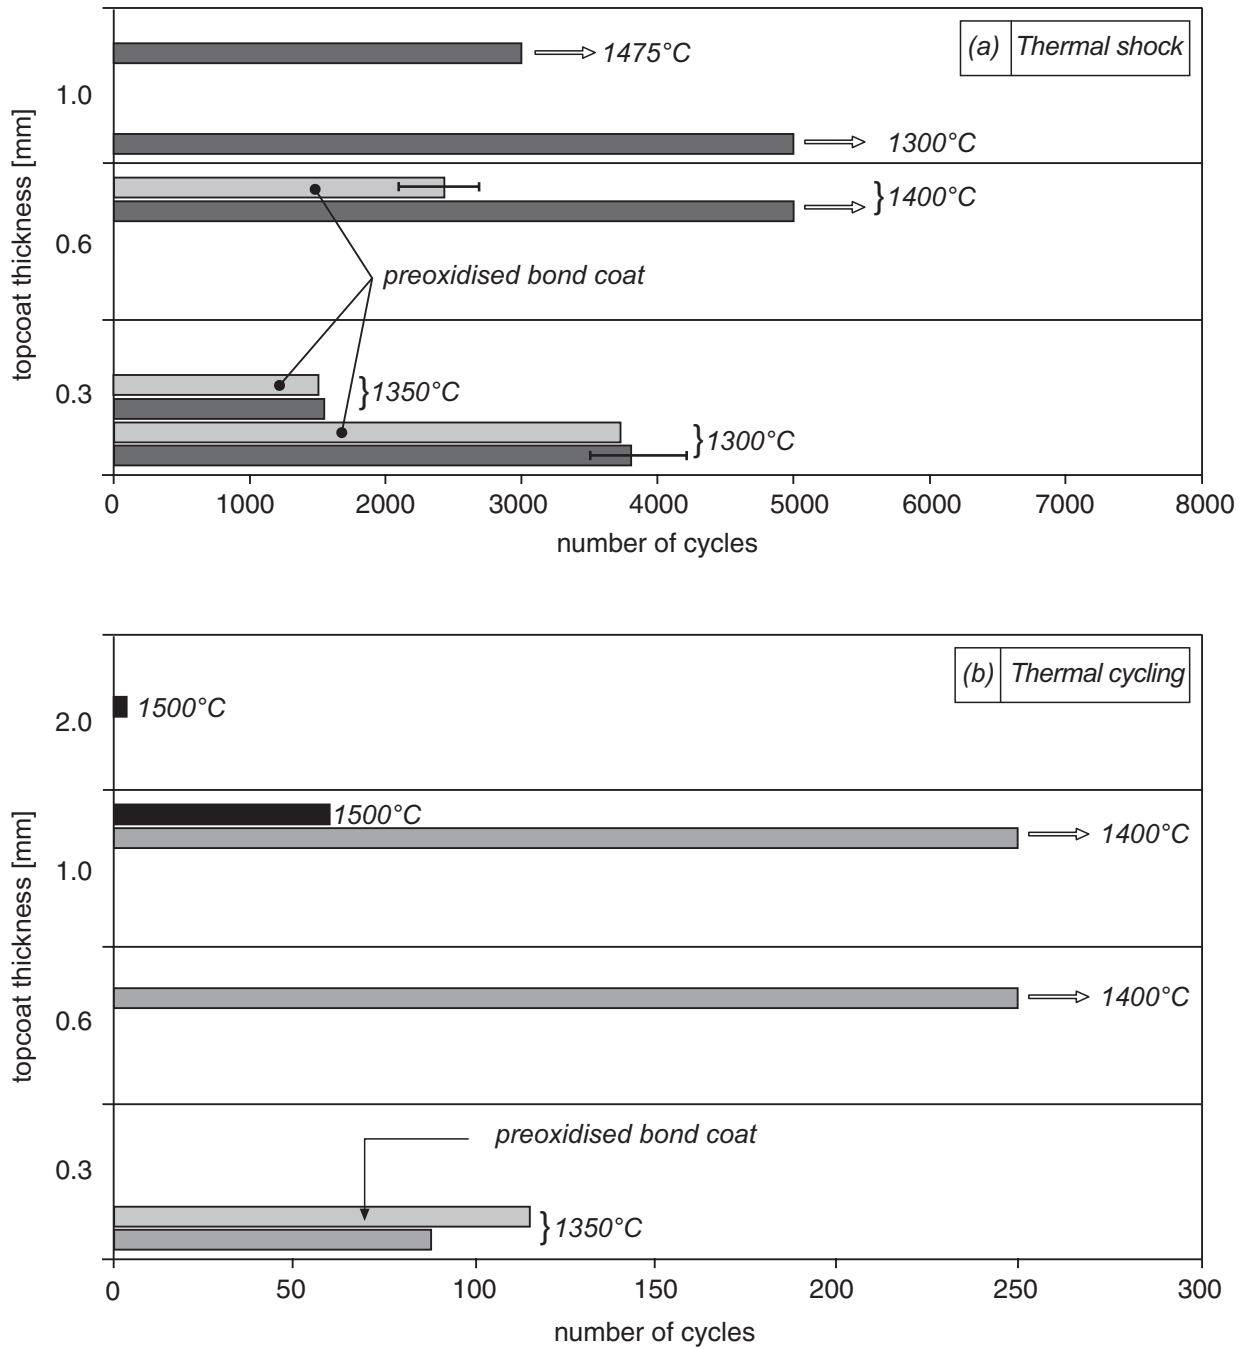
Fig. 4 Burner rig test results

Figure 4 presents the burner rig test results. The thermal shock tests, figure 4a, showed a strong effect of maximum temperature on the number of cycles to failure for the 0.3 mm thick top coats. There was also a change in failure mode, discussed in section 5.2. Somewhat unexpectedly, these strips did not show a significant effect of bond coat preoxidation. The thicker 0.6 mm and 1.0 mm top coat strips without a preoxidised bond coat did not fail – or would not have failed – within 5000 cycles (testing of the 1.0 mm TBC at 1475 °C was stopped already after 3000 cycles because there was little external evidence of damage (Ref. 10)). However, the two strips with 0.6 mm top coats *and* preoxidised bond coats failed at about 2400 cycles.

Figure 4b shows the thermal cycling results. The thin top coats failed after about 100 cycles with a  $T_{\text{surf}} = 1350$  °C, but the strips with 0.6 mm and 1.0 mm top coats survived 250 cycles with a  $T_{\text{surf}} = 1400$  °C. However, the thickest top coats, 1.0 mm and 2.0 mm, failed after only 60 and 3 cycles, respectively, with a  $T_{\text{surf}} = 1500$  °C. As in the case of thermal shock testing, there was a change of failure mode, but in this case it depended on the top coat thickness rather than the maximum temperature, see section 5.3.

In contrast to thermal shock testing, bond coat preoxidation was beneficial to the lives of the thermally cycled 0.3 mm top coats, with an increase in life of about 25 %. The difference in lives for 5 hr and 10 hr preoxidation was negligible: delamination failure occurred after 116 and 115 cycles respectively.

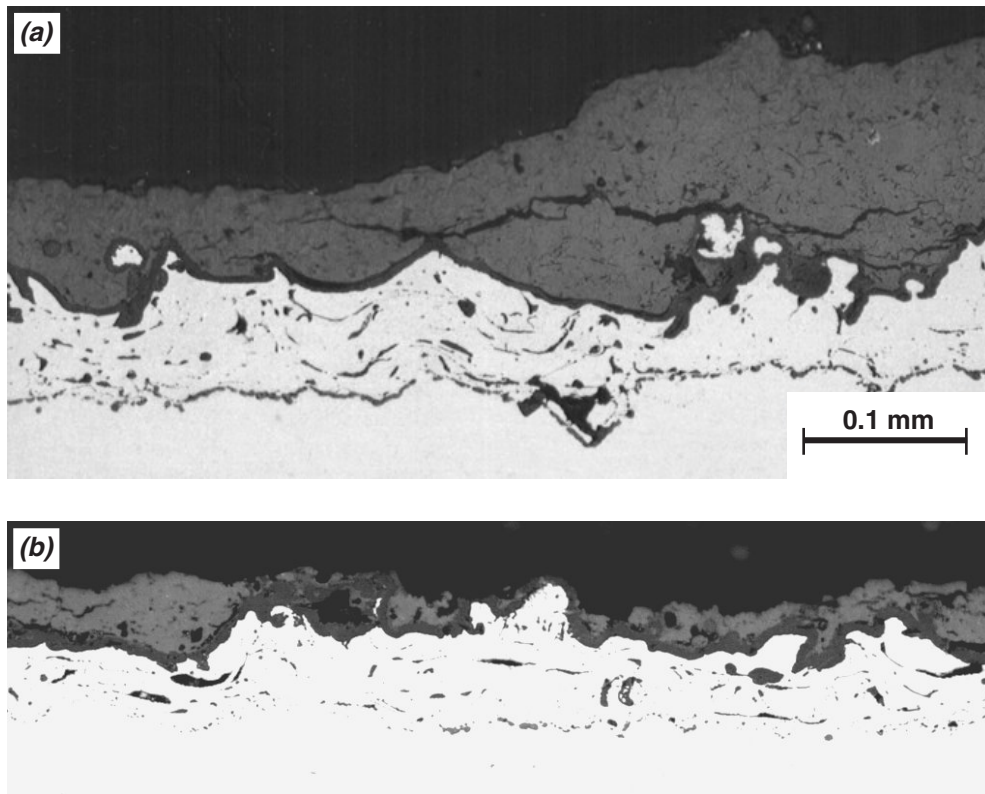
The 0.3 mm top coats degraded similarly: first, delamination occurred at the sample corners and free edges, after which the top coat was gradually “nibbled off” (NO, see Fig. 5). The *remaining* coating showed interface-associated and vertical cracking (IC and VC). In some cases the top coat delaminated completely (CD) without first reaching the failure criterion of 25 % delamination. Figure 6 gives example cross-sections for the 1 hr cycle samples: (a) near the edge of the *remaining* top coat after 90 cycles; (b) after failure (300 cycles) by complete delamination. Figure 6a shows the interface-associated cracks (IC) in the *remaining* top coat, and figure 6b shows that these would have linked up to form a crack path just above the interface roughness peaks. Both micrographs also show severe bond coat degradation (BD). As stated previously, and listed in table 3, similar degradation and failure modes were observed for the other 0.3 mm top coats. This was irrespective of furnace cycle length and bond coat preoxidation or non-preoxidation.

Failure of the thicker (0.6 mm and 1.0 mm top coat) TBCs was essentially different. The top coat delaminated completely (CD) after a low number of cycles and without “nibbling off”. However, the delamination was preceded by through-thickness segmentation cracking (SC) of the top coat. This feature is illustrated schematically in figure 5, and was found to correspond near the interface to “islands” of *residual* top coat separated by “canals” of bond coat.

Fig. 6 Furnace tested 0.3 mm coat (a) after 90 cycles near edge of remaining topcoat, (b) after failure (300 cycles) by complete delamination

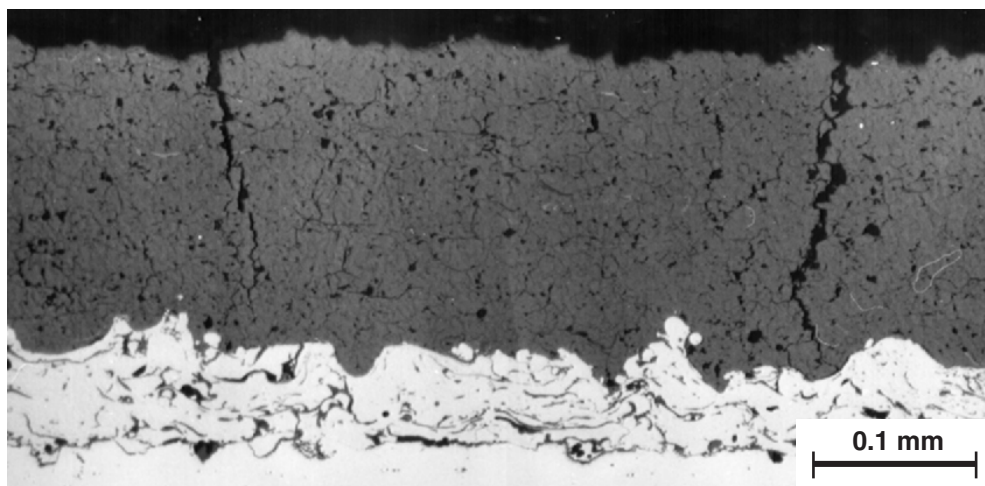
$T_{\text{surf}} = 1300 \text{ }^{\circ}\text{C}$ , see Fig. 4a). Outside the flame area the 0.3 mm top coats all showed vertical cracks (VC). An example is given in figure 7.

Fig. 7 Vertical cracks outside the flame area in a 0.3 mm topcoat after burner rig thermal shock testing with  $T_{surf} = 1300^{\circ}\text{C}$

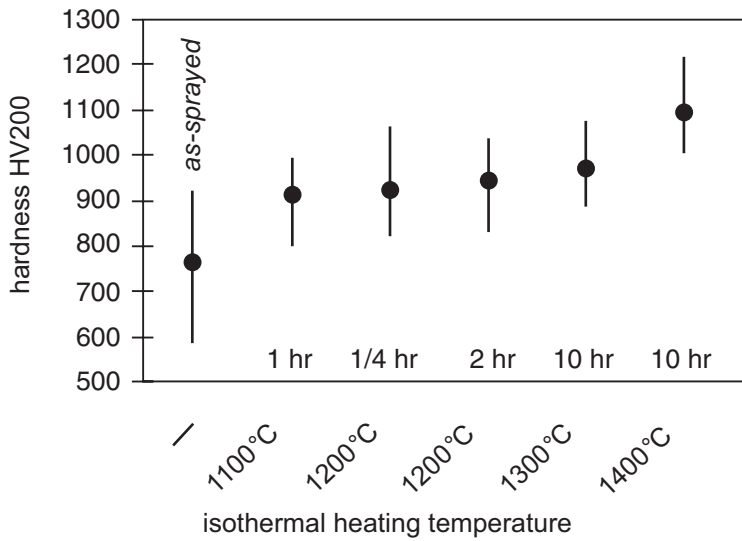
Figures 8, 9 and table 4 present microhardness measurements on as-sprayed, isothermally heated and thermal shock tested TBCs (Ref. 10). The isothermal heating results in figure 8 agree with previous work, which indicates that below about  $1350 \text{ }^{\circ}\text{C}$  some localised sintering

Fig. 8 Microhardness (HV 200) for as-sprayed and isothermally heated 0.3 mm topcoats

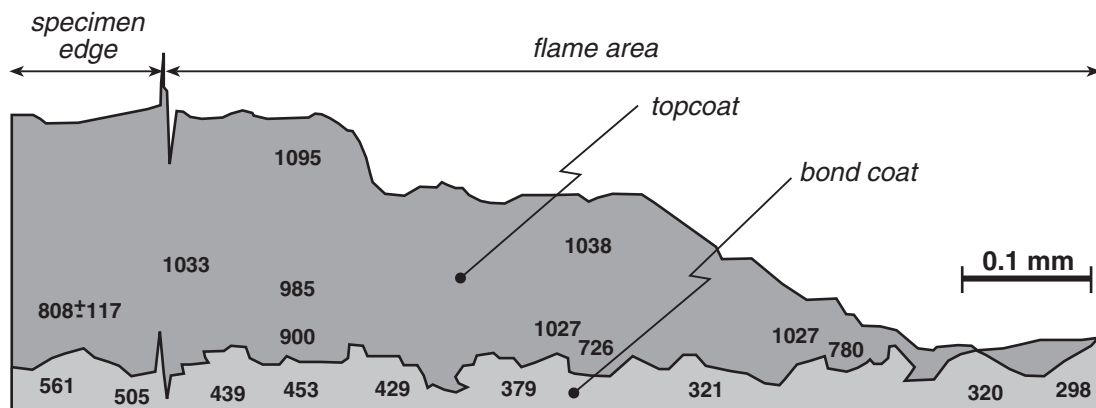
of small defects occurs (Refs. 14, 16), and above 1350 °C bulk sintering takes place (Ref. 17). The average microhardnesses for thermal shock specimens, table 4, show dependence on  $T_{\text{surf}}$ , the number of cycles, and the location. Thus, in the flame area and after large numbers of cycles the hardnesses increased to the same level as at similar temperatures during isothermal testing, cf. table 4 and figure 8. This indicates that the amount of sintering during thermal shock testing depends on time rather than cycles. Figure 9 provides more insight by illustrating that though there are average trends, the local hardness variations in the top coat (and the bond coat) can be large.

Fig. 9 Microhardness (HV 200) variations in a thermal shock strip undergoing topcoat Flame area Delamination (FD): topcoat thickness 0.3 mm, maximum  $T_{surf} = 1300^{\circ}C$ , 4220 cycles, see table 4
