GLARE teardowns from the MegaLiner Barrel (MLB) fatigue test

NLR-TP-2009-068

February 2009

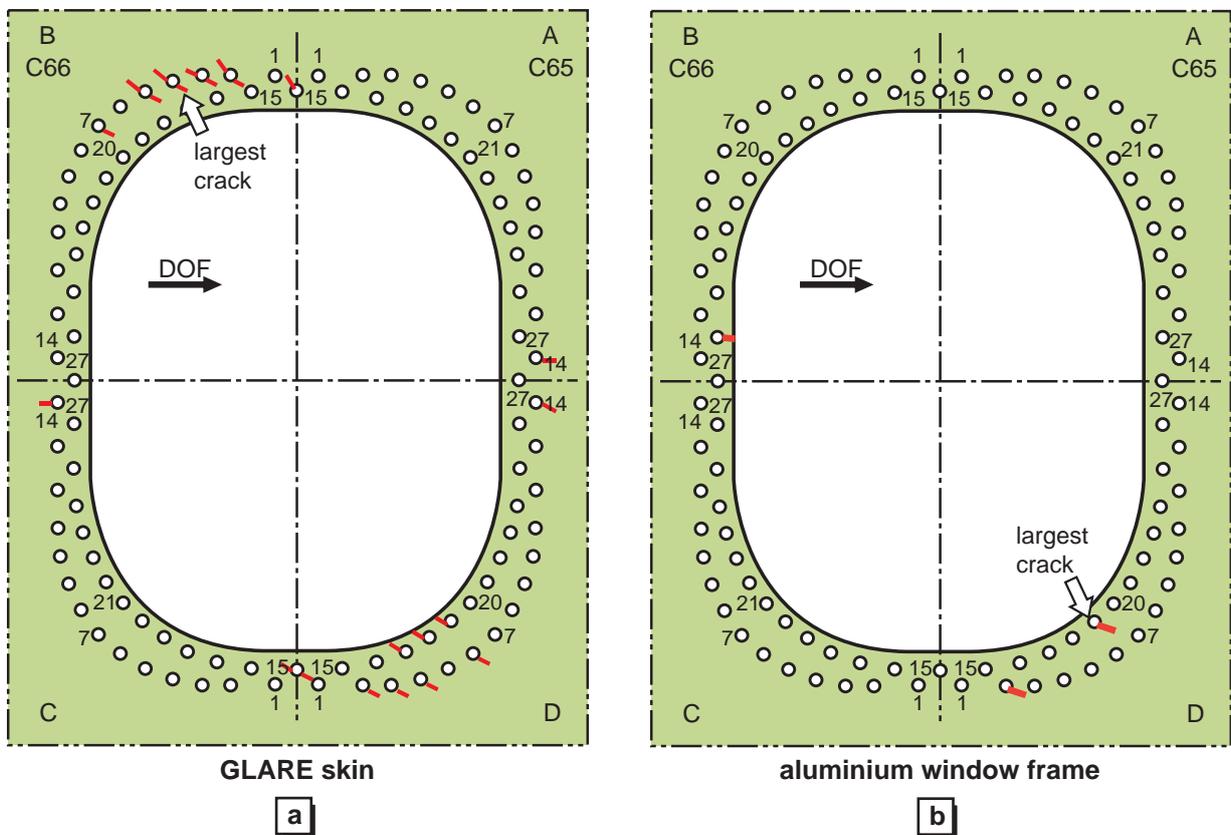
Figure 4 NDI crack indications for the GLARE skin and aluminium window frame fastener hole bores of window C65-C66: DOF = Direction Of (simulated) Flight

216 fastener holes were inspected. 45 crack indications were obtained for the GLARE fastener hole bores in the partially disassembled condition, and 41 when completely disassembled. 8 crack indications were obtained for the aluminium window frames. The crack indications were almost equally divided between the windows. Figure 4 shows 21 crack indications for the GLARE skin and 3 crack indications for the aluminium window frame of the C65-C66 window. Both of the windows had most crack indications in the B and D quadrants. These were the quadrants largely subjected to tensile shear loads during the MLB test.

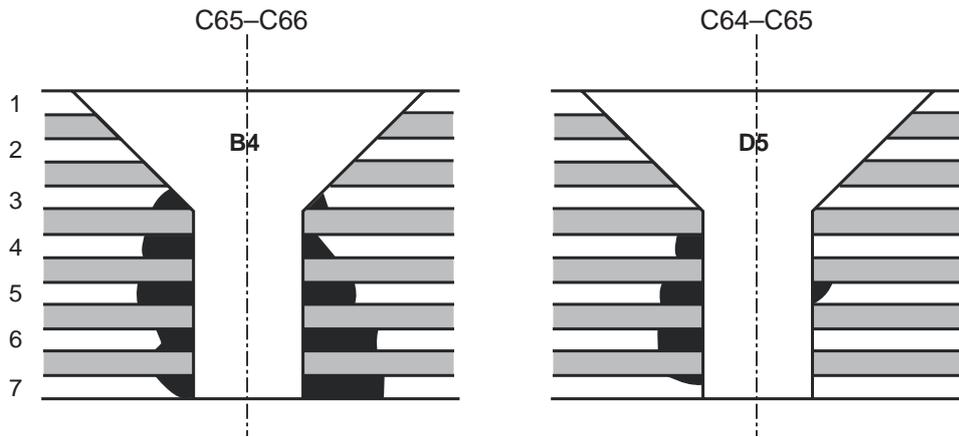
Figure 5 Examples of fatigue cracking patterns in the GLARE aluminium layers

Mapping the GLARE skin fatigue cracks showed that most were in the fastener hole bores, with only a few in the countersinks [3]. Figure 5 gives examples of the cracking patterns in the aluminium layers. The shapes of smaller cracks indicated that cracking generally began at aluminium layer corners, most probably because of the stress concentrations provided by the corners. However, this does not explain why most cracks were in the bores rather than the countersinks, where there were relatively severe “knife edge” stress concentrations. The explanation, confirmed by fractography of the window frame cracks, is that local secondary bending favoured cracking in the fastener hole bores.

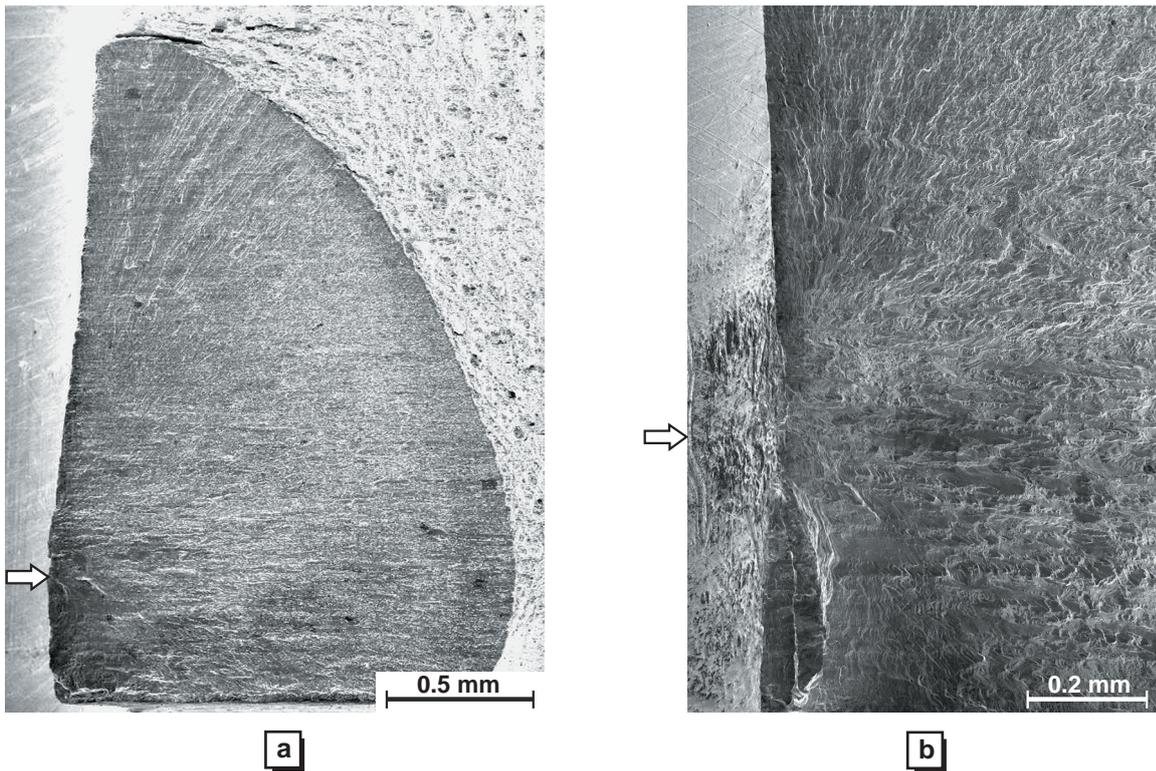
Figure 6 Largest window frame fatigue crack: (a) overview with fatigue origin arrowed; (b) detail with fretting scar in fastener hole bore arrowed

Load history “readability”: Figure 6 gives an overview and a low-magnification detail of the largest crack in the window frames. Its position is arrowed in figure 4b. Higher magnifications showed crack front markings due to severe simulated flights, and the “readability” was generally very good. Figure 7 is an example of identifying the severest flight types A, B and C.

Back-extrapolation of the data in figure 8a suggests a fatigue “initiation” life of zero and an initial crack size of about 0.06 mm. In fact, the fatigue crack began at a fretting scar caused by fastener movement against the bore of the hole, see figure 6b. Since fretting rapidly induces fatigue-initiating damage [7] and promotes early crack growth [8], it explains the (effectively) zero “initiation” life and also the suggestion of an initial crack size.

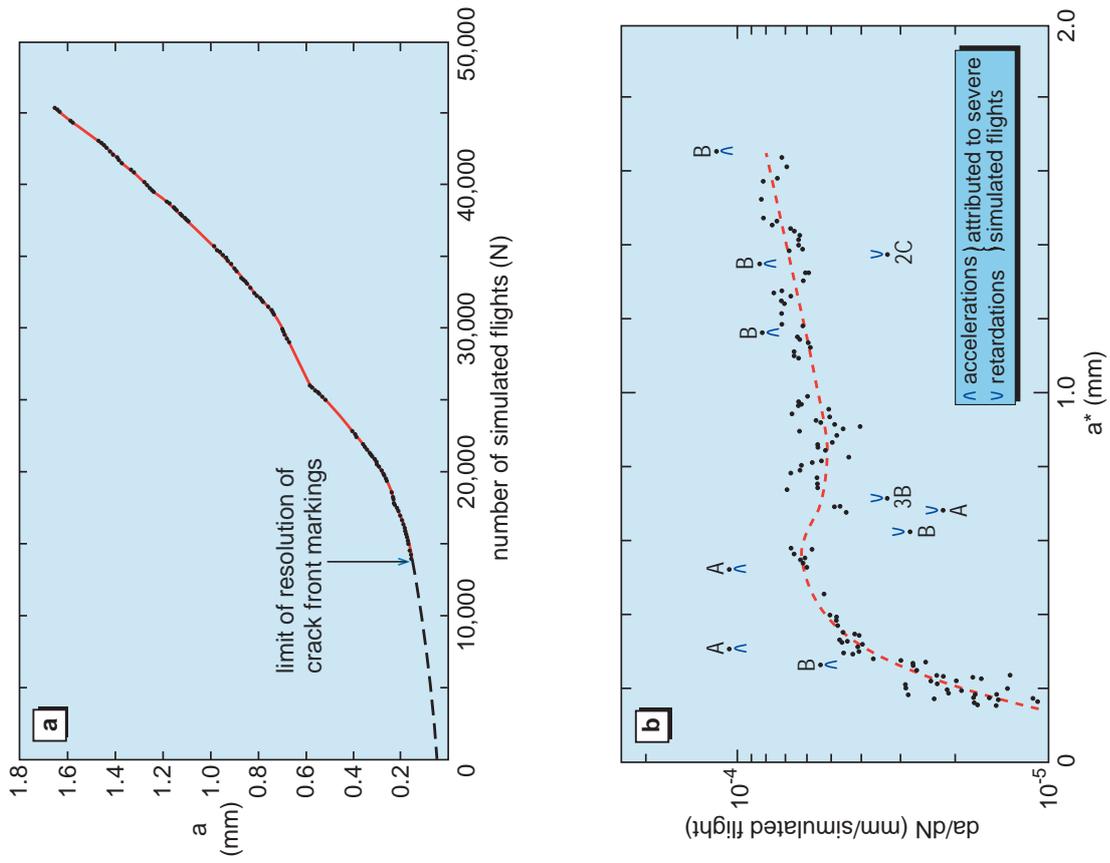
Figure 8 Crack growth curves for the largest window frame crack. The material was die forged aluminium alloy 7175-T73

Fractographic analysis of the largest window frame crack: Figures 8a and 8b show the crack lengths, a and a^* , perpendicular to the fastener hole bore, plotted against the number of simulated flights (N) and the crack growth rates, da/dN , where a^* is the mean crack length for each growth interval used to calculate da/dN . Both figures show the effects of severe simulated flights, pointed out explicitly in figure 8b. Some effects appeared to be transient, but a significant period of crack growth retardation began at $a = 0.6$ mm. This could be due to termination of a “short crack effect”. Such effects are generally attributed to a lack of fatigue crack closure in cracks smaller than about 0.5 mm [6]. Thus it is likely that once the window frame crack grew beyond about 0.5 mm the peak loads in severe simulated flights caused closure-induced retardation.

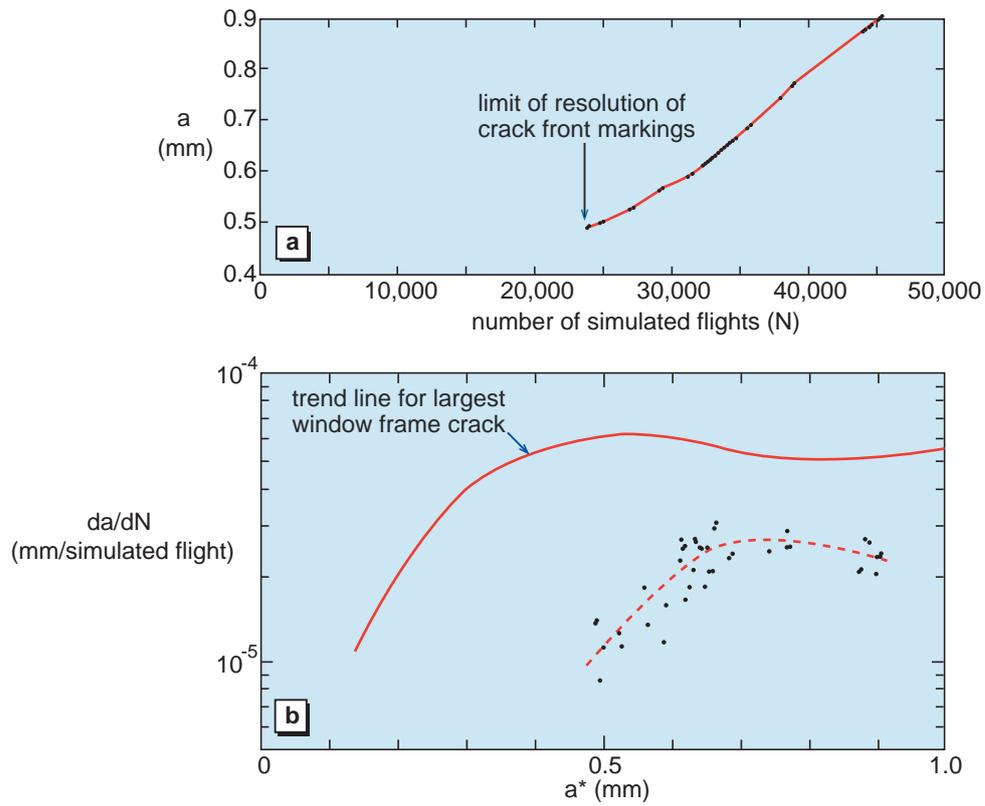
Figure 9 Crack growth curves for the largest "readable" GLARE skin crack

Fractographic analysis of the largest “readable” GLARE skin crack: The position of this crack is arrowed in figure 4a. The crack was 0.91 mm long. Preliminary examination showed that the initial 0.2 mm was obscured by debris and sealant. Figures 9a and 9b show the crack lengths, a and a^* , perpendicular to the fastener hole bore, plotted against N and da/dN . The data are limited but sufficient to show a maximum crack growth rate about 50 % of that in the aluminium window frame at similar crack lengths.

Back-extrapolation of the data in figure 9a is unfeasible, owing to the limited data. Hence an estimate of the fatigue “initiation” life was not possible. Also, this crack (and, of course, all the other GLARE skin cracks) was too small to provide a check on fatigue crack growth models for GLARE: see, for example, the models proposed by De Koning [9], Alderliesten and Woerden [10], Beumler [11], Alderliesten and Homan [12] and Alderliesten [13]. However, on the positive side this teardown result demonstrates the high fatigue damage tolerance capability of the GLARE skin.

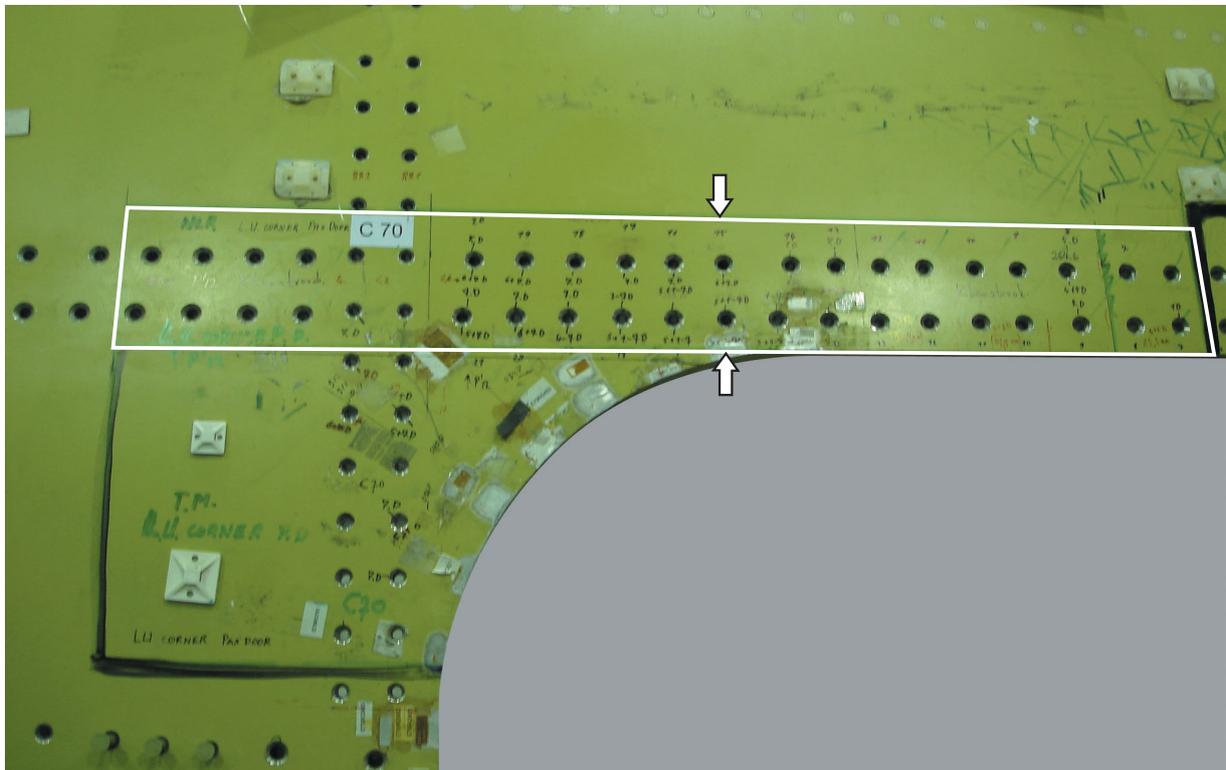
Figure 10 The F7 GLARE door beam area before removal of the rectangular sample indicated by the white border. The arrows point to the subsequent failure position

Figure 10 shows the F7 GLARE door beam area before removal of a rectangular sample to be pulled to failure. The basic structure of the door beam area was a GLARE 3-9/8-0.4 countersunk skin reinforced with seven GLARE doublers to make a total of 34 aluminium layers. The GLARE skin code means nine 2024-T3 aluminium layers 0.4 mm thick and interleaved with eight glass fibre layers 0.25 mm thick. The doublers also consisted of 2024-T3 aluminium layers 0.4 mm thick and interleaved with glass fibre layers 0.25 mm thick.

The sample indicated in figure 10 was pulled to failure in a 900 kN machine. The arrows in figure 10 point to the failure position, and figure 11 shows this position after failure. The sample failed across fastener holes 12 and 33, with some fibre pullout and delamination. Note the cracks at the nearby fastener holes 11, 32 and 34. These cracks were made visible (opened up) by the testing. The sample breaking load exceeded the Limit Load (LL) requirement despite the prior presence of fastener hole cracks.

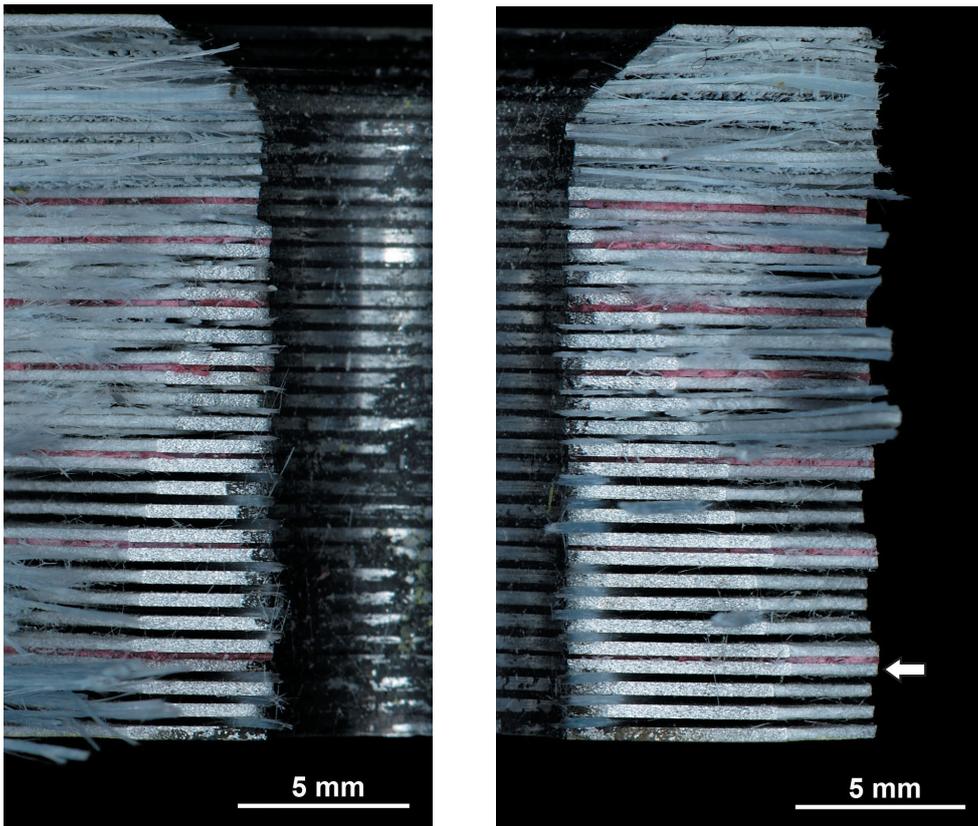
Figure 12 Macrofractographs for fastener hole 33. The arrow points to the largest fatigue crack

Fractography for fastener hole 33: Figure 12 shows the best visible fracture surfaces. The aluminium layer fatigue cracks generally appeared silvery-white, although there were blackish areas near the fastener hole bore and on much of the fatigue fracture surfaces of the bottom aluminium layer. The overall contours of the fatigue cracks indicate a strong influence of local bending. This bending was due to pressurization-induced bulging of the door cutout area during the MLB fatigue test [14]. The largest fatigue crack was in aluminium layer 31 (the first layer of the last doubler), see the right-hand image in figure 12. The crack length was 6.54 mm, which is close to the Airbus Deutschland NDI indication of 7 mm.

Fastener holes 31 – 35: The left-hand image in figure 12 shows considerable black debris and/or damage in the bore of fastener hole 33. Consequently some nearby fastener holes were sectioned perpendicular to the visible or NDI-indicated cracks. All the holes had circumferential scoring (grooves) suggesting poor initial hole quality [15].

- More severe cracking of the aluminium layers led to cracking of the interleaved glass fibre layers as well as further protrusion.
- Black debris in the hole bores, see the left-hand image in figure 12, was most probably due to cyclic displacements of the protruding glass fibre layers during the MLB fatigue test. In other words, the debris was a kind of fretting product.

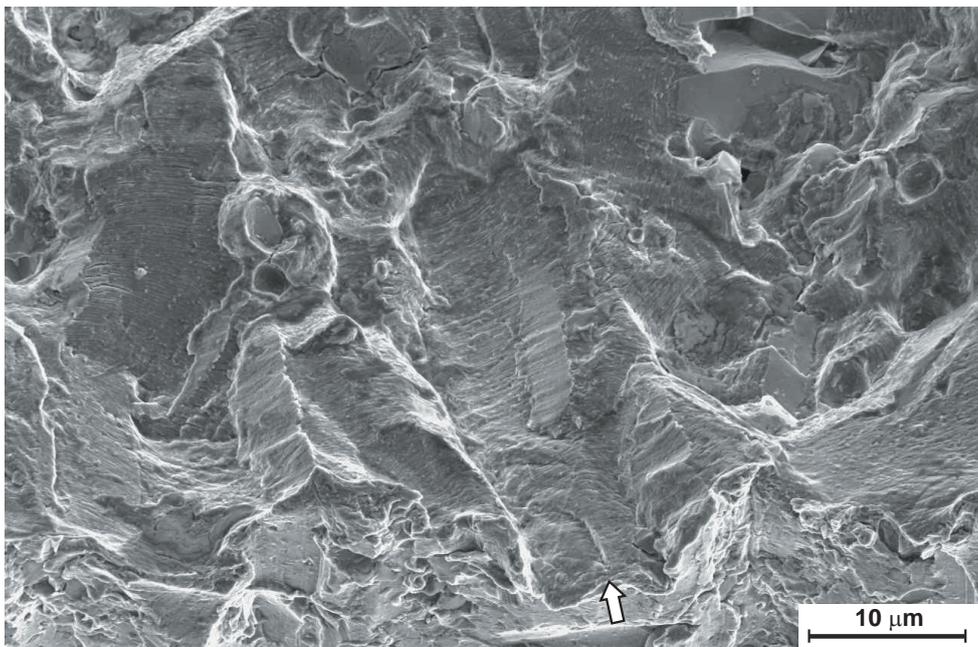
Figure 13 Fatigue crack growth (striations) commencing directly from the bore of fastener hole 33. The arrow points to a fatigue striation “plateau”

Fractographic analysis of the largest crack in fastener hole 33: The fatigue fracture surface was first checked for “readability”. This was generally excellent: most of the fracture surface, *including the very beginning*, see figure 13, was covered with uniformly spaced fatigue striations. There were occasional larger striations, but the load history was essentially constant amplitude cycling. This must have been due to the predominance of pressurization loads at the F7 location.

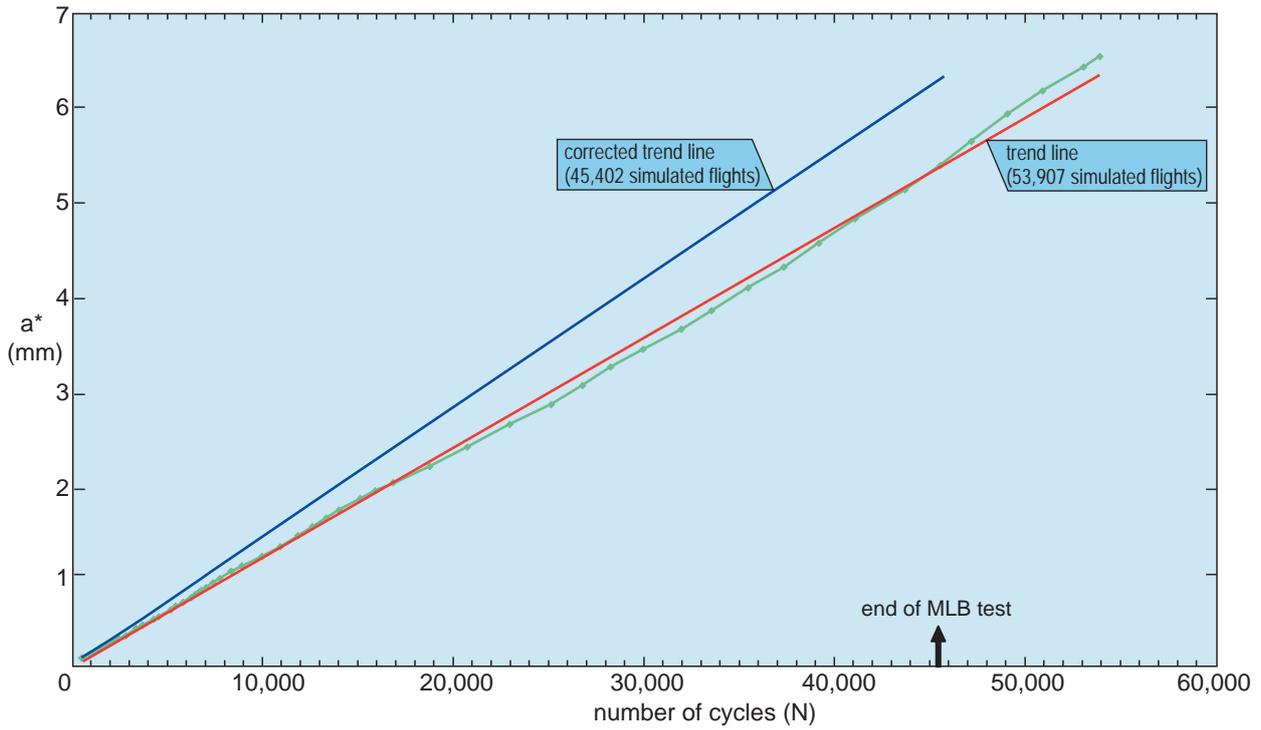
Figure 14 Crack growth plot, a^* versus N , derived from fatigue striation spacings for the longest crack in the door beam GLARE sample

As a first approximation the uniform striation spacings were taken to represent the crack growth in each simulated flight. This meant obtaining an a versus da/dN plot first, and then deriving the a versus N plot, i.e. the reverse procedure to that for the F4 window area cracks. Figure 14 shows the derived a versus N plot based on a fatigue “initiation” life of zero. The trend line for the data points shows that the estimated total life is too long by about 18 %. This is most probably because severe simulated flights (occasional larger striations, ignored in the first approximation) accelerated the overall crack growth. Consequently, figure 14 also includes a corrected trend line.

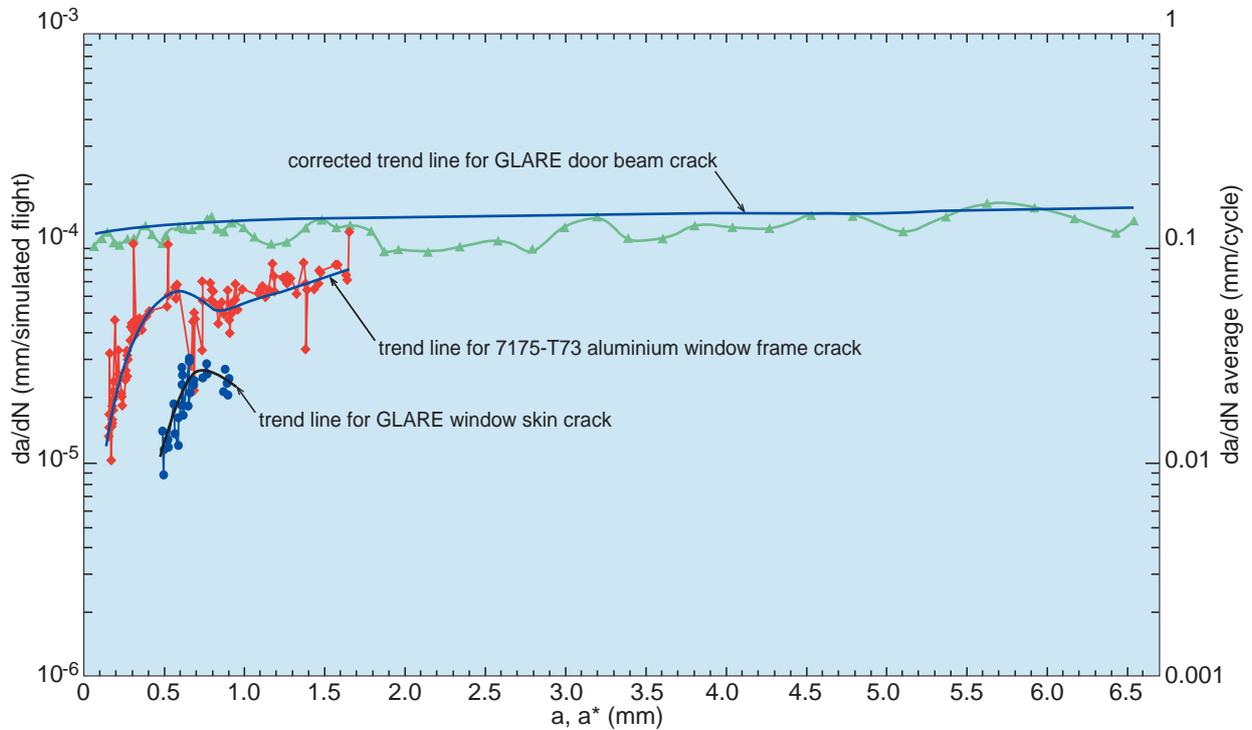
Figure 15 Comparison of crack growth rates for the longest cracks in the F7 and F4 locations

Figure 15 is a compilation of the a versus N results for the F7 door beam and F4 window area cracks. There are two main points to make:

- The data for the door beam crack shows the original a versus da/dN plot and a trend line derived from the corrected plot in figure 14. There is an evident trend of nearly constant crack growth rates. Bearing in mind that the load history was almost constant amplitude cycling, this result is an encouraging validation of the more sophisticated crack growth models for GLARE [9, 10, 13].
- There are significant differences in crack growth rates for the F7 and F4 locations and also differences in the trends. These differences are attributable to differing structural geometries, local load levels and load histories, and also different materials (GLARE compared to a monolithic aluminium alloy).

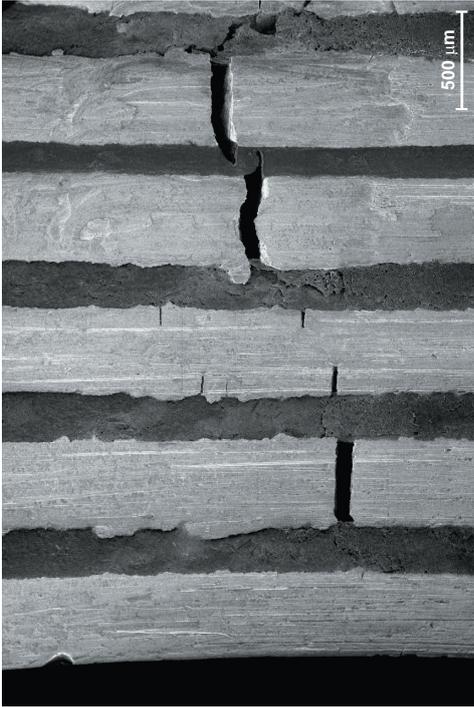
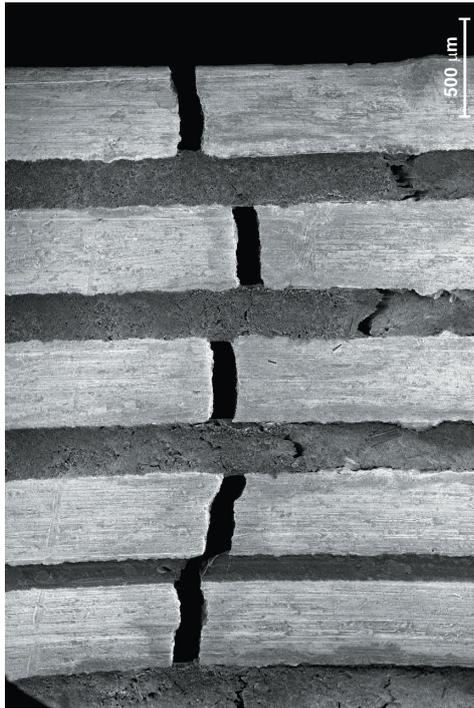
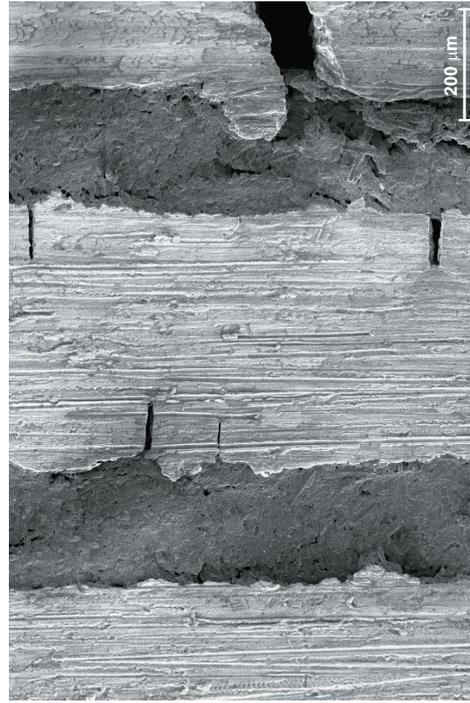
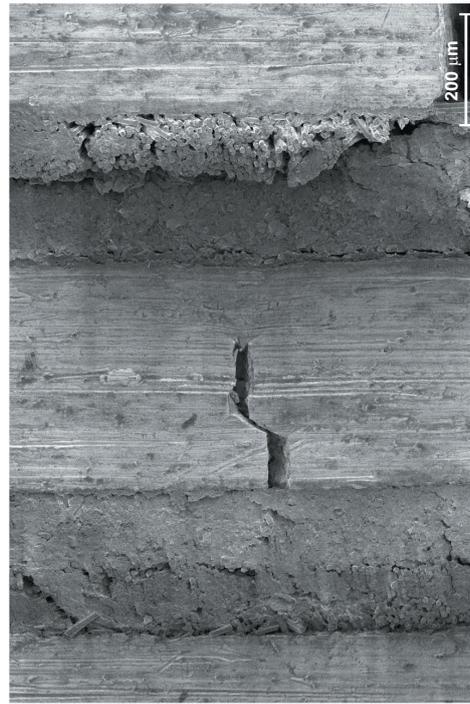
Figure 16 Example of fatigue cracking and damage in the bore of fastener hole 34

Fastener holes 31 – 35: Detailed viewing of the cracked fastener hole bores was enabled by the FEG-SEM, owing to its capability of operating at low kV to minimise charging-up the non-conducting glass fibre layers. Figure 16 gives an example of the observed damage in the bores. The following characteristics of cracking were ascertained:

- Fatigue cracking began in the aluminium layers, generally at or near corners. However, the higher magnification micrograph in figure 16a shows a kinked crack that initiated both at a corner and heavy scoring. This proves that (a) the scoring was present during the MLB fatigue test and was not a result of fastener removal before the NDI by Airbus Deutschland, and (b) the initial hole quality was indeed poor.
- As sequential aluminium layers became through-cracked the intermediate glass fibre layers began to protrude into the hole bores.

These results suggest it is difficult to drill good quality fastener holes in a thick GLARE laminate. For the F7 door beam area this meant that fatigue crack growth in some fastener holes began as soon as the MLB test commenced. Even so, the longest fatigue crack was less than 7 mm at the end of the test. Since the applied fatigue load history was set at a conservatively high level, this teardown result once again demonstrates the high fatigue damage tolerance capability of GLARE.

severe cracking

- glass fibre layers starting to protrude and crack

less severe cracking

- fatigue crack "initiation" often at aluminium layer corners
- occasional heavy scoring on aluminium surfaces leading to crack "initiation" away from corners

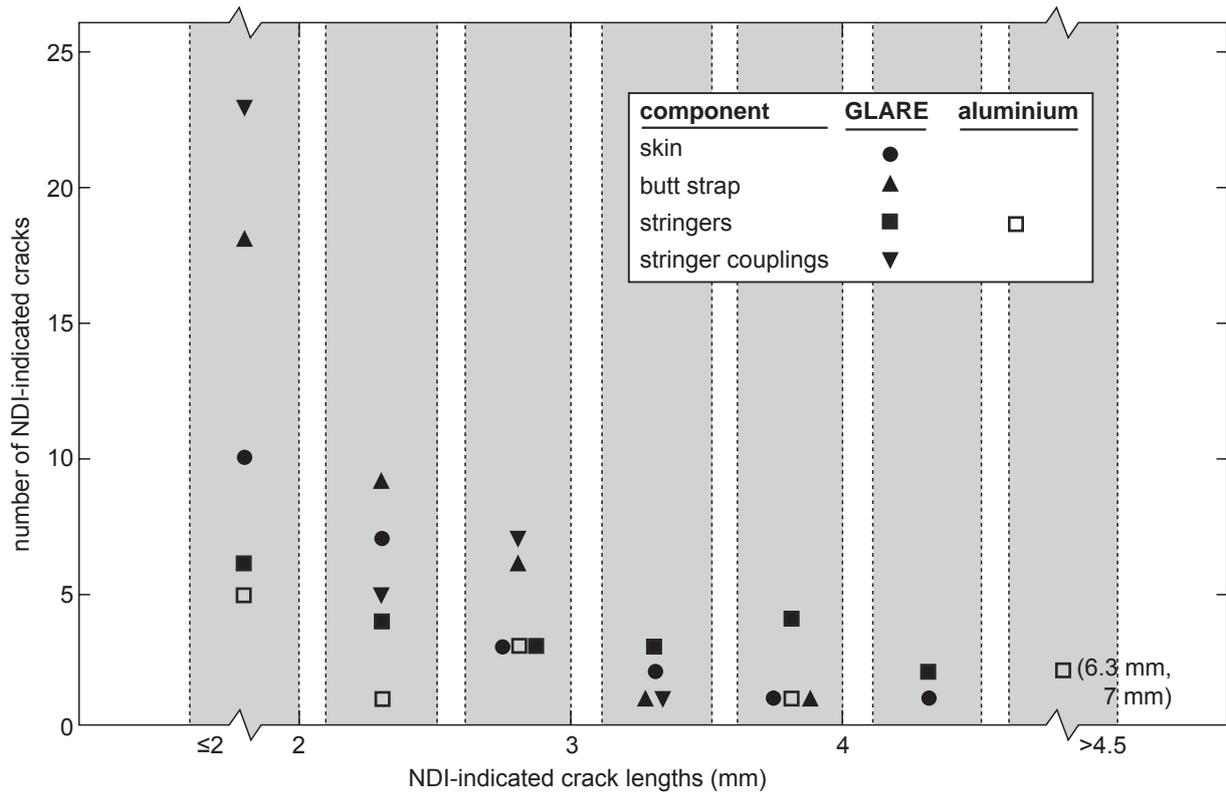
Figure 18 Classification of NDI-indicated cracks for the F6 stringer coupling assembly

Figure 18 classifies the NDI-indicated crack lengths for the components of the F6 stringer coupling assembly, with the exception of the 2524-T351 aluminium skin, for which there were 4 crack indications. There were many crack indications for the GLARE components, but they were all less than 4.5 mm. However, two aluminium stringers contained cracks with indicated lengths of 6.3 mm and 7 mm [16]. These differences are consistent with GLARE's susceptibility to fatigue crack "initiation" in the aluminium layers of the laminates, but its increasing resistance to crack growth, owing to fibre bridging [12].

Support for the above interpretation comes from comparing the NDI-indicated crack lengths for GLARE and aluminium stringer couplings. The maximum indicated crack length for the GLARE stringer couplings was 3.4 mm after 45,402 simulated flights [16]; but aluminium stringer couplings gave fifteen indications with crack lengths 6 – 25 mm after about 20,000 simulated flights, and another twenty-four indications with crack lengths 6 – 16 mm after less than 40,000 simulated flights [14].
