Patch repair of cracks in the upper longeron of an F-16 aircraft of the Royal Netherlands Air Force (RNLAf)

W.G.J. 't Hart and J.A.M. Boogers

This report is based on a presentation held at ICAS, Toronto, Canada,
8-13 September 2002.

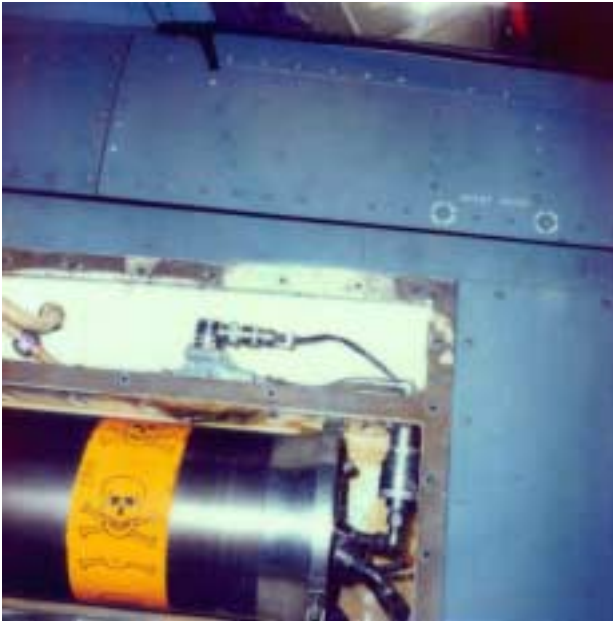
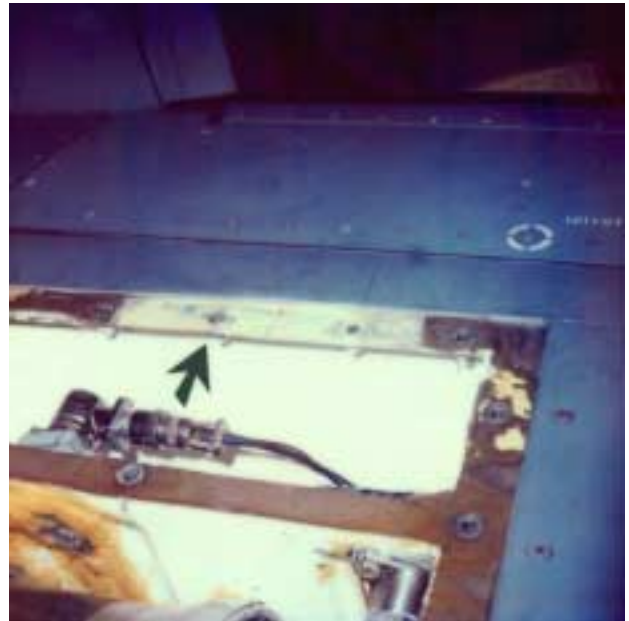
Fig. 1 Cracks in longeron 16B1111 at third fastener hole from the right (see arrow)

During a phase inspection of the RNLAf F-16, cracks were detected in the upper right longeron 16B1111-21, FS 186.90 – FS 247.89. The cracks occurred in the longeron flange for fixing the access panel 2408, at the location of the third fastener hole from the right of the panel, see figure 1. There are two cracks: one in longitudinal direction (outside the hole) and one transverse crack through the hole, see figure 2. The longitudinal crack length is about 70 mm and the transverse crack about 22 mm.

Location of access panel 2408

Arrow indicates location of cracks

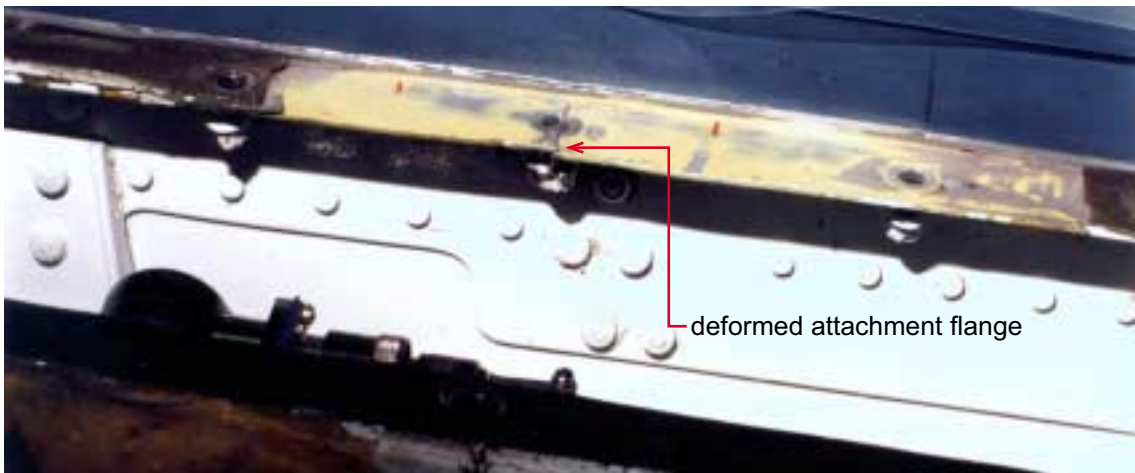
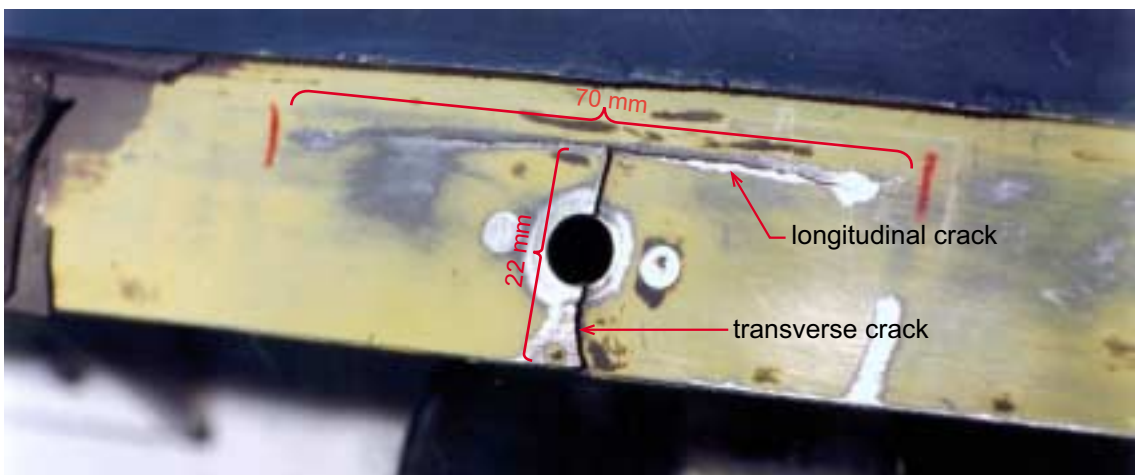
Fig. 2 Details of cracks in longeron

Figure 2 shows the main cracks that were found in the upper attachment flange. In the upper view it is seen that the flange is somewhat deformed and the upper surface shows signs of rubbing. Further, it was observed that the nut riveted to the flange lower side had an oblique orientation. These discrepancies indicated a bad fit of the panel on the longeron flange.

Operational aircraft loads in combination with assembly-induced bending stresses most probably caused the longitudinal crack first. Subsequently, the transverse crack initiated

from the fastener hole owing to dynamic tensile stresses in the longeron.

Side view

deformed attachment flange

Upper view

longitudinal crack

transverse crack

The patch repair concentrated on restoration of the longeron strength in the longitudinal direction. However, a bonded patch does not remove the longitudinal crack. In order to prevent possible further growth of the longitudinal crack, stop drilling at the tips of the longitudinal crack was recommended.

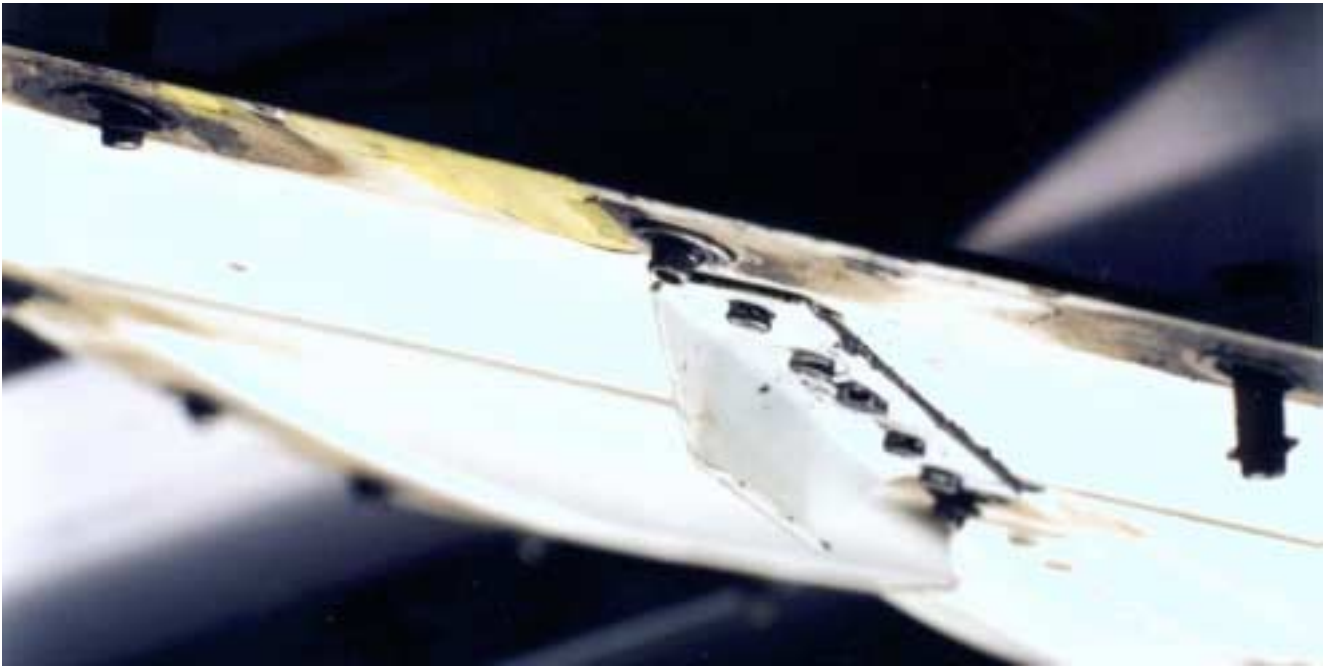
Fig. 3 Lower side of access panel 2408 with a stiffener repair

The specific access panel had been previously repaired with a relatively large stiffener that ended at the fastener hole where the cracks were found (Fig. 3). It is most likely that the access panel with this large stiffener, had introduced large static bending stresses in the flange owing to the bad fit.

In the present investigation cracks in the upper right longeron of an F-16 aircraft of the RNLAf were investigated. The main cause for cracking was the occurrence of assembly stresses due to an improperly repaired access panel 2408. Since a conventional mechanical repair could not be done, the OEM advice was removal and replacement of the longeron. However, because the aircraft would be retired from service after 400 flights hours, a cost effective bonded patch repair was evaluated and applied to the cracked longeron. Inspections during the remaining operational life did not show any damage propagation in the repair. Thus the present investigation has shown that adhesively bonded patch repairs can be very useful and cost-effective, especially when the repair has to be sustained only during a limited service life.

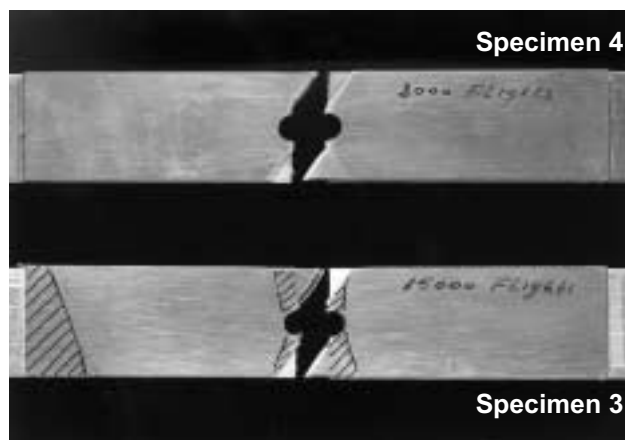
Figure 7 gives the test results. The static failure load of the undamaged open hole specimen was 19.9 kN, specimen 1. Fatigue testing at 130 % LW-VAL resulted in a life of 14300 flights, specimen 2. Specimen 3 demonstrated that the repair survived 15000 flights after which a residual strength of 23.1 kN was obtained. NDI before residual strength testing showed local delamination at the edges of the titanium patches. Specimen 4 did not show signs of debonding after testing for 3000 flights. The residual strength was 25.3 kN. Figure 8 shows the failed repair specimens. Both specimens showed tensile failure of the

Titanium patches despite local fatigue induced delamination for specimen 3.

Fig. 8 Residual strength tested specimens after fatigue testing for 3000 and 15000 flight hours. (delamination after fatigue testing was only found for the specimen tested for 15000 flights)
