Development and evaluation of a hard patch repair method for composite stiffened wing panels

A.L.P.J. Michielsen, L.C. Ubels and F. Baas

This report is based on a contribution to EUCLID-CEPA 3-RTP 3.1 Aeronautical Application Technology, Repair Methodology "On Aircraft", contract number E/L41A/NO266/N5260, and represents a presentation held at the JEC/SAMPE Conference, Paris, France, 1999.

Customer:	National Aerospace Laboratory NLR
Owner:	National Aerospace Laboratory NLR
Division:	Structures and Materials
Distribution:	Unlimited
Classification title:	Unclassified
	February 1999

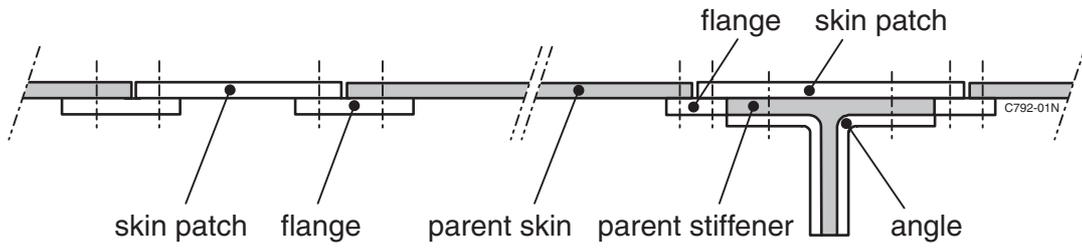
Figure 1: Principle of the hard patch repair method

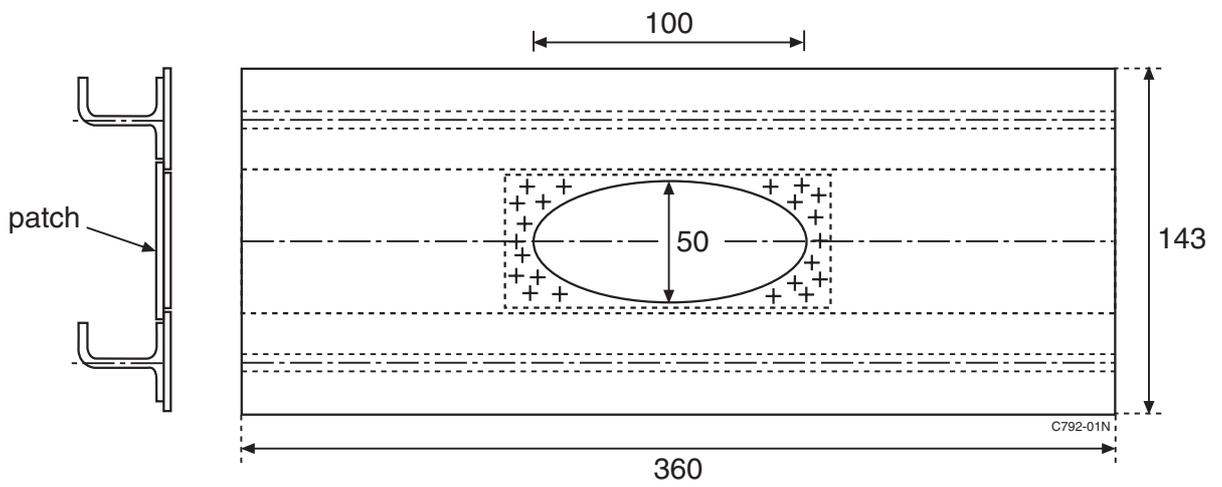
Figure 2 presents the developed skin repair method which can be applied on J-, blade- and I-stiffened configurations. The ‘imaginary’ damage was positioned mid-bay between the stiffeners in the centre of the panel. The damage was removed by cutting an elliptical hole around the damage. This shape was chosen to allow easy access for repair. The direction of the major axis of the ellipse is in the direction of the forces on the panel. Two different pre-cured patches were made from the same material as the panel. The first patch was made of two flat parts which were bonded together: an elliptical plate which fills up the hole in the skin and a rectangular plate which forms the flanges of the patch. An alternative patch consisted of a single piece and had the same external dimensions, except that the centre of this part was elevated (dimpled). With the chosen geometries, it was still possible to insert the patch from the outside through the hole of the panel. The patch was bonded with a cold curing adhesive and riveted with blind fasteners. Bolted repairs are the most common for battle damage repairs because of reliability and relatively fast application to a damaged part. They are to be preferred over bonded repairs. Therefore, one configuration was tested with rivets only, the bond layer was omitted (specimen J-skin-4). For each configuration a repair manual was written with detailed information how to perform the repair [Refs. 4,5,6 and 7]

Figure 2: Skin repair patch in a lightly loaded J-stiffened panel

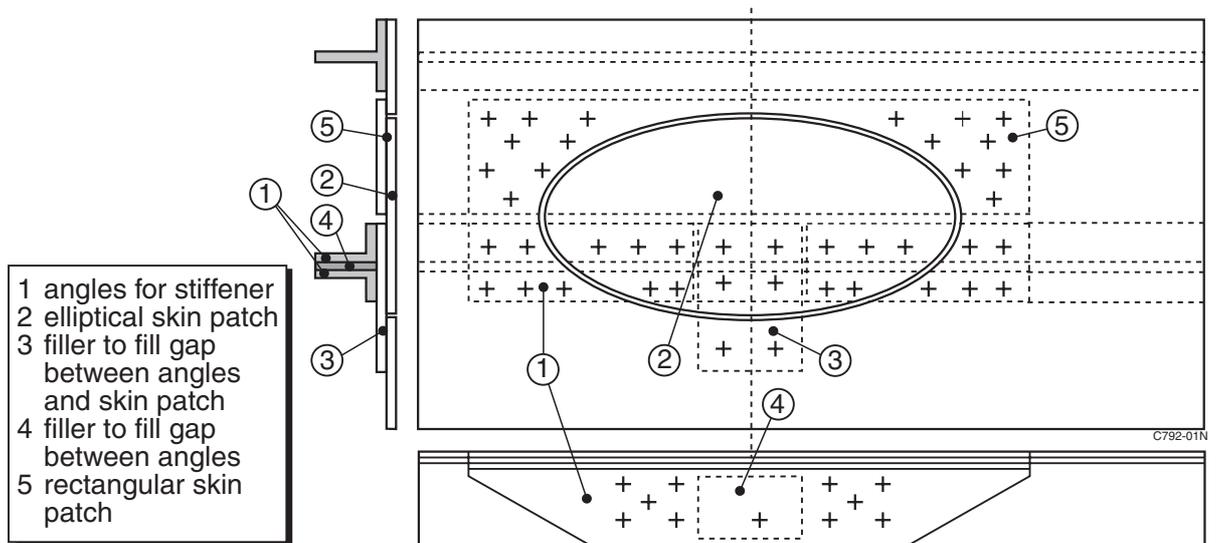
Figure 3 presents a skin-stiffener repair in a blade-stiffened panel. The imaginary damage was located directly above one of the stiffeners. To restore the required strength, both the skin and the stiffener had to be repaired. The repair of the stiffener was performed with two carbon/epoxy angle-sections. These angle-sections were attached to both sides of the stiffener. A small flat part was used to fill the gap of the removed web between the angles. The repair of the skin was performed with a skin patch. The skin patch consisted of an elliptical plate bonded to a rectangular plate both made from carbon/epoxy. The rectangular part of the skin patch was attached underneath the skin between the stiffeners. Again, small plates were used to fill the gap between the substitute stiffener and the skin. Both rivets and adhesive were used to attach the replacement parts.

Figure 3: Skin-stiffener repair in a lightly loaded blade-stiffened panel

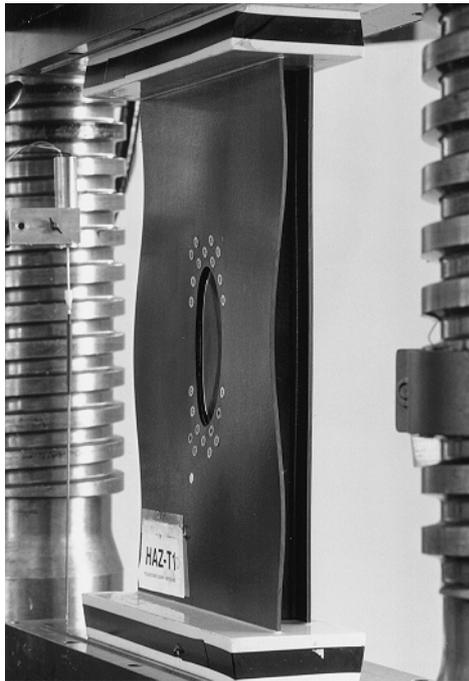
0792-01N

- Static compression tests were performed at room temperature and at a temperature of -85°C or -50°C . The required strength of 100% DUL was obtained for all configurations. Figure 4 presents the deformation of an intermediately loaded I-stiffened panel with a skin repair subjected to 120% DUL (specimen I-skin-2). Figure 5 presents failure of an intermediately loaded panel with a skin-stiffener repair (specimen I-stiff-1). In this case, panel failure originated from the parent structure and was not initiated by the repair.
- Several panels were fatigue loaded at 50% DUL following a residual strength test up to 70% DUL. Figure 6 presents a panel (specimen I-stiff-4) in which several rivets failed during fatigue loading. Even with these failed rivets, sufficient residual strength was obtained.

Figure 4: I-stiffened panel with a skin repair subject to 120% DUL (692 kN) in compression (specimen I-skin-2)

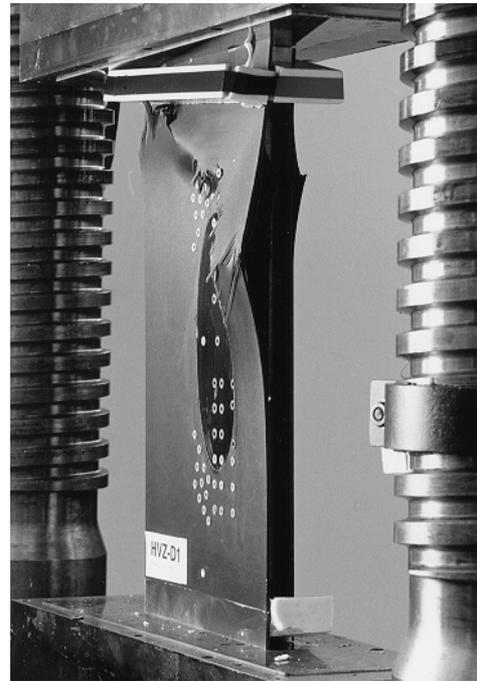
For the lightly loaded blade- and J-stiffened configurations, significantly higher load levels were obtained than required, as both types of repairs resulted in thickening of the skin, preventing the skin from buckling. In case of the intermediately loaded I-stiffened panels, failure of the panels was obtained at a load level only slightly above the required load level. The tests showed that the repair methods developed, fulfilled the requirements with respect to the structural strength.

Figure 5: Failed intermediately loaded panel repair (specimen I-stiff-1)

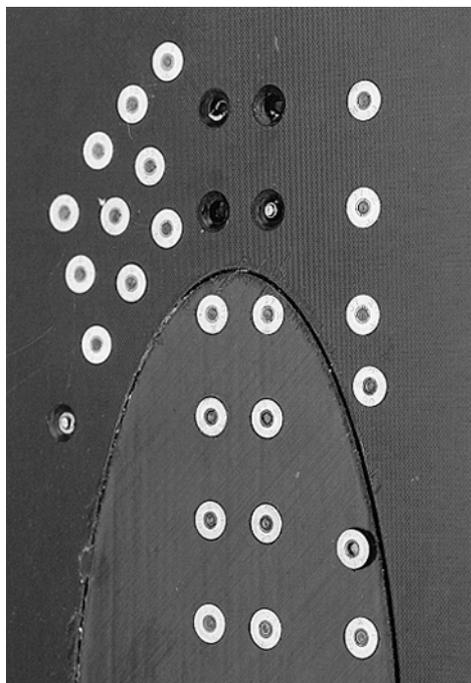
Figure 6: Failed rivets of a skin-stiffener repair in an intermediate loaded panel (specimen I-stiff-4)

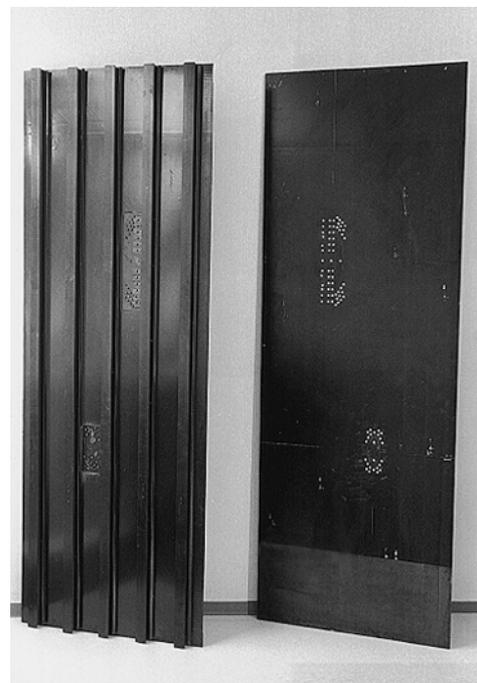
The positions of the repairs in the 5-stiffener panel are indicated in figure 7. The repairs were performed by OGMA, based on the repair manuals [Refs. 5,6] written by Techcare. Some of the prescribed tools of the repair manual were not available at OGMA so the repairs were accomplished with tools that were available. It was found that the geometry described in the repair manuals did not correspond with the actual geometry of the structure to be repaired. At 'field level' several modifications to the geometry were applied and the repair was accomplished. The repairs were inspected by C-scans, and indicated a good quality.

Figure 7: Skin repair and skin-doubler repair in I-stiffened panel
