National Aerospace Laboratory NLR

Service experience with single crystal superalloys for high pressure turbine shrouds

It is shown that uncoated single crystal superalloy HPT shrouds primarily degrade by environmental attack. Depending on the engine Report no. NLR-TP-2011-547

This report is based on a presentation held at the 5th International Gas Turbine Conference: "The Future of Gas Turbine Technology", Brussels, Belgium, 27-28 October 2010.

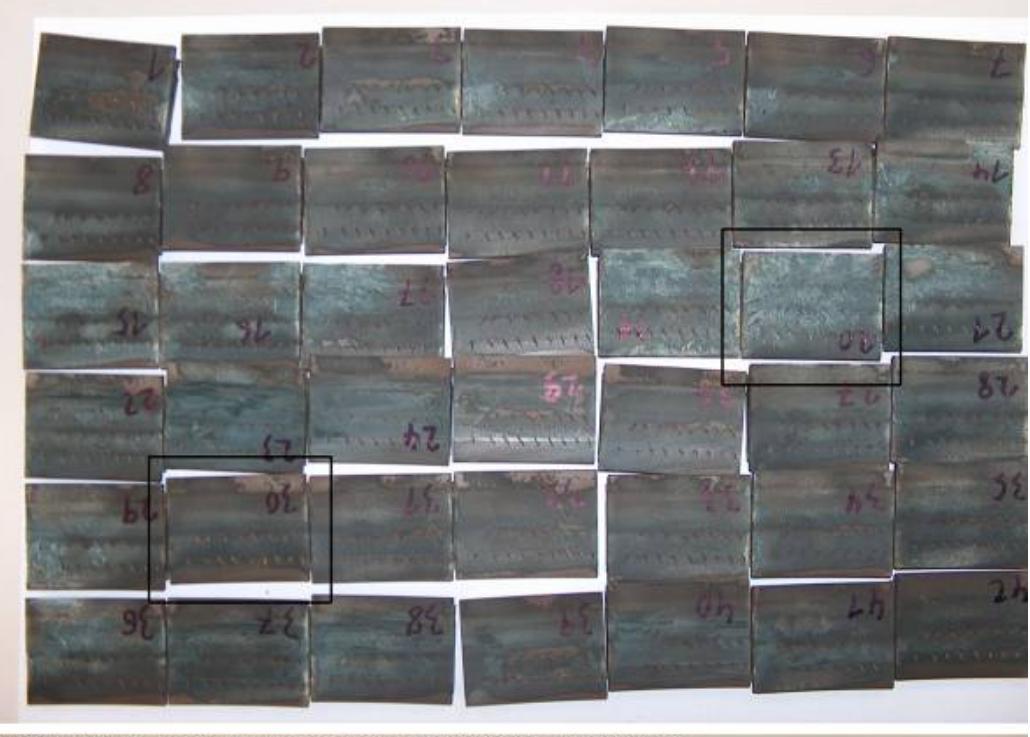
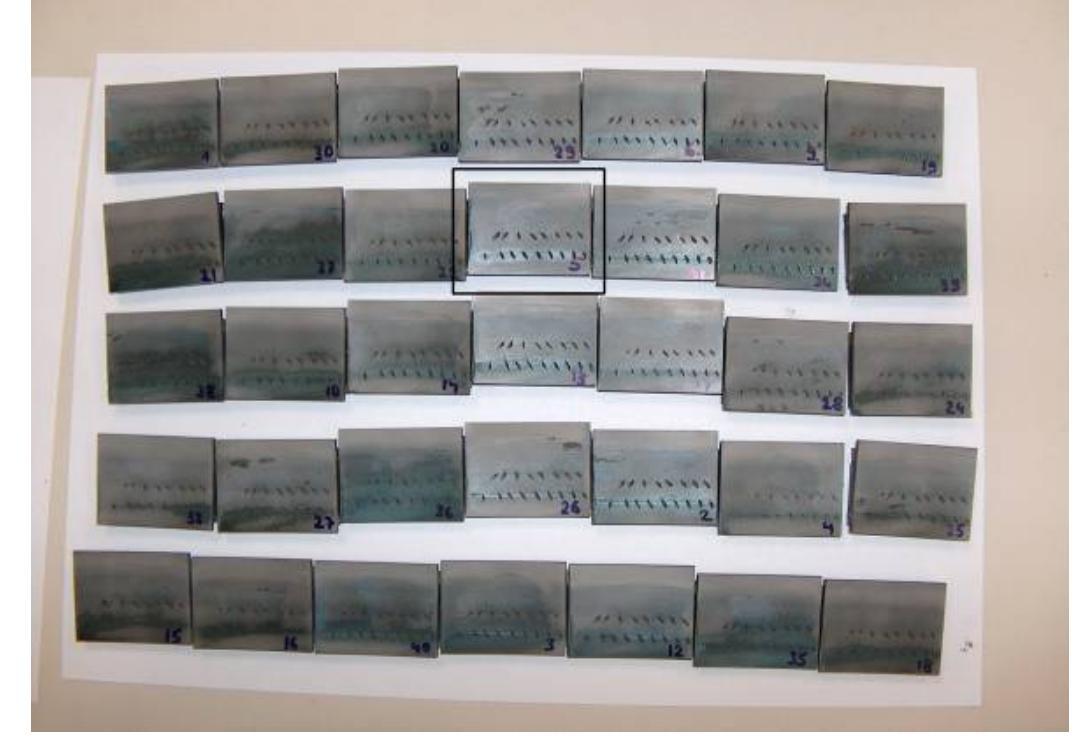
Generally speaking, the observable damage to CMSX-4 and René N5 CFM56-5C HPT shrouds is mostly confined to the gas path surface. The appearance of the sets of shrouds that are supplied to Chromalloy can differ significantly. Fig. 7 gives two representative examples. It is seen that one set of shrouds is highly discoloured, indicating severe environmental attack, while the other set of shrouds appears almost completely clean. So far, no systematic relation has been found between the appearance of the shroud gas path surface and the engine service conditions. In other words, no difference has yet been observed for shrouds exposed to long flights (high time since overhaul (TSO) and low number of cycles since overhaul (CSO)) and short flights (low TSO and high CSO). Moreover, frequently, significant differences in the appearance of the shrouds originating from the same set (i.e. from the same engine; see e.g. Fig. 7a).

To examine whether this difference in macroscopic appearance was an indication for a different degree of environmental attack, the shroud that macroscopically appeared to be the most attacked and the shroud that appeared to be the least attacked were analyzed in more detail for the set of shrouds shown in Fig. 7a. The results of this analysis are presented in Figs. 8 and 9. It is seen that, for both shrouds, a very thick $(300 - 400 \,\mu\text{m})$ corrosion product formed at the gas path surface during service. A compositional analysis of the corrosion product revealed that it consisted of a porous continuous upper layer composed of mainly nickel and cobalt oxides and an inner layer composed of isolated internal aluminium and chromium oxides. Hence, in contrast to what is expected based on laboratory cyclic oxidation tests, no continuous alumina scale developed for these shrouds upon service. As a result, the corrosion product is able to rapidly consume the single crystal superalloy shroud. There seems to be no difference in the thickness of the corrosion product for the shroud that appeared to be severely degraded and the shroud that appeared to be less degraded macroscopically. It is therefore believed that the different appearance for shroud 20 (Fig. 8) is related to differences in blade tip rubbing. It is clearly seen that shroud 20 (Fig. 8) exhibited a deeper rub trace than shroud 30 (Fig. 9). As a result, due to this deeper rubbing, part of the corrosion product has been removed away by erosion or spallation (Figs. 8a and 8b). Macroscopically, it therefore appears that shroud 20 is more severely attacked while in reality it is not.

(a) CFM56-5C René N5 uncoated) ; TSO 28306 ; CSO 3430

b) CFM56-5C René N5 (uncoated) ; TSO 11616 ; CSO 2257

Fig. 7: Macrographs of two complete sets of CFM56-5C René N5 HPT shrouds (uncoated). The blue inserts show which shrouds were selected for further evaluation.

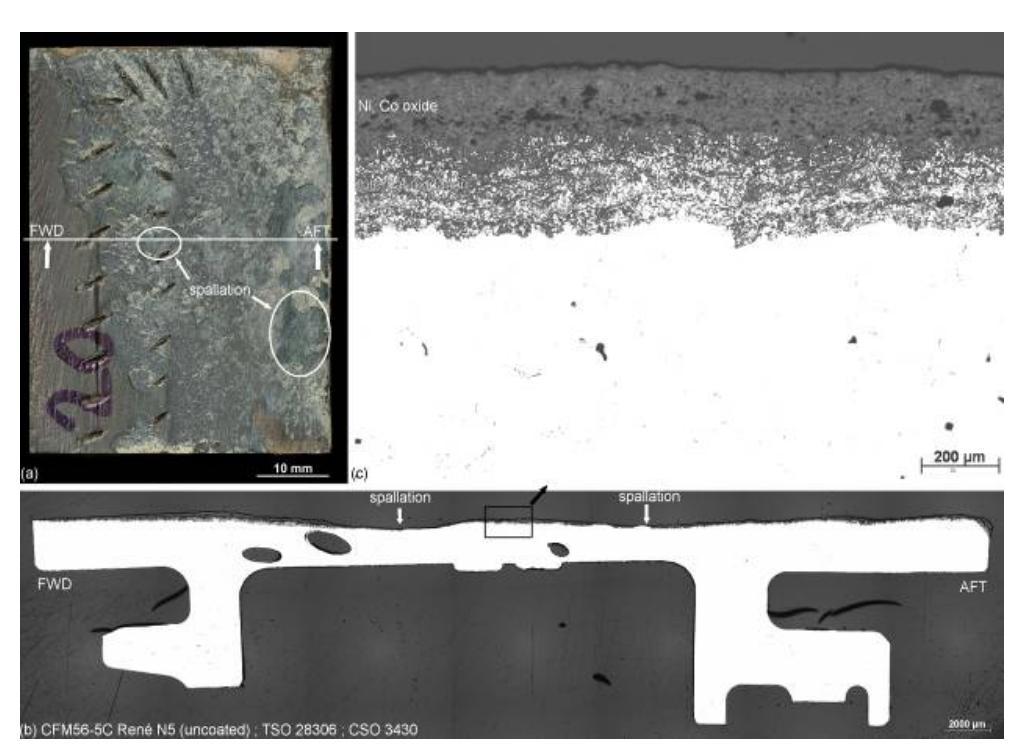
Fig. 8: (a) Surface macrograph, (b) optical micrograph of the cross-section indicated in (a) and (c) optical micrograph of the corrosion product at the location indicated in (b) of an ex-service René N5 CFM56-5C HPT shroud.

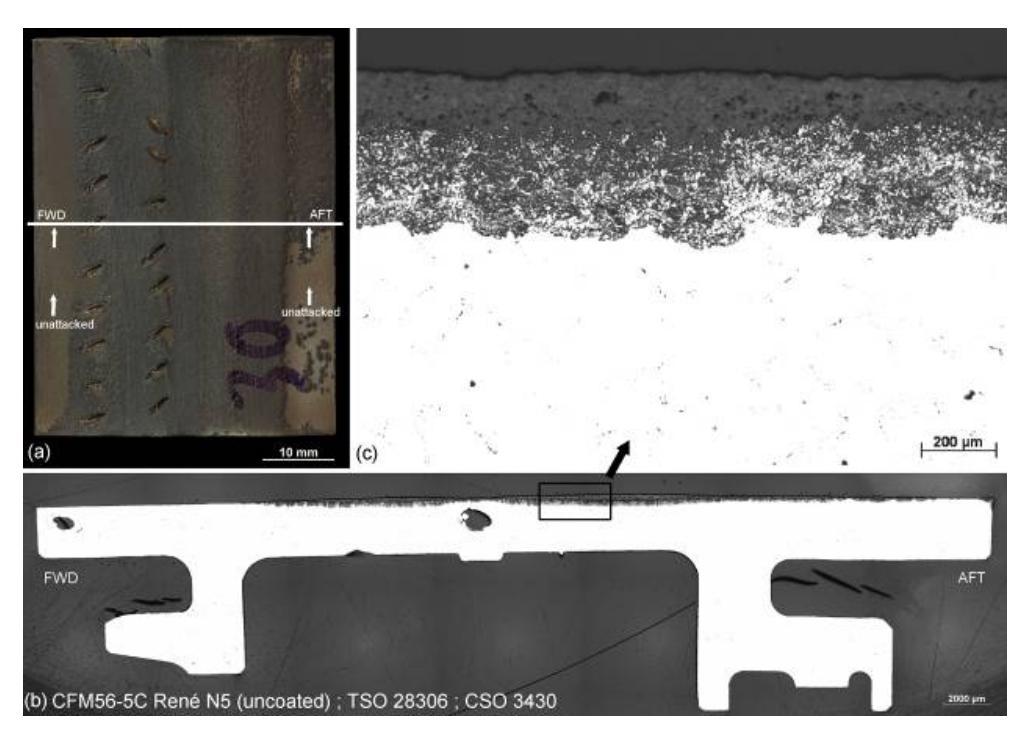
Fig. 9: (a) Surface macrograph, (b) optical micrograph of the cross-section indicated in (a) and (c) optical micrograph of the corrosion product at the location indicated in (b) of an ex-service René N5 CFM56-5C HPT shroud.

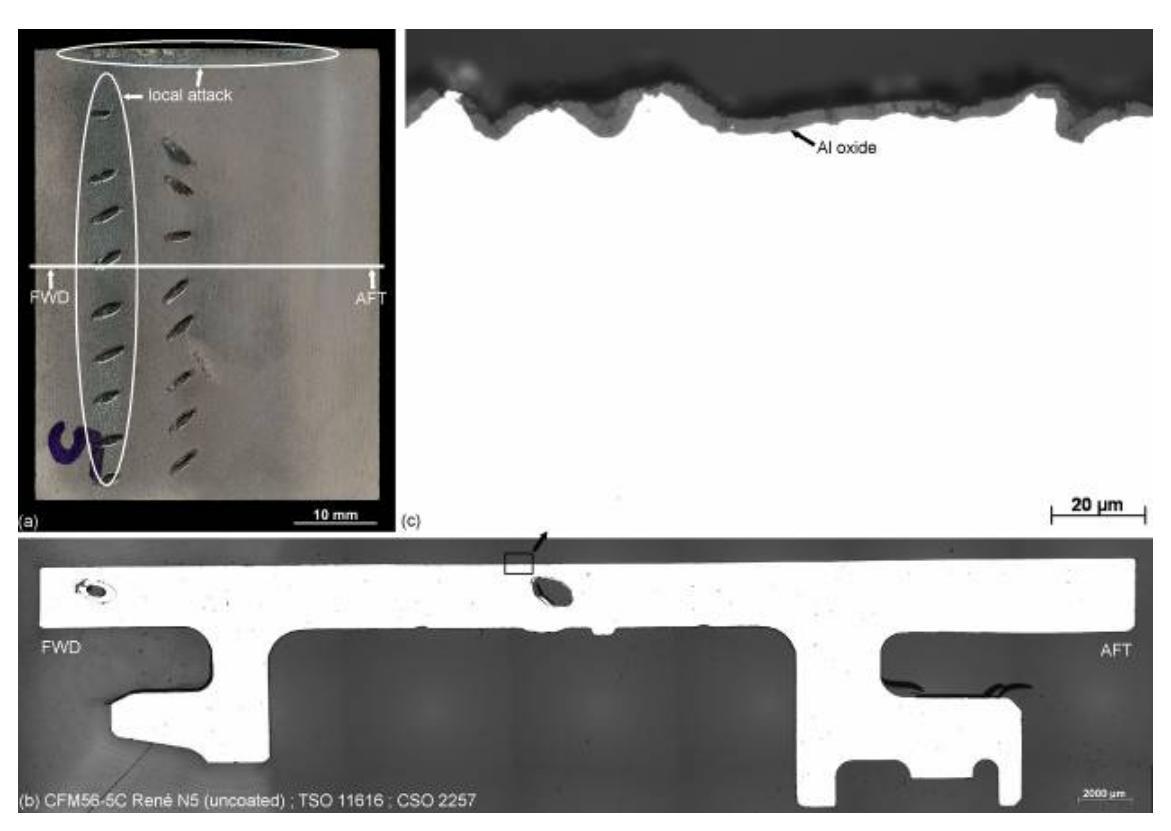
Fig. 10: (a) Surface macrograph, (b) optical micrograph of the cross-section indicated in (a) and (c) optical micrograph of the corrosion product and the location indicated in (b) of an ex-service René N5 CFM56-5C HPT shroud.

Fig. 10 shows an example of a shroud that appears to be relatively clean after service. An examination of this shroud cross-section revealed that it indeed has not been severely attacked by corrosion. Only a very thin continuous oxide scale (2.5 µm thick) could be detected upon the gas path surface of this shroud despite its TSO of more than 11.000 hours. Compositional analysis revealed that this oxide layer was composed of aluminium oxide, in agreement with the laboratory furnace tests. It seems highly unlikely that differences in normal engine conditions can explain the huge difference (more than two orders of magnitude difference in oxide thickness) between the environmental attack for the shrouds shown in Figs. 7a and 7b. On closer inspection of Figs. 8 to 10 and other cross-sectioned René N5 and CMSX-4 CFM56-5C shrouds, it seems that the difference in oxidation behaviour can be attributed to rubbing. In the shrouds where rubbing was absent (e.g. Fig. 10) oxidation always proceeded very slowly, in agreement with what is observed in the laboratory. However, in the shrouds which experienced rubbing, the oxidation rate was always much faster. Additional evidence for this explanation can be found on the gas path surface of rubbed shrouds far away from the rub area. As is seen in e.g. Figs. 9a and b, shroud no. 30 does not seem to be environmentally attacked far away from the rub area. Apparently, rubbing only influences a limited area surrounding the rub trace. The

question remains why rubbing does result in such an enhancement of the oxidation rate. One explanation could be that due to rubbing the material temperature at the gas path surface raises to such a high level that a continuous alumina layer cannot be formed anymore. However, such an explanation needs yet to be verified.

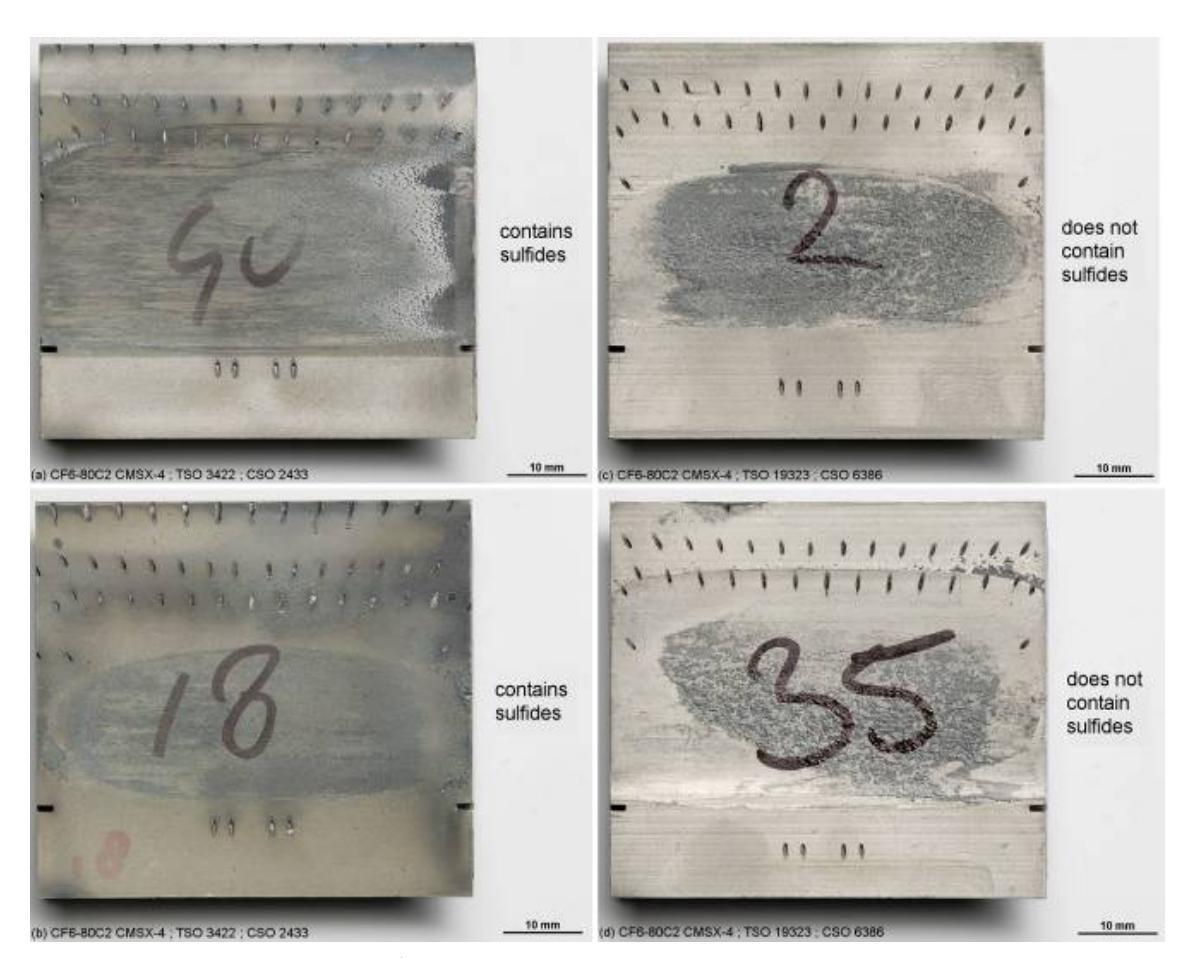
Typical macrographs from the gas path surface of 1st stage CMSX-4 CF6-80C2 HPT shrouds are shown in Fig. 11. Similar to what was observed for the CFM56-5C HPT shrouds, environmental attack seems to be accelerated in the area where rub has occurred on the shroud surface. However, typically, the extent of the environmental attack for the CF6-80C2 shrouds seems to be less than what is usually observed for CFM56-5C shrouds. This was confirmed when a cross-section of one of the CF6-80C2 HPT shrouds was examined in more detail (see Fig. 12). As shown in Fig. 12c, the corrosion product on this shroud had a thickness of only 5 – 10 μ m, which is much thinner than what was observed for CFM56-5C shrouds (Figs. 8-10). EDS analysis revealed that the corrosion product in Fig. 12c was made up of three layers: (1) an outer Ni rich oxide layer, (2) an intermediate Ta, W rich oxide layer, and (3) a continuous inner aluminium oxide layer. In addition, Cr-rich sulphides were detected just below the alumina layer. This indicates that this shroud was attacked by type I hot corrosion. Due to the relatively thin corrosion product, it is likely that the hot corrosion reaction was still in its initiation phase after 3402 hours of engine operation.

While type I hot corrosion was observed within other 1st stage CMSX-4 and René CF6-80C2 HPT shrouds, there were also some CF6-80C2 shrouds for which the corrosion product did not contains sulphides (i.e. these shrouds were attacked by oxidation). For example, the two shrouds shown on the left of Fig. 11 were found to be attacked by hot corrosion while the two shrouds on the right of Fig. 11 were attacked by oxidation. It seems that this different degradation mechanism also has an influence on the discoloration pattern at the gas path surface. The two shrouds that were attacked by hot corrosion had a more "greenish" appearance also in the areas away from the rub area. On the other hand, for the shrouds attacked by oxidation, the corrosion product had a "greyish" appearance. Moreover, further away from the rub area, these shrouds appeared to be virtually free of environmental attack (i.e. they had a metallic appearance).

Fig. 11: Macrographs of four 1st stage CMSX-4 CF6-80 C2 HPT shrouds. The two shrouds on the left originate from the same engine. This applies also for the two shrouds shown on the right.

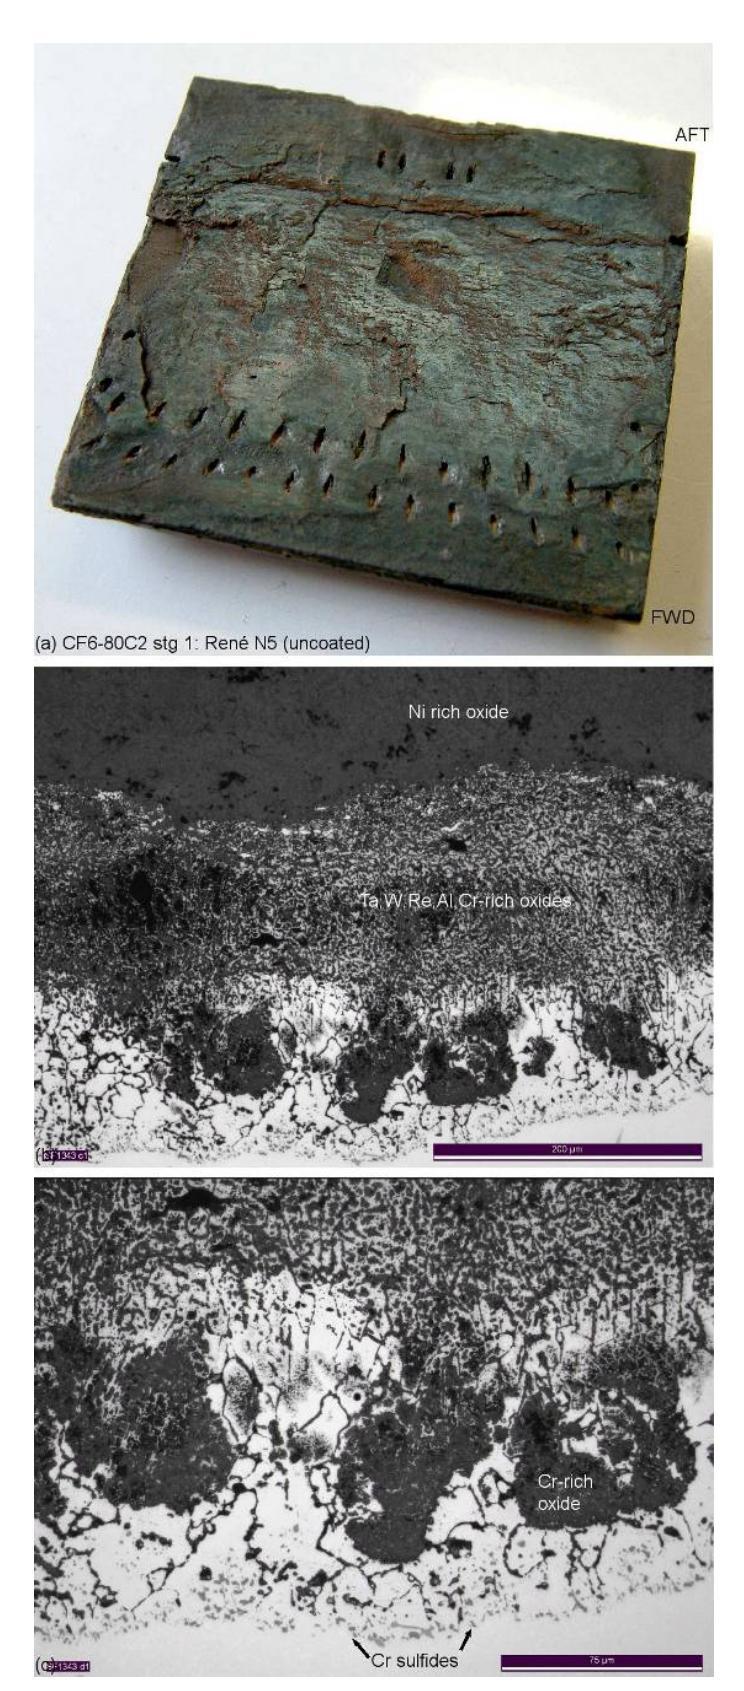
Fig. 13: (a) Surface macrograph, and (b,c) optical micrographs of the corrosion product for an ex-service 1st stage René N5 CF6-80C2 HPT shroud.

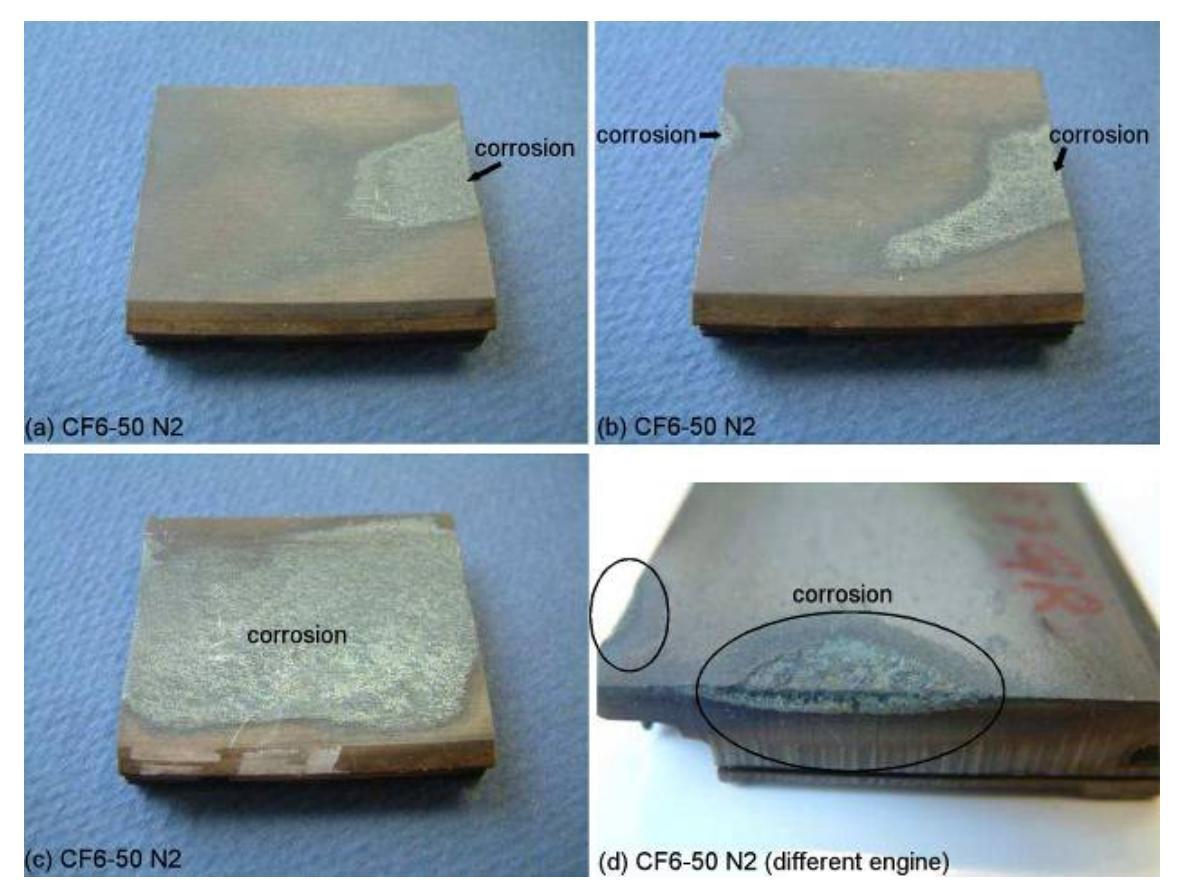
HPT shrouds made from the single crystal superalloy N2 have only recently been introduced by the OEM. However, several sets of deteriorated 1st stage CF6-50 N2 shrouds have already been sent to Chromalloy for repair. Such shrouds show macroscopic signs of severe environmental attack. This attack seems to be concentrated mostly near the edges of the shroud's gas path surface (Figs. 14a and b), but in some shrouds almost the entire gas path surface is attacked (Fig. 14c). As can be seen from one of the side surfaces of a N2 shroud (Fig. 14d), the environmental attack consumes a significant part of the original thickness of the shroud.

Fig. 14: Macrographs of four 1st stage N2 CF6-50 shrouds. The three shrouds with the blue background originate from the same engine. The circles highlight areas of severe environmental attack.

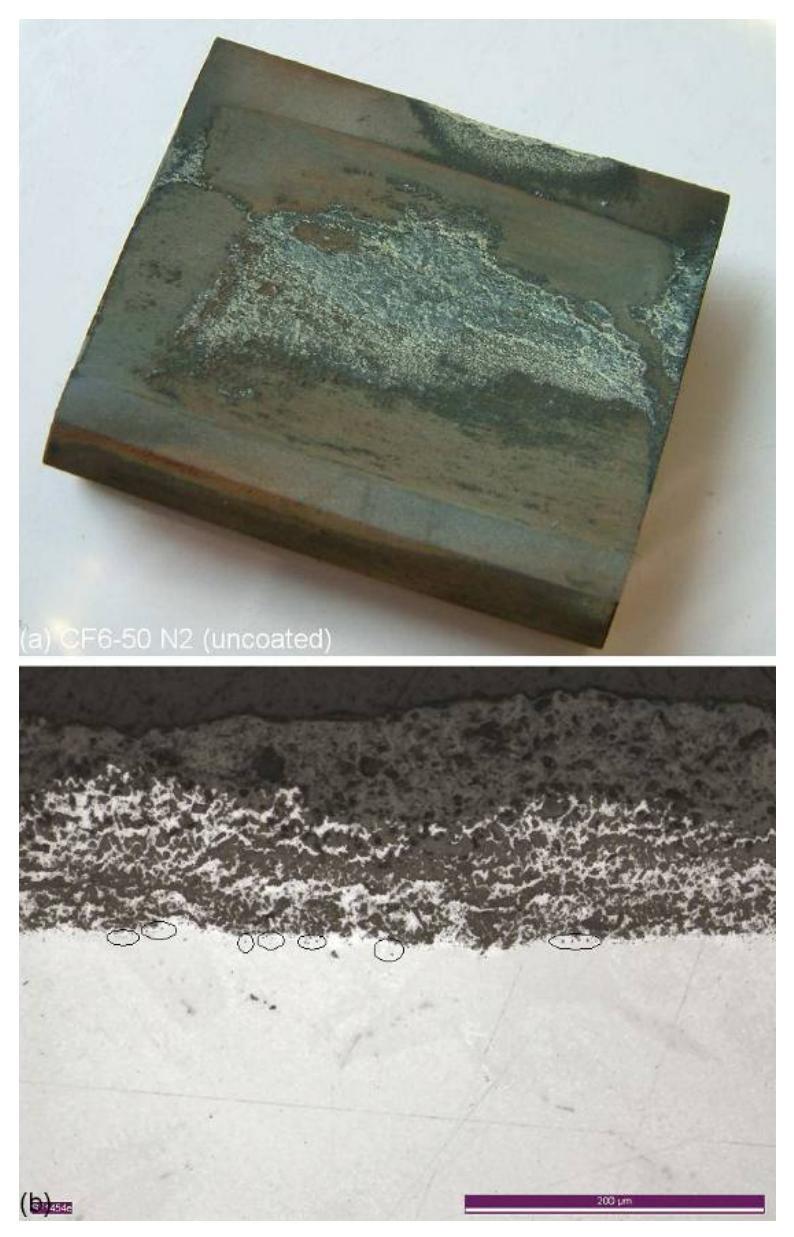
A cross-section through one of the shrouds revealed the presence of a thick corrosion product (more than 200 μ m) which consisted of a porous outer layer and an inner layer containing isolated oxides (Fig. 15). Again, just below the corrosion product an array of small particles can be observed, which hints at the presence of sulphides (an EDS analysis to confirm this has not yet been executed). Therefore, this indicates that (1) the N2 CF6-50 shrouds were attacked by type I hot corrosion and (2) the corrosion reaction takes place at a relatively fast rate (indicating

that the propagation phase of hot corrosion reaction was already reached for these shrouds). This finding is surprising since the N2 patent [3] and the property data for N2 generated for this paper (Figs. 3-6) indicate that N2 was primarily introduced for its hot corrosion resistance. A similar degree of environmental attack is not observed for CoNiCrAlY coated 1st stage CF6-50 MAR-M509 HPT shrouds. This is in agreement with the hot corrosion laboratory test (Fig. 6), in which it was shown that Chromalloy's HVOF rub coating has a superior hot corrosion resistance over N2. Apparently, the improvement in the hot corrosion resistance of N2 over René N5 is not sufficient to prevent it from degrading by hot corrosion in some CF6-50 engines.

Fig. 15: (a) Surface macrograph and (b) scanning electron micrograph of the corrosion product in an ex-service 1st stage N2 CF6-50 HPT shroud. The circles highlight areas where (sulphide) particles are visible below the corrosion product.

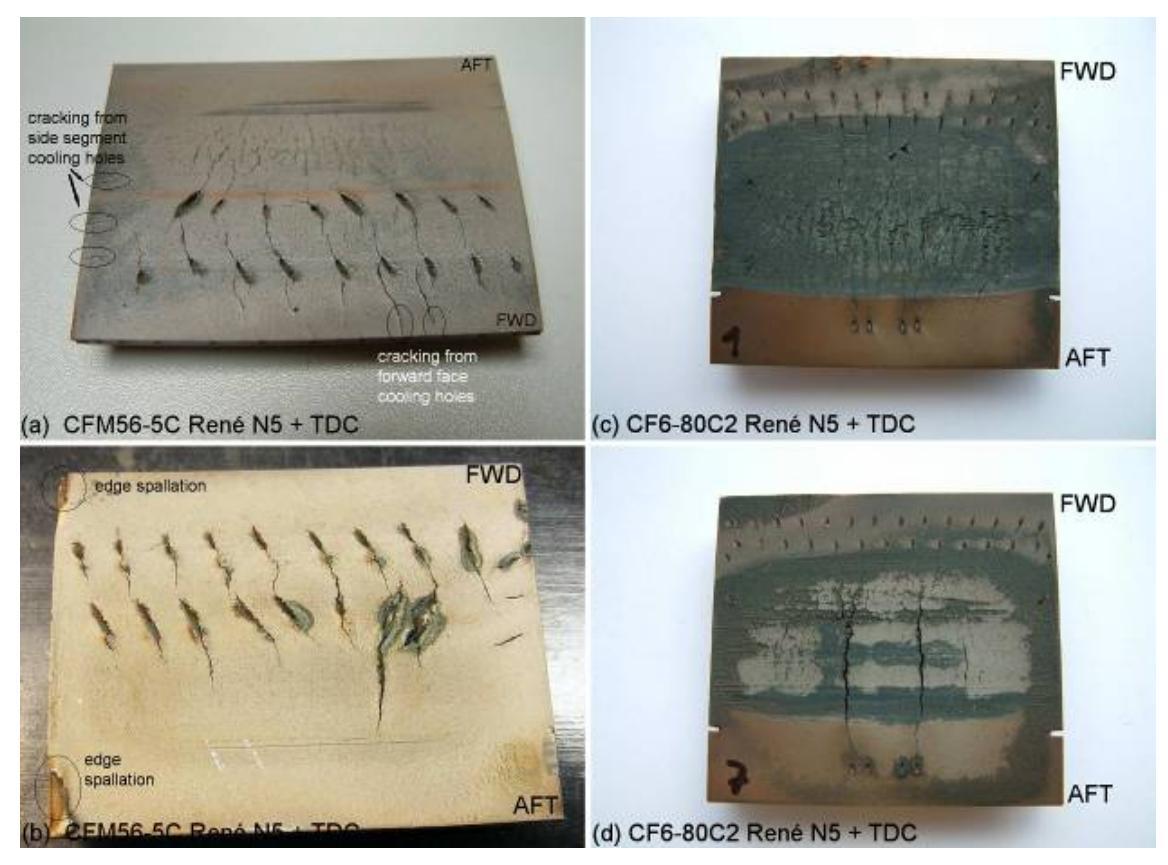
Most ex-service René N5 CFM56-5C shrouds with TDC rub coat examined so far are cracked and/or show signs of coating spallation (in particular near corners and edges; see Figs. 17b). Cracks are preferentially formed near cooling holes (not only near the cooling holes at the gas path surface but also near the cooling holes from the forward face and the left side surface, Fig. 17a). In addition, for some shrouds an additional mud-like crack pattern can be detected at the gas path surface behind the second row of cooling holes. The cracks near the cooling holes are more easily explained since finite element calculations show that at these locations the highest principle tensile stresses occur. In this respect it is noted that the CoNiCrAlY rub coatings are very thick (> 1 mm), i.e. much thicker than the MCrAlY coatings normally employed on turbine blades (~ 150 μ m thick). In such thick coatings, cracking and spallation is more easily promoted, in particular if thermal expansion differences exist between the coating material and the single crystal superalloy substrate. An explanation for the mud-like cracking pattern behind the second row of cooling holes is currently lacking, but the formation of these cracks may be associated with rubbing (Fig. 17a).

1st stage René N5 CF6-80C2 HPT shrouds with a TDC rub coat show similar crack patterns as those observed for René N5 CFM56-5C shrouds with a TDC rub coat (Figs. 17c and d). However, apart from the cracking, the rub coat surface in the CF6-80C2 shrouds also seems to be attacked by oxidation and or corrosion (as apparent from the greenish discoloration at the surface of these shrouds in the rub area). Since no cross-sections have yet been prepared for

Fig. 17: Surface macrographs of ex-service René N5 shrouds with an external TDC rub coating. (a,b) CFM56-5C HPT shrouds; (c,d) 1st stage CF6-80C2 HPT shrouds.

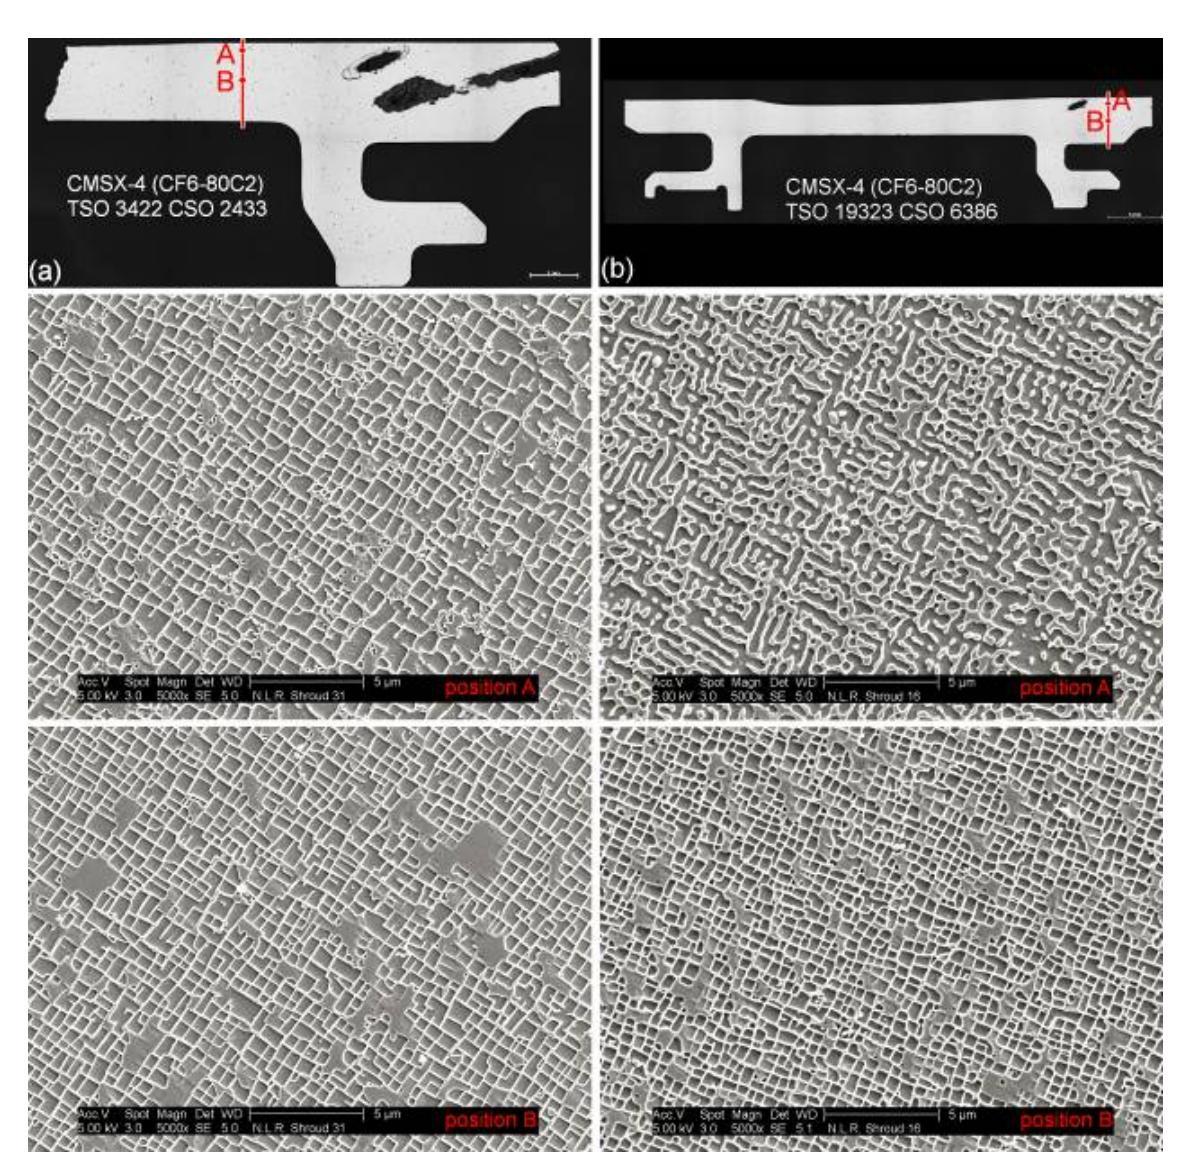
Apart from visible damage, almost all investigated single crystal superalloy shrouds experienced non-visible damage in the form of microstructure degradation (Fig. 18). This microstructure degradation was either in the form of the coarsening of the original γ' cuboidal microstructure (Fig. 18a) or more severely by the formation of a plate-like γ' microstructure due to coarsening and coalescence of the original γ' cuboids (Fig. 18b). Strongly directional γ' coarsening (i.e. rafting), which is frequently observed as the main form of microstructure degradation in turbine blades, has not yet been detected within HPT shroud cross-sections. Particle coalescence has been observed in CMSX-4, René N5 and N2 shrouds in the CFM56-5C, CF6-80C2 and the CF6-50 engines, indicating that this is a common form of microstructure degradation in HPT shrouds. However, the microstructural degraded area is normally confined only to a small region just below the gas path surface. Further into the interior of the shroud, the original microstructure is retained (Fig. 18). Since the microstructural degraded area is relatively thin, it is usually removed away by grinding during repair.

Fig. 18: Scanning electron micrographs of the microstructure in two ex-service CMSX-4 1st stage CF6-80C2 HPT shrouds at two positions (A) and (B) below the gas path surface.
