Fatigue initiation and crack growth behaviour in GLARE from the Airbus MegaLiner Barrel test

Teardown fractography of a GLARE window panel (F4) from the Airbus MegaLiner Barrel (MLB) fatigue test.

Report no. NLR-TP-2006-276

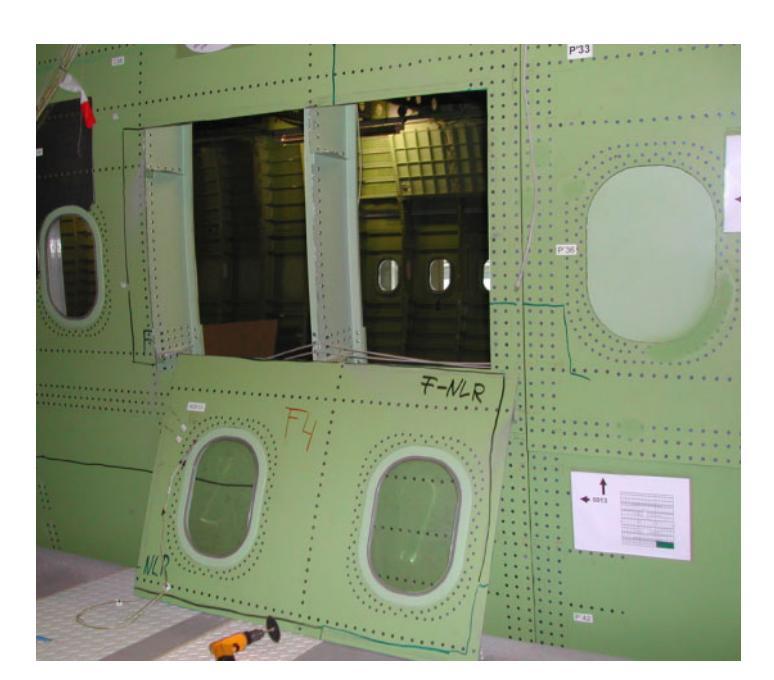
Fig. 1 GLARE window area cut from the MLB

Figure 1 shows the GLARE window area after its removal from the MLB. The windows are A340 shape rather than the A380 elliptical ones. This difference is unimportant for the present work. This window area was in the lower row of starboard windows, midway along the MLB. The basic structure is a GLARE 3-7/6-0.3/0.4 skin fastened to die forged 7175-T73 aluminium window frames by press fit 3/16" (4.76mm) Hi-Loks. The GLARE code means seven 2024-T3 aluminium layers 0.3mm thick (five inner layers) or 0.4mm thick (two outer layers), interleaved with six glass fibre layers.

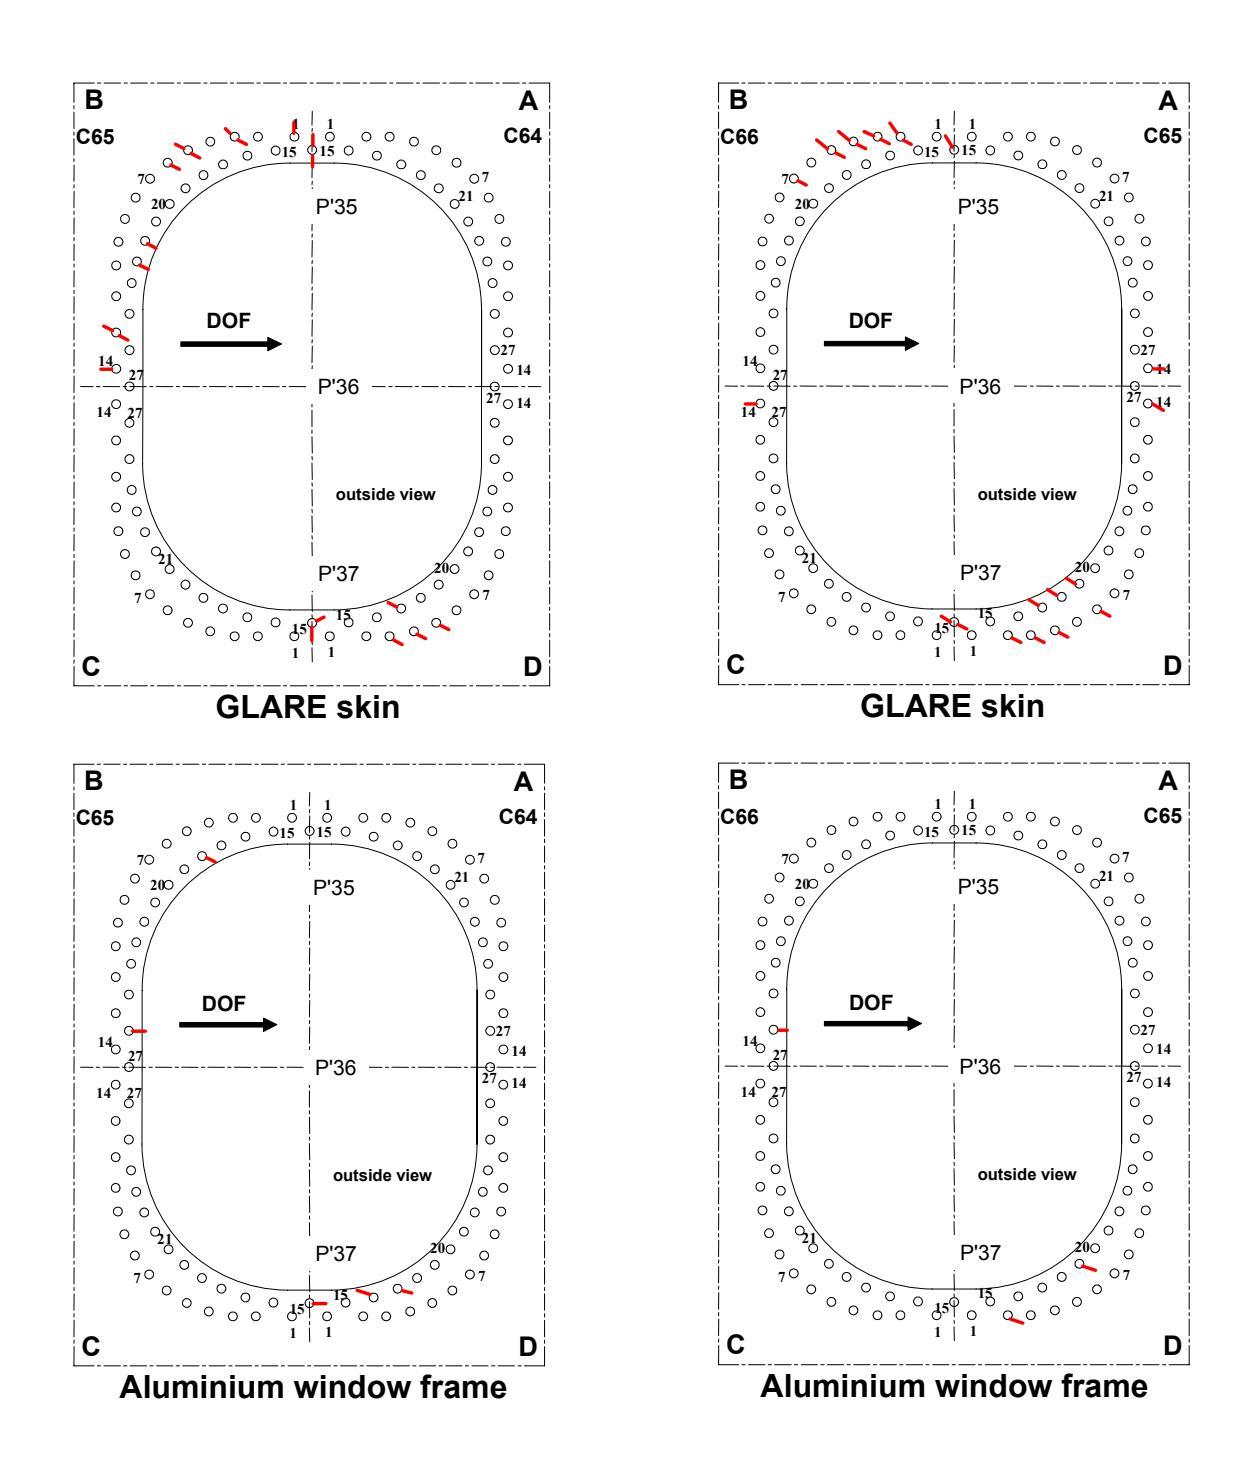
Fig. 2. Overviews of the crack indications from NDI of the fully disassembled GLARE skin and aluminium window frames. **DOF =** Direction Of (simulated) Flight

Figure 2 gives an overview of the NDI results after fastener removal and separation of the GLARE skin and aluminium window frame. These results were obtained from eddy current pencil probe rotor inspections of the fastener hole bores. The GLARE contained many more crack indications than the window frames, mostly in the **B** and **D** quadrants. These were the quadrants largely subjected to shear loads during the MLB fatigue test.

The largest crack in the aluminium window frames was at fastener hole D19 in window area C65-C66, see figure 2. This crack was quarter-elliptical with length 1.68mm normal to the fastener hole bore. This direction was selected for fractographic analysis.

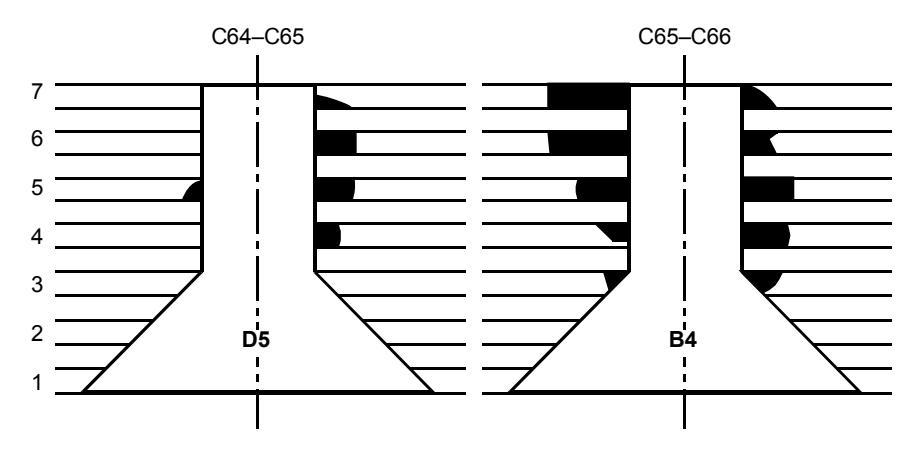
Fig. 4 Examples of GLARE cracking

Figure 4 gives representative examples of the cracking patterns in the aluminium layers of the GLARE skin. Most cracks were in the fastener hole bores, the largest mainly in layer 5. Only a few cracks grew from the countersinks, and only in layer 3.

The R.H. example in figure 4 shows the fastener hole (B4, C65-C66) with the largest GLARE cracks. These were 0.91 and 0.95mm long. The crack in layer 6 was selected for detailed fractography.

The smaller cracks in figure 4 show that they began from one or both corners of an aluminium layer. This was also the case for all the other cracked fastener holes in the GLARE skin. Thus the most likely causes of fatigue crack initiation, besides the severity of the applied fatigue load spectrum, are the stress concentrations provided by these corners.

However, this does not explain why many more cracks began in the fastener hole bores (layers 4 - 7) rather than in the countersinks (layers 1 - 3), where there are so-called "knife edges". It is possible that local secondary bending favoured fatigue initiation in the fastener hole bores. Support for this possibility comes from the window frame cracks. These were all corner cracks with maximum dimensions along the fastener hole bores.

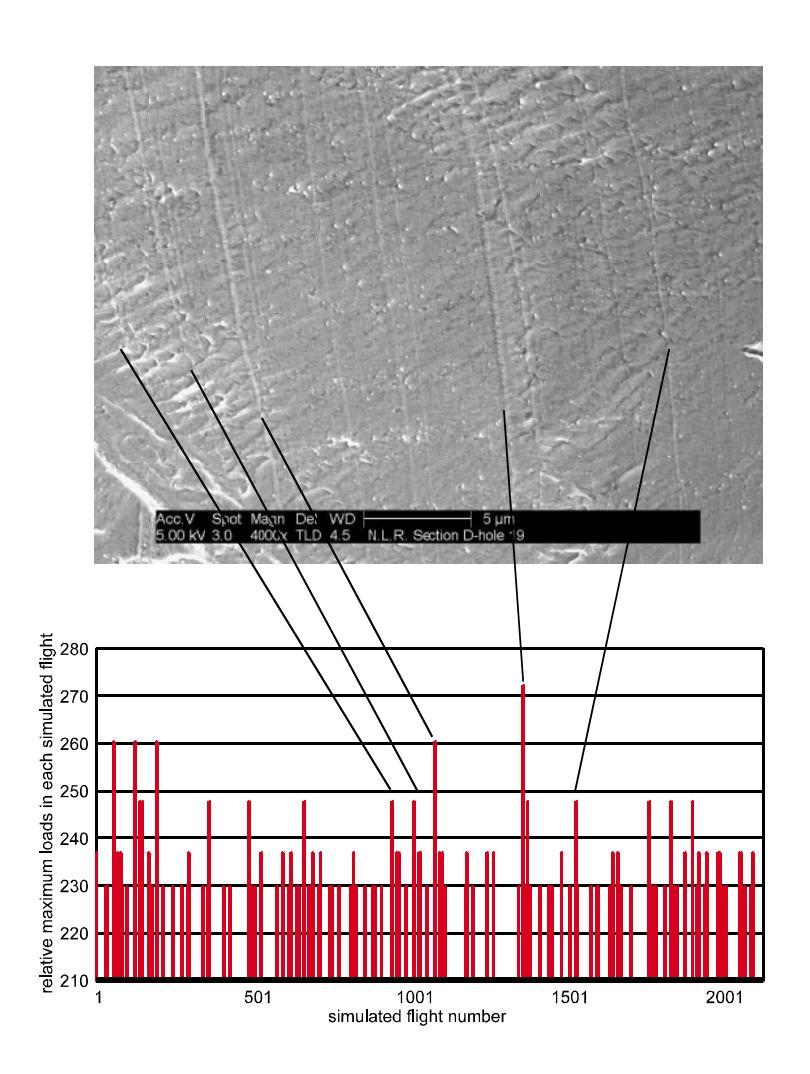
Fig. 5 Example identification of severe flights from crack front markings by peak loads

Figure 5 gives an example of identifying the severe simulated flights, notably flight types **A**, **B** and **C**. The crack front markings from these flights were mostly sufficient for tracing fatigue crack growth back to a small crack length. However, the fainter crack front markings from **D** type flights helped in checking the numbering of **B** and **C** type flights. In general, the fractographic "readability" was excellent.

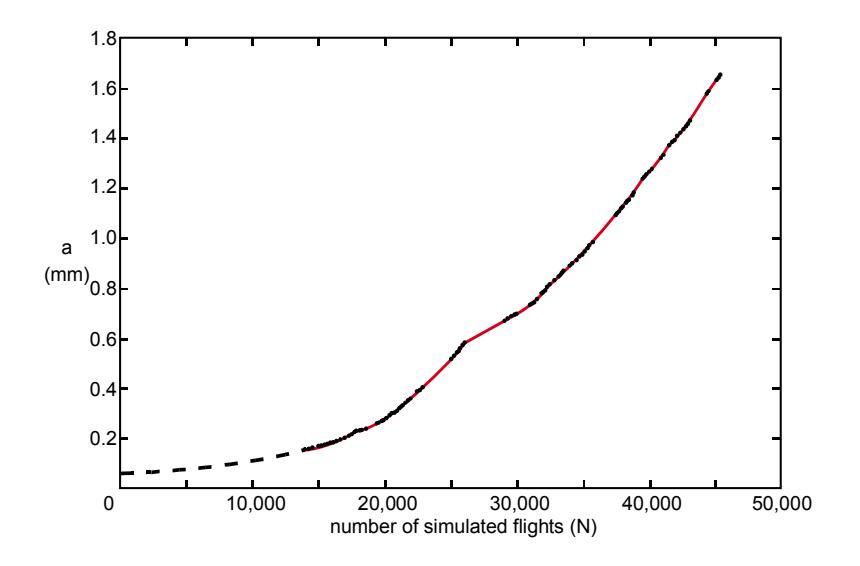
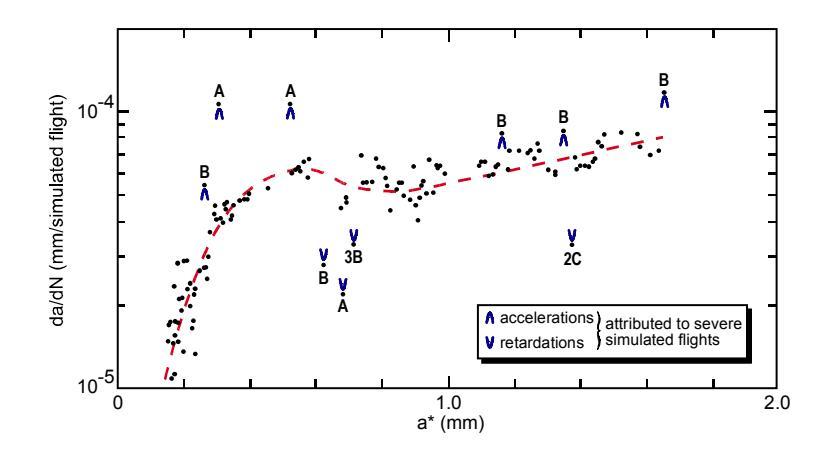
Fig. 6 Window frame crack analysis

Figures 6a and 6b show the curves of a *versus* N and da/dN *versus* a*, respectively. Both show the effects of severe simulated flights, pointed out explicitly in figure 6b. Most of these effects appeared to be transient. However, beginning at a crack length of about 0.6mm there was a persistent retardation of fatigue crack growth. This could be due to termination of the "short crack effect". This effect is well known, and is generally attributed to no fatigue crack grew beyond 0.5mm, closure-induced retardation due to peak loads in severe simulated flights would have become possible.

The a *versus* N curve in figure 6a suggests that the fatigue "initiation" life was zero, and that there was an initial crack size of about 0.06mm. In fact, the crack initiated from a fretting scar due to fastener movement against the bore of the fastener hole [2]. This explains the effectively zero fatigue "initiation" life [3] and also the indication of an initial crack size, which was most likely due to the fretting scar.

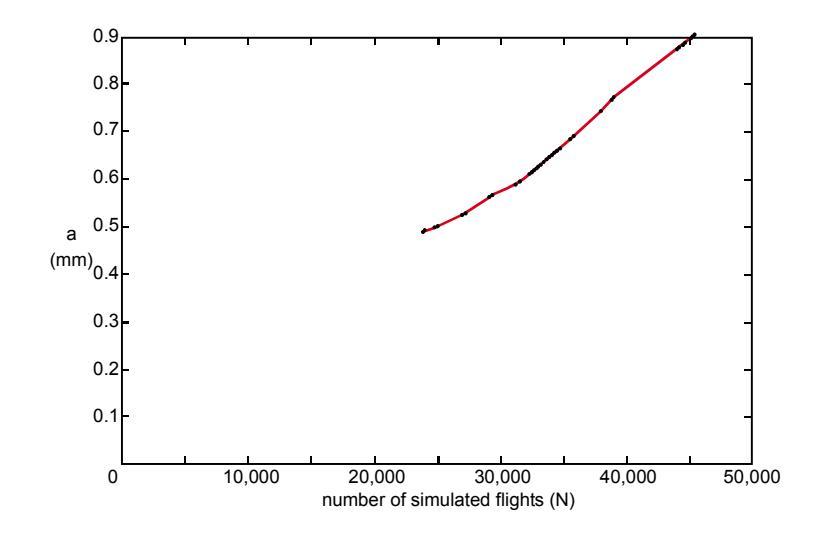
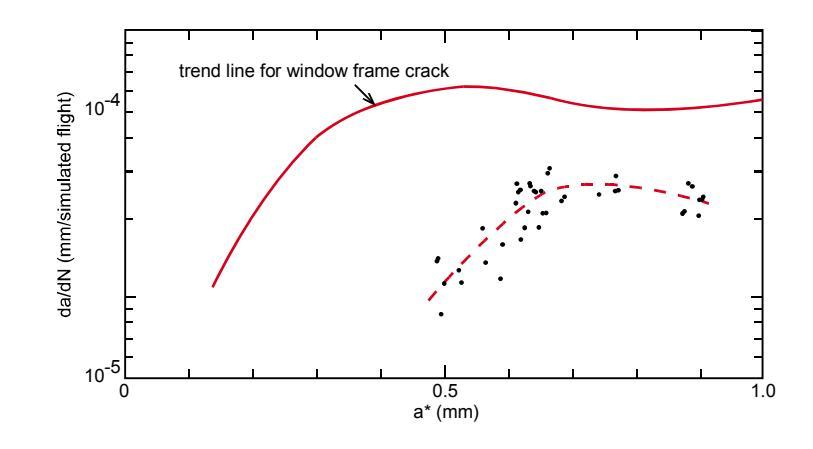
Fig. 7 GLARE crack analysis

As stated in subsection **4.2**, the selected crack was in aluminium layer 6 of fastener hole B4 in window area C65-C66. Figure 7 presents the same types of crack growth curves as those for the window frame crack. The data are limited, but enough to show a growth rate "plateau" at about 50% of that for the aluminium window frame.

Back-extrapolation of the a *versus* N curve in figure 7a is unfeasible, owing to the limited data. The crack could not be traced back to less than 0.45mm, owing to too closely-spaced crack front markers. Hence an estimation of the fatigue "initiation" life is not possible.
