NLR-TP-2017-061 | April 2017

# Modal Strain Energy Based Structural Health Monitoring Validation on Rib Stiffened Composite Panels

CUSTOMER: Defence Materiel Organisation

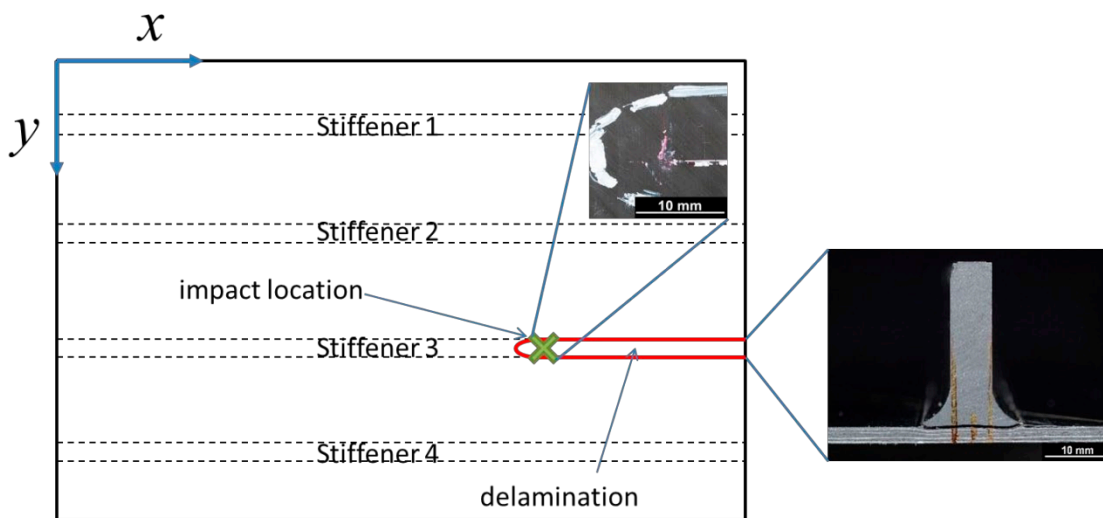
Figure 3: Schematic drawing of the rib-stiffened panel. Delamination size and location are similar to both panels

where  $EI_y$  stands for bending rigidity in  $y$ -direction (see Figure 1 and 3 for the sign convention),  $U_i^{(n)}$ ,  $u_z^{(n)}$  and  $\gamma_i^{(n)}$  stand for the strain energy, displacement in  $z$ -direction at the element  $i$  and the right-hand side  $n^{\text{th}}$  mode shape integral respectively. Assuming that the beam can be divided in  $N$  elements,  $U_i^{(n)}$  is calculated for each element. By dividing each  $U_i^{(n)}$  over the total sum of the modal strain energy in the beam, the ratio of the fractional modal strain energy can be extracted. The DI is extracted by comparing the fractional modal strain energy for each element and mode shape before and after impact loading is applied to the structure:

Panel 5565 and 5567 have been subjected to a single impact load each. The panels were clamped on four edge sides, while stiffeners were kept unsupported such that a typical aircraft skin-stiffener condition is created. The impact was applied on the skin side, directly underneath stiffener 3, see Figure 3. The impact was applied with a hemispherical metallic head with a diameter of 12.7 mm and a mass of 2.267 kg. The impact location on both panels is identical:  $x = 450$  mm and  $y = 250$  mm. The impact energies on panel 5565 and 5567 were registered to be 17.8 and 13.7 J respectively. Nondestructive inspection with an ultrasonic probe revealed that both impacts have caused a similar delamination at the skin stiffener connection. The impact loading on the outer skin side has caused no visible damage from the outside. However, skin stiffener connection is deteriorated significantly over a length of 150 mm, see Figure 3.

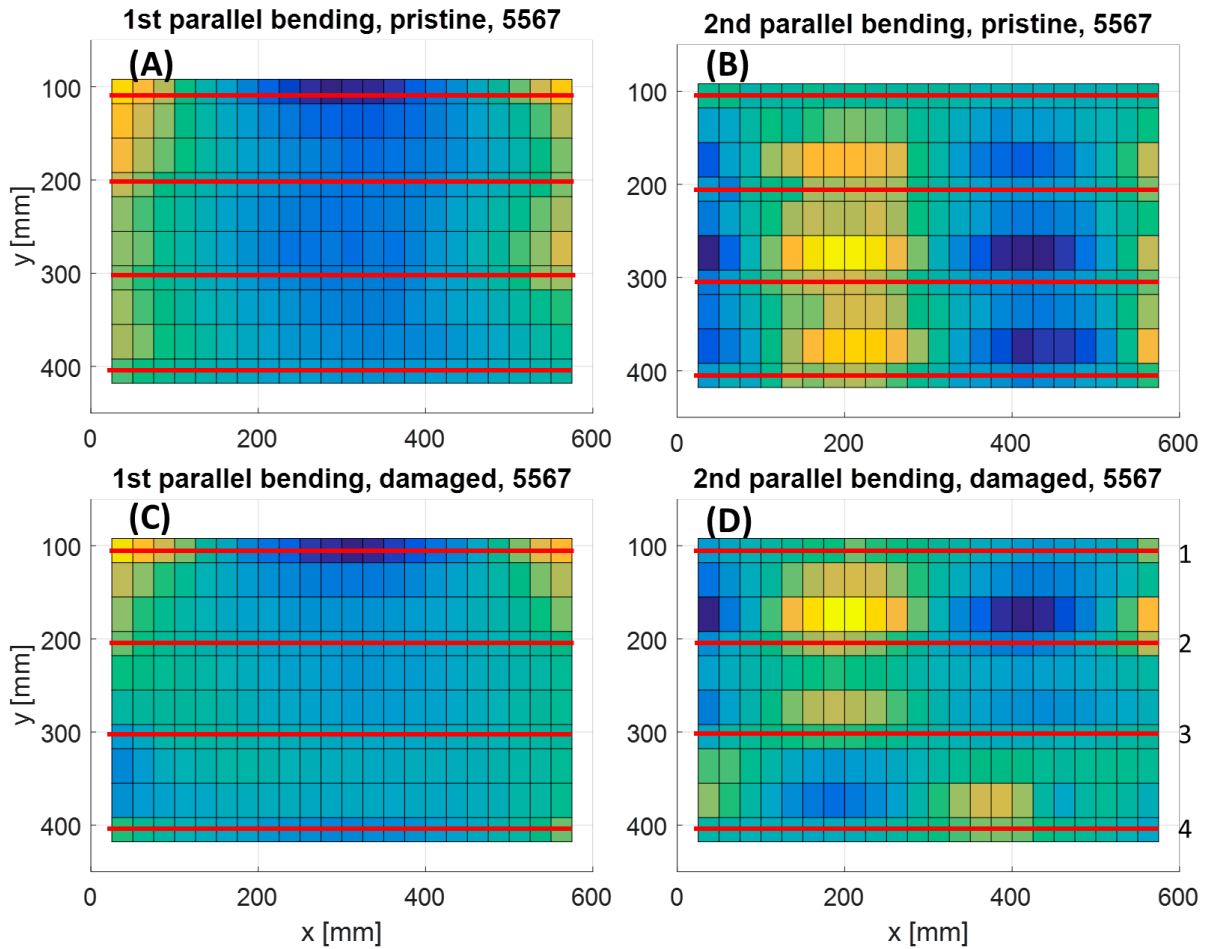
Figure 5: ODS of the plate 5567, relevant for the parallel bending moment mode shapes. (A) and (C) represent 1st bending moment before and after the impact damage respectively, (B) and (D) represent 2nd bending moment before and after the impact

Figure 5 and 6 present the ODS of the panel 5567 indicating the first two parallel bending modes and the calculated MSE-DI for both panel 5565 and 5567 respectively. Notice that some natural frequencies could not be determined properly. Furthermore, the natural frequency of 1st parallel bending mode seems to have gone up after the damage. This mode may have been influenced by different boundary condition caused by the different tension in the elastic chord suspension.

According to Ooijevaar et. al [9], the mode shapes that are most sensitive to the skin stiffener delamination are the bending modes in the direction of the stiffeners. Therefore, the bending modes parallel to the stiffeners are used to calculate the damage indices. However, this panel is, compared to the work of Ooijevaar et. al., much stiffer, due to both skin thickness and stiffeners dimensions. This causes small displacements of the relevant mode shapes, resulting in limited measurements of the mode shapes.

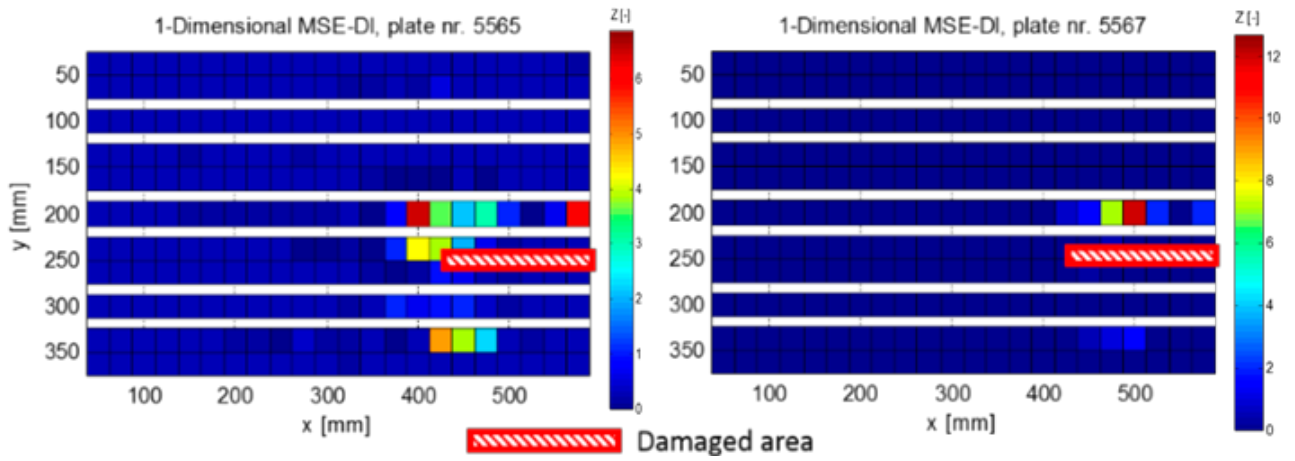
Figure 6: MSE-DI extracted from panel 5565 and 5567

Figure 6 shows that damage has been detected successfully on both panels, although the peaks appear at different locations, indicating inaccurate damage localization. The highest normalized damage index is found adjacent to the damaged area between stiffener 2 and 3. However, a number of additional peaks in the MSE-DI appeared in panel 5565, despite the impact being applied at the same location. The modal strain energy is based on the second order spatial derivative of the mode shapes and therefore is even more inaccurate. The limited number of measured ODS has contributed even more to the inaccuracy.
