Braking Capabilities on Flooded Runways: Flight Test Results Obtained with a Business Jet

NLR - Netherlands Aerospace Centre, P.O. Box 90502, 1006 BM Amsterdam, The Netherlands

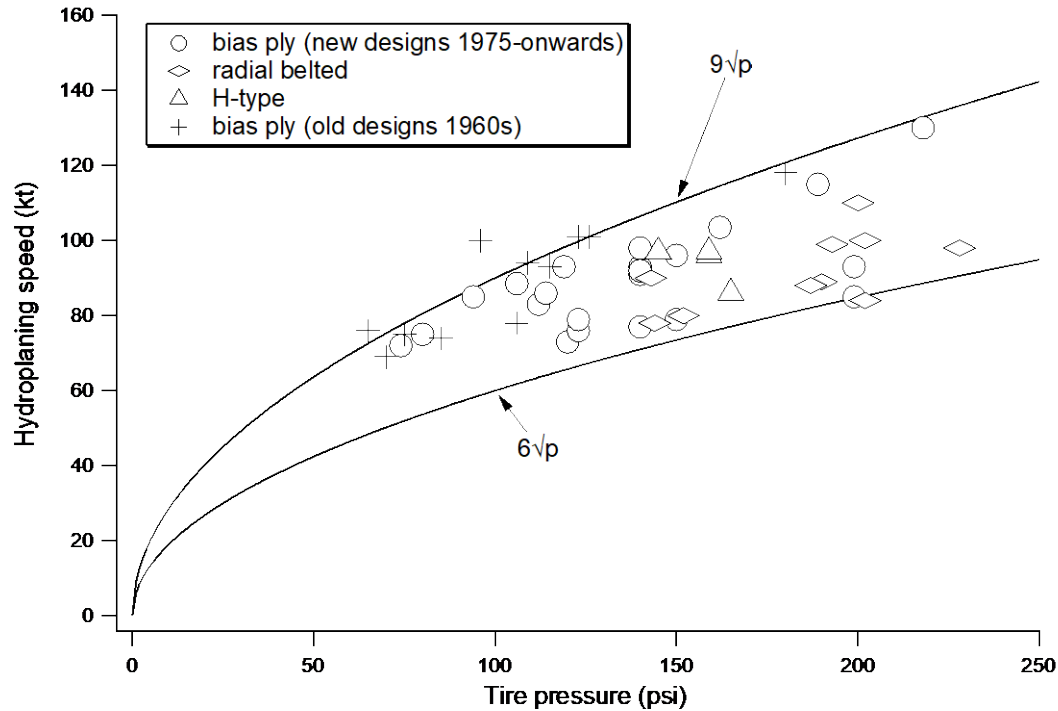
Figure 2: Dynamic hydroplaning speeds for different aircraft tyres as function of inflation pressure (mainly obtained from unpublished full scale aircraft tests¹).

As shown in Figure 2, the classic NASA formula for predicting the full dynamic hydroplaning speed under spin-down conditions², $9\sqrt{p}$, over-predicts the hydroplaning speed for modern aircraft tyres. This was already anticipated by some aircraft manufacturers which used a modified version of the classical dynamic hydroplaning equation for performance calculations during the late 70s. Following the simple NASA relation the available full scale experimental data suggest that a modern bias ply tyre would hydroplane (dynamically) on a well flooded runway at around $8.5\sqrt{p}$, a H-type tyre at around $7.5\sqrt{p}$ and a radial tyre at around $6.9\sqrt{p}$, with the speed in knots and p in psi ¹. These relations can be used for a first estimation of the spin-down dynamic hydroplaning speed in absence of experimental data.

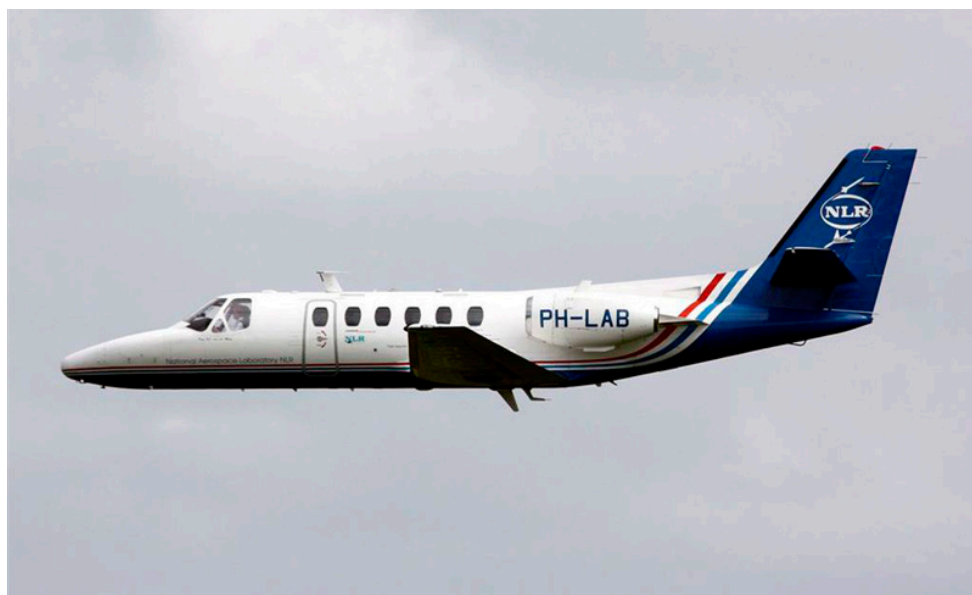
Figure 4: NLR Cessna Citation test aircraft.

The research aircraft of NLR, a Cessna Citation II, was used for the flight test programme described in this paper (see Figure 4). Originally designed for executive travel, the Cessna Citation II aircraft (registration PH-LAB) has been extensively modified by NLR to serve as a versatile research and test platform. The aircraft has two Pratt & Whitney JT15D-4 turbofan engines each rated 2,500 pounds of thrust. The aircraft is equipped with a fully modulating anti-skid braking system. The system detects incipient skids by using a wheel speed transducer to measure the deceleration of each landing wheel, and then prevents skids by reducing the brake pressure in proportion to the deviation of each wheel from normal braking deceleration. The system modulates brake pressure to maximize braking efficiency. The left and right wheel brakes are hydraulically operated by independent master cylinders attached to the pilot's and co-pilot's rudder pedals. The brake system is pressurised when either pilot depresses the toe pedals. Interconnect assemblies allow either pilot to operate the brakes with equal authority. The single-wheel main gear used 22 × 8, 24 P.R., type VII aircraft tyres. The tyre inflation pressures were 115 psi for the main-gear tyres and maintained within ±5 psi throughout the course of the test programme. The main gear tyres as well as the brake units were not new. The left hand tyre had a tread depth of 5.2 mm at the start of the test programme and the right hand main gear tyre had a tread depth of 4.8 mm. When the tests were finished this had reduced to 5.1 and 4.6 mm respectively. The aircraft was configured for the Future Sky Safety Contaminated Runway campaign to enable measurement of lateral and longitudinal acceleration, wheel speed rotation by using the aircrafts anti-skid system and pressure in the low pressure pilot brake system. The aircraft was operated by NLR flight crews.

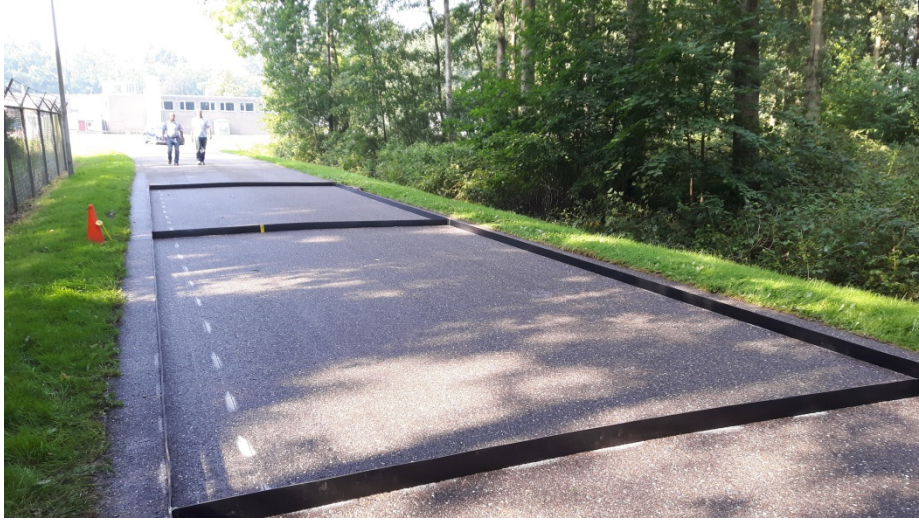
Figure 6: Test water pond.

The runway at Twente did not have a water pond facility at the start of the project. This facility had to be constructed. A classical water pond consists of series of grooves into which flexible rubber strips are put to form dikes. To gain some experience with such a setup, a small test pond was constructed at the NLR premises before making one at Twente airport. This water pond measured 4 by 10 m and is shown in Figure 6 (empty). The test pond was filled to several water levels. Experiences were gained in grooving, fixing the rubber strips into the grooves, measuring of water depths and managing leakage of the pond.

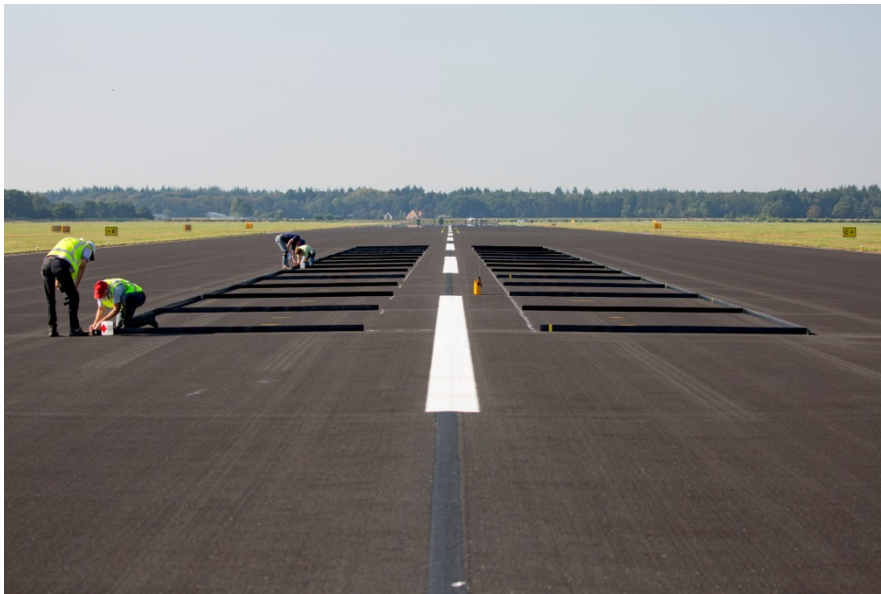
Figure 7: Water pond at Twente airport.

After positive experiences gained with the test water pond it was decided to construct a water pond at the flight test location. The runway at Twente airport has a very consistent longitudinal slope of 0.2% along the runway. Likewise the cross slope is also very consistent along the runway being 0.6-0.8% at the runway centreline and 1.5-1.6% further away from the centreline. The longitudinal slope required that several rubber cross dams had to be constructed to get reasonable consistent water levels in the water pond. These cross dams were placed every 7.7 m to form 13 separate sections. The final water pond on the test runway is shown in Figure 7. As the aim of the flight tests is to analyse braking performance it was not necessary to have the nosewheel running through the water. Therefore no pond was construction for the nosewheel to run through. Keeping the centre part dry also provides additional controllability in case the aircraft deviates from its track during the test run.

The overall length of the water pond was 100 m. This is sufficient long to obtain useful test data. Braked tests done by NASA used a water pond of similar length. The water pond starts 1.15 m from the centreline and stretches to 5 m from the centreline. The target average water depth in the water pond at the main wheels was set to 15 mm. Along each section the actual water depth will normally vary both in longitudinal as well as in lateral direction as the test section is not completely flat. However the main gear tyres should be exposed to target water depth when the

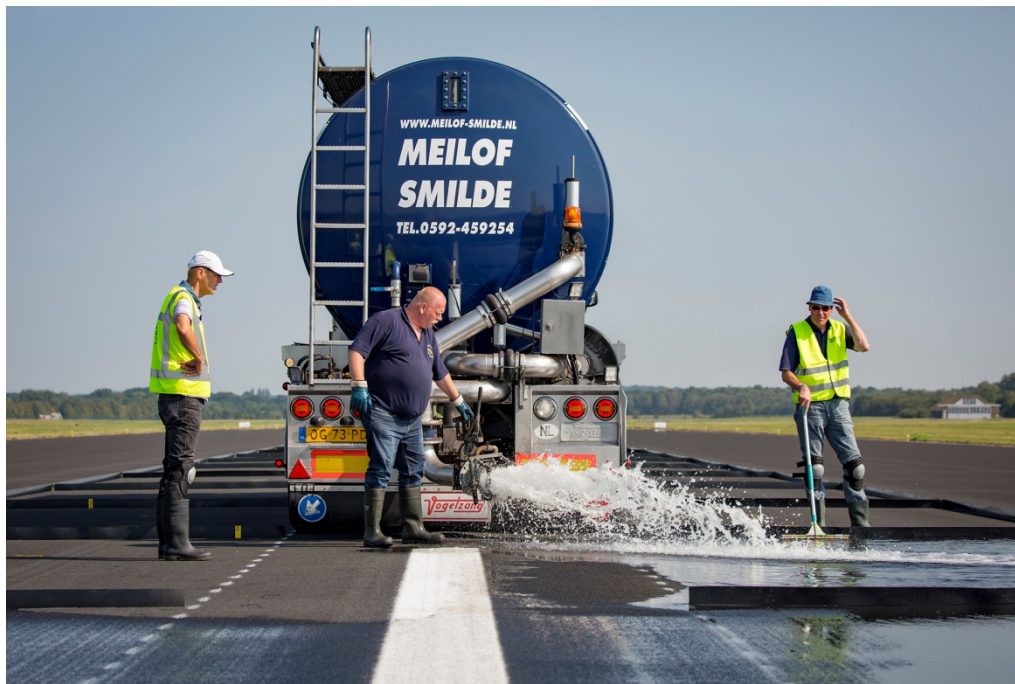
Figure 8: Filling of the water pond.

The water pond was filled to the target depth using water trucks as shown in Figure 8. Water depths were measured using a specially constructed wedge which is shown in Figure 9. Prior to each run water depth measurements were taken and recorded at pre-defined positions in each section of the water pond (see Figure 10). These positions matched the location of the main gear tyres. If the water depth was well off the target value, water was either removed from the section or added. High winds can make it difficult to maintain consistent water levels. Based on previous experiences with water pond testing a maximum wind speed of 12 kt. was defined for the test programme. Figure 11 and Figure 12 show the surface of the water pond under calm and light windy conditions. In order to minimise the influence of wind on the water depth measurements, a metal ring was placed around the water depth gauge as illustrated in Figure 13.

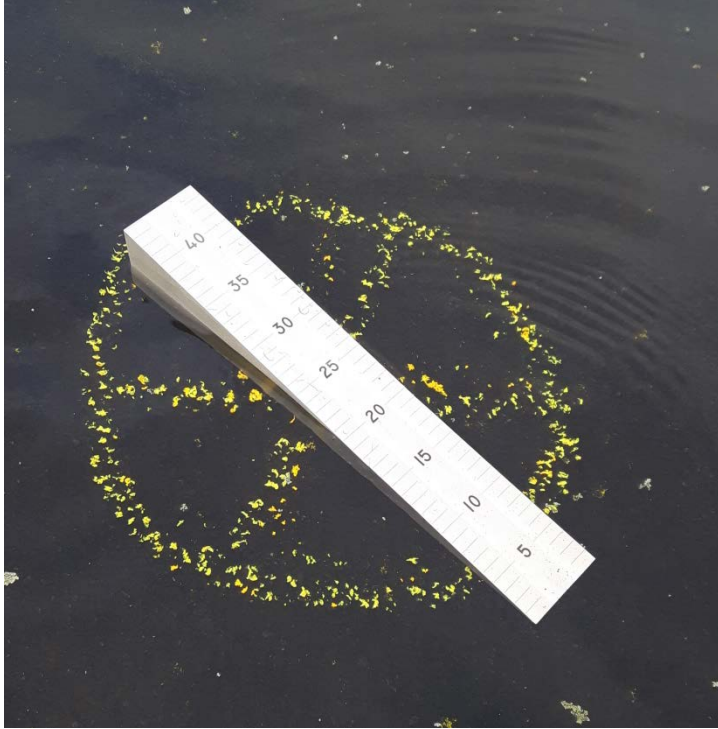
Figure 9: water depth gauge.

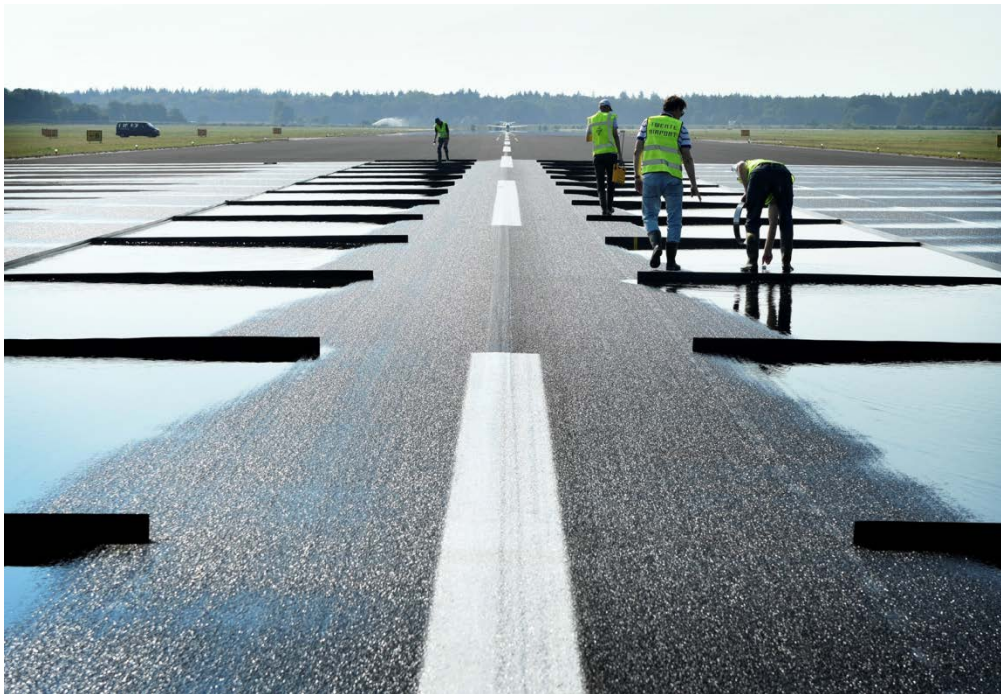
Figure 10: Example of measuring water depth level in each section.

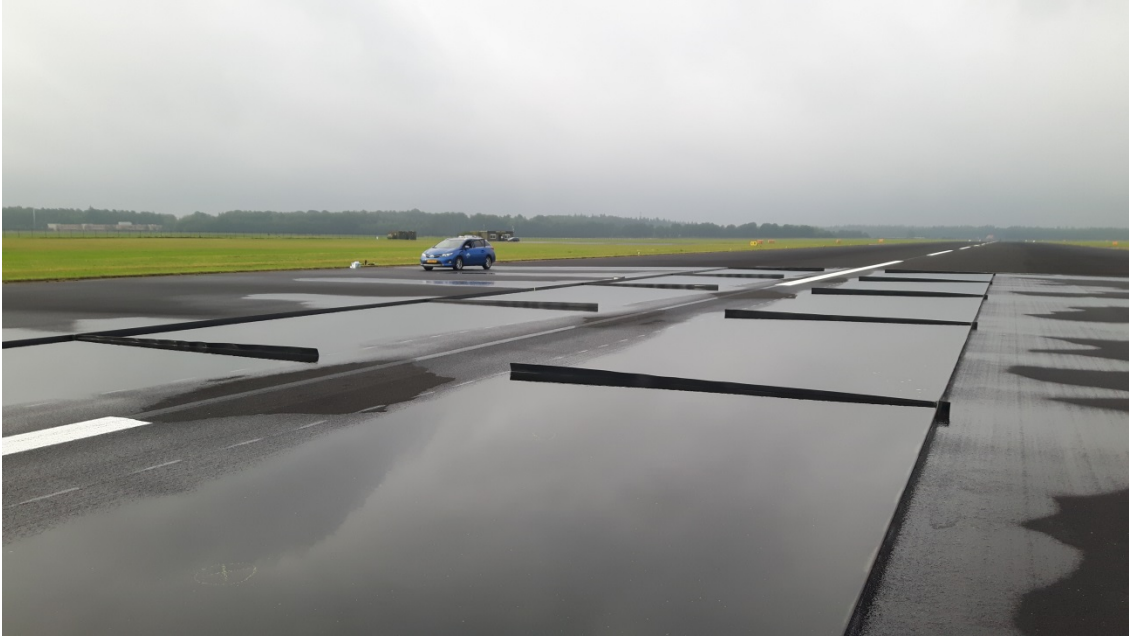
Figure 11: Water pond in calm wind conditions.

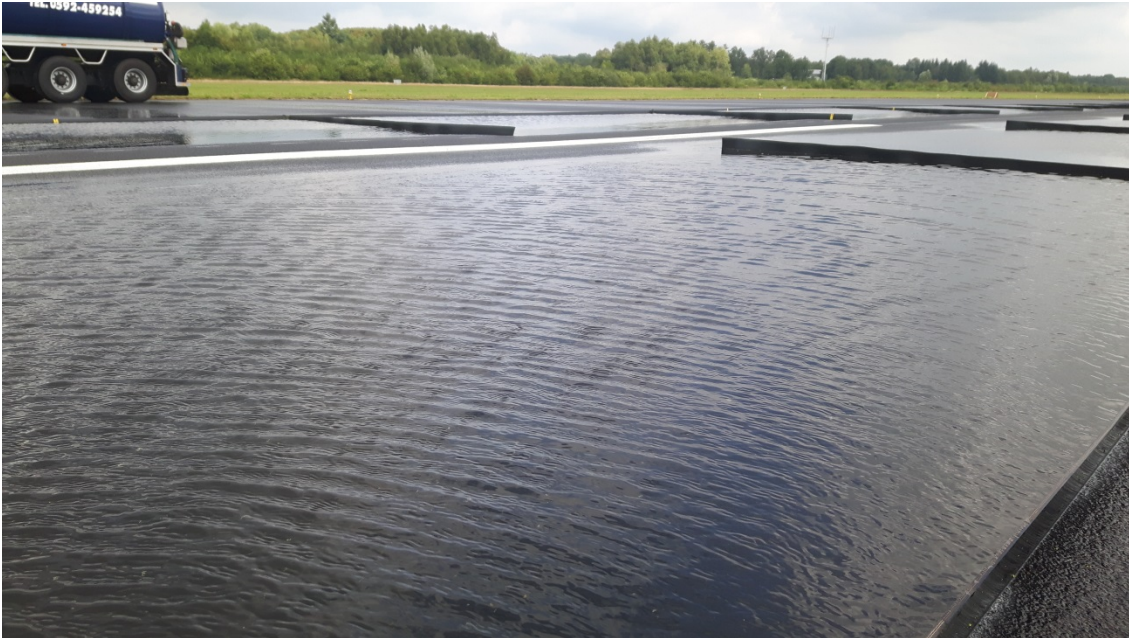
Figure 12: Water pond at 8 kt. wind.

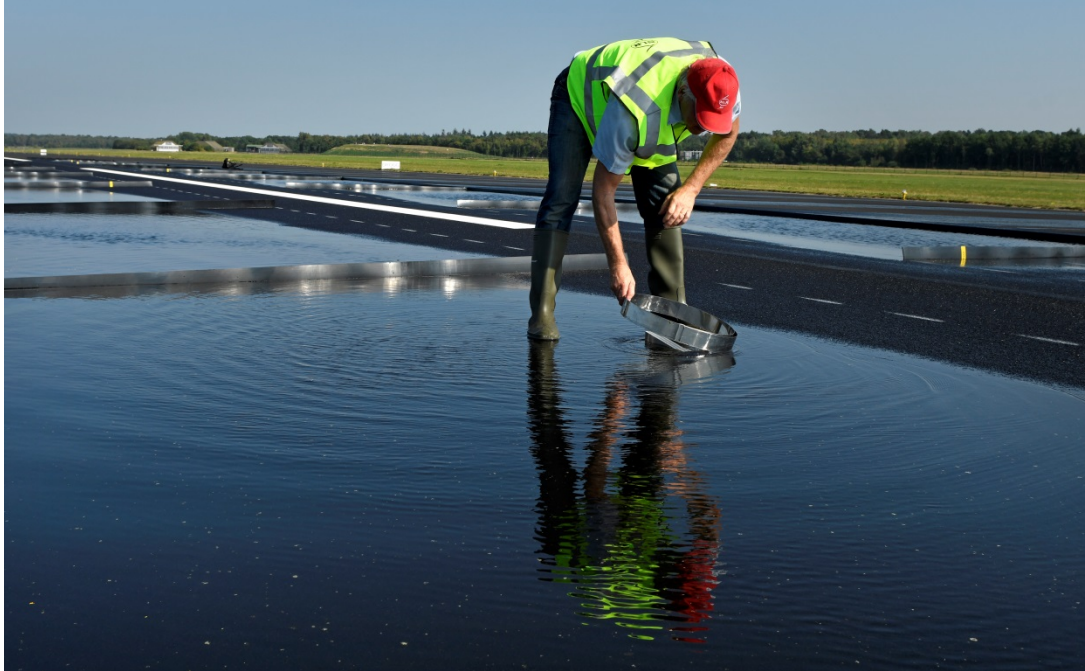
Figure 13: Measuring of water depth using a metal ring around the water depth gauge.

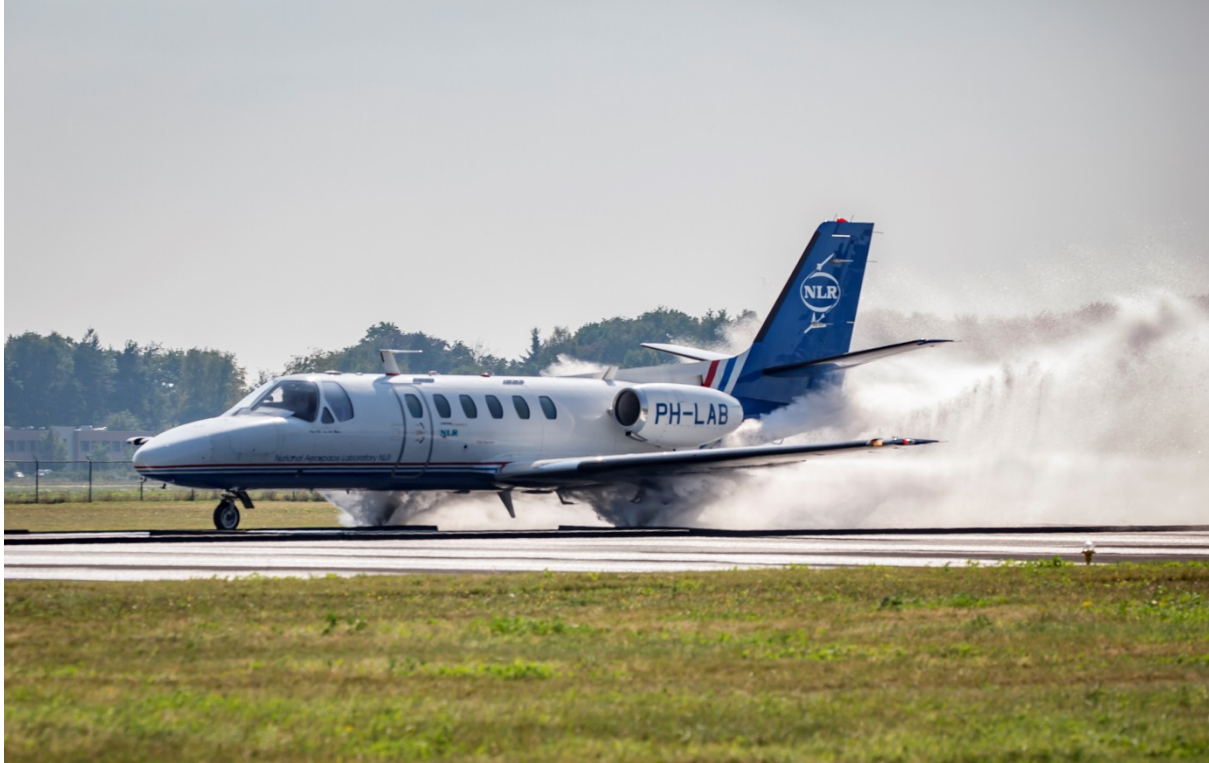
Figure 18: Cessna Citation test aircraft running through the water pond.

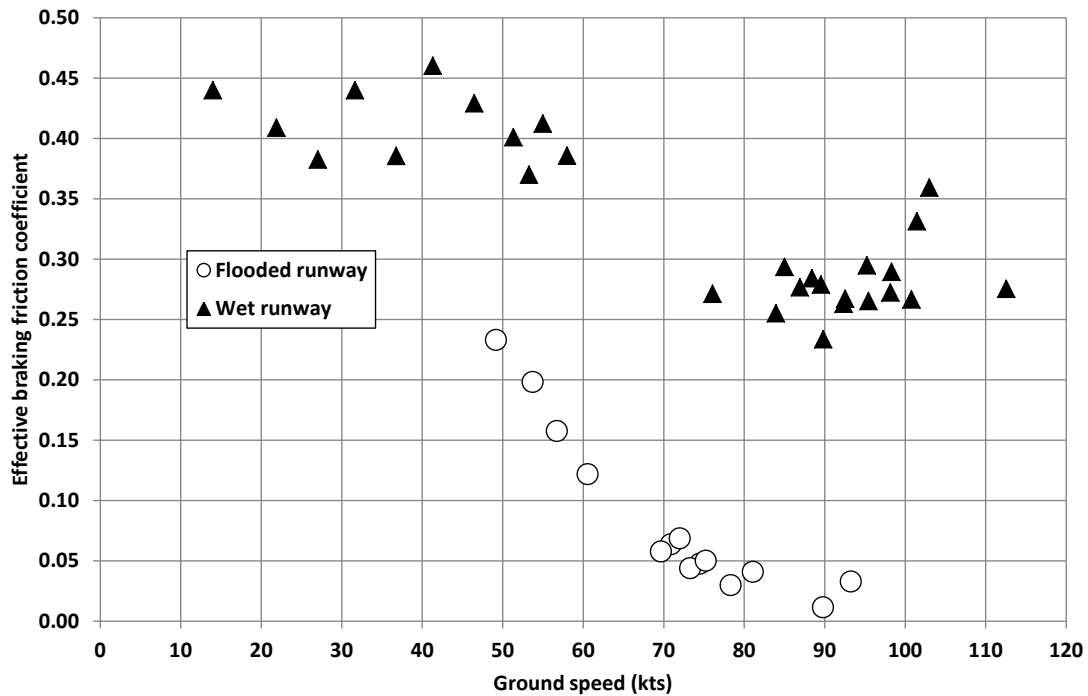
Figure 21: Comparison of wet and flooded runway braking capabilities of a Cessna Citation II.

The effective braking friction coefficients derived from the test data are shown in Figure 20 as function of ground speed. As clearly illustrated the braking friction coefficient rapidly reduced as ground speed increases. Above 80 Kt. only very low friction levels are found, similar to an icy runway. As part of a different project, the Cessna Citation was also tested on the same runway under wet conditions. The runway was artificially wetted for these tests and the water depths varied between 0.4-1.3 mm. Runways with a water depth up to 3 mm are considered to be wet. Figure 21 shows a comparison between the wet and flooded runway braking capabilities of the Cessna Citation II test aircraft. The impact of the flooded runway on the braking capabilities is significant. The dry runway effective braking friction coefficient of the Cessna Citation II test aircraft was determined from separate tests to be around 0.48 for ground speeds below 120 kt.

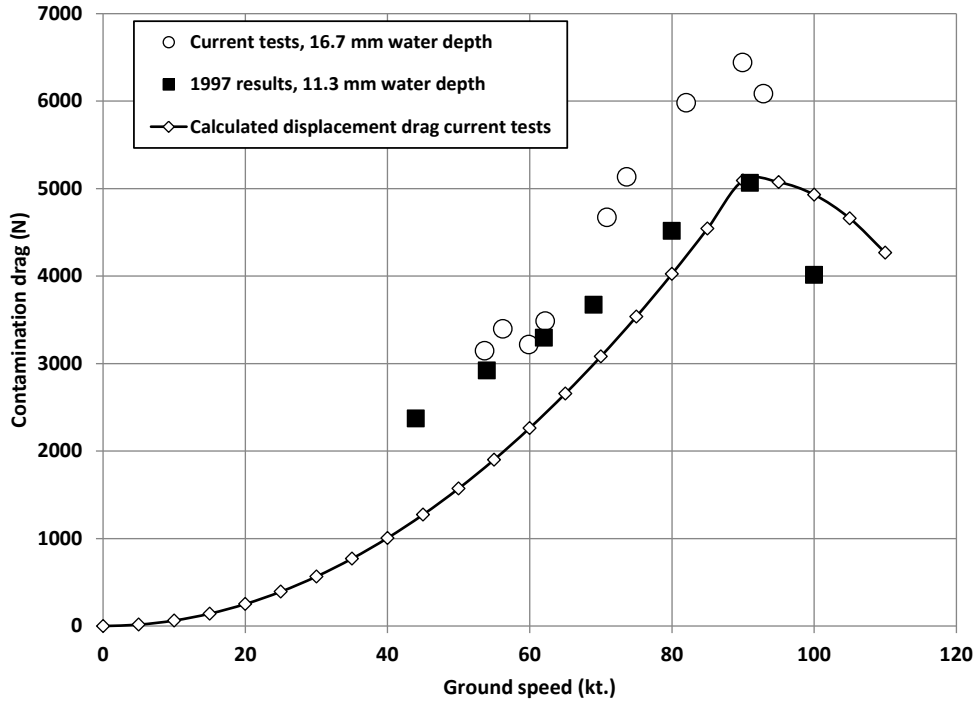
Figure 22: Comparison of contamination drag derived in the present test programme to earlier tests and predictions.

Figure 22 gives a comparison of the contamination drag for the main wheels derived in the present test programme to earlier tests conducted by NLR and EASA AMC 25.1591 model results. Note that the test aircraft in these previous tests had a slightly higher main gear tyre inflation pressure then in the present tests. As shown in Figure 22 the predicted water contamination drag is somewhat lower than measured. This is caused by the impingement drag which is not accounted for in the model. In particular the bow wave causes additional drag from the forward spray hitting the airframe (mainly the wing in case of the Cessna Citation test aircraft, see Figure 23). In front of the tyres a bow shaped wave front can develop at speeds greater than the surface wave as water builds up ahead of the tyre, ejecting a spray in forward and upward direction. The drag on the airframe by the forward spray depends upon where in the trajectory of the forward spray the aircraft catches up with the spray. If this occurs near the maximum height point of the trajectory then there would be a high impingement drag. However if this point is near the maximum forward point of the trajectory, hardly any impingement drag from the forward spray will be noticed. In case of the Citation test aircraft it is somewhere in between both of these extremes. Finally also some water sprayed backwards hit the wing and fuselage of the test aircraft causing additional impingement drag.

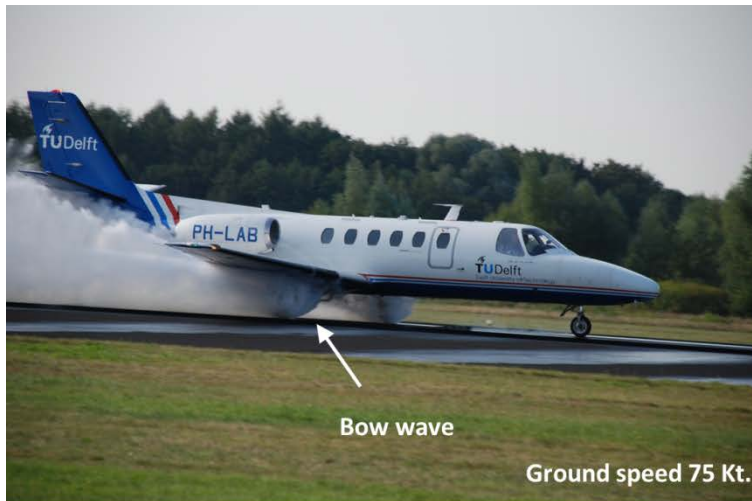
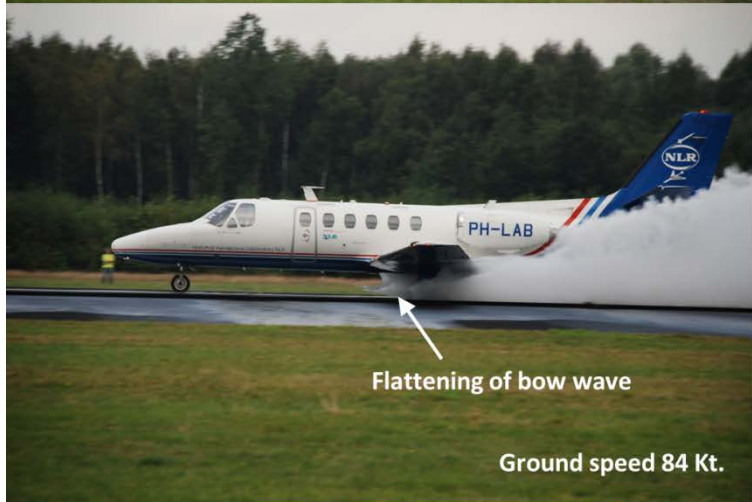
Figure 24: Bow wave development.

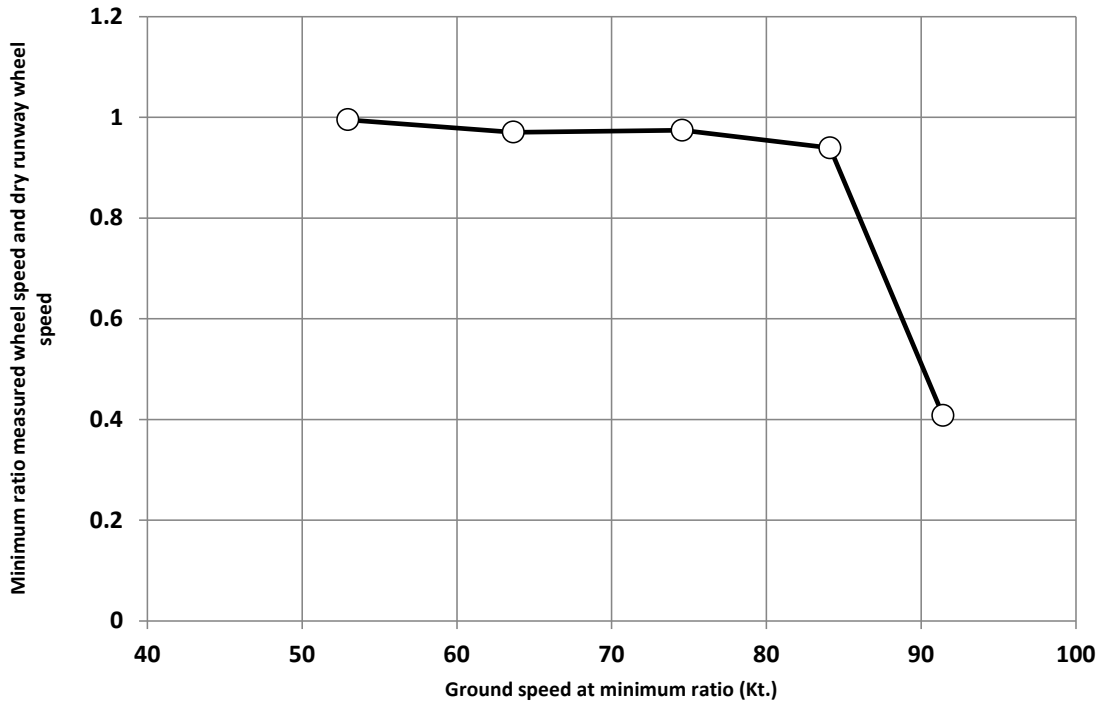
Figure 25: Minimum ratio between wheels speed in water pond and expected wheels speed on a dry surface as function of ground speed.

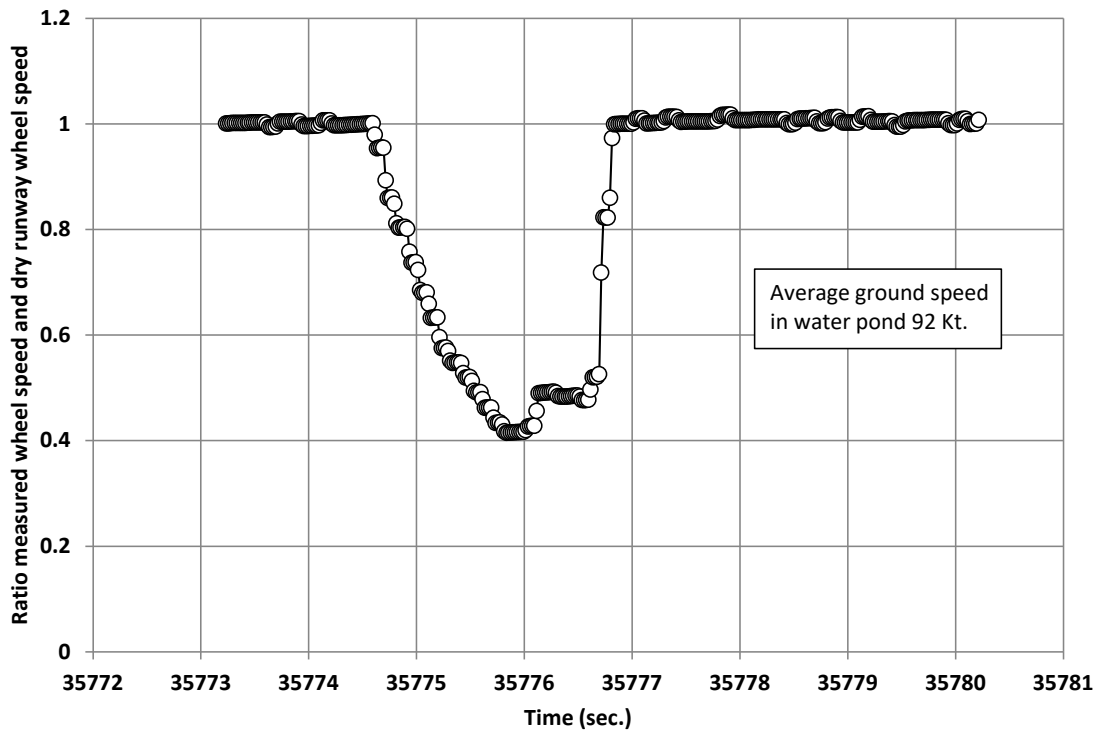
Figure 26: Relative wheel speed left main gear tyre.

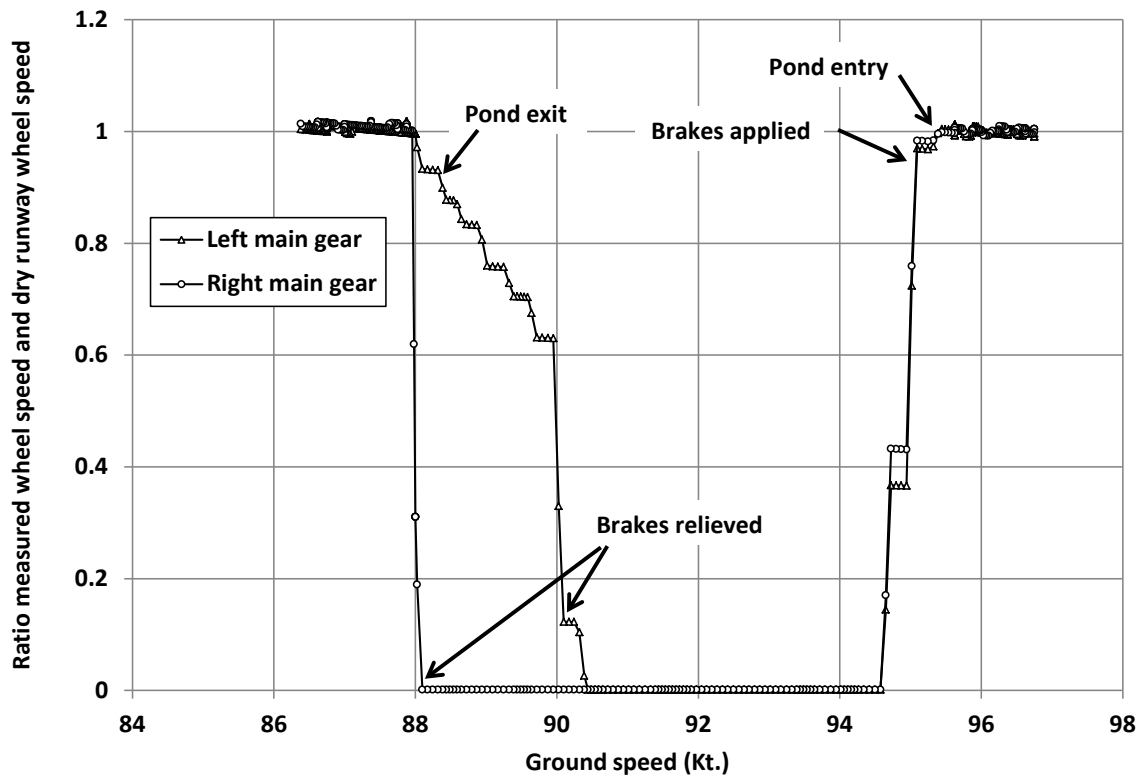
Figure 27: Relative wheel speed as function of ground speed when running through the water pond in a braked condition.

Braked runs cannot be used to estimate the hydroplaning speed of the Citation test aircraft as discussed next. However, they can provide insight in how the brake system functions in particular the anti-skid system. The anti-skid system is only active if the pilot meters a pressure in excess of that required to skid the tyre. The system then immediately reduces the braking level to minimise the depth and duration of the skid. This allows the wheel to spin back up, generating a reference speed for the anti-skid system. The anti-skid then immediately allows braking to re-apply at a lower level. The pressure will be allowed to gradually increase again until either another skid occurs or the pilot's metered pressure is achieved. The anti-skid does not apply pressure on the brakes, but only relieves it. This whole process is conducted at a very high frequency (typically 200 Hz), allowing the anti-skid to react quickly to changes in runway slipperiness. When brakes are applied during severe tyre hydroplaning, the anti-skid system may lose its reference speed as the wheels are not spun up. The wheels remain locked up until the pilot released the brake pedals. On some aircraft this problem is solved by using the groundspeed signals from the aircraft's inertial reference system as a backup wheel reference speed. On aircraft with a bogie main landing gear the rear wheels are used as a reference speed in preventing locked wheels conditions. The Cessna Citation II has a locked wheel crossover protection system installed. This prevents loss of aircraft control caused by unequal wheel rotation rates. When the anti-skid system detects that one main gear wheel is rotating 50% slower than the other, brake pressure to the slow wheel is dumped, allowing wheel speeds to equalise. The 50% tolerance between the wheel speeds is provided to permit an amount of differential braking, for steering purposes. Locked wheel crossover protection is functional at ground speeds greater than 40 knots on the test aircraft. This level of protection is not available if both wheels are locked. The full hydroplaning speed of the main gear tyres was estimated from unbraked runs to be 90 Kt. Just before this ground speed the wheels start to spin-down. If full brakes are then applied lockup of the wheels can occur. The locked wheel crossover protection system cannot prevent this from happening as the system will not detect that one main gear wheel is rotating 50% slower than the other as both are spinning down due to hydroplaning. This is illustrated in the wheel speed data shown in Figure 27 for ground speeds higher than the full hydroplaning speed. Just after entry of the water pond full brakes are applied. Immediately the wheel speeds drops to zero for both left and right main gear wheels. Only after relieving of the brakes the wheels start turning again. At lower ground speeds locked wheel conditions were not recorded. This means that the anti-skid system remained active.
