# Multiple load path damage detection with optical fiber Bragg grating sensors

REPORT NUMBER NLR-TP-2020-415

**AUTHOR(S)** F.P. Grooteman

**DATE**November 2020

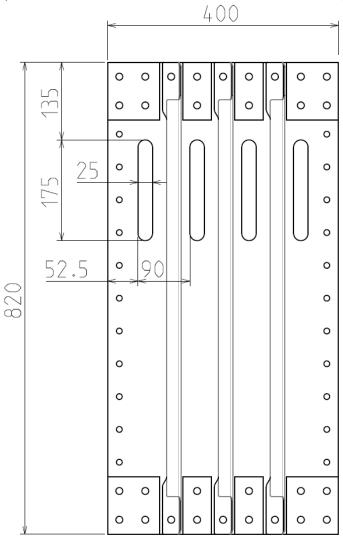
Figure 1: Stiffened aluminium panel

The selection of the sensor locations is demonstrated here for a box-shaped structure consisting of two similar aluminium (7075-T6) panels (400x820x2 mm) with 3 stiffeners each at a distance of 90 mm depicted in Figure 1 and Figure 4. Four slots (175x25 mm) were inserted in the upper half of each panel in between the stiffeners to create three, more individual, load paths. The structure has various similarities with a vertical tail plane or wing structure.

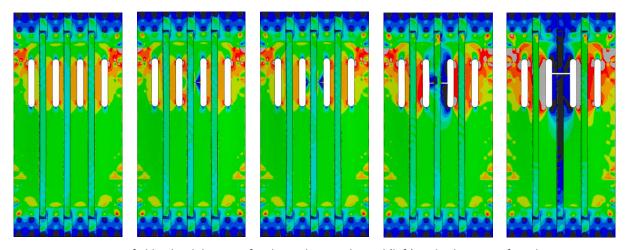
Figure 2: Strain field in load direction for the undamaged panel (left) and subsequent four damage states

A finite element model of the box-shaped structure was created in Abaqus to determine the number and positions of the FBG sensors. The finite element model consisted of 100544 nodes and 92546 linear elements and an artificial through crack was modelled half-way the width of the middle slot, as indicated in Figure 2. Here the best FBG orientation, in load direction, is obvious but this is more complicated for complex structures in geometry and loading and can be obtained from the finite element analysis as well. With the finite element model, strain fields for a unit load were computed for the undamaged panel and subsequently used to compute the strain variation over time for the given load time history, for the following four intermediate damage states, depicted in Figure 2:

- 1. Skin failure right of the centre stiffener (crack size 25 mm)
- 2. Skin failure left and right of the centre stiffener (crack size 25 + 32.5 mm)
- 3. Full skin failure under the centre stiffener (crack size 65 mm)
- 4. Fully broken centre stiffener, i.e. full load path failure (crack size 90 mm)

Figure 2 shows the obtained strain distribution in load direction for the four damage states, from which optimal strain sensor locations can be selected. One strain sensor was selected in load direction on both sides of each stiffener, 40 mm from the bottom end of the slot, see Figure 5. Additionally, one strain sensor was installed on the web of the centre stiffener. On the second undamaged panel only one strain sensor was selected on the right side of each stiffener, see Figure 6.

Figure 8: Artificial damage states in front panel centre load path, from top left (crack right of stringer) to bottom right (fully failed load path), see also Figure 2

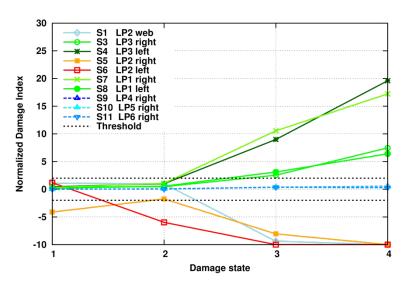
Figure 3: Normalized damage index versus the damage state obtained from FEM

From the computed strain fields, the unit load strains at the different strain locations were derived and multiplied with the actual time variation, representing the simulated local stress spectra at each location. Subsequently, these spectra were used to compute the normalized damage indicator *nDI* for each damage state, depicted in Figure 3. The sensors on the front panel (with damaged centre stiffener) are labelled S1 to S8 (note that S2 is missing to obtain the same labels as applied in the test) and on the rear panel S9 to S11. The value of *nDI* should be around zero when no

damage is present. This clearly is the case for the undamaged load paths in the rear panel monitored by S9, S10 and S11 (blue dashed lines) for all four damage states of the front panel. Also, for the first smallest damage state most strain sensors on the front panel show a nDI value around zero. The strain sensors in the damaged load path (S5 and S6) have a negative nDI value when the strain in this load path decreases due to an increasing damage. The sensors closest to the damaged load path (S4 and S7) show a strong increase in nDI due to a strain increase caused by load redistribution from the nearby damaged load path. An upper and lower threshold level of  $\pm 2.0$  standard deviations is set below or above which the normalized damage indicator convincingly indicates that damage is present. A standard deviation of  $\pm 2$  sigma away from the mean of the normalized damage indicator (eq 9) indicates a high probability of the presence of damage due to a significant loss of stiffness, to avoid falls calls and also to cope with (load or environmental) uncertainties in a real application, for instance noise.

At the first damage state, the damage index for S5 is already below threshold, because the strain level significantly drops at this damaged side of the stiffener. Some load is transferred to the skin on the other undamaged side causing some increase in the strain and damage index for S6 as well. At damage state 2, with a skin crack at both sides of the stringer, the strain in this load path decreases and both S5 and S6 yield a negative normalized damage index *nDI* at or below threshold indicating the damage. The strain and therefore *nDI* at S3, S4, S7 and S8 in the neighbouring load paths and S1 on the web of the centre stringer slightly increases due to some load transfer and yield a *nDI* around 1 not signalling the damage. At damage state 3, full skin failure, the strain and *nDI* at the sensors in the damaged load path (S5 and S6) further decreases and vice-verse increases in the neighbouring load paths (S4 and S7). At damage state 4, full load path failure, the *nDI* for S5 and S6 is -10, indicating full load path failure. The *nDI* for S4 and S7 has further increased.

In conclusion, from damage state 2, the damaged load path can correctly be identified by the sensor(s) in the load path, as well as from damage state 3 by the sensors in the neighbouring load paths, long before actual full load path failure. It should be noted that it takes a considerable amount of time (flights) to grow the damage from one state to the other, in which period there are many SHM inspection moments to detect the damage. From the finite element analyses, the damage size can be obtained for the *nDl* value for each of the sensors, i.e. each point in Figure 3, arriving at a level 3 SHM system. It suffices to have one sensor per load path, e.g. S3, S5, S7 or S4, S6, S8.

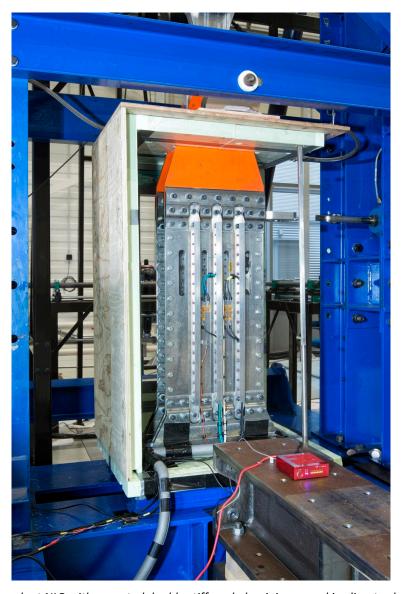
Figure 4: SHM test bench at NLR with mounted double stiffened aluminium panel in climate chamber with the fibre optic interrogator (Gator, small red box) from Technobis

A test was performed on the box-shaped structure analysed in the previous section. The component is mounted in a generic SHM test rig developed at NLR for verification and validation of SHM sensor networks and algorithms for complex components. Components can be installed in the rig by means of a modular interface. The rig can apply biaxial loads by means of two actuators up to a frequency of around 20 Hz. Also, it is possible to add a shaker to apply additional dynamic loading up to a few kHz. A climate chamber can be installed to run tests at elevated or low temperatures in the typical temperature range of aerospace components, -50 to 85 °C. Figure 4 shows part of the SHM test rig (in blue) with the double stiffened panel mounted inside the opened climate chamber. The small red box visible on top of the two metal beams in front of the panel is the commercially available optical chip based fibre optic interrogator system (Gator) manufactured by Technobis [5]. The Gator system has one input channel for fibre with 8 FBGs and has a wavelength range of [1514, 1586] nm with a maximum sample rate of 19.23 kHz and an achieved measurement accuracy of 1 microstrain.

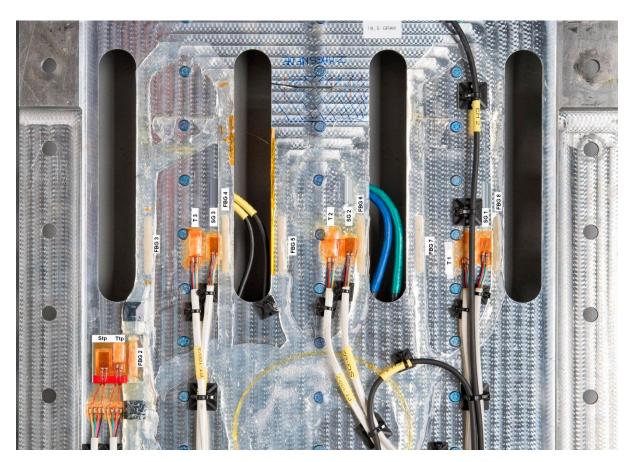
Figure 5: Installed FBG, strain gauge and temperature sensors on the rear side of the front panel

Several FBG sensors were installed on the rear side of the front panel, using the adhesive M-Bond 200 to adhere the FBG to the panel and the adhesive HBM X60 to cover the FBG to achieve a stiff bond. Both are well-known for adhering strain gauges to surfaces a well. An FBG was installed on both sides of each stiffener, see FBG3 to FBG8 in Figure 5. Furthermore, one FBG (FBG1) was installed on the web of the centre stiffener and one (FBG2) on a small aluminium rectangular sheet to act as a temperature sensor, visible in the top of Figure 5. This small rectangular sheet was made of the same material as the panel and was mounted to the rear of the front panel by means of some silicon to allow free expansion/compression of the sheet during temperature fluctuations. The surplus optical fibre in between any two FBG locations was coiled up with a sufficiently large radius to prevent optical losses and was attached to the panel with some silicon to prevent breakage of the fibre. On both sides of the fibre a connector was installed to be able to access all FBGs in case of fibre breakage.

For several FBG locations, also a quarter bridge strain gauge and a PT100 temperature sensor were installed next to the FBG, see Figure 5. The strain gauges were installed for comparison of the FBG strain responses. The PT100 sensors were used to monitor the temperature of the panel at a number of locations during cooling down and heating up of the panel and to compare against the FBG temperature sensor. On the rear panel, only a single strain gauge was installed in each of the load paths, see Figure 6. An overview of all installed sensors and their position is given in Table 1.

Figure 10 shows the measured strain response in microstrain (mu) for a few load cycles for two FBG/SG pairs (see also Figure 5 and Table 1) at room temperature. Both sensor types give a similar strain response. Small differences are due to the slight difference in sensor location. The FBG sensor/interrogator combination had a much (five times) lower noise level, as can be noted in Figure 10. Hence, more accurate measurements could be obtained with the FBGs.

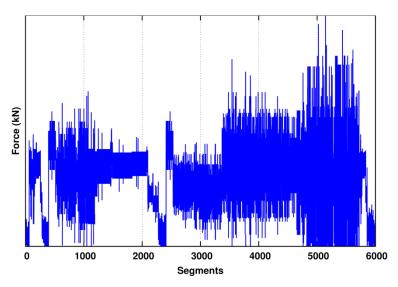
Figure 7: Detail of applied load time variation for three individual flights

Airbus supplied a typical (wing) variable amplitude load time variation consisting of various flights of which 90 were applied in the test. In Figure 7, a detail of the scaled time variation for three flights as applied in the test is depicted, clearly showing a taxiing, climb, cruise and descend phase. The time variation was scaled for the test article, yielding a maximum actuator load of 100 kN. With this time variation, low cycle dynamic tests were performed for the undamaged and four damaged states, described in section 3 and depicted in Figure 8, at room temperature (around 18 °C) and at -30 °C. During each test, the load time variation was applied at a rate of 13 Hz and the load, temperature, FBG and strain gauge responses were measured and stored in a database. For each five (undamaged and

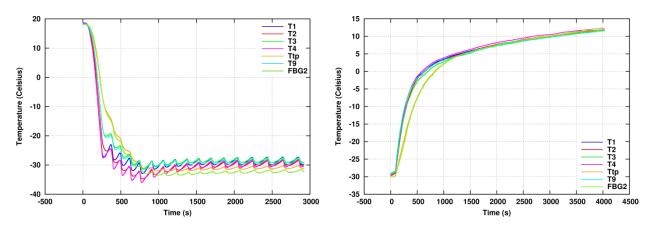
Figure 9: Measured temperature profiles during cooling-down (left) and warming-up (right) phase of the test article

damaged) panel configurations, first the test at room temperature was performed after which the climate chamber was closed and the panel was cooled down to -30 °C. The panel was cooled by spraying nitrogen inside the climate chamber through a number of nozzles. Temperature sensors were used to control the start and stop of the nitrogen flow, causing the oscillations in the temperature sensor profiles during cooling down, as depicted in Figure 9. After approximately one hour a stable situation was obtained and the load time variation was applied. After this test, the climate chamber was opened on the front and side, and the panel warmed up to room temperature overnight.

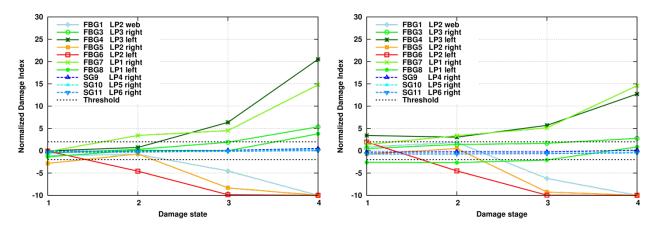
Figure 11: Normalized damage index versus the damage state from measurements at RT (left) and -30  $^{\circ}$ C (right), generated from the first 5 flights of the reference time variation and only the 21<sup>st</sup> flight of the damaged spectra

The normalized damage index nDI (9) was computed for each damage state from the measured variable amplitude strain responses at each strain sensor, in which the reference time variation was obtained on the undamaged panel. The mean value  $\mu_{DI}$  was the average of the non-normalized damage indicators DI of all sensors. As explained in section 2, for the standard deviation  $\sigma_{DI}$  a fixed value of  $0.1x\mu_{DI}$  is applied, yielding a fixed lower damage indicator value of -10 that signals full load path failure (no load transfer) at the corresponding sensor.

Figure 11 depicts the change in damage index as function of the damage states. On the left the results are presented for the measurements at room temperature and on the right at -30 °C, which are similar as the results obtained with the numerical simulation depicted in Figure 3, having an error between the numerical and experimental values as a percentage of the full scale of less than 10% for room temperature and 20% for -30 °C. The value of the damage indicator is around zero when no damage is present. This clearly is the case for the undamaged load paths in the rear panel monitored by SG9, SG10 and SG11 (blue dashed lines) for all four damage states in the front panel, and also for most strain sensors on the front panel for the first smallest damage state. The sensors in the damaged load path (FBG5 and FBG6) have a negative normalized damage index value when the strain in this load path decreases due to an increasing damage, and the sensors closest to the damaged load path (FBG4 and FBG7) show a positive normalized damage index due to a strain increase caused by load redistribution from the damaged load path. The dotted blacklines in the plots represent the damage indicator threshold value ( $\pm 2.0\sigma$ ) below which no definitive conclusion can be drawn about any damage present, due to small fluctuations in the damage index caused by for instance noise. The damage and its location (level 2) is correctly signalled at damage state 2, long before actual full load path failure, see section 3 for a more detailed discussion. The damage index value depends on the strain levels at the various sensors which on turn depend on a nearby crack size. The normalized damage index values in Figure 3 and Figure 11 can thus be correlated with a damage size for the structure at hand using FE simulations, making it even a level 3 SHM system.

The right plot in Figure 11, shows the normalized damage index obtained from the measurements at -30 °C using the FBG data <u>not</u> corrected for temperature, showing that the damage indicator works well for temperature uncorrected data. Some small differences can be observed, but these do not influence the correct indication of presence of damage.

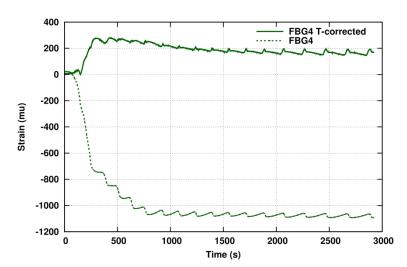
Figure 12: Temperature corrected (solid) and uncorrected (dashed) FBG strain responses during cooling down phase of the test article

Figure 12 depicts the strain responses during the cooling-down phase for an FBG sensor. The plots depict the temperature corrected as well as the uncorrected strain response. The uncorrected FBG strains have an offset of approximately 1300 microstrain ( $\alpha\Delta T/(1-p_e) = 21x(18+30)/0.78=1300$ ) and are very sensitive for temperature fluctuations (27 microstrain per degree Celsius). However, the FBG temperature correction, given by equation (10), is a linear relation while for a strain gauge this is a non-linear relation, given by equation (11). The damage indicator is based on a relative strain difference for each load cycle and therefore does not require a temperature correction in case of FBGs since the strain difference between any two successive load levels is independent on temperature, assuming the temperature is constant between two successive load levels, i.e. the load variation (typically larger than 1 Hz) has a much higher rate than the temperature variation being much more gradual. In case the temperature shows a significant temperature gradient over the structure, this still has no influence on the relative strain at the FBG location in a cycle. In case of strain gauges, a temperature correction is required and therefore temperature sensors, increasing the complexity of the SHM system.

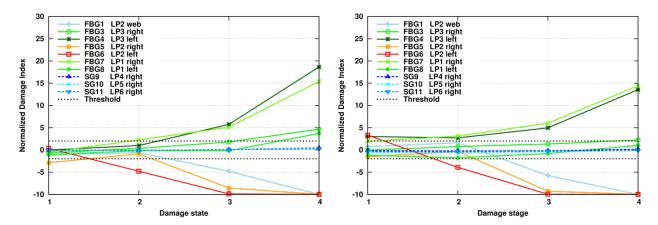
Figure 13: Normalized damage index versus the damage state from measurements at RT (left) and -30  $\,^{\circ}$ C (right), generated from the first ten flights of the reference time variation and flights 81 to 90 of the damaged spectra

Ideally, also the damage indicator should only require the data gathered during the next flight, to be able to monitor the damage on a flight-by-flight basis. To demonstrate this, the damage indicator was computed for various numbers of flights. The damage indicator curves in Figure 11 were generated from the first 5 flights of the measured reference time variation (undamaged state) and only the 21<sup>st</sup> flight of the spectra measured on the damaged states. Figure 13 shows the plots based on the first ten flights of the reference time variation and flights 81 to 90 for the damaged states. Other combinations using more flights for both the reference and damaged spectra, were examined as well yielding similar plots, not shown in here for reasons of space. This demonstrates that after a few number of flights

from the start of the usage period (reference set), the damage indicators can be determined for each successive flight. After a structural repair or modification in the region of interest, a new set of reference flights should be build consisting of the response measured during the first few flights after a repair or modification.
