NLR-TP-98002

## **Impact energy absorbing surface layers for protection of composite aircraft structures**

W.G.J. 't Hart and L.C. Ubels

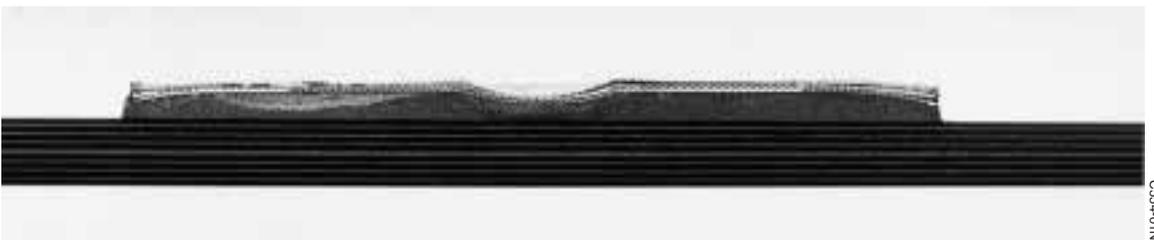
**20 Joule (Unprotected)**

**20 Joule (core + Al-gauze face sheet)**

Fig. 2 Cross sections of impacted 4 mm thick carbon/epoxy specimens

Figure 2 illustrates the effectiveness of the surface layer applied on a 4 mm thick quasi-isotropic carbon/epoxy laminate at an impact energy of 20 Joule. The performance of surface layers was determined in an earlier stage, i.c., at a lower impact energy level, by "Compression after Impact" tests on coupon specimens, figure 3 [3]. It is shown that without protection layer the compression strength drops from about 550 MPa to 200 MPa for an impact energy level higher than 15 Joule. A 3 mm thick protection layer can prevent impact damage in the substrate material in case of an impact of 25 Joule (no detectable damage by ultrasonic C-scanning). The latter type protection layer was selected for further evaluation on stiffened compression panels.

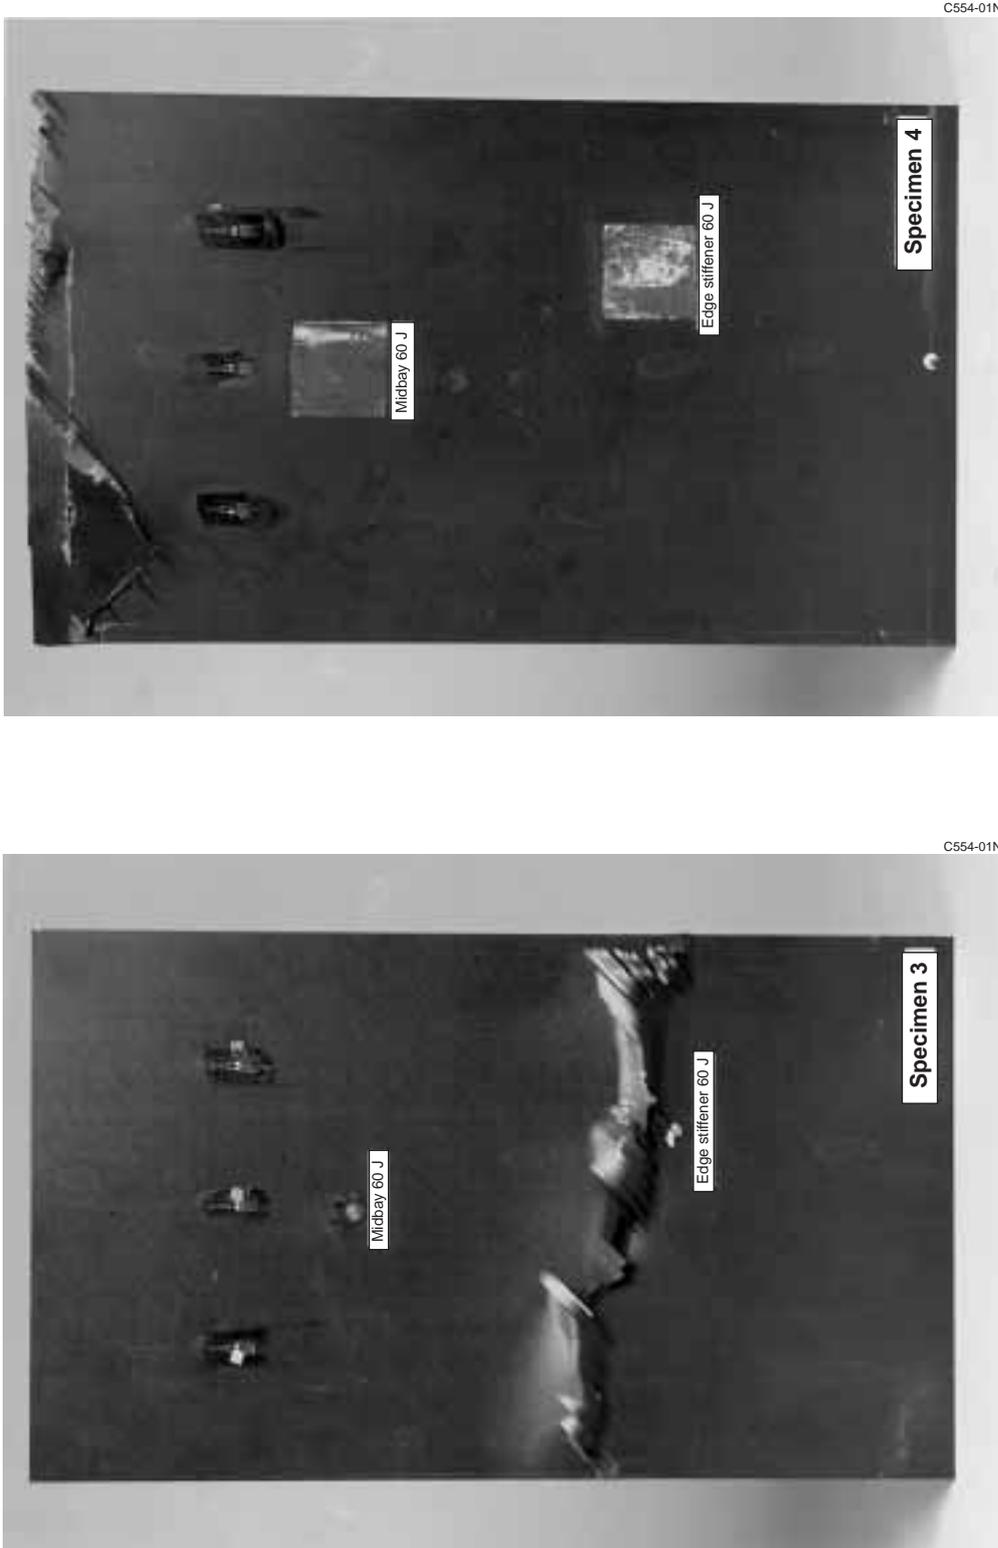
Fig. 17 Failed compression panels III and IV (surface layers removed for C-scan inspection)

Panel III : A 60 Joule impact on the unprotected panel resulted in a slightly smaller (Fig. 7) C-scan area as compared with that in panel I, see table 1. However, in this case the impact at the edge/stiffener was the most critical. Only small out-of-plane displacements were observed at the failure strain of about 0.5-0.55 %.

(Fig. 7) panel is therefore also the reference panel for the behaviour of the undamaged compression panel. Failure occurred at the panel end by "brooming" at a failure strain of about 0.75 %, without any load drop in the load displacement curves.
