# Fractography-assisted Observations on Fatigue Thresholds in an Aerospace Aluminium Alloy

Fatigue crack growth thresholds,  $\Delta K_{th}$ , were determined for aluminium alloy 7075-T7351 plate material used for the hinge beams

#### Report no. NLR-TP-2009-596

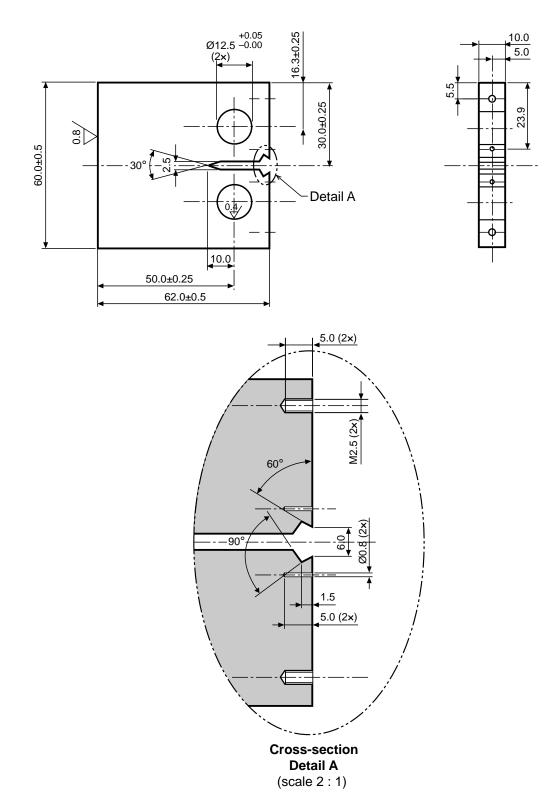
Fig. 1 Compact Tension (CT) specimen dimensions (mm). Detail A shows the locations of the leads for the DC. potential drop measurement system and the integrally machined knife edges for clip gauge measurements of crack opening displacements

10 mm thick Compact tension (CT) specimens were machined from the plate such that loading would be in the longitudinal (L) direction and crack growth in the long-transverse (T) direction. The crack plane orientation is then referred to as L-T. The specimens were provided with drilled holes for the electrical leads of a D.C. potential drop automated crack growth measurement system (ISIS), see figure 1.

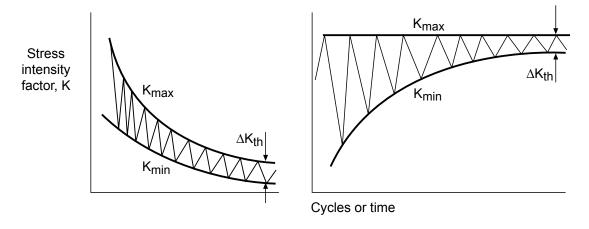
Fig. 2 Constant R (left) and constant  $K_{max}$  test methods to determine  $\Delta K_{th}$ : R is the stress ratio,  $S_{min}/S_{max} = K_{min}/K_{max}$ , of a loading cycle

- (1) <u>Constant R tests</u>: The applied loads are reduced during fatigue crack growth such that the stress ratio, R, remains constant while the cyclic stress intensity factor range,  $\Delta K$ , gradually decreases to the threshold value,  $\Delta K_{th}$ .
- (2) <u>Constant  $K_{max}$  tests</u>: The applied loads are changed during fatigue crack growth such that the maximum stress intensity factor,  $K_{max}$ , remains constant while the minimum stress intensity factor,  $K_{min}$ , gradually increases until  $\Delta K$  reaches  $\Delta K_{th}$ .

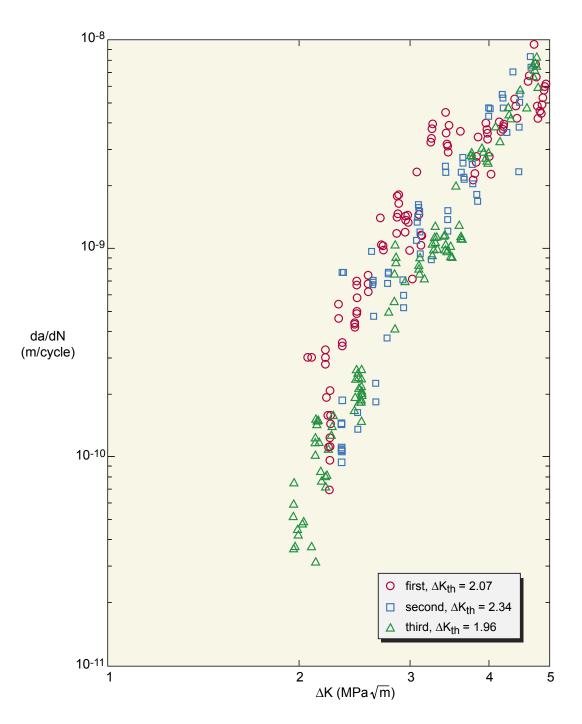
Fig. 3 Corrected crack growth rate results for R = 0.1

Figures 3 – 8 show the corrected da/dN *versus*  $\Delta K$  data for each value of R and K<sub>max</sub>. Plotted in this way the data show the considerable scatter in crack growth rates over the entire range of  $\Delta K$ , especially as da/dN decreases below 10<sup>-9</sup> m/cycle.

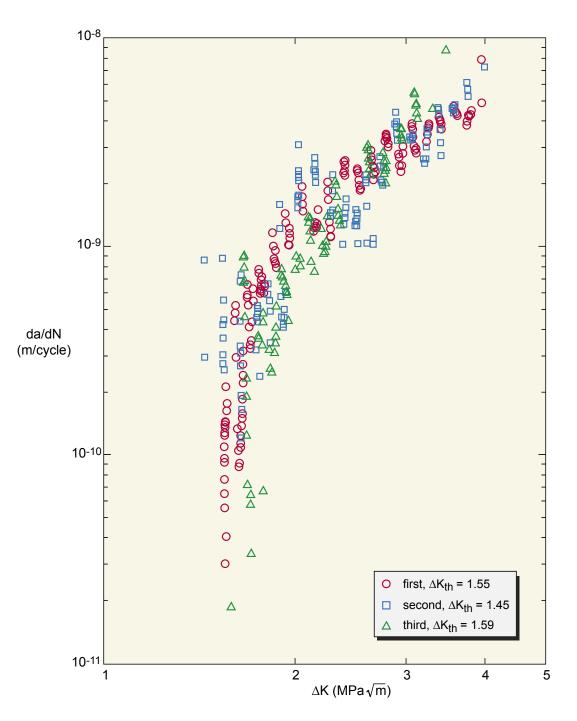
Fig. 4 Corrected crack growth rate results for R = 0.4

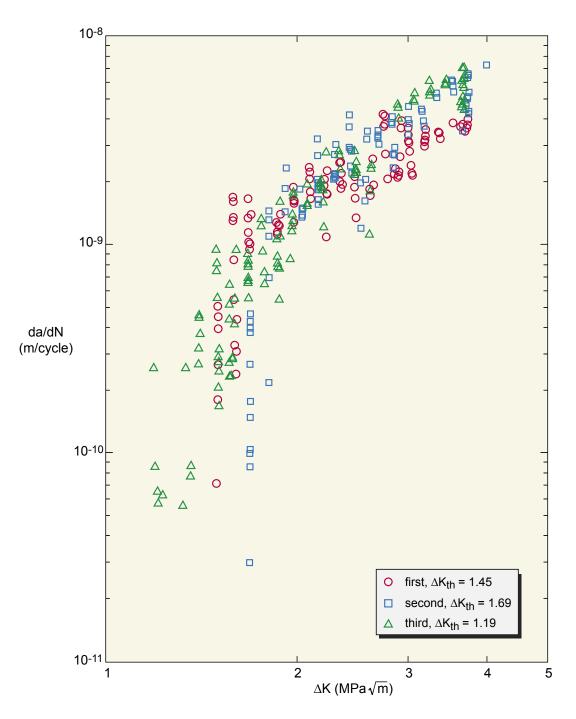
Fig. 5 Corrected crack growth rate results for R = 0.7

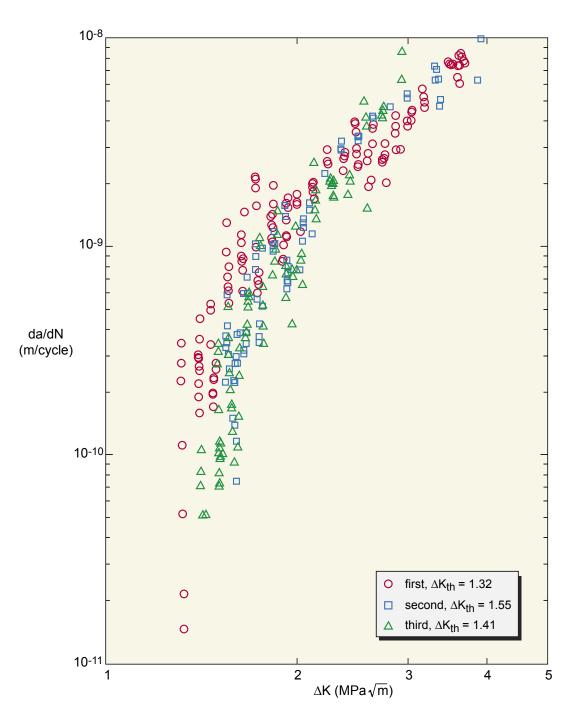
Fig. 6 Corrected crack growth rate results for R = 0.8

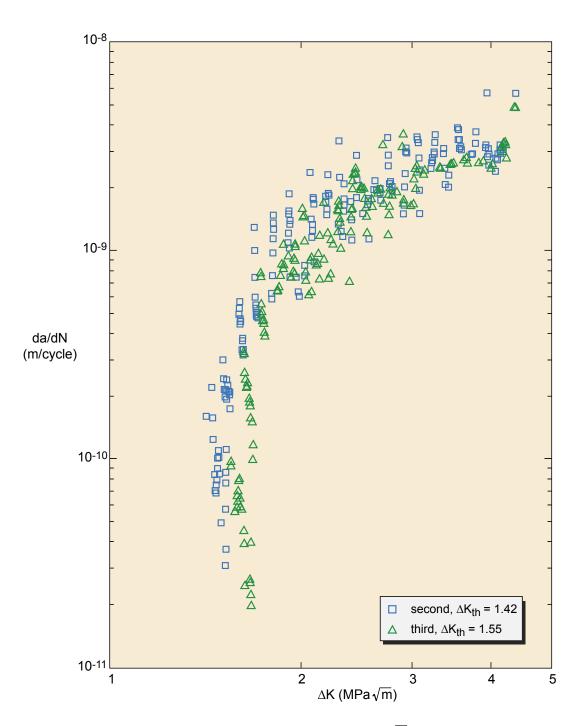
Fig. 7 Corrected crack growth rate results for  $K_{max} = 5 MPa\sqrt{m}$

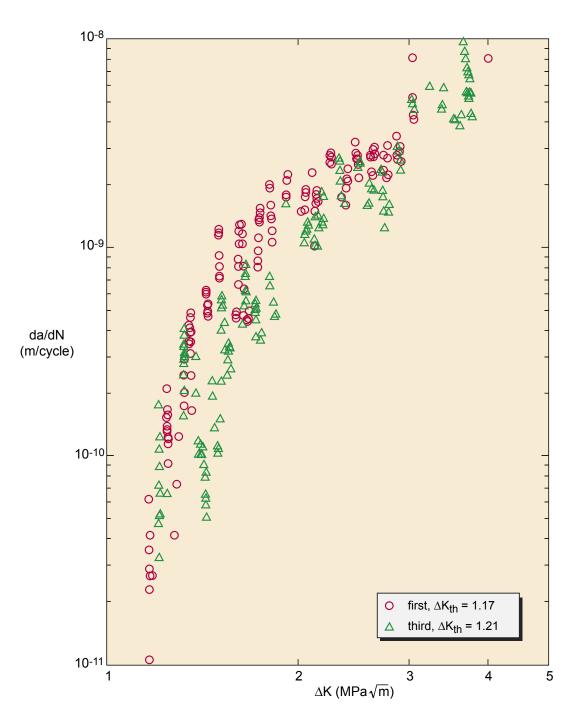
Fig. 8 Corrected crack growth rate results for  $K_{max} = 15 MPa\sqrt{m}$

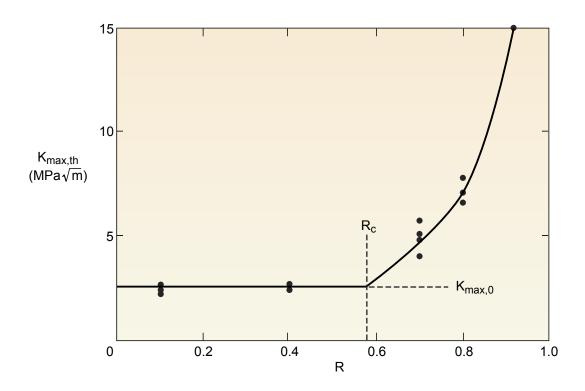
Fig. 9 K<sub>max,th</sub> versus R: data from table 2

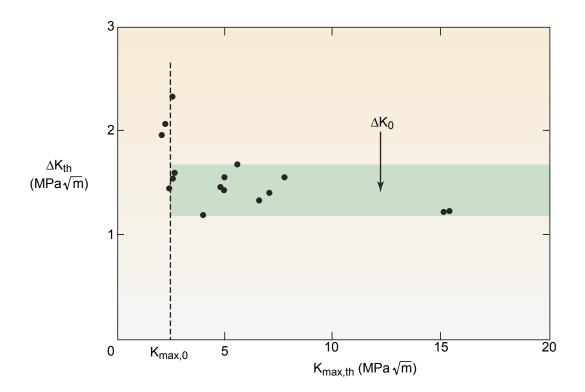
Fig. 10 Two parameter  $\Delta K_{th}$  versus  $K_{max,th}$  diagram: data from table 2

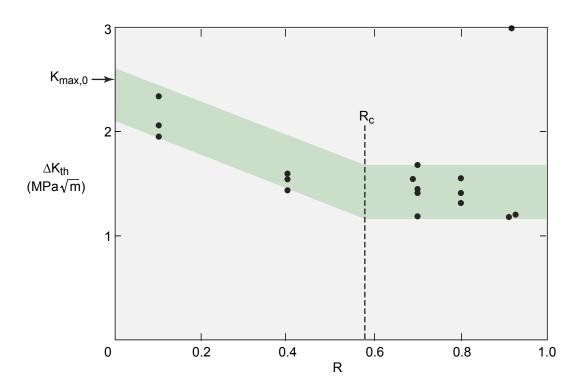
Fig. 11  $\Delta K_{th}$  versus R: data from table 2

Of primary importance to this objective is the determination of fatigue crack growth thresholds,  $\Delta K_{th}$ . Figures 11 and 12 show the final results of the present investigation, including the very good agreement with Marci's data (Marci 2000). Our results may be quantitatively expressed as follows:

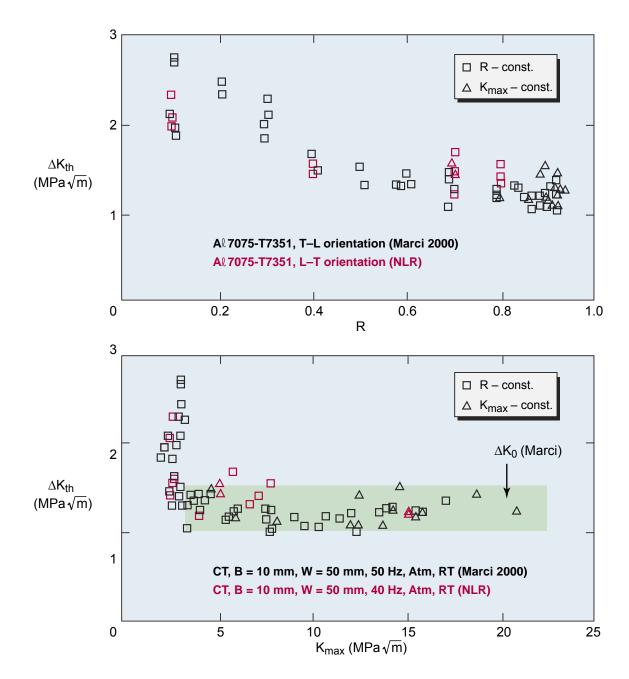
Fig. 12 Comparison of the NLR's and Marci's threshold data

Figure 12 compares the  $\Delta K_{th}$  versus R and  $\Delta K_{th}$  versus  $K_{max,th}$  values from the present investigation and from Marci (2000). Bearing in mind that the 7075-T7351 aluminium alloy came from different batches, the specimen orientations were different, and the tests were done using different equipment in different laboratories, the agreement is very good. The effective, or intrinsic, fatigue crack growth threshold stress intensity factor ranges,  $\Delta K_o = K_{max,o} - K_{op}$ , are slightly different:

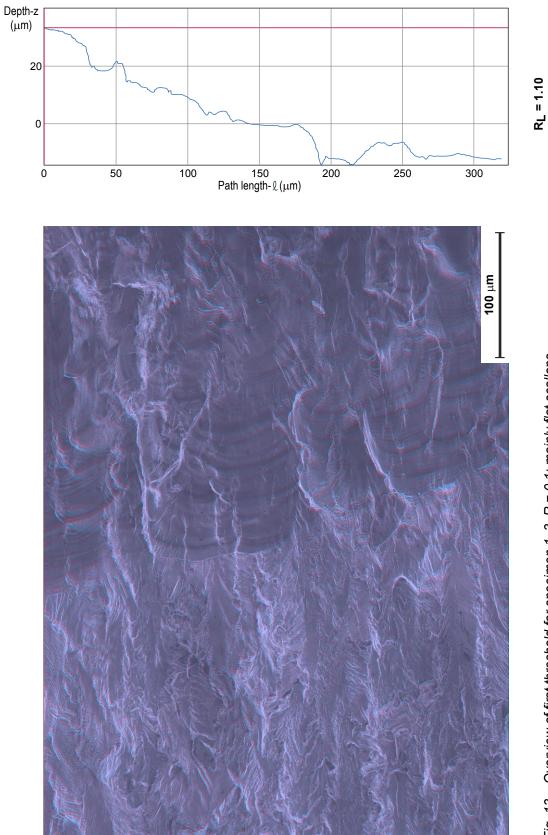
Fig. 13 Overview of first threshold for specimen 1-3, R = 0.1: mainly flat scallops

- At low to intermediate stress ratios (R = 0.1 0.4) the fracture topography consisted mainly of flat "scallops" (locally curved crack fronts) separated by narrow ridges. The scallops in figures 13 15 were clearly marked by alternating light and dark bands having the contours of the fatigue crack fronts. Observation of these bands for the specimen tested at R = 0.1 led to recording the humidity and temperature for the remaining tests, see Appendix A. Though much less evident, the alternation of light and dark bands can also be seen in figures 19, 20 and 24.

R	Specimen code	Thresholds and figures	Threshold R.H. (%)	Threshold Temp. (°C)	R <sub>L</sub>	Fatigue fracture features
0.1	1-3	I : fig. 13 II : fig. 14 III : fig. 15	- - -	- - -	1.10 1.09 1.10	• scalloped flat fracture separated by narrow ridges; light and dark bands contouring the crack fronts prior to threshold

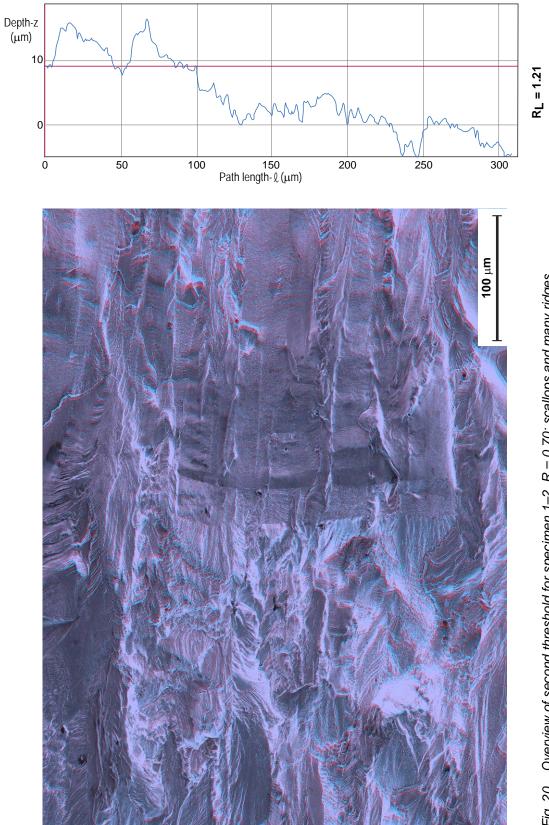
Fig. 20 Overview of second threshold for specimen 1–2, R = 0.70: scallops and many ridges

0.67 - 0.70	1-2	I : fig. 19 II : fig. 20 III : fig. 21	17 - 18 23 - 24 25 - 26	22 23 23	1.21 1.18 1.14	• scalloped fracture separated by wide and rough ridges; light and dark bands contouring the crack fronts prior to threshold

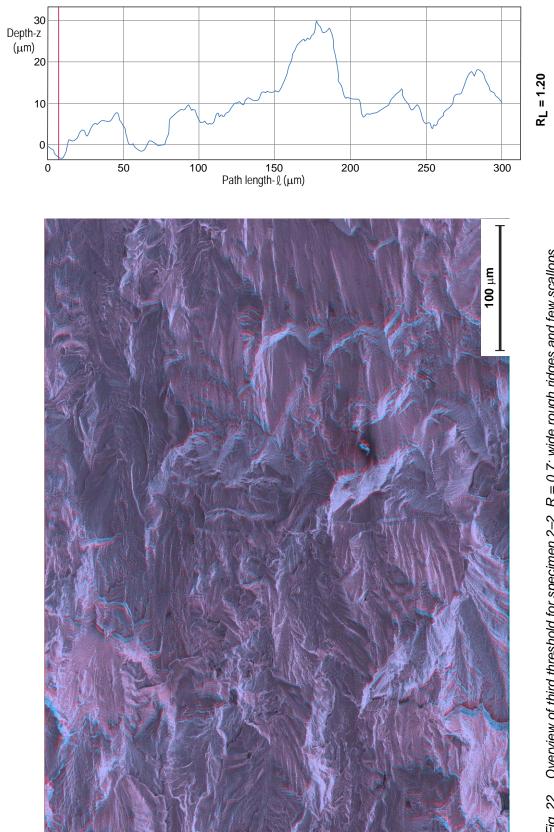
Overview of third threshold for specimen 2-2, R = 0.7: wide rough ridges and few scallops Fig. 22

0.7	2-2	I : fig. 22 II : fig. 23 III : fig. 24	29 - 30 42 - 43 38 - 39	21 21 20	1.20 1.15 1.10	<ul> <li>I, II: wide and rough ridges separating some scalloped fracture</li> <li>III: scalloped flat fracture separated by narrow ridges: light and dark bands prior to threshold</li> </ul>

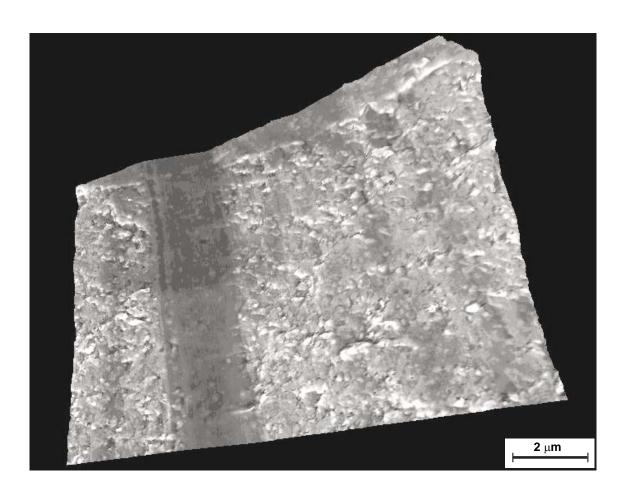
Fig. 39 Perspective view, constructed from a FEG-SEM stereopair, of a typical dark band between two light ones on a flat scallop: specimen 1-3, R = 0.1

As mentioned in subsection **4.2.1**, the FEG-SEM images in figures 13 - 15, and to a lesser extent figures 19, 20 and 24, show alternations of light and dark bands which have the contours of the fatigue crack fronts. Figure 39 gives a perspective view of a typical dark band between two light ones on a flat scallop. This view shows that (a) the dark band has an even flatter topography and (b) the fracture surface details are partially obscured by an overlying featureless layer.

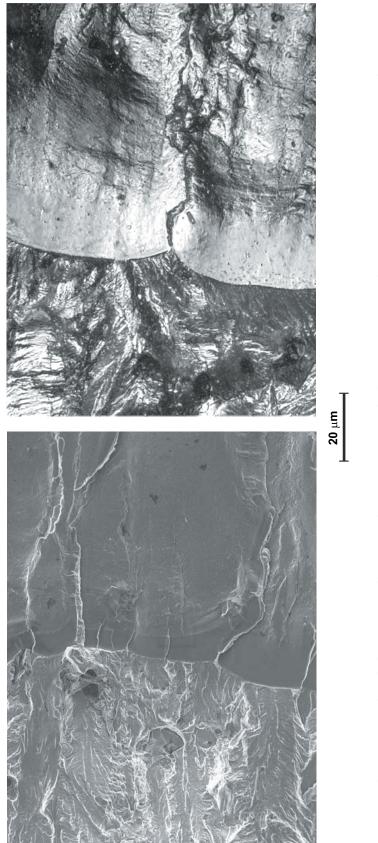
Comparison of FEG-SEM and DFOM details (not identical areas) of second threshold for specimen 3-1, R = 0.4, 38-39% R.H. The final crack front sisted entirely of almost featureless flat scallops Fig. 40

- (1) The FEG-SEM dark bands correspond to highly reflective and almost featureless bands in DFOM images, see figures 40 and 42.
- (2) These bands occurred only at relative humidities approaching 40 %, compare figures 41 and 42.
- (3) These almost featureless bands are the result of a brittle layer overlying the fatigue fracture surfaces, see figure 43.
- (4) The most obvious explanation for these bands is that they are due to fracture surface oxidation that requires a local relative humidity approaching 40 %, and certainly more than 30 %. This explanation is semi-quantitatively consistent with the earlier work of Vasudévan and Suresh (1982) and Suresh *et al.* (1984) mentioned in subsection **4.1**.

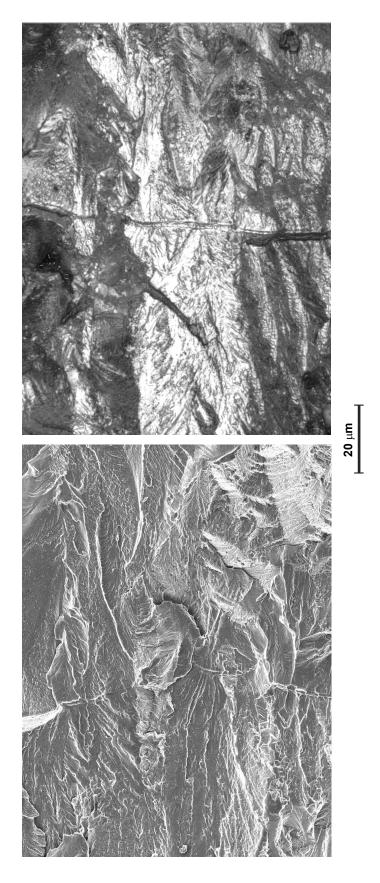
Comparison of FEG-SEM and DFOM details (not identical areas) of first threshold for specimen 2–2, R = 0.7, 29–30 % R.H. The final crack front preceding the narrow stretch zone between the first and second threshold determinations consisted almost entirely of wide rough ridges Fig. 41

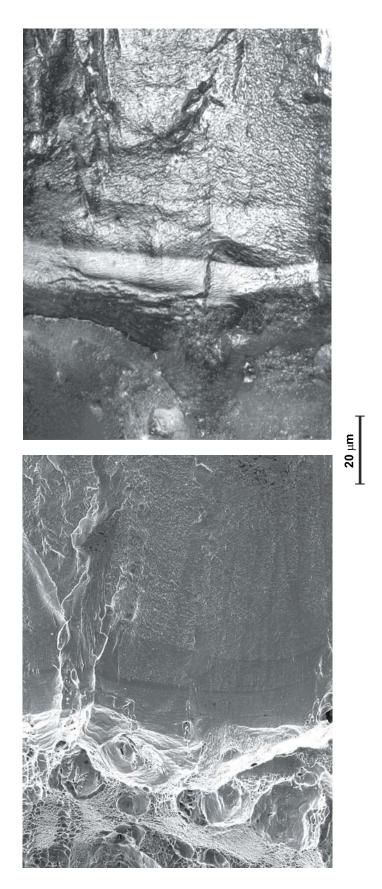
Comparison of FEG-SEM and DFOM details (not identical areas) of third threshold for specimen 2-2, R = 0.7, 38-39 % R.H. The final crack front consisted mainly of almost featureless flat scallops Fig. 42

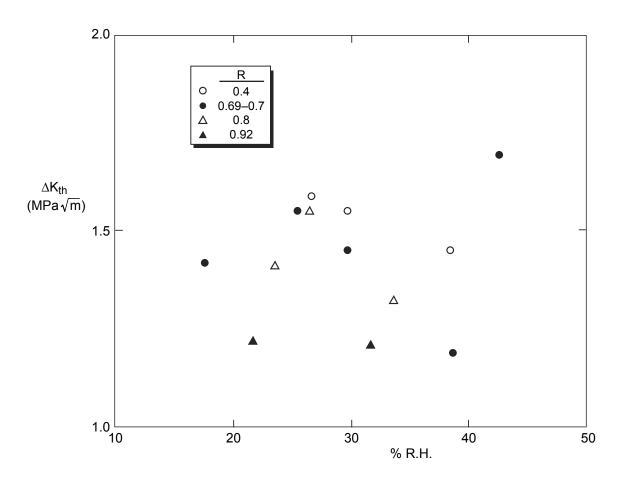
Fig. 44 Comparison of threshold atmospheric humidities (R.H.) and  $\Delta K_{th}$  values
