NLR-CR-2019-100-RevEd-1 | July 2023

Round Robin Test Results of Laser Ultrasonic Systems on Composite Panels

CUSTOMER: OPZuid (Operationeel Programma Zuid-Nederland)

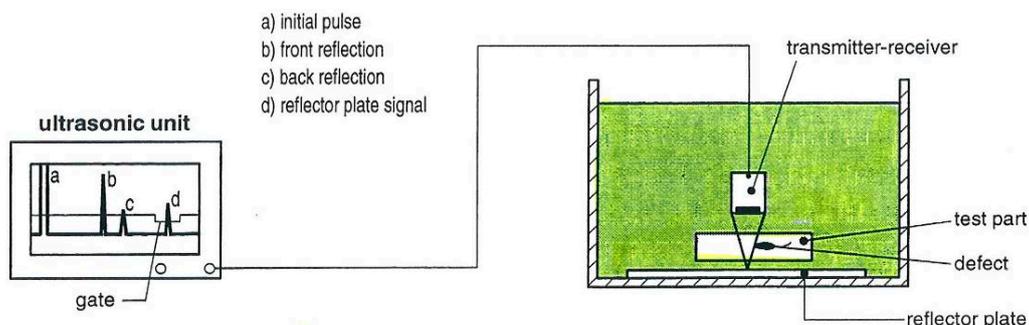
Figure 1.2: Ultrasonic C-scan inspection using the reflector-plate technique in immersion (test part immersed in a water tank)

When the UT transducer is directed perpendicularly to the material surface, longitudinal waves will be transmitted into the specimen. When these waves hit a material interface (e.g. the specimen backwall), both reflection and transmission of the waves will occur with their ratio depending on the difference in acoustic impedance (product of material density and wave velocity). Material defects constitute extra interfaces and these will result in extra reflection signals and in a decrease of the transmitted signal. These signals can be observed in the time domain (called A-scan) and an electronic gate can be placed at different positions in the time-domain to allow different inspection techniques. For the base-line inspection discussed in this report, the so-called 'reflector-plate' set-up was used with the following inspection techniques (all techniques with one transducer acting both as transmitter and receiver, see figure 1.2):

A wide gate of the UT unit is placed over all relevant reflections behind the reflection of the front surface of the specimen (signal 'b' in Fig. 1.2). Instead of measuring the amplitude of the UT signal now the wave travel time of the reflected UT signal is measured. The relative position of a defect reflection signal on the time base gives information about the depth of the defect. The resulting C-scan is, therefore, often also called 'thickness scan'.

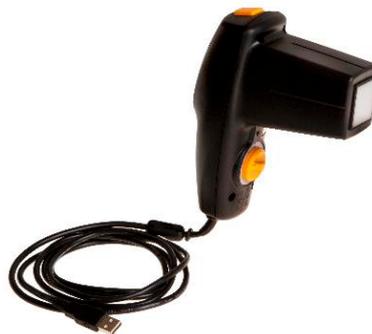
Finally, the Norwegian company DolphiTech AS has developed a handheld, UT imaging camera for fast and real-time UT inspection of CFRP products (Ref. 7), see figure 1.4 (middle and right). The camera, DolphiCam™, presents a high-resolution C-scan image over an area of 31 x 31 mm of the specimen utilising an array of 124 x 124 piezoelectric sensing elements. The array is responsive over a wide array range of ultrasound frequencies (2 – 6 MHz, centre frequency about 3.8 MHz). Different ways of presentation of the inspection result are possible, see for example figure 1.4 for the detection of impact damage in a CFRP specimen. There are two models of the camera: DolphiCam™ model CF08 for the inspection of CFRP material with thickness up to 8 mm and model CF16 for the inspection of CFRP material with thickness up to 16 mm. The difference between the models is the different thickness of the silicone

based membrane (functioning as delay line) in front of the transducer (2.8 mm for the CF08 model, 4-5 mm for the CF16 model). The membrane enables dry coupling inspection on painted or shiny surfaces but application of a couplant (e.g. a fine water spray) will always provide a better inspection result.

Figure 1.4: PAUT RapidScan™ (left, Ref. 6) and DolphiCam™ with different ways of presentation of impact damage (middle and right, Ref. 7)

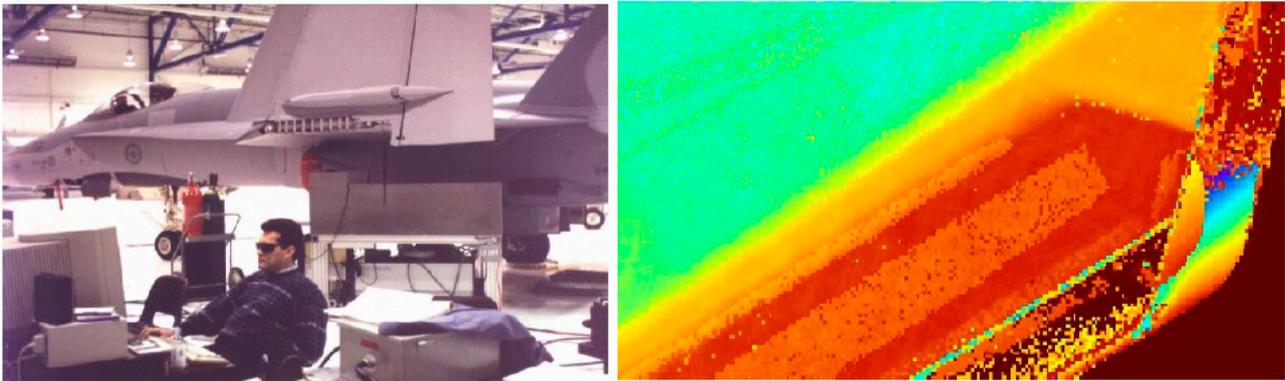
Figure 2.2: LU in-service inspection of a CF18 and resulting C-scan of the horizontal stabilizer (Fig. 4 from Ref. 8)

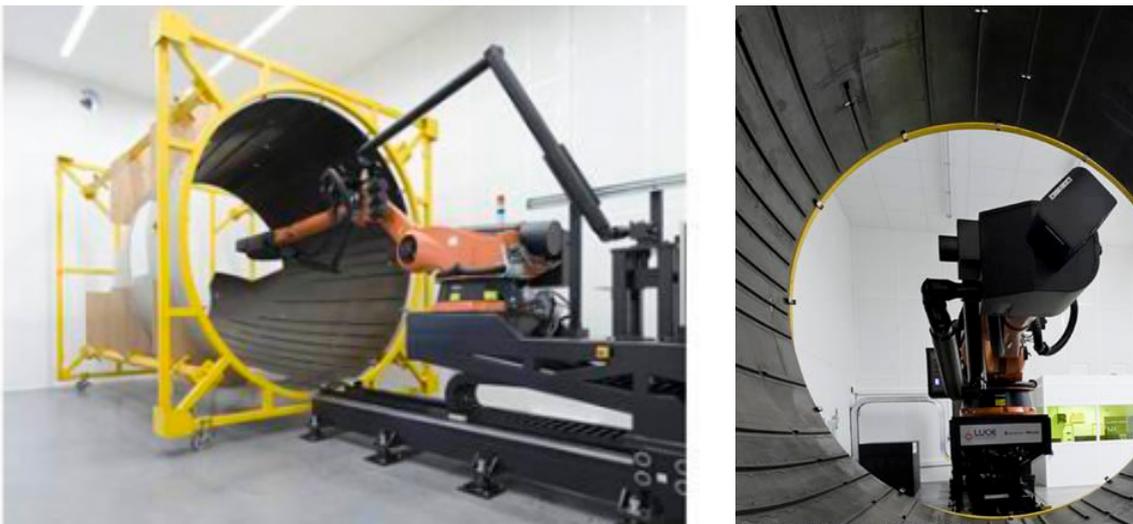
There are a number of companies that develop and produce LU systems, even fully robotised. The drawback of these systems, however, is their cost price. For example, the Spanish company Tecnatom S.A. and the American company PaR Systems Inc. produce LU systems that have a cost price far exceeding 1 M€. Figure 2.3 illustrates the LUCIE system of Tecnatom S.A. while inspecting a composite fuselage part. With the LUCIE system, the twofold scanning laser head (one laser for the interrogation and generation of ultrasound in the part and another, almost co-linear laser interferometric system for the detection of UT reflection signals) is mounted on a robot that can scan a complex shaped part following a predetermined scan profile.

Figure 2.3: LUCIE system of the company Tecnatom S.A. inspecting an Airbus composite fuselage part (Ref. 14)

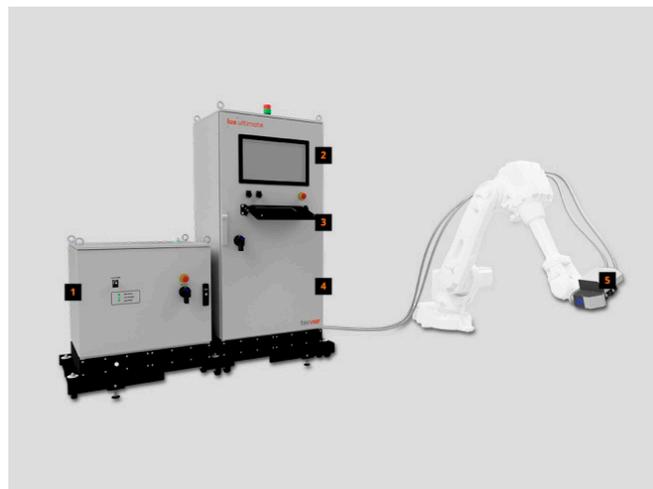
The Canadian Company Tecnar has recently delivered to Boeing a turn-key laser ultrasonics robotic system for the inspection of large aerospace structures, see figure 2.5. Tecnar laser-ultrasonic equipment is modular and can also be sequentially acquired. A basic turn-key system amounts to 350 k€.

Figure 2.5: Tecnar Ultimate laser ultrasonic system (Ref. 16)

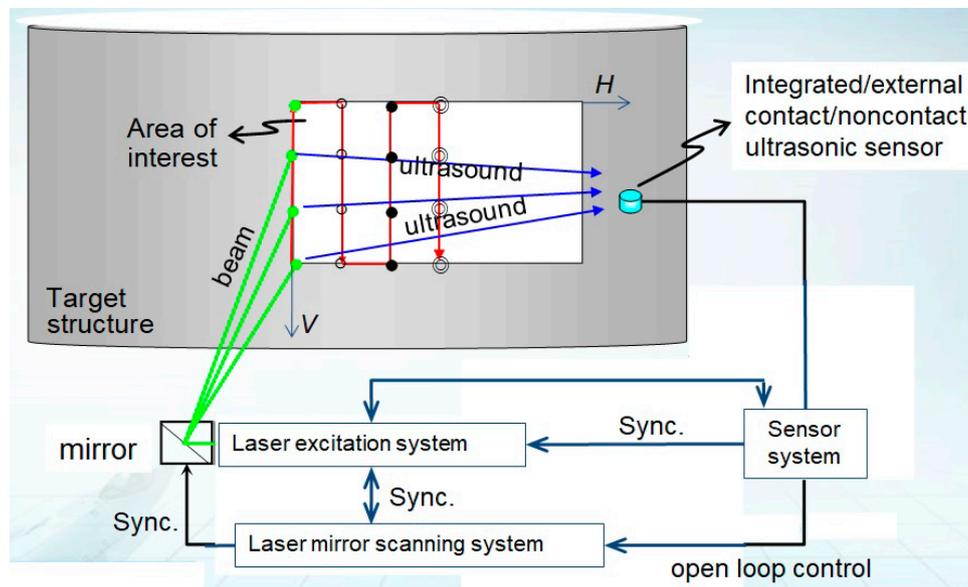
Figure 2.6: LU inspection using the Ultrasonic Propagation Imaging (UPI) technique (Ref. 17)

algorithms. Present defects change the responses of the guided waves and can therefore be identified in the resulting C-scan presentations. There is also a UPI version where the guided wave responses are not collected with a surface mounted piezoelectric sensor but with a fully noncontact laser Doppler vibrometer system directed at a fixed location of the test part.

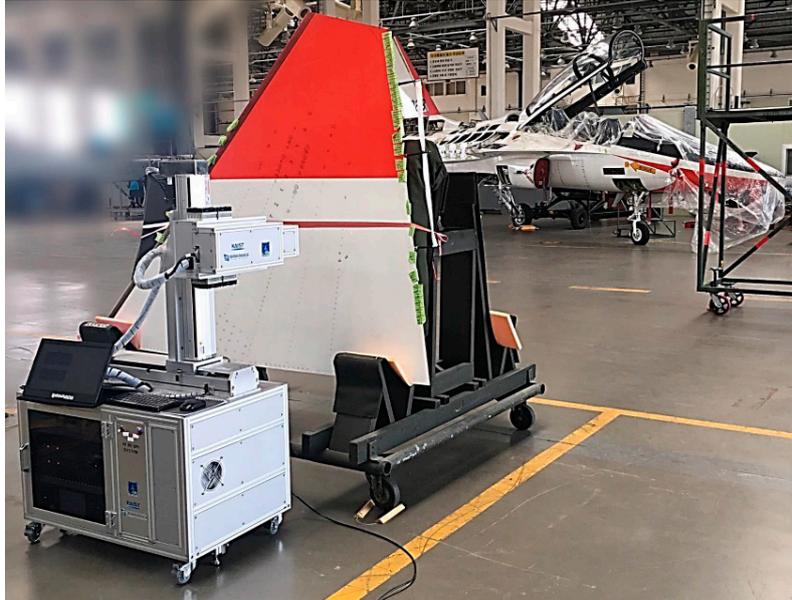
Figure 2.7: PE-UPI laser ultrasonic system of the South Korean company X-NDT. Field inspection of a T-50 horizontal stabilizer (Ref. 21)

A drawback of the UPI technique employing guided waves is the complexity of wave transmission through composite materials with their high anisotropy. X-NDT Inc. has developed a number of visualization algorithms such as UWPI (space-time domain representation of the wave field), USI (ultrasonic spectral imaging to visualize defects in the frequency domain), WUPI (wavelet-transformed ultrasonic propagation imaging), AWPI (anomalous wave propagation imaging) and VTWAM (variable time window amplitude mapping), see reference 18, but the sensitivity, accuracy and reliability of defect detection remains limited when compared to standard UT inspection with perpendicular interrogation and employing longitudinal waves. However, X-NDT Inc. has recently developed a relatively low-cost LU system (about 240 k€) that does work in a pure pulse-echo mode (PE-UPI) while using longitudinal waves (Refs 19 and 20, Fig. 2.7). This system is of interest for the DCMC round robin test program.

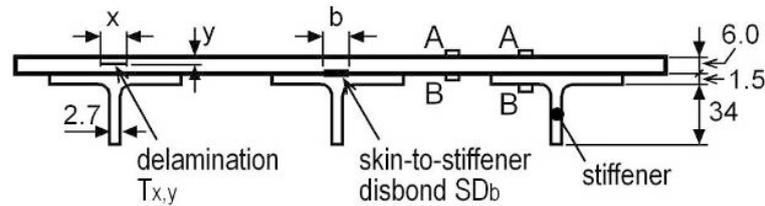
Figure 3.1: Structural detail of specimen NLR-B, a solid laminate with three T-shaped stiffeners

Specimen NLR-B is a solid laminate with three T-shaped stiffeners, see figure 3.1 for a structural detail. The laminate has dimensions of 485 x 294 mm, with thickness 6.0 mm. The laminate is 24 layers with quasi-isotropic lay-up. The stiffener pitch is 100 mm. The specimen contains the following defects (21 in total):

- Impact damages with impact energy in the range of 20 to 70 Joule. The impacts are inflicted both mid-bay and on the edge of the stiffeners.
- Interply delaminations in the skin simulated by Teflon foils of diameter 0.25, 0.5 and 1 inch, and placed at three different through-the-thickness positions (depths of 0.75, 2.25 and 5.25 mm).
- Skin-to-stiffener disbonds simulated by Teflon foils of diameter 0.25, 0.5, 1 and 2 inch.

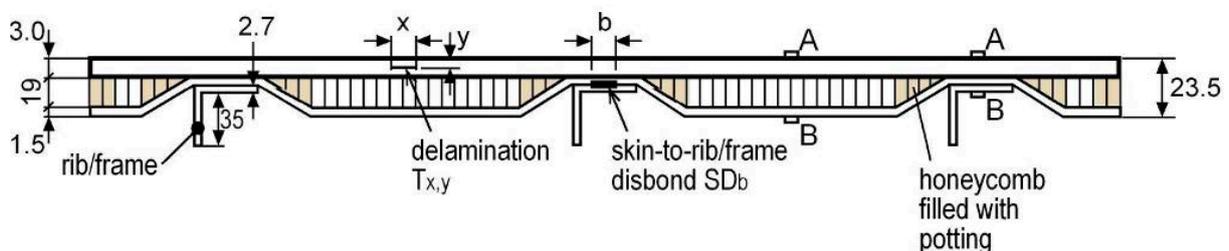
Figure 3.2: Structural detail of specimen NLR-D, a chamfered sandwich structure with three L-shaped ribs/frames

Specimen NLR-D is a chamfered sandwich structure with three L-shaped ribs/frames, see figure 3.2 for a structural detail. The panel has dimensions of 905 x 800 mm, with outer/inner skin thickness 3.0/1.5 mm. The Nomex honeycomb has a height of 19 mm. The outer skin laminate is 12 layers with quasi-isotropic lay-up; the inner skin laminate is 6 layers with quasi-isotropic lay-up. The specimen contains the following defects (22 in total):

- Impact damages with impact energy in the range of 20 to 70 Joule. The impacts are inflicted both mid-bay and on the stiffeners.
- Interply delaminations in the outer skin simulated by Teflon foils of diameter 0.25, 0.5 and 1 inch. The foils are placed at the rib/frame locations and at three different through-the-thickness positions (depths of 0.75, 1.50 and 2.25 mm).
- Skin-to-rib/frame disbonds simulated by Teflon foils of diameter 0.25, 0.5, 1 and 2 inch.

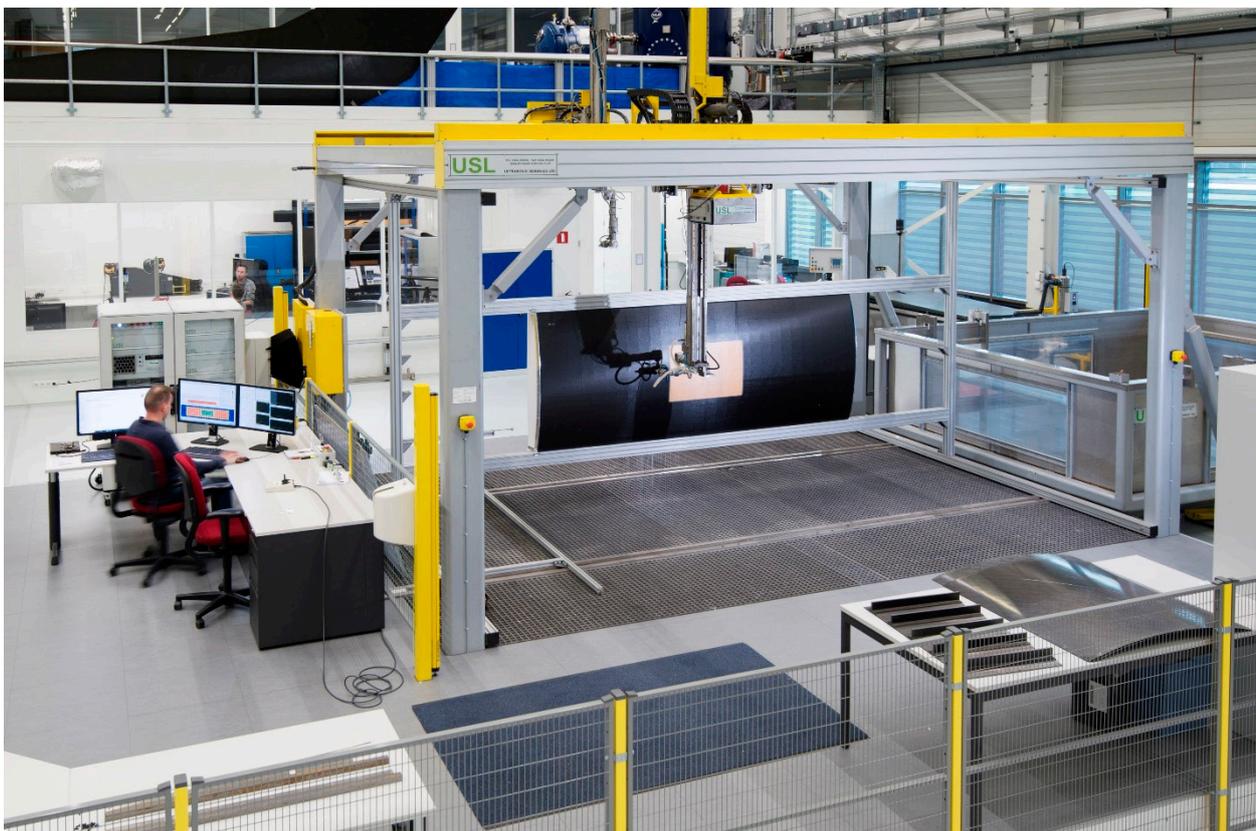
Figure 4.1: Ultrasonic C-scan equipment at NLR

Ultrasonic C-scan inspections can be carried out with dedicated multi-axis scan systems. Figure 4.1 shows the C-scan equipment at NLR. It is a 12-axis scanner of Ultrasonic Sciences Ltd. with a scan window of 4.0 x 2.5 x 2.5 m. It can be used both in the immersion and water-jet inspection mode. Complex geometry components (double curved) can be scanned with both the pulse-echo and through-transmission technique.

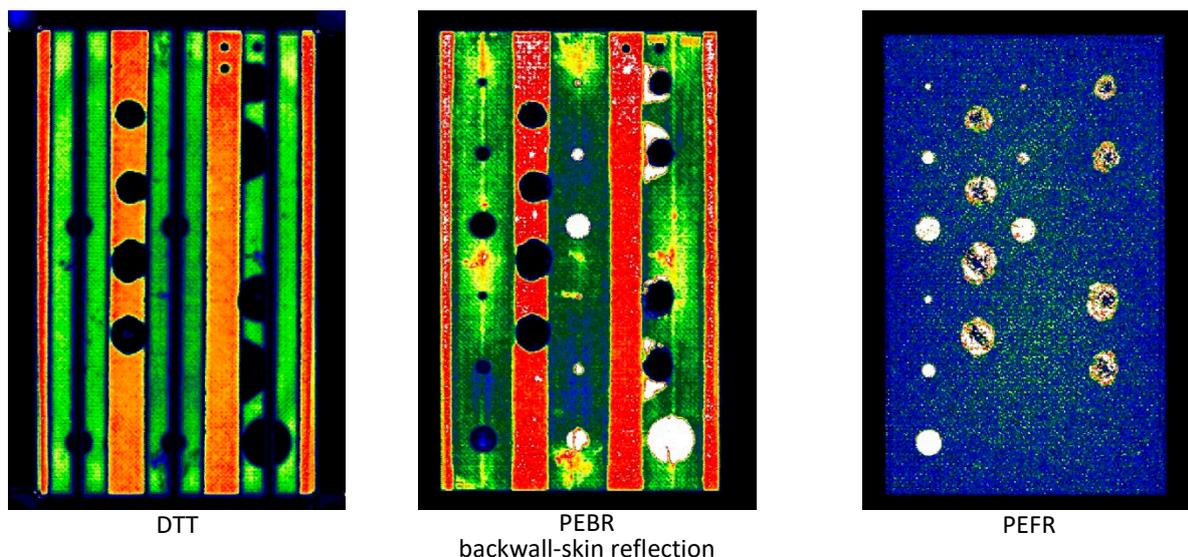
Figure 4.2: Overview of baseline UT C-scan inspection results for specimen NLR-B

All base-line C-scan measurements for specimen NLR-B were done in immersion using a 5 MHz focused transducer (IM-5-19-R80, S/N 2753 B101). The instrument settings for these measurements are given in reference 1. The inspection results are given in Appendix B.1, figures B1 – B4. An overview of the results is given in figure 4.2.

The base-line UT C-scan results for specimen NLR-B have been discussed in detail in reference 1. In summary, we can say that the combination of different inspection techniques (DTT, PEBR and PEFR) resulted in the reliable detection of almost all defects in the panel. Only one small defect with size of 6 mm (skin-to-stiffener disbond SD1) was qualified as detectable with limitation. The sizing of defects is fairly accurate but deviations in the range of 1 to 2 mm can easily occur. The depth estimation of defects has a varying accuracy but, generally, it is very accurate with deviations in the range of only 0.1 to 0.2 mm.

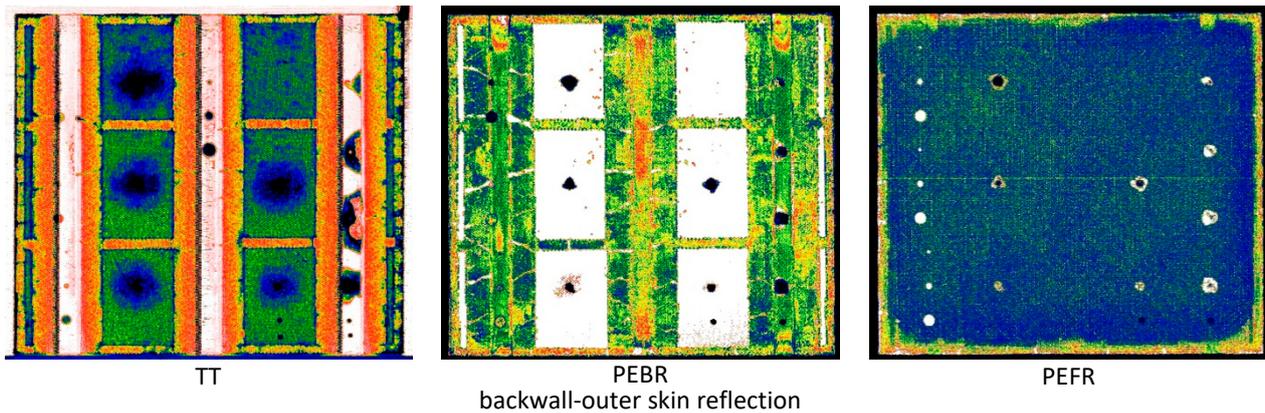
Figure 4.3: Overview of baseline UT C-scan inspection results for specimen NLR-D

Most base-line C-scan measurements for specimen NLR-D were done in immersion using a 5 MHz focused transducer (IM-5-19-R80, S/N 2753 B101). An additional single through-transmission inspection (TT) was done with water jets with a 2.25 MHz focused transmitter (IM-2.25-19-F76, S/N 2913 0101) and a 2.25 straight-beam receiver (IM-2.25-19R118, S/N 2913 B101). The instrument settings for these measurements are given in reference 1. The inspection results are given in Appendix B.2, figures B5 – B8. An overview of the results is given in figure 4.3.

The base-line UT C-scan results for specimen NLR-D have again been discussed in detail in reference 1. In line with NLR-B specimen, the conclusions are similar to those for specimen NLR-B. Only the small skin-to-stiffener disbond SD1 (diameter 6 mm) was qualified as detectable with limitation, similar to the results from NLR-B. Moreover, the conclusions for defect sizing and depth estimation are similar, with one remark that the largest disbond SD4 in panel D was largely undersized (37 instead of 51 mm).

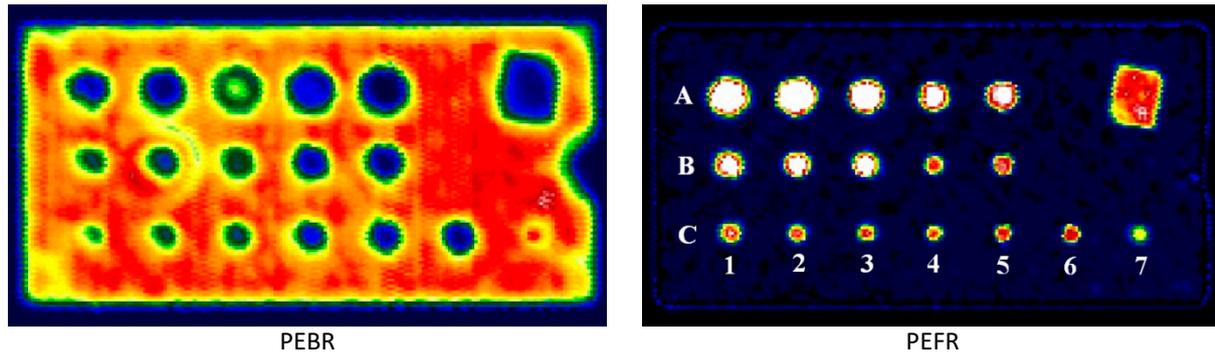
Figure 4.4: Overview of baseline UT C-scan inspection results for RTM specimen #2118

All base-line C-scan measurements for RTM specimen #2118 were done in immersion using a 2.25 MHz focused transducer (IM-2.25-19-F76, S/N 2913 0101). The instrument settings for these measurements are given in reference 7. The inspection results are given in Appendix B.3, figures B9 – B10. An overview of the results is given in figure 4.4.

The base-line UT C-scan results for RTM specimen #2118 generated DAC/TCG application (Distance Amplitude Curve & Time Corrected Gain) have been discussed in detail in reference 7. The figures show that the combination of the different gating techniques (PEBR, PEFR and TOF) provides a reliable detection of all FBH's, both in location and depth. Also the FBH's located near the front and back wall surface are well detectable which confirms a good near- and far surface resolution. The PEFR inspection clearly shows the best detection performance. The defect indication in the upper right corner is the detection of a foil which was erroneously left during manufacturing of the specimen. The analysis in reference 7 showed that the PEFR inspection also yielded the most accurate sizing of the FBH's, with a maximum error of 3 mm for the larger holes (diameter 12 mm) at larger depths. The last is most probably due to the increasing beam width caused by beam spread at larger depth. And finally, the analysis showed that the TOF scan (Fig. B10) could not detect FBH C7 (located 1 mm from the back wall) due to the dynamic range of the selected colour palette. On the other hand, the TOF scan could accurately determine the depth of the other FBH's with a maximum deviation of less than 1 mm.

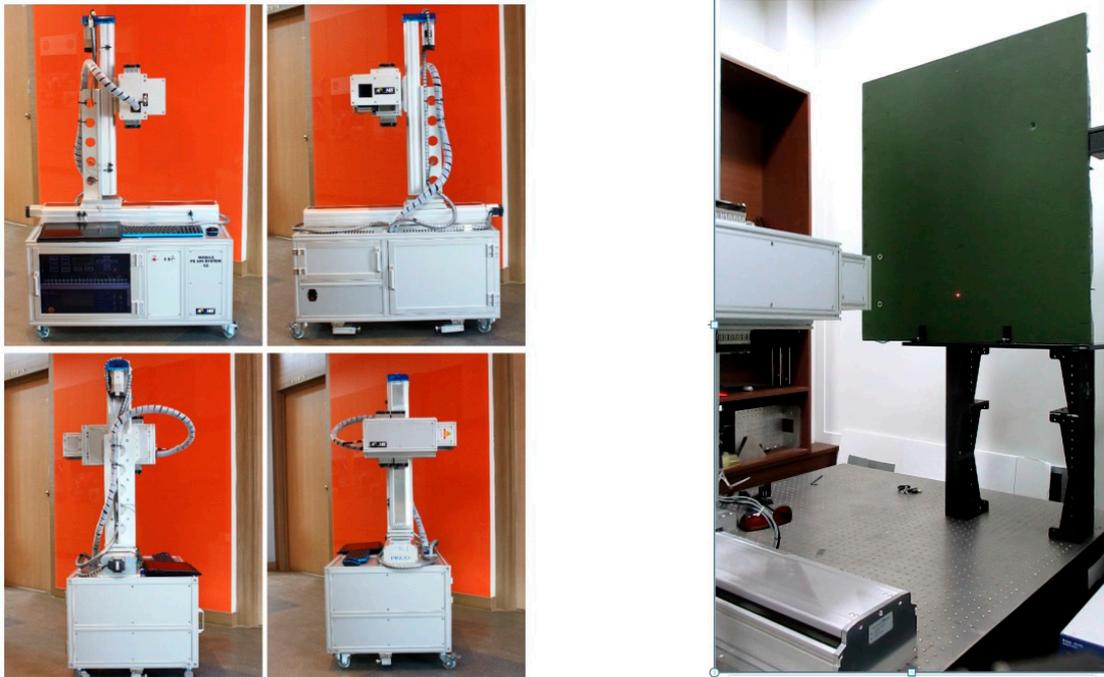
Figure 4.7: PE-UPI system in different views (left) and inspecting specimen NLR-D (right)

Figure 4.7 shows the PE-UPI system in more detail and in action for measurement on specimen NLR-D. The system is portable with a weight of about 130 kg. For all measurements a stand-off distance (specimen to laser head) of 0.6 m was used. Scanning at farther distances is possible but as the laser ultrasonic sensor has local sensitivity maxima at every 0.2 m. Shorter distances are also possible and can be chosen in the same way. The scan speed was 1 kHz pulse repetition rate (PRR) with a 0.25 mm spatial interval for all measurements.

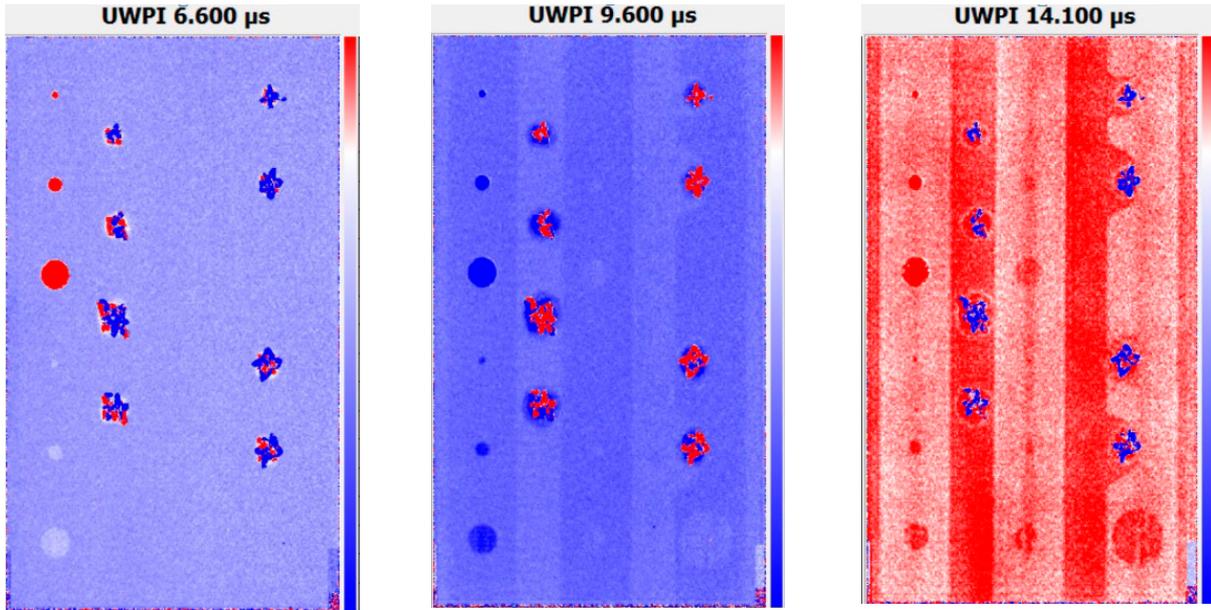
Figure 4.8: Selection of three PE-UPI freeze frames at different times from the UWPI wave propagation movie of panel NLR-B

The PE-UPI inspection results for specimen NLR-B are given in Appendix C, figures C1 and C2. A scan area of 480 x 290 mm² was used for this specimen. The UWPI movie in figure C1 contains the sequential display of all individual C-scan images of the reflected UT wave amplitudes in time over a total time period of 51.1 μ s. It is a whole propagation video in which the defects are visualized in different time, providing depth information. Figure C2 shows two examples (freeze frames) of the UWPI results at the specific times of 11.7 and 13.4 μ s. These times have been selected by the PE-UPI system operator as being relevant and providing information about the presence of defects in this panel. The choice for these freeze frames, however, is a user's choice based on experience with the PE-UPI system. Obviously, other freeze frames can also be selected, and figure 4.8 gives three more examples at different propagation times. The different images in this figure clearly show the different views of present defects and structural details such as the presence of three stiffeners.

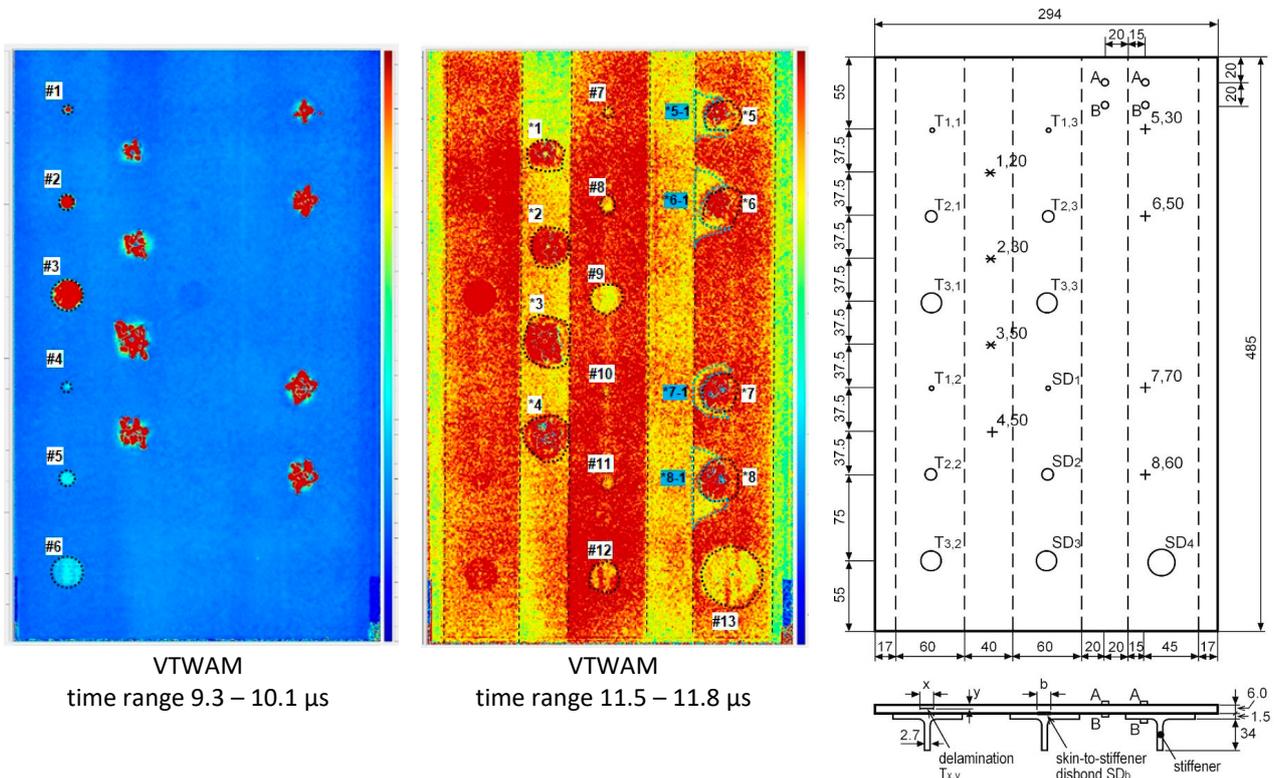
Figure 4.9: PE-UPI VTWAM results of two time ranges from the UWPI wave propagation movie of panel NLR-B

From the UWPI data, two relevant time ranges were selected by the PE-UPI system operator and further processed to produce VTWAM amplitude images, see figure C2. These figures have also been included in figure 4.9 together with the NLR-B specimen drawing from figure A1. The figure shows that almost all defects in the panel (impact damages, artificial delaminations and disbonds) are reliably detectable. Only one small defect with size of 6 mm (skin-to-stiffener disbond SD1) is qualified as detectable with limitation. This is, in fact, the same conclusion as was drawn for the baseline UT C-scan inspection, see Chapter 4.1. Also the sizing of the defects is of the same accuracy (in the range of 1 to 2 mm diameter).

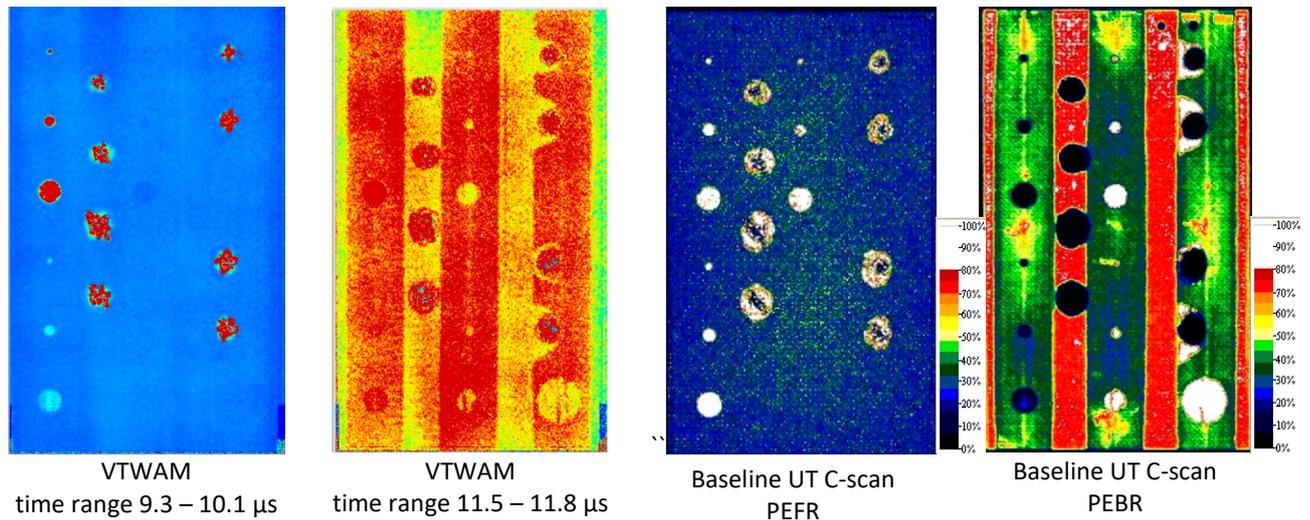
Figure 4.10: Comparison of PE-UPI VTWAM results with baseline UT C-scan results of panel NLR-B

Figure 4.10 gives a comparison of the PE-UPI VTWAM results with baseline UT C-scan results (PEFR and PEBR images). The figure shows that the baseline UT-scan images give a slightly better definition of the defects and their size and the presence of substructure (stiffeners) is also more clearly defined. However, this can also be expected because the baseline C-scan inspection was performed with a coupling medium (immersion mode) and used a focused UT transducer. All-in-all, it can be concluded that the PE-UPI system is capable of detecting relevant defects and that it is, hence, a viable option for in-service UT inspection of structures similar to the panel NLR-B configuration.

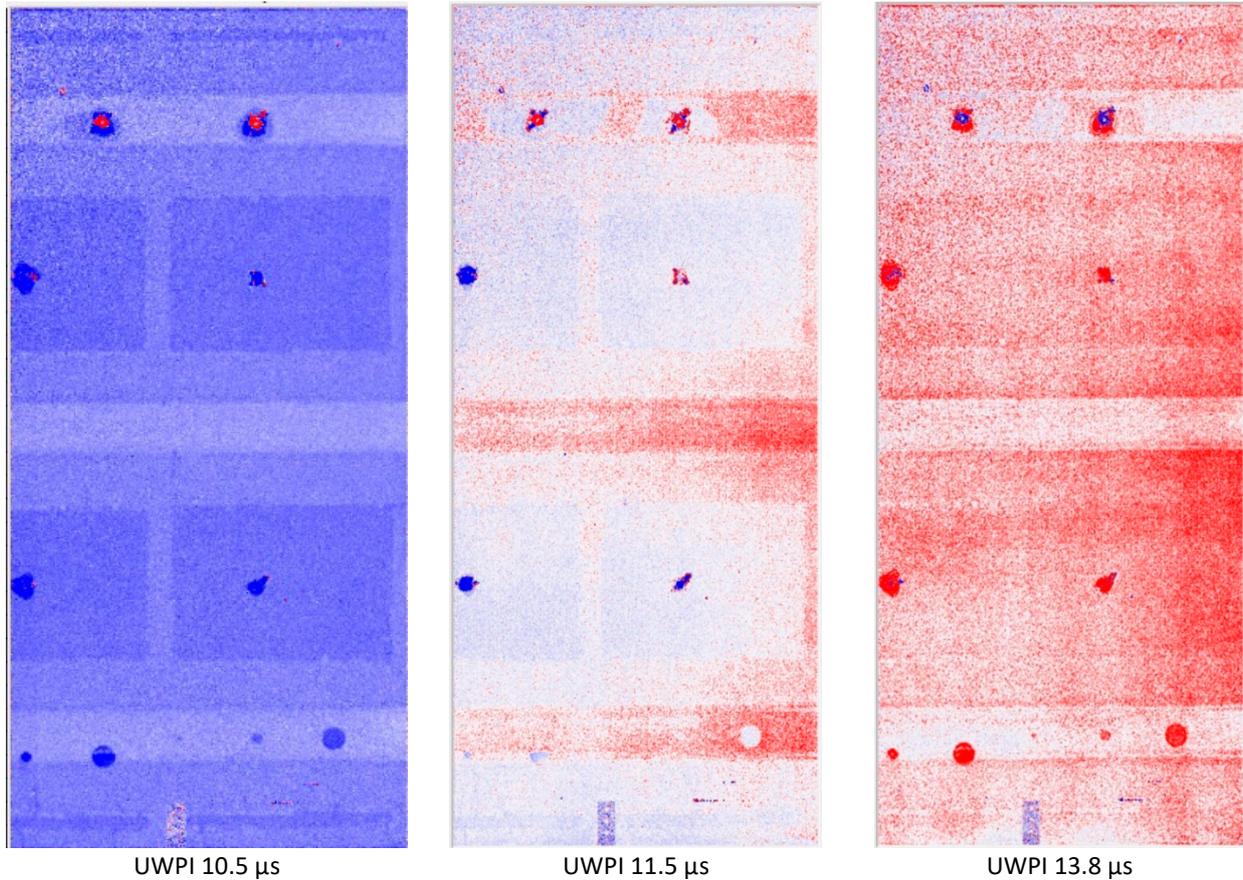
Figure 4.11: Three PE-UPI freeze frames at different times from the UWPI wave propagation movie of the right side of panel NLR-D (lower half of Fig. A2)

The PE-UPI inspection results for specimen NLR-D are given in Appendix C, figures C3 – C5. Because of the large size of the specimen and the limitation in scan range of the PE-UPI system the specimen was scanned in two parts with scan area of 420 x 900 mm² each. The two UWPI movies in figures C3 and C4 contain again the sequential display of all individual C-scan images of the reflected UT wave amplitudes in time over a total time period of 51.1 μ s. Figure C3 shows two examples (freeze frames) of the UWPI results of the left side of panel NLR-D and figure C5 two examples of the UWPI results of the right side of the panel. These times have again been selected by the PE-UPI system operator as being relevant and providing information about the presence of defects in this panel. Figure 4.11 includes the two UWPI freeze frames of the panel right side and an additional freeze frame at the specific time of 10.5 μ s. The different images in this figure clearly show the different views of present defects and structural details such as the presence of the ribs and honeycomb (filled or not filled with potting).

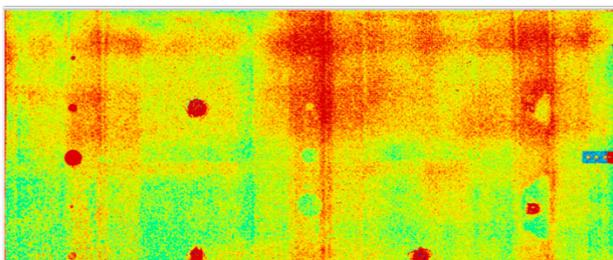
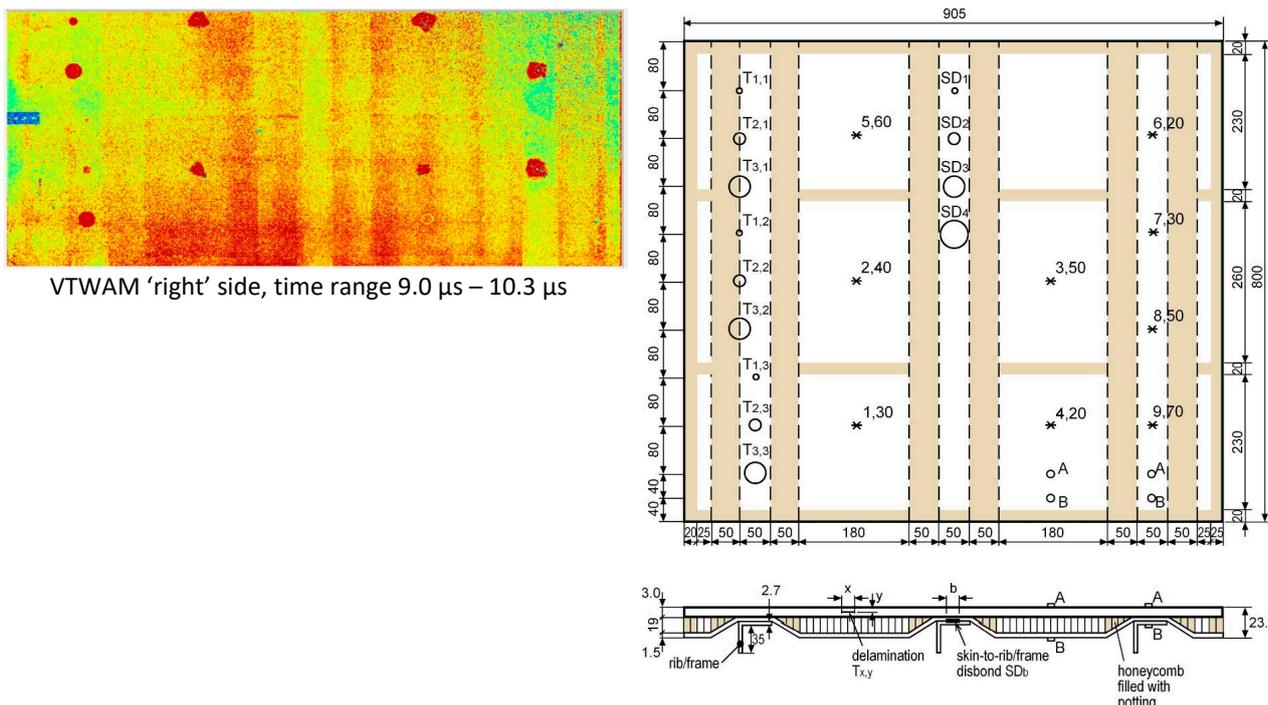
VTWAM 'left' side, time range 10.5 μ s – 13.5 μ s

Figure 4.12: PE-UPI VTWAM results from the UWPI wave propagation movies of the left and right sides of panel NLR-D

From the UWPI data relevant time ranges were selected by the PE-UPI system operator and further processed to produce VTWAM amplitude images, see figures C4 and C5. These figures have also been included in Figure 4.12 together with the NLR-D specimen drawing from figure A2. The VTWAM images have herewith been rotated 90° clockwise to resemble the panel view in figure A2. Figure 4.12 shows almost all defects in the panel (impact damages, artificial delaminations and disbonds) are reliably detectable. Only the small skin-to-rib disbond SD1 is qualified as detectable with limitation. This is, in fact, the same conclusion as was drawn for the baseline UT C-scan inspection, see Chapter 4.1.

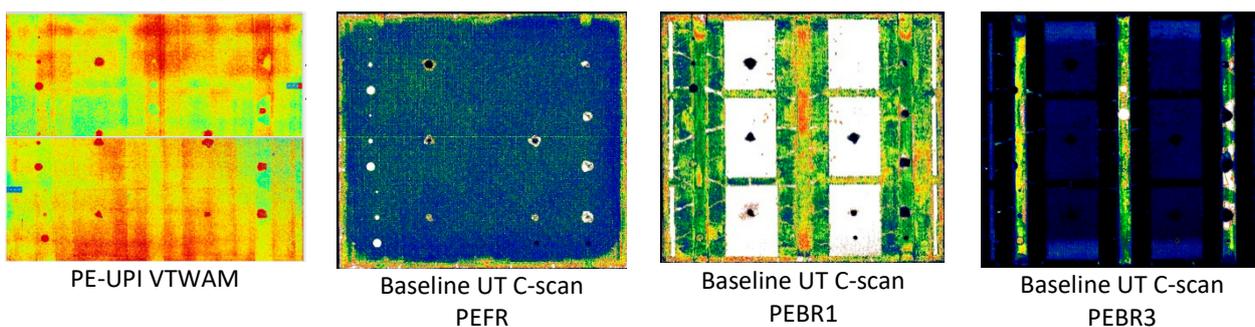
Figure 4.13: Comparison of PE-UPI VTWAM result with baseline UT C-scan results of panel NLR-D

Figure 4.13 gives a comparison of the PE-UPI VTWAM results with baseline UT C-scan results (PEFR and PEBR images, not the TT image because TT is not an in-service option with one-sided accessibility). The figure shows that the baseline UT-scan images have a slightly better defect detectability and a better definition of the presence of substructure. However, this can again be expected because the baseline C-scan inspection was performed with a coupling medium (immersion mode) and used a focused UT transducer. All-in-all, it can be concluded (as with panel NLR-B) that the PE-UPI system is capable of detecting relevant defects and that it is, hence, a viable option for in-service UT inspection of structures similar to the panel NLR-D configuration.

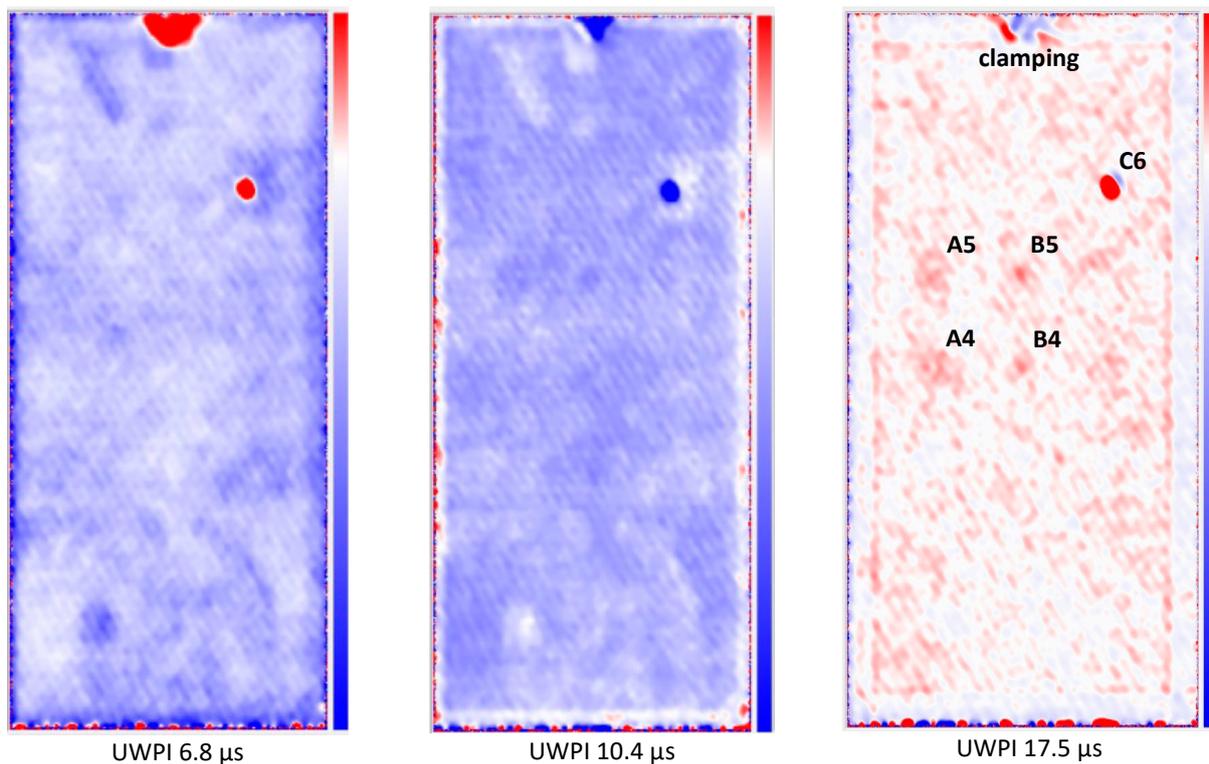
Figure 4.14: Three PE-UPI freeze frames at different times from the UWPI wave propagation movie of specimen #2118

The PE-UPI inspection results for RTM specimen #2118 are given in Appendix C, figure C6. A scan area of 100 x 200 mm² was used for this specimen. The UWPI movie in figure C6 contains again all individual C-scan images of the reflected UT wave amplitudes in time over a total time period of 51.1 μs. Figure C6 shows one example (freeze frame) of the UWPI at the specific time of 17.5 μs. Figure 4.14 includes this UWPI freeze frame and two additional freeze frames at the specific times of 6.8 and 10.4 μs. The figure shows that most defects in this panel are not detectable. Only the near-surface FBH C6 (depth 1 mm) is considered reliably detectable, and some FBH's at a depth of 4.4 mm (A5 and B5) and at a depth of 8.9 mm (A4 and B4) show some defect indication but with a poor signal-to-noise ratio.

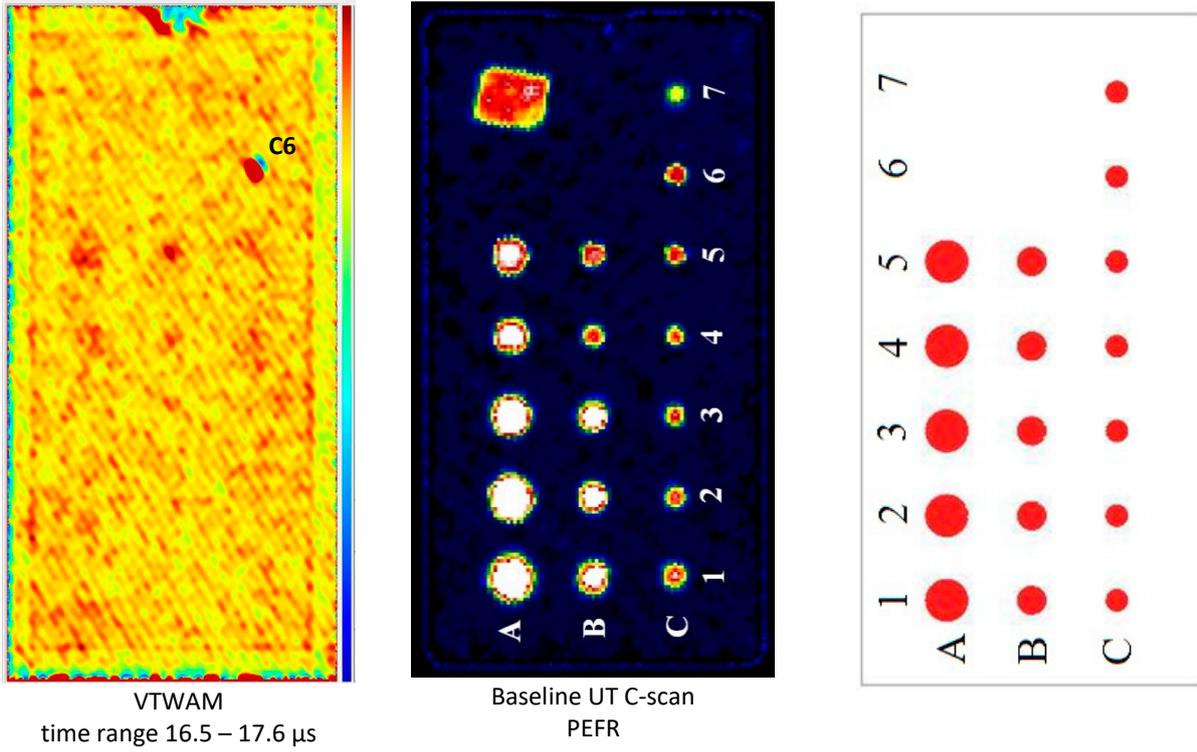
Figure 4.15: PE-UPI VTWAM result of RTM specimen #2118 together with a baseline UT C-scan result (PEFR image) and the specimen drawing

From the UWPI data, one relevant time range was selected by the PE-UPI system operator and further processed to produce a VTWAM amplitude images, see figure C6. This figure has also been included in figure 4.15 together with a baseline UT C-scan result (PEFR image) and the specimen drawing from figure 3.3. As with the UWPI image, only the near-surface FBH C6 is considered reliably detectable in the VTWAM image. FBH's A5 ($\varnothing 12\text{mm}$ at 4,4 mm depth) and B5 ($\varnothing 8\text{mm}$ at 4,4 mm depth) are considered detectable but the other FBH's at a depth of 4.4 and 8.9 mm have a too low signal-to-noise ratio. The other FBH's at larger depth and the manufacturing defect (foil) are clearly undetectable. This poor defect detectability is in great contrast with the result for the baseline UT inspection. A possible explanation for the poor defect detectability might be the specimen thickness (27 mm) and/or the fibre waviness present in this specimen. However, these explanations are not definite and more investigation is needed to conclude the cause of this poor performance. A contributing factor can also be the surface finish of specimen #2118 (shiny and unpainted, in contrast with the NLR-B and NLR-D specimens that are painted and have a mat finish) that can influence the effectiveness of the laser systems. All-in-all, it can be concluded that the PE-UPI system seems not a good option for in-service UT inspection of structures similar to the RTM specimen #2118 configuration.

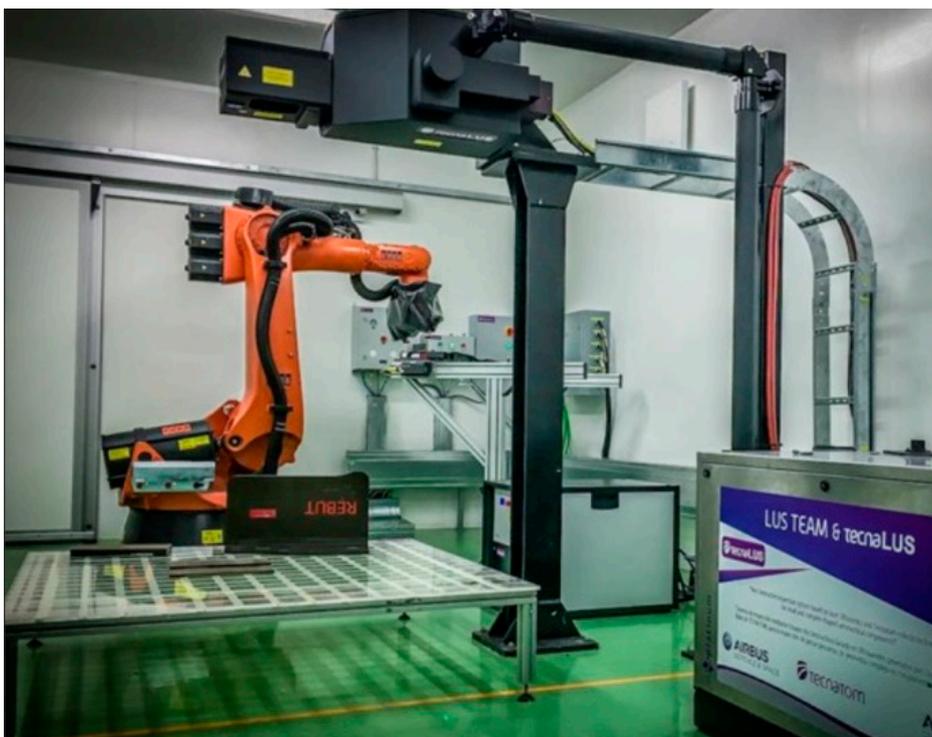
Figure 4.16: Tecnatom TecnaLUS system

1. A pulsed CO₂ generation laser with an energy of 180 mJ/puls at a wavelength of 10.6 μm . Main advantage of a CO₂ laser is the efficient generation of longitudinal waves in composite specimen, in contrast to the Nd:YAG laser with much smaller wavelength, where many wave types are generated (besides longitudinal, transverse, Lamb and Rayleigh waves). This laser also gives less chance on surface damage. Main disadvantage is that CO₂ have to use periscopic or mirror systems to guide the waves and cannot be integrated with fibre transmission.
2. Nd:YAG detection laser with a wavelength of 1.064 μm in combination with a Fabry-Perot interferometer.

Both laser systems are co-linear aligned (towards the common surface point). The TecnaLUS system has been optimized by the manufacturer with the consequence that relative minor settings can be altered by the user. Main setting parameter is the surface spot size of the generation laser (variation between 10 and 16 mm). A smaller spot size increases the energy share in the ultrasonic high frequency band. Stand detection frequency band in operation is between 0.5 and 20 MHz, for composites the band is somewhat lower between 0.5 and 8 MHz. The broadband spectrum leads to a good near-surface resolution. Ultrasonic generation with a CO₂ laser has a large tolerance with respect to laser incident angles: flat surfaces $\pm 25^\circ$ and rough surfaces $\pm 40^\circ$. The inspection philosophy of Tecnatom is that their system is less suitable for the inspection of large flat structure/components but more suitable to inspect smaller components with a complex geometry. The price of the used system is about 2.5 M€.

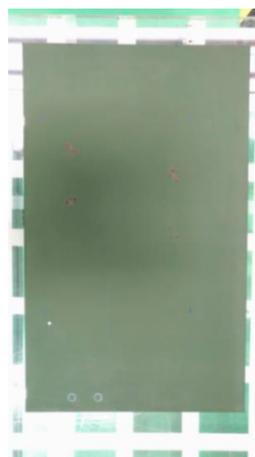
Table 4.2: Scan parameters and panel

Inspection Time (s):	36
Inspection pose:	1
Step Size (mm):	2
X dimension (mm):	315
Y dimension (mm):	505
X center (mm):	0
Y center (mm):	0

Scan results of the TecnaLUS system (both delamination $T_{x,y}$ and Disbonds SD_b) are good, both for the Amplitude as Time of Flight depending at different gate settings (Fig. 4.17).

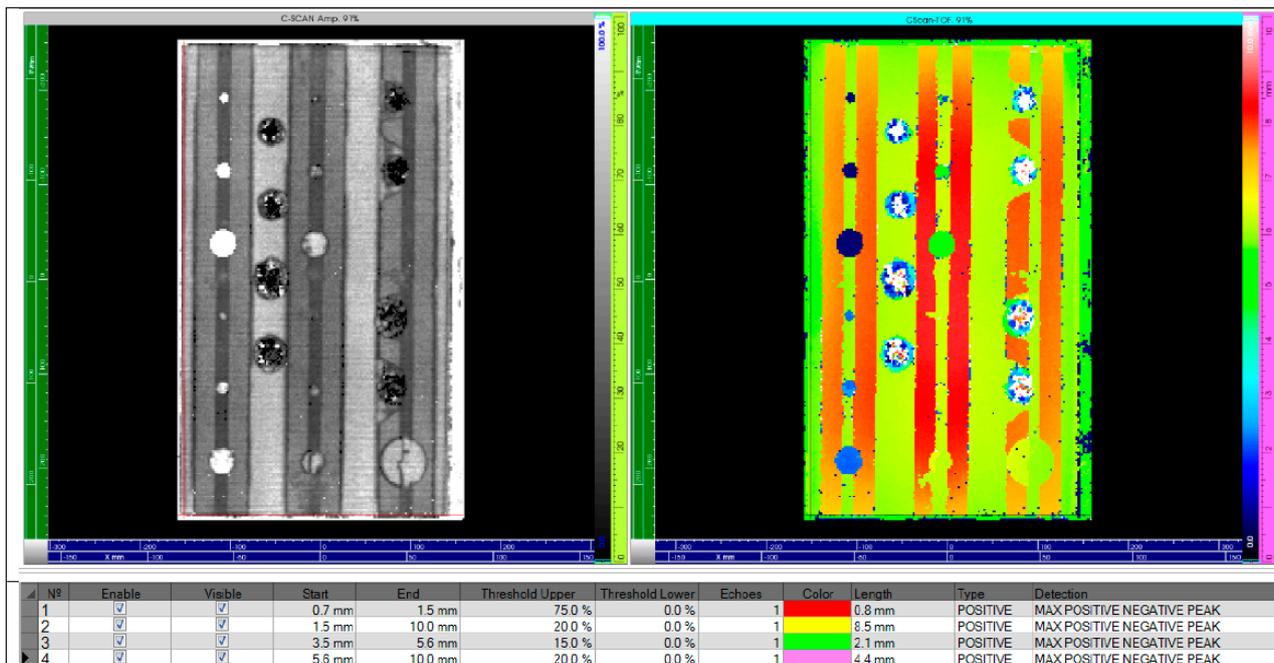
Figure 4.17: TecnaLUS C-Scan results on panel NLR-B (left amplitude, right time of flight)

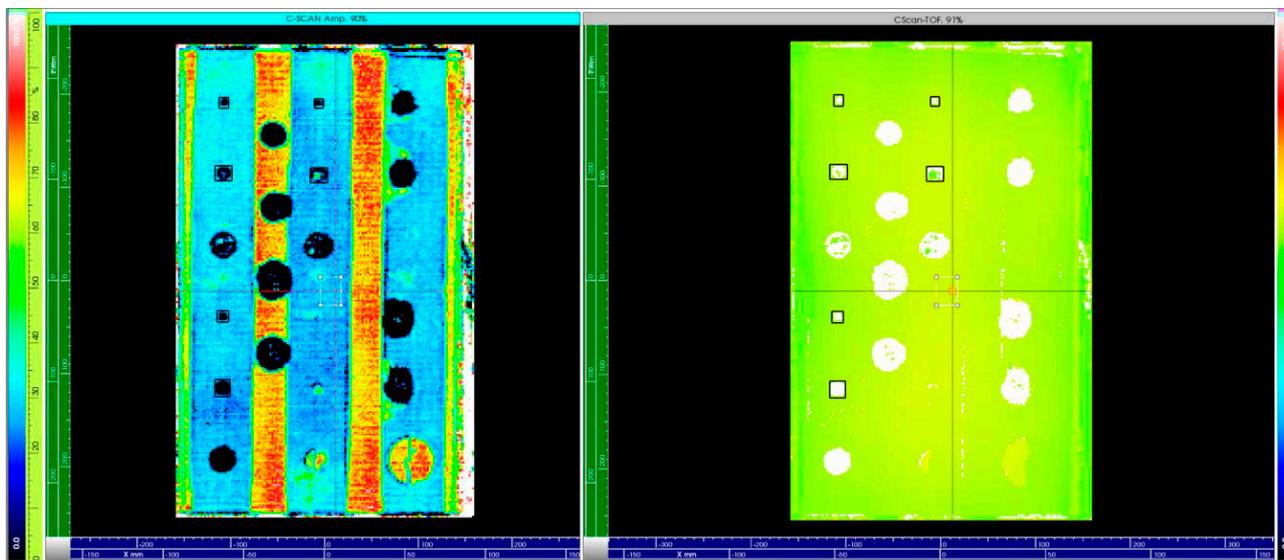
Figure 4.18: TecnaLUS C-Scan results on panel NLR-B (left amplitude, right time of flight) at gate setting 5.8-6.5 mm

Another convincing and illustrative example is the C-scan result (amplitude and time of flight) at gate setting 5.8 – 6.5 mm is shown in figure 4.18.
