NLR-CR-2019-100-RevEd-1 | July 2023

Round Robin Test Results of Laser Ultrasonic Systems on Composite Panels

CUSTOMER: OPZuid (Operationeel Programma Zuid-Nederland)

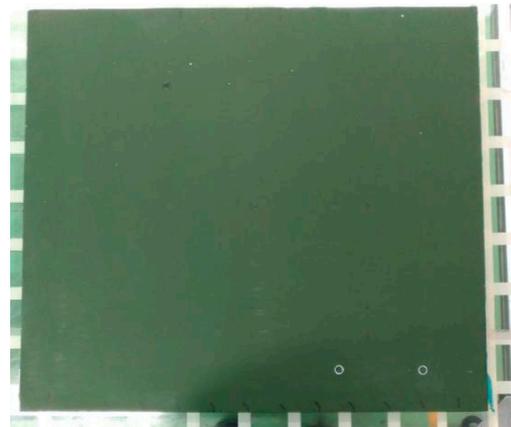
Table 4.4: Scan parameters and panel

Inspection Time (s):	4
Inspection pose:	1
Step Size (mm):	2
X dimension (mm):	940
Y dimension (mm):	840
X center (mm):	0
Y center (mm):	0

The results with the TecnaLUS system on NLR-D panel are good (Fig. 4.19).

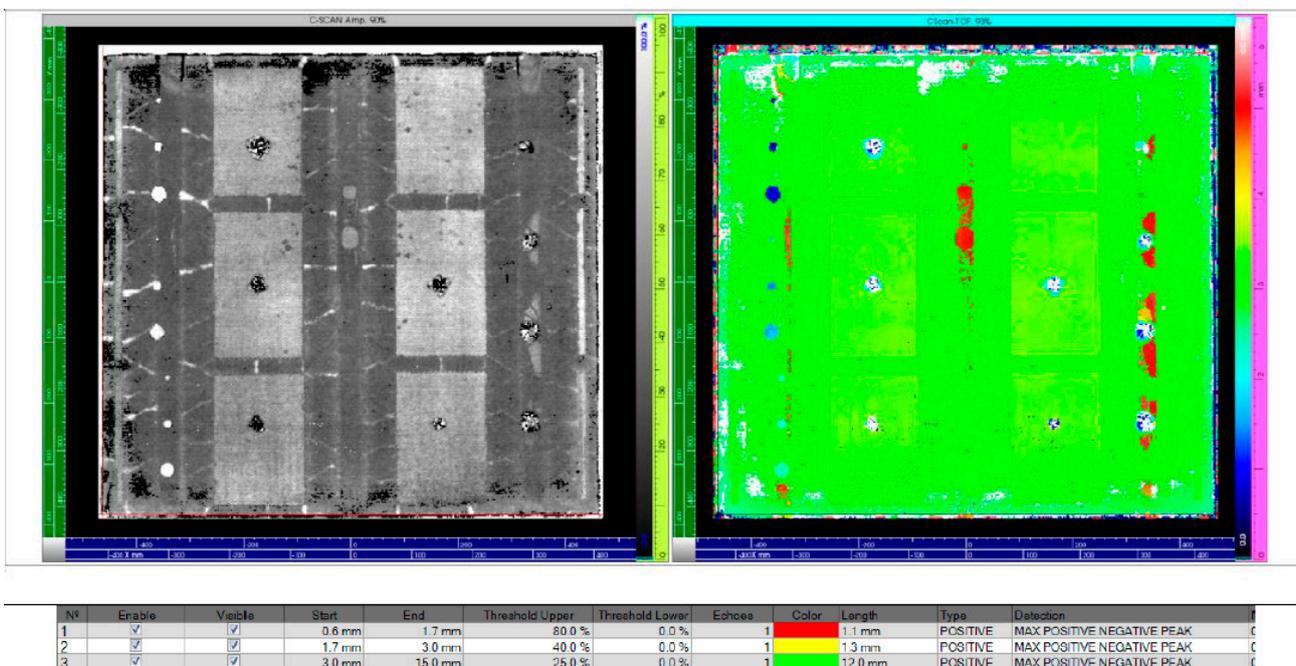
Figure 4.19: C-scan results (amplitude and TOF) of NLR-D panel, gate settings: 0.6 – 15 mm

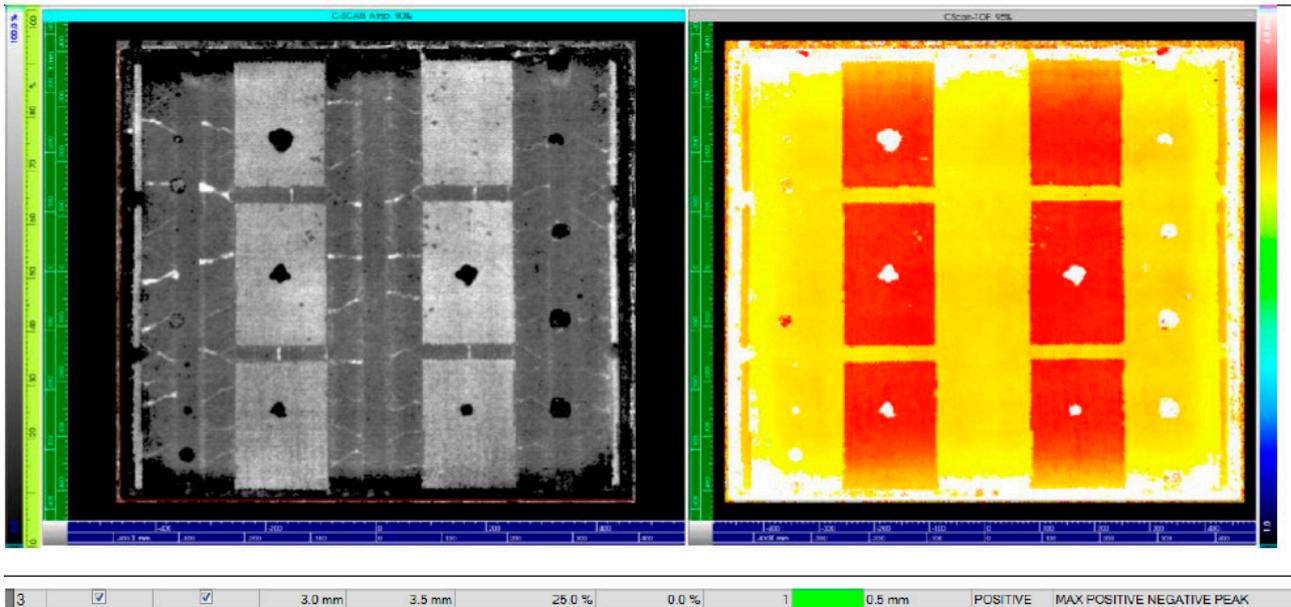
Figure 4.20: C-scan results (amplitude and TOF) of NLR-D panel, gate settings: 3 – 3.5 mm

Good results are also reproduced at different gate settings (3 – 3.5 mm, fig. 4.20).

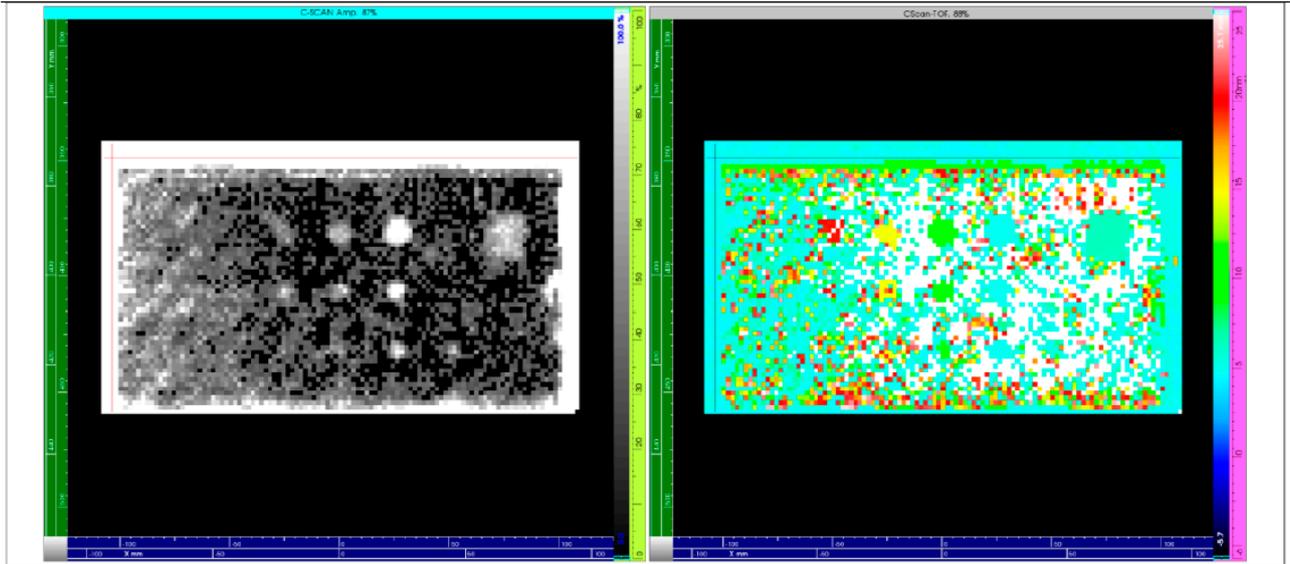
Figure 4.21: C-Scan overview (amplitude and TOF), gate setting 4.5-25.1 mm

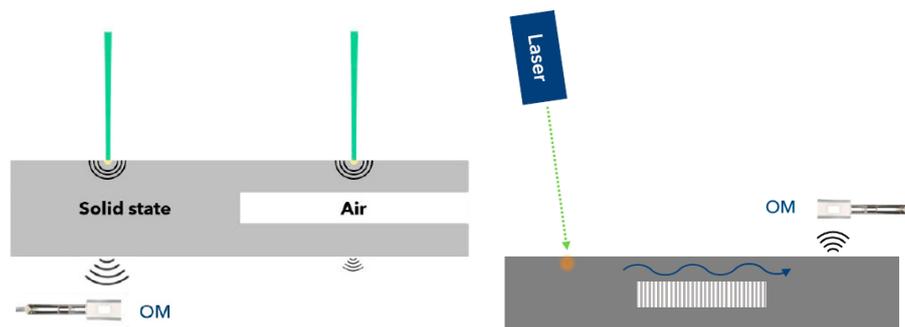
Figure 4.23: Transmission and pitch & catch mode using the Xarion optical microphone

It is noted that the transmission mode is hampered by the alignment of the excitation and detection probes, which also may limit the accessibility.

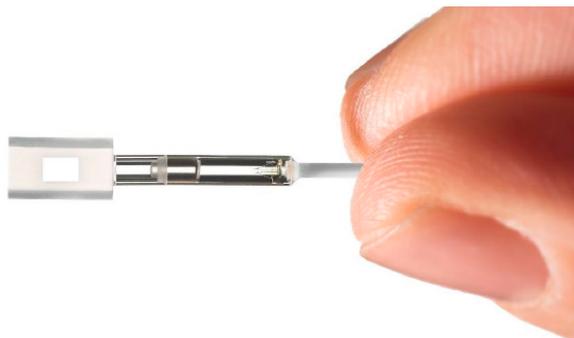
The detection probe consists of a small-sized optical microphone based on laser interferometry principles (Fig. 4.24, Ref 31). Features are:

1. Broad frequency range due to the absence of moving membranes (10 Hz to 2 MHz).
2. Immunity to electromagnetic fields.
3. Operational in air and liquids.
4. Long optical fibre cabling possible (attenuation 0.3 dB/km).

Figure 4.24: Xarion optical microphone (Ref. 31)

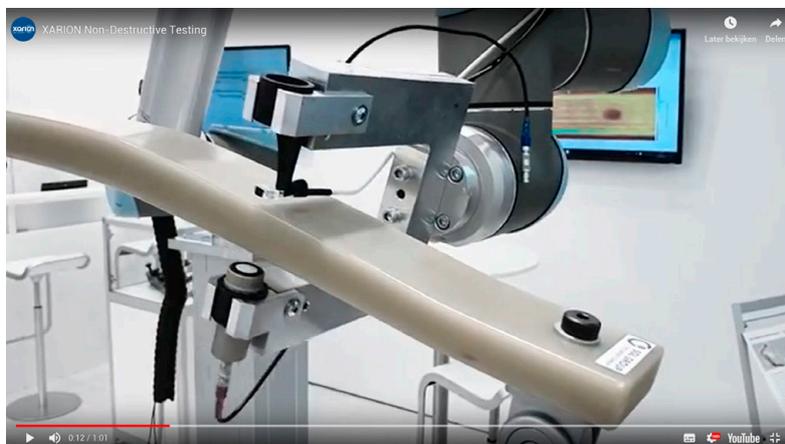
The frequency range for acoustic applications is rather broad, though for Ultrasonic applications still limited (but may be sufficient dependent on the application). Typical ultrasonic frequency bandwidth is 400 kHz, maximum bandwidth is 2 MHz. The transmission test set-up is shown in fig. 4.25.

Figure 4.25: The Xarion transmission set-up with aligned excitation laser (under) and optical microphone

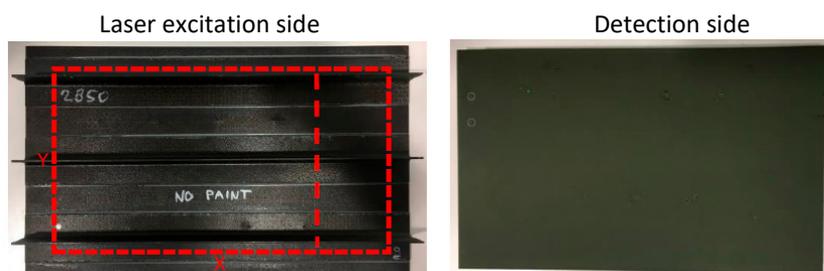
Figure 4.26: Excitation and detection sides of panel NLR-B

The excitation and detection side are depicted in figure 4.26. Due to the presence of the stiffeners, the ultrasonic microphone, which requires to be close to the test specimen in order of 10 mm, had to be placed on the flat surface side. Note that this is one of important limitations of this method. Results of the transmission mode measurements show clearly the locations of the defects (Fig. 4.27). Contrary to PE measurements, transmission mode measurements don't contain depth information. Remark: the transmission mode is not suitable for MRO applications because two sided access is needed.

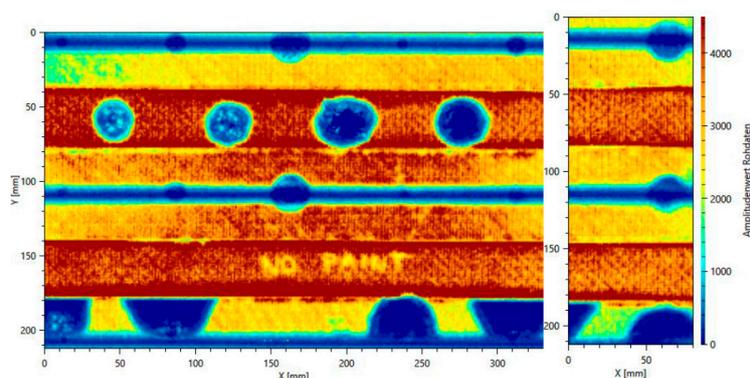
Figure 4.27: Xarion transmission mode amplitude results on panel NLR-B

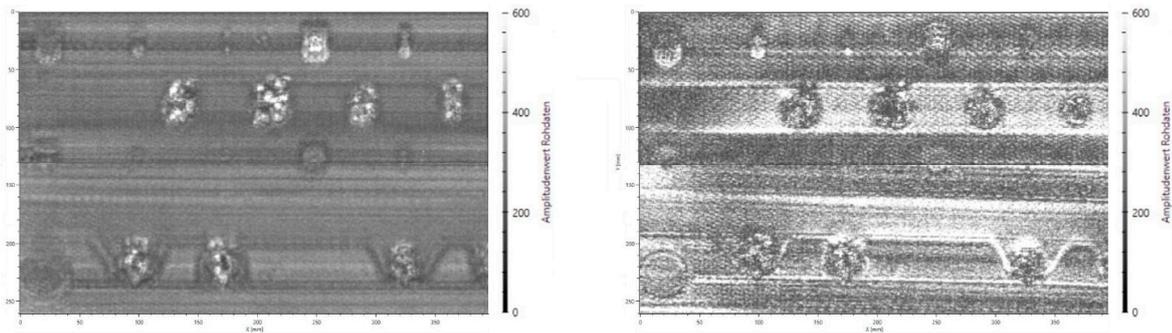
Figure 4.28: Xarion pitch & catch results on the NLR-B panel

The provisional results on the NLR-B panel in pitch & catch mode show results on the locations of the defects (Fig. 4.28). The displayed C-scans refer to the same measurements but represent different time frames.

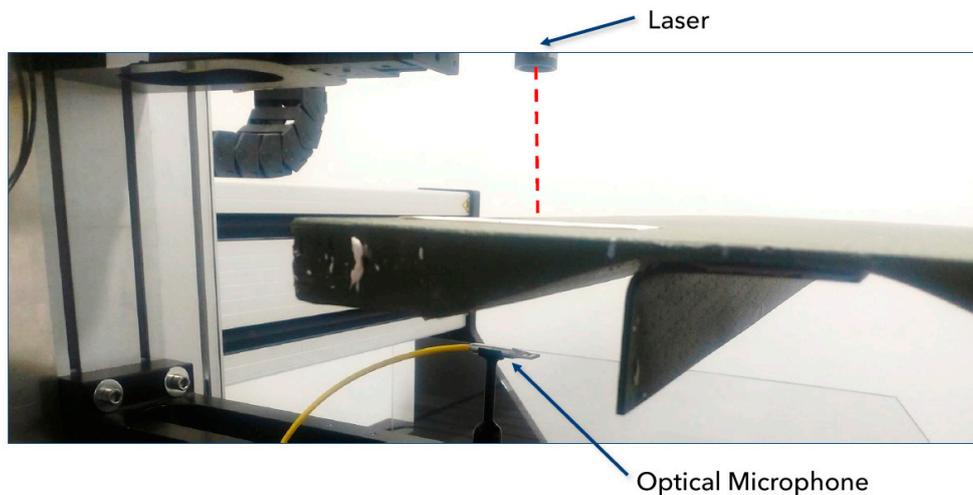
Figure 4.29: Xarion set-up for the NLR-D transmission measurements

It is noted that for panel NLR-D only transmission measurements have been carried out.

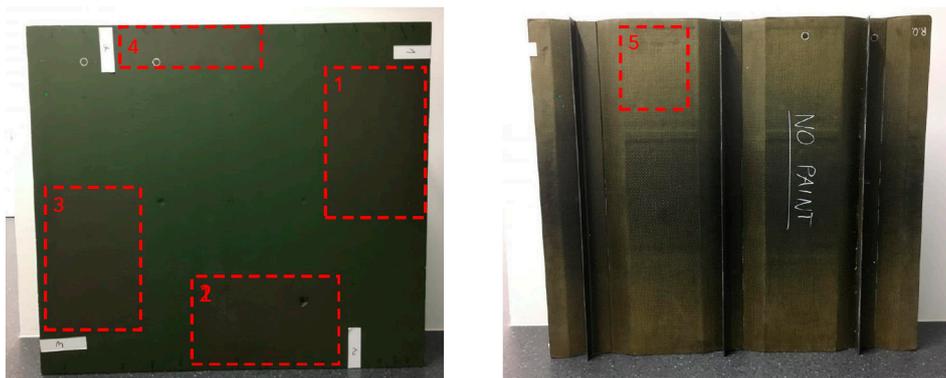
Figure 4.30: Numbering of measurement areas of panel NLR-D

Five excitation and measurement areas are indicated in figure 4.30. It is noted that these locations are near the panels edges due to the U-shaped transmission head, which at present prevents full area coverage.

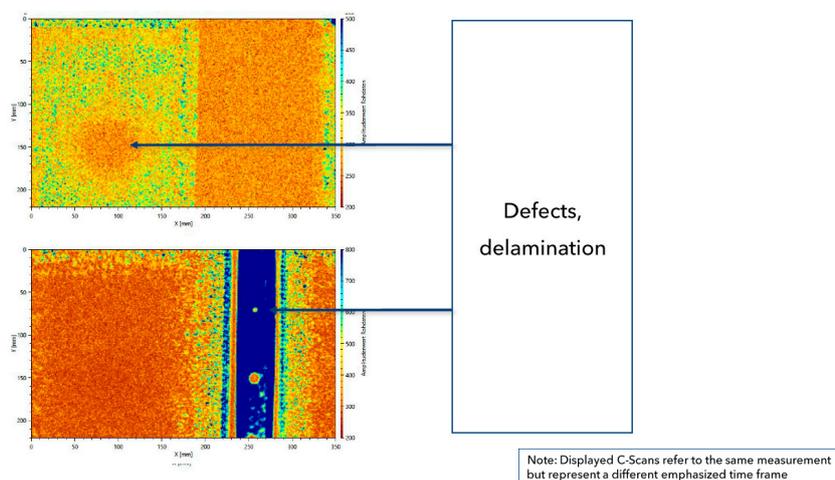
Figure 4.31: Xarion transmission result on area 2 of panel NLR-D

The location of defects in area 1 are shown figure 4.31. The different C-scans refer to the same measurement with a different chosen time frame. Interpretation of the results is facilitated by the knowledge of the artificial defects.

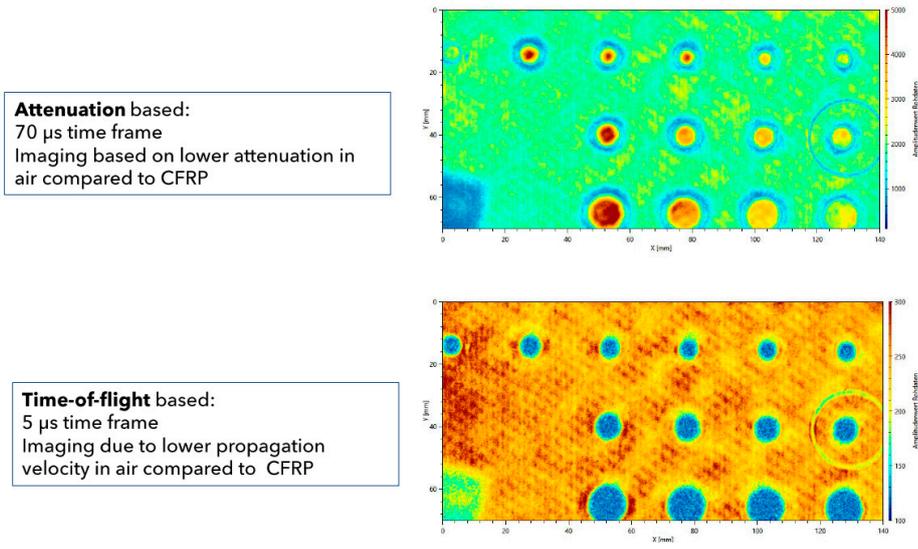
Figure 4.35: Results of Xarion transmission mode measurements on panel #2118

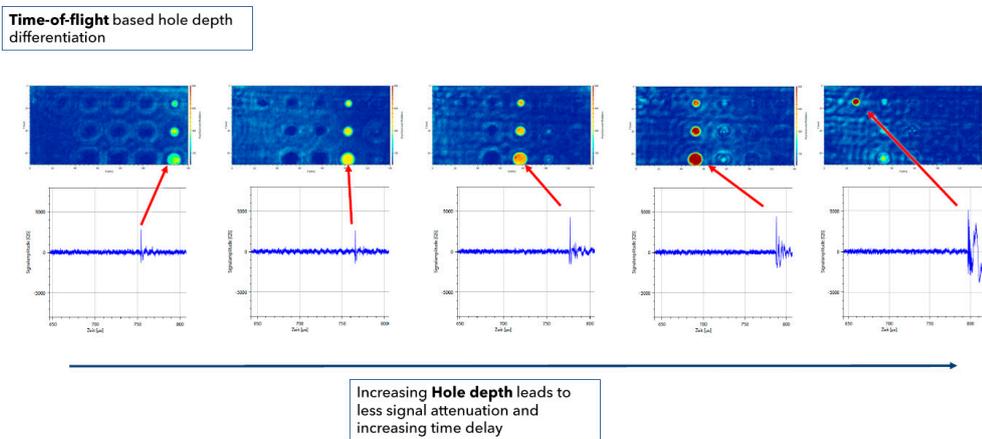
Figure 4.36: Provisional exploration of depth estimation by Xarion transmission measurements using attenuation and time-of-flight parameters

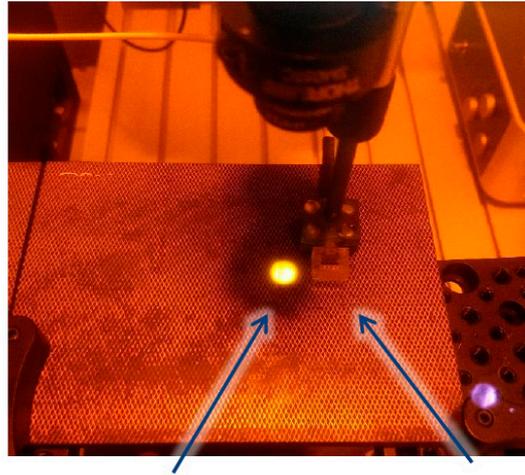
The pitch and catch measurements on panel #2118 have been performed from the opposite side of the defects (flat surface, fig. 4.37).

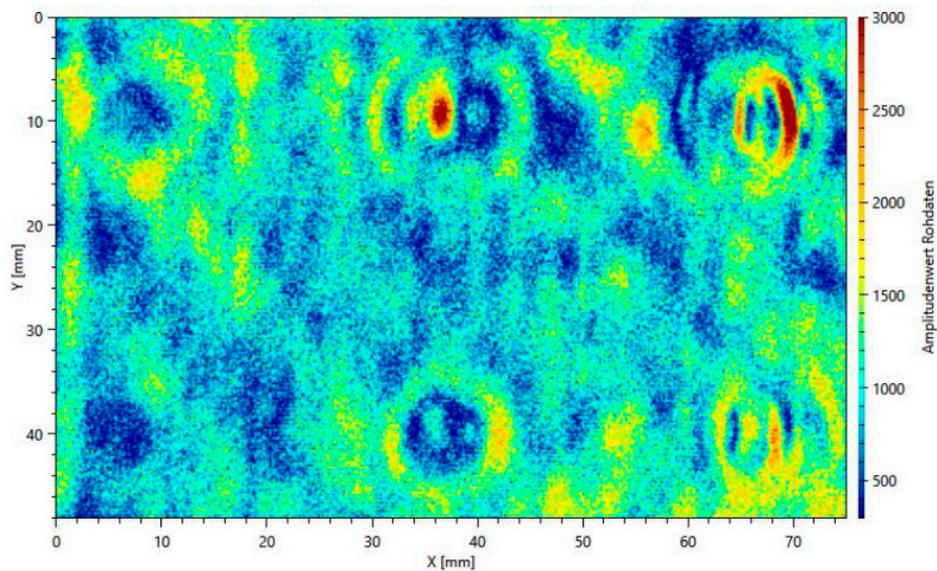
Figure 4.38: Final Xarion catch & pitch results on panel #2118

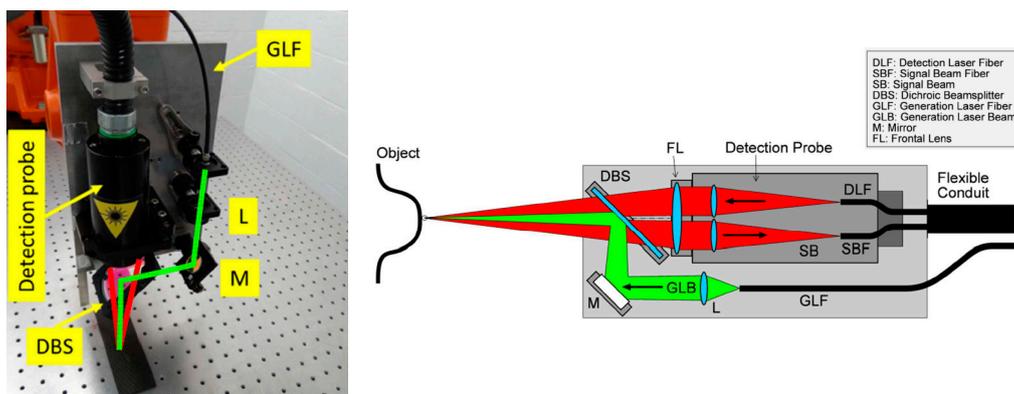
Figure 4.41: The fibre based CLS probe with Tecnar co-linear excitation and detection lasers

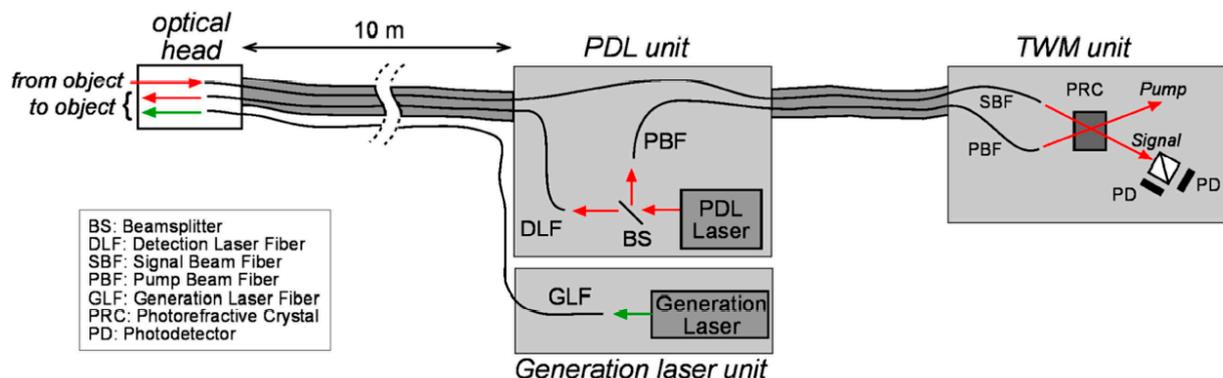
Figure 4.42: Overall scheme of CLS equipment

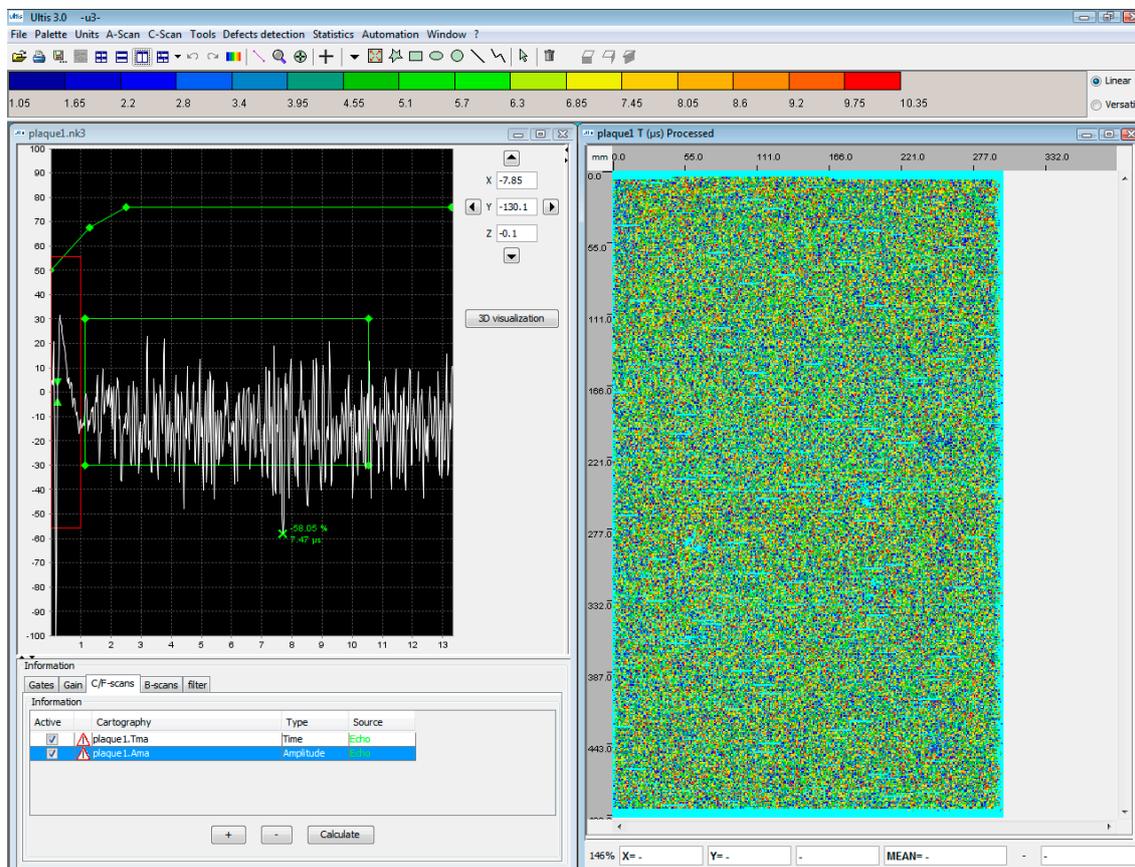
Fig. 4.43: C-scan time of flight response of the NLR-B panel (right window)

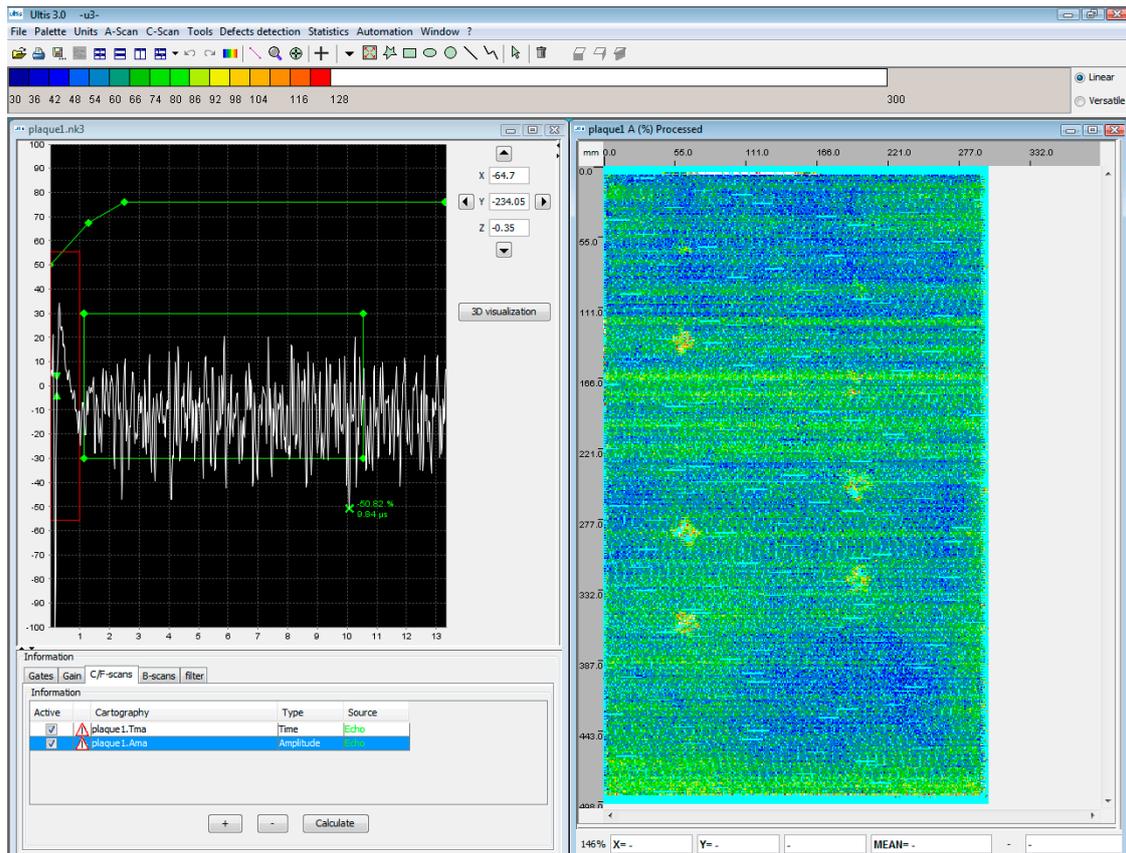
Fig. 4.44: C-scan amplitude response of the NLR-B panel (right window)

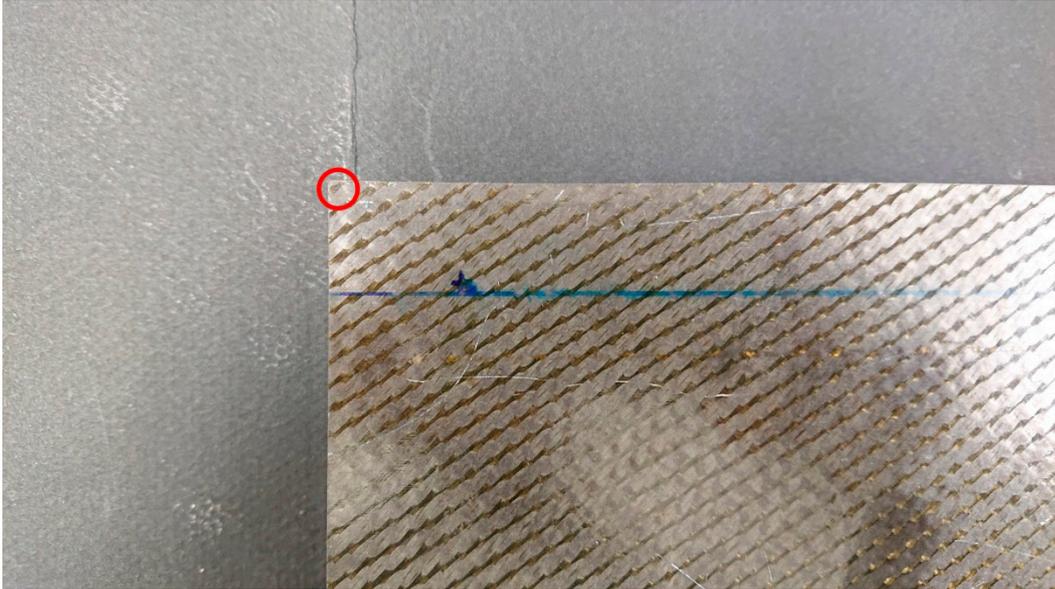
Fig. 4.45: Assessment of laser generated damage effects on panel #2118

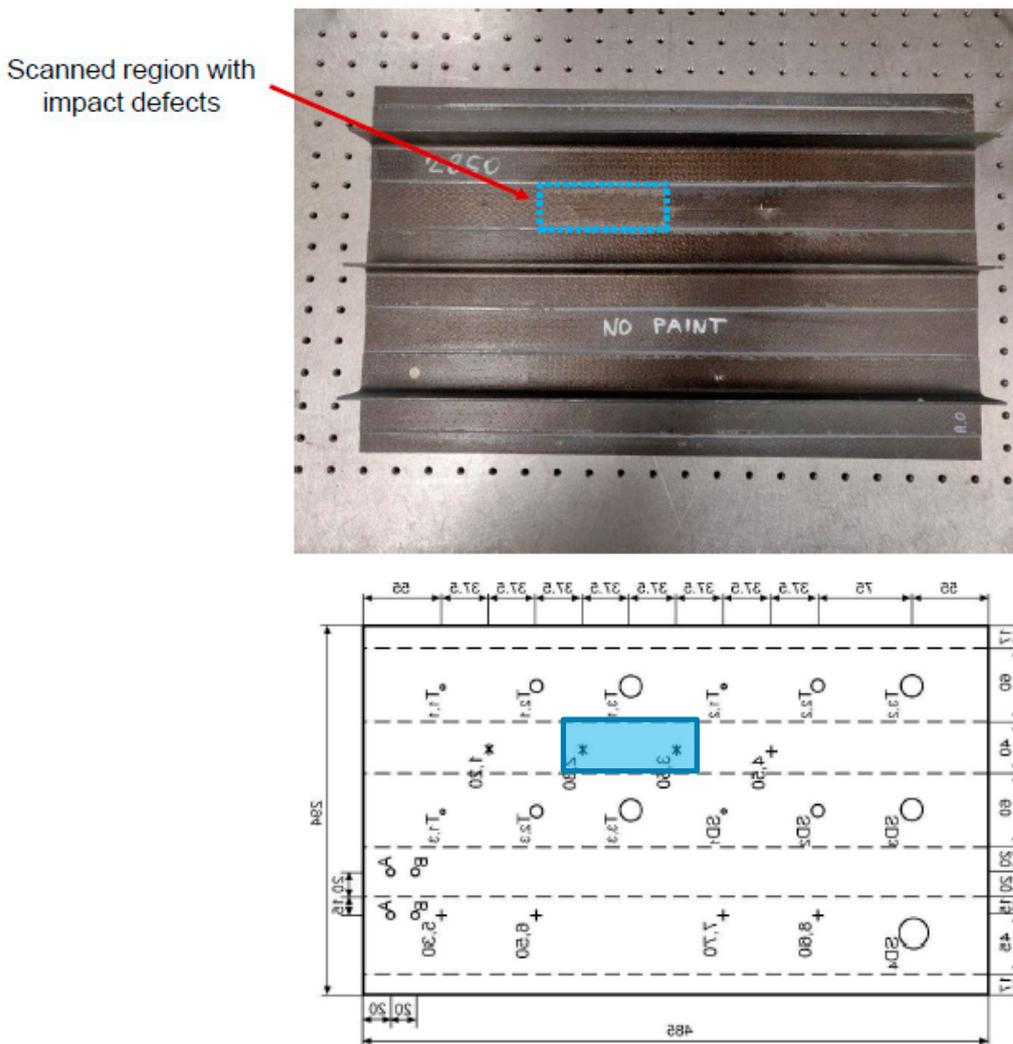
Fig. 4.49: Selected region on the unpainted back wall of panel NLR-B (to be checked)

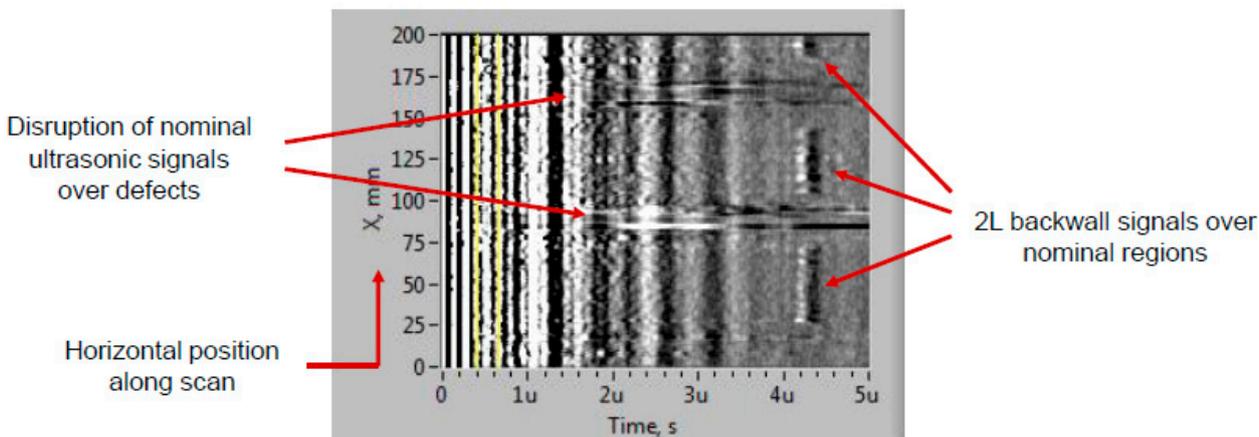
Fig. 4.50: B-scan results on selected region on panel NLR-B

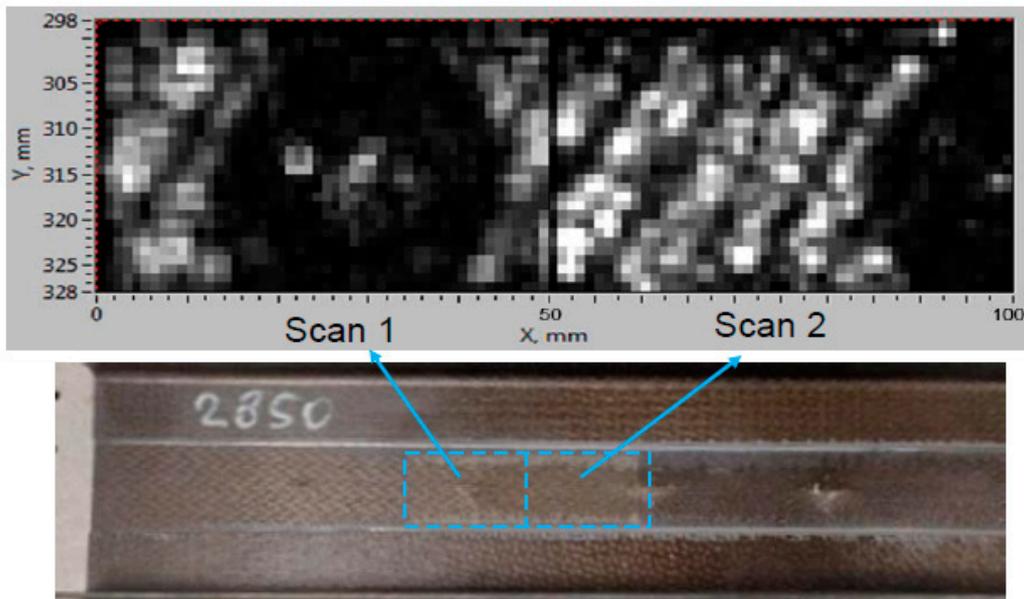
Two C-scans were acquired in neighboring regions then combined. Each C-scan was generated by plotting the peak-to-peak amplitude of the 2L backwall signal at each position

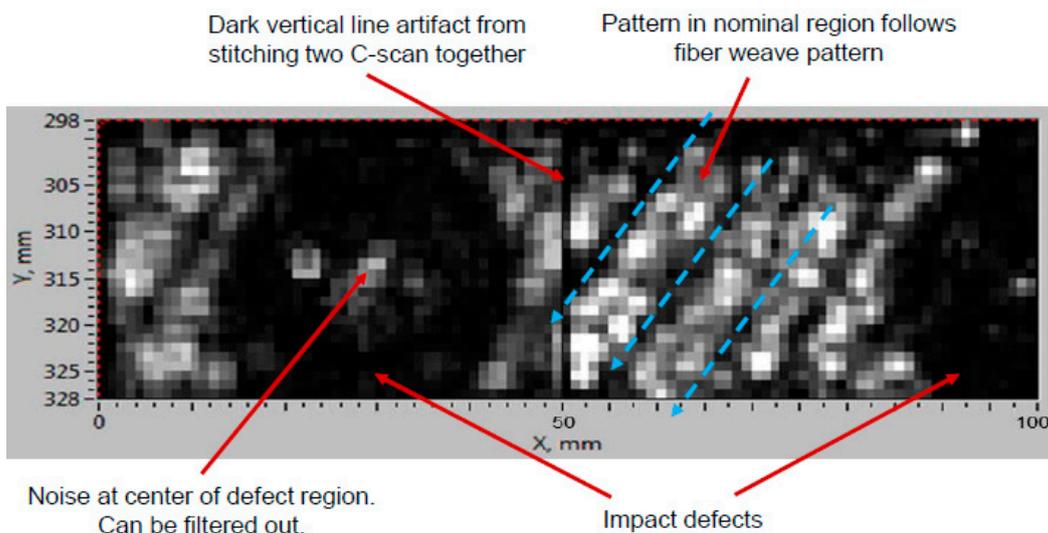
Fig. 4.52: Combined high resolution C-scan of the impact defects

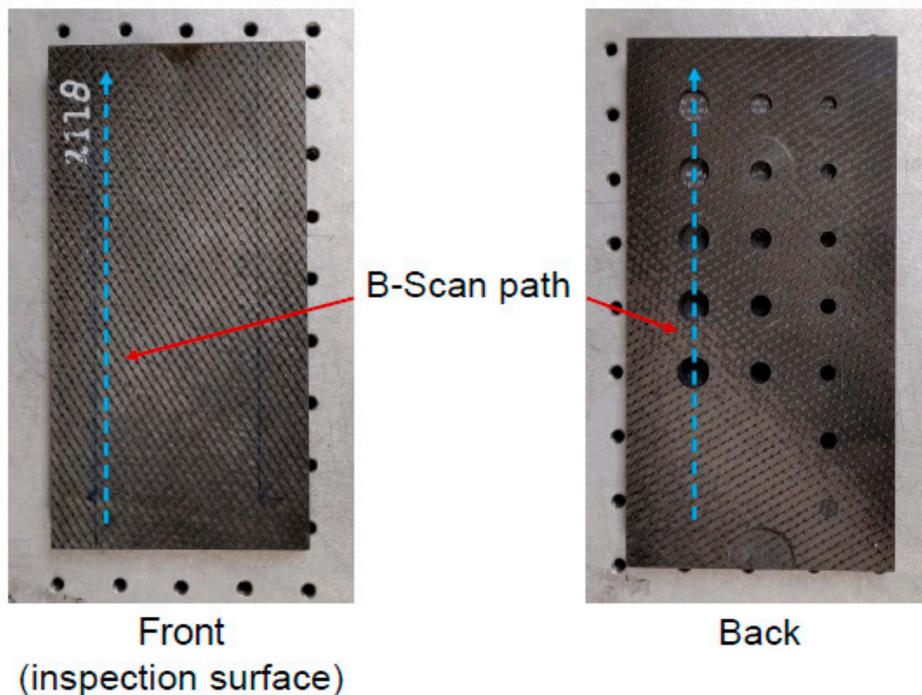
Fig. 4.53: Scanning line of panel #2118

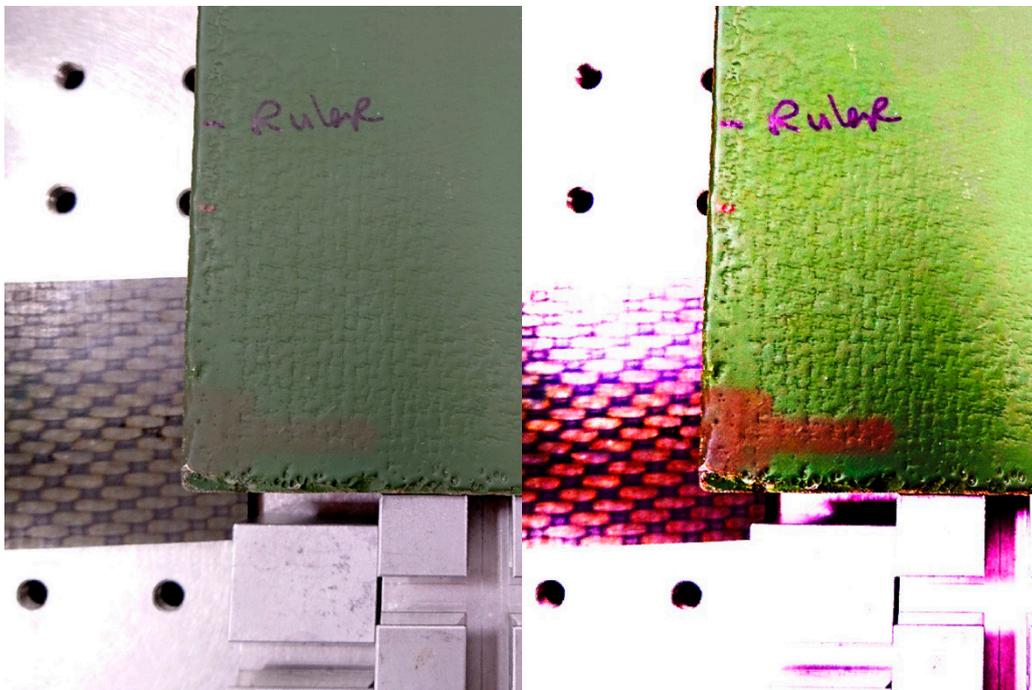
Fig. 4.55: Discolouration of NLR-D panel tested at CSL with Tecnar equipment

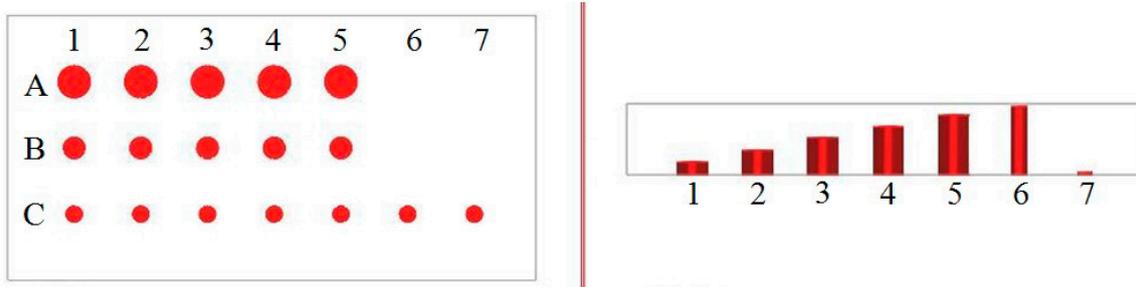
Fig. A3: Specimen #2118, RTM calibration specimen with flat-bottomed holes)

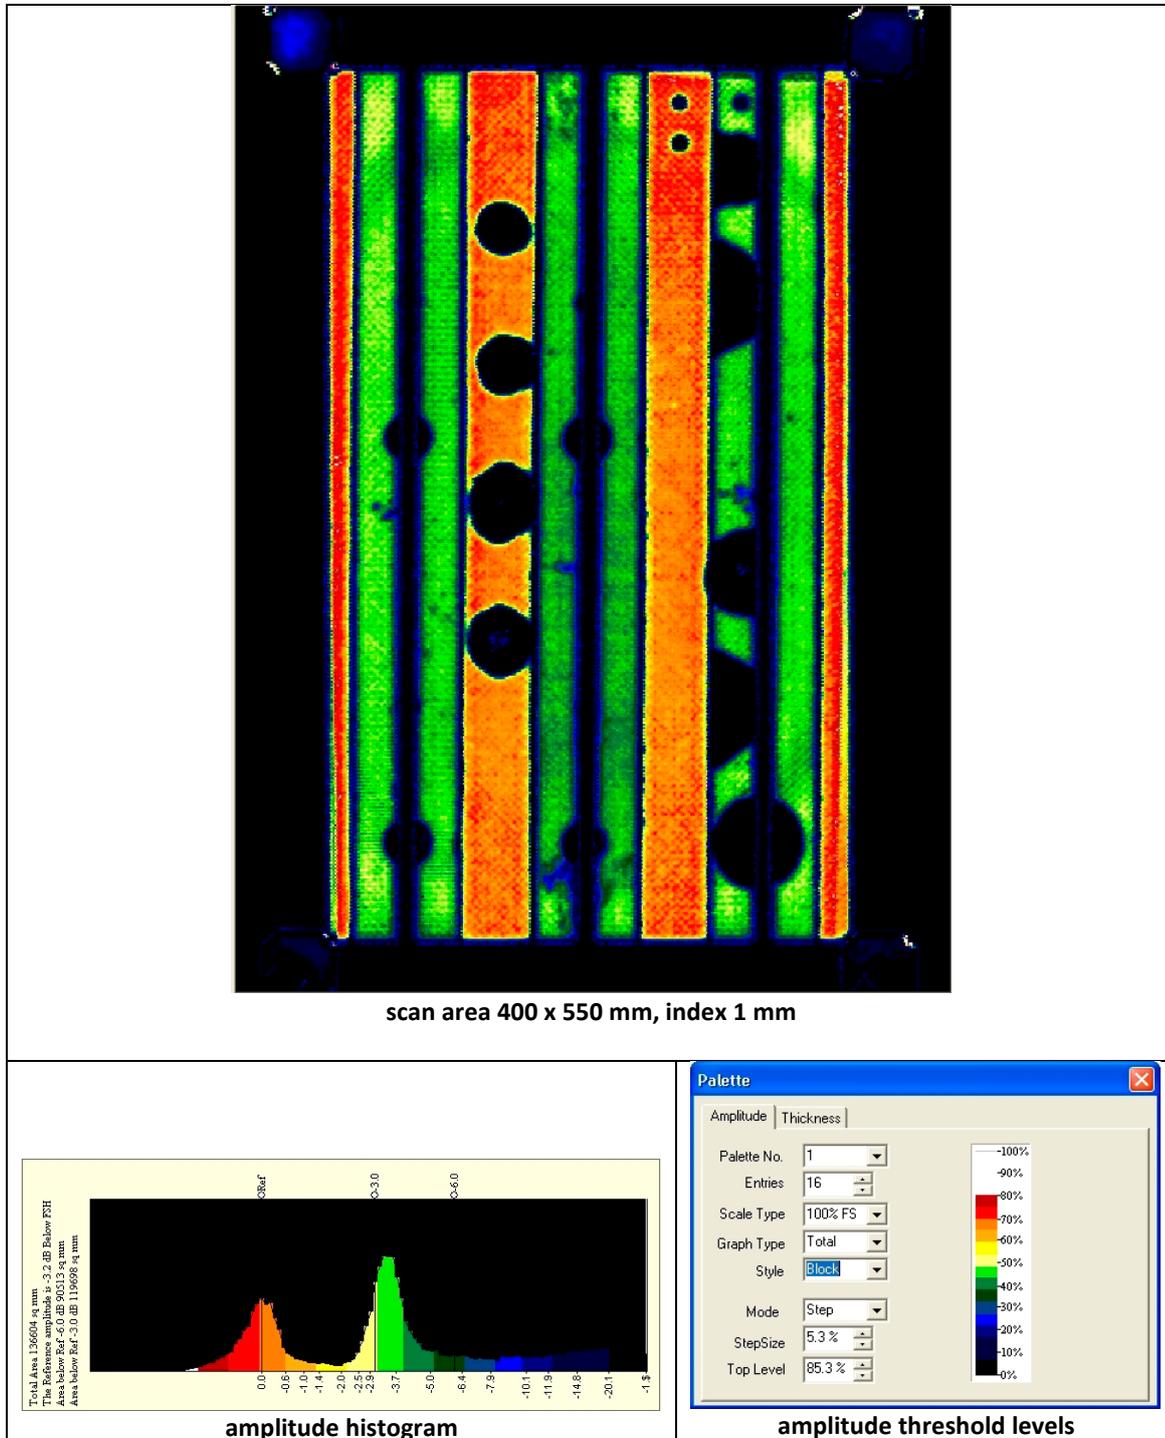
Fig. B1: Ultrasonic C-scan inspection of specimen NLR-B. Immersion mode. Double-through transmission (DTT) inspection with a 5 MHz focused transducer (Fig. B7 from Ref. 1

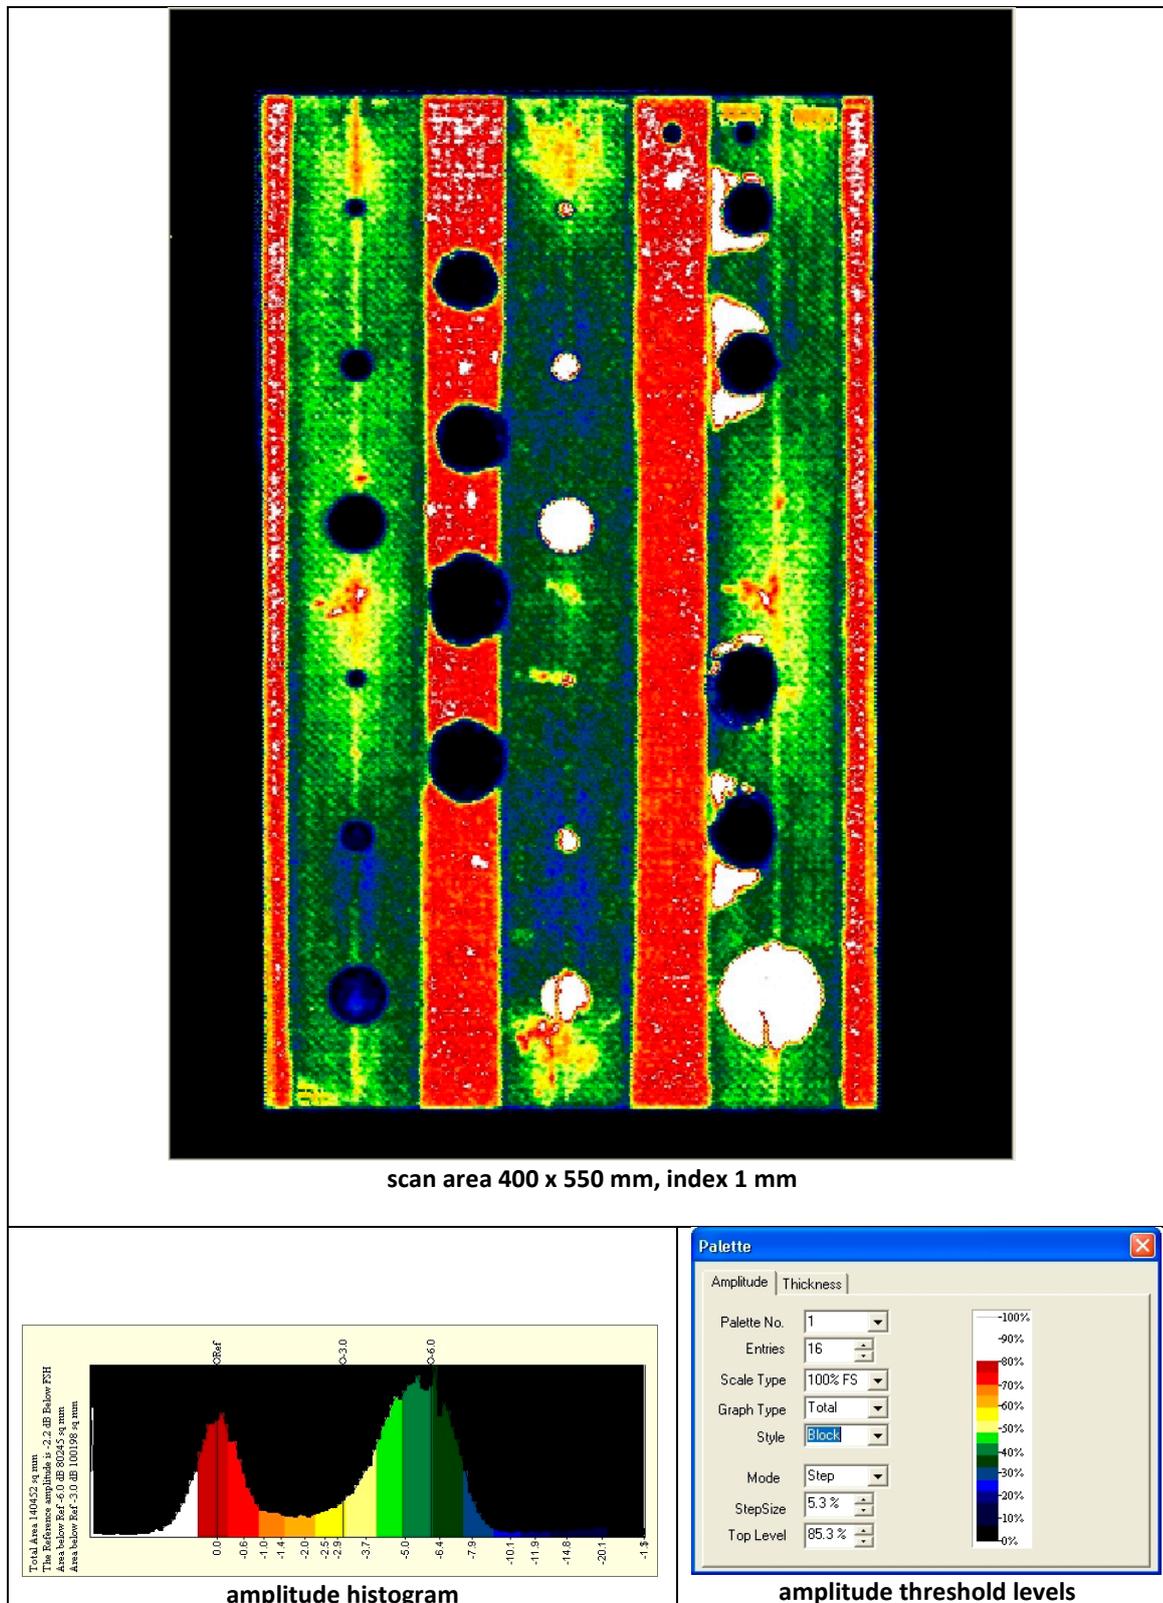
Fig. B2: Ultrasonic C-scan inspection of specimen NLR-B. Immersion mode. Pulse echo backwall-skin reflection (PEBR1) inspection with a 5 MHz focused transducer (Fig. B8 from Ref. 1)

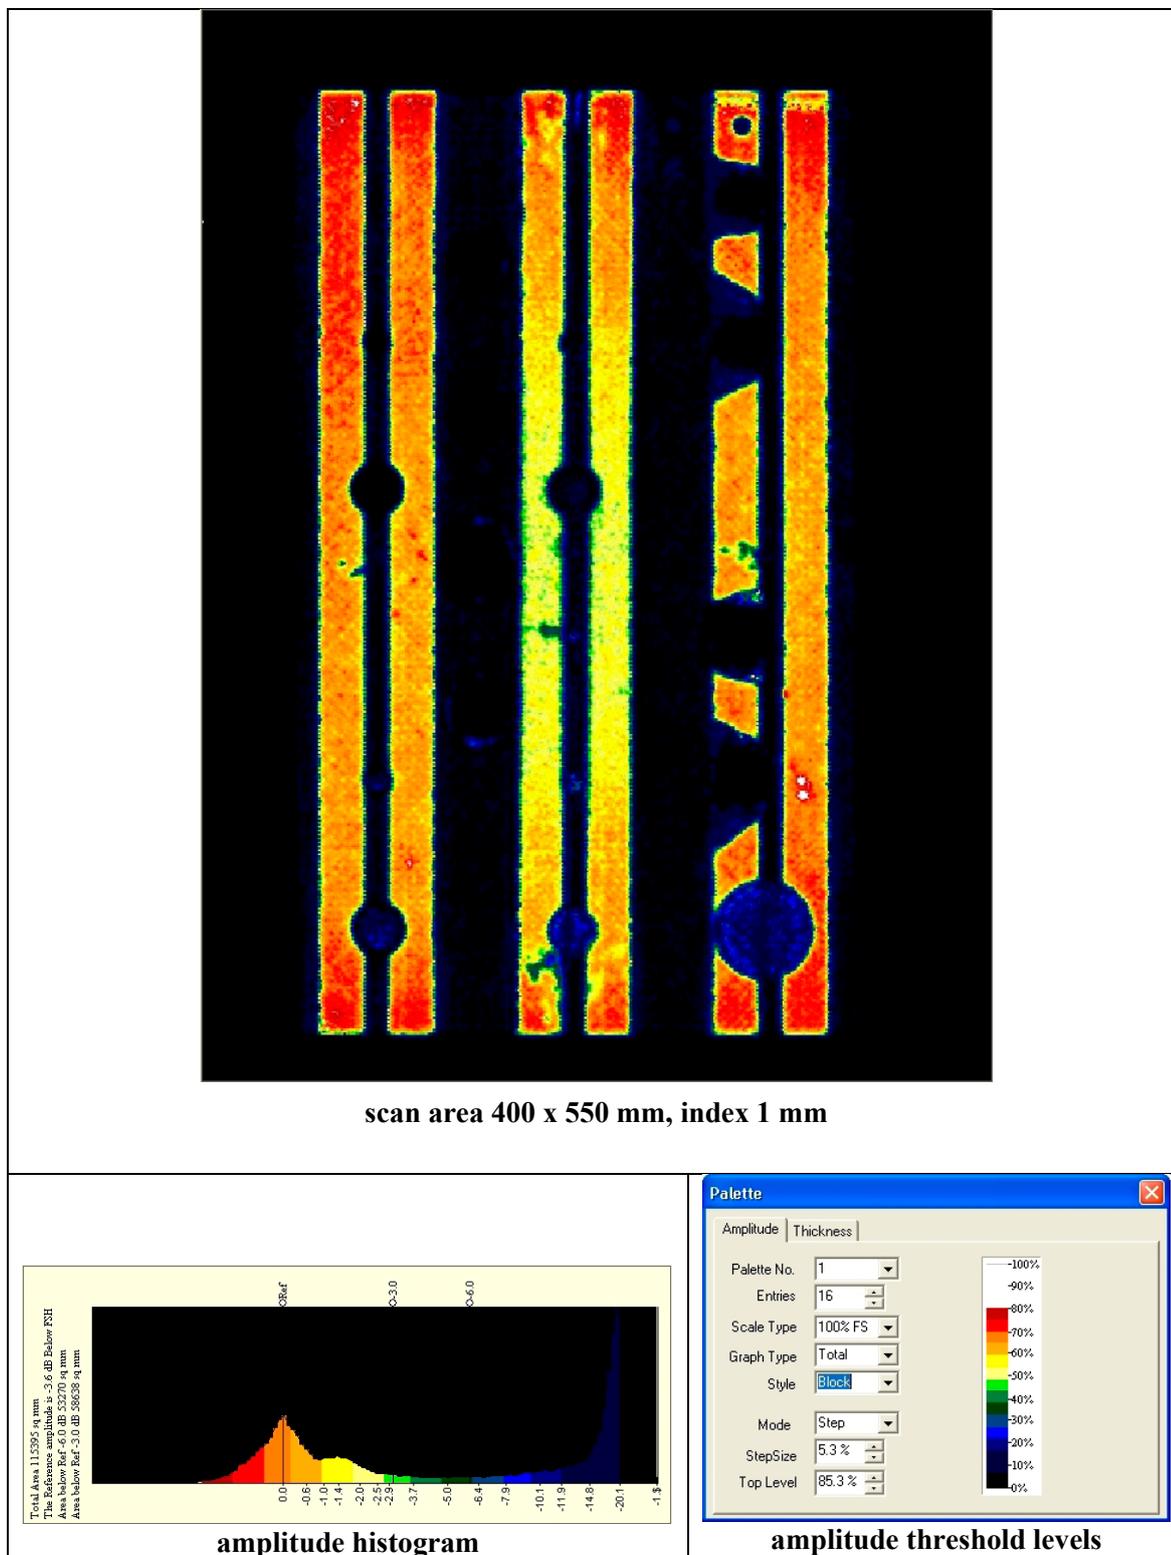
Fig. B3: Ultrasonic C-scan inspection of specimen NLR-B. Immersion mode. Pulse echo backwall-stiffener reflection (PEBR2) inspection with a 5 MHz focused transducer (Fig. B9 from Ref. 1)
