NLR-CR-2019-100-RevEd-1 | July 2023

Round Robin Test Results of Laser Ultrasonic Systems on Composite Panels

CUSTOMER: OPZuid (Operationeel Programma Zuid-Nederland)

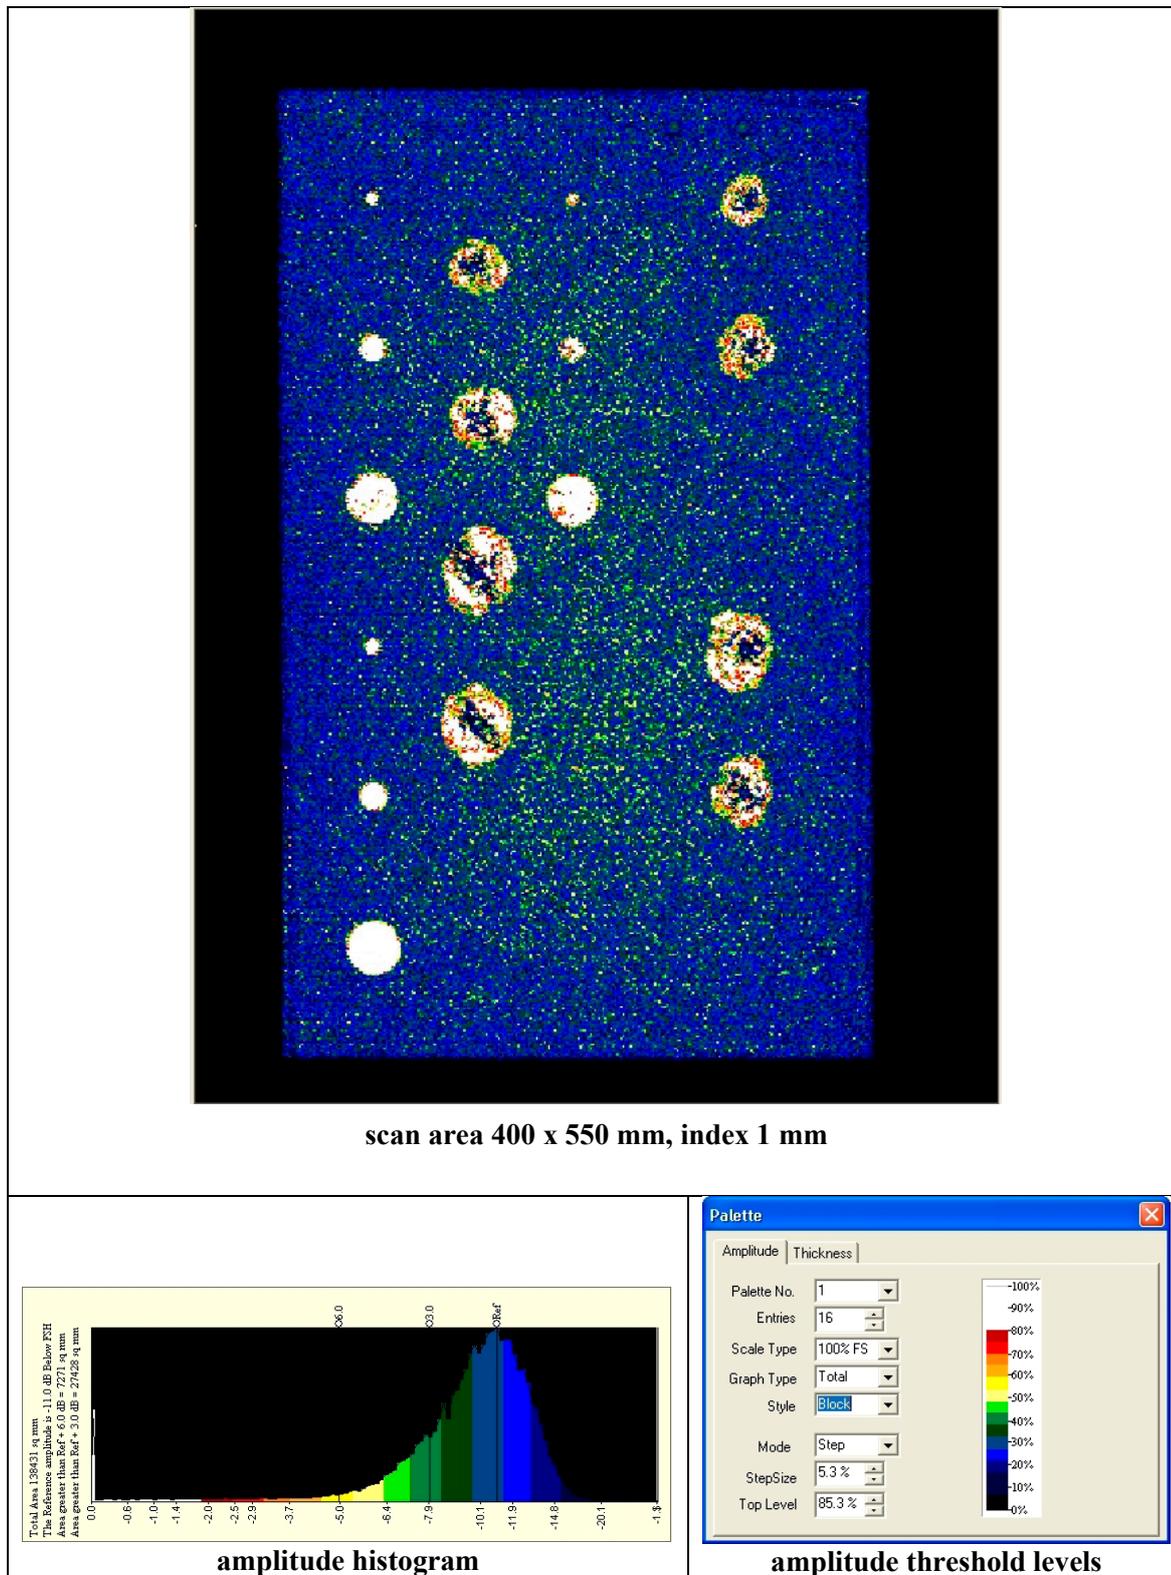
Fig. B4: Ultrasonic C-scan inspection of specimen **NLR-B**. Immersion mode. Pulse echo flaw reflection (PEFR) inspection with a 5 MHz focused transducer (Fig. B10 from Ref. 1)

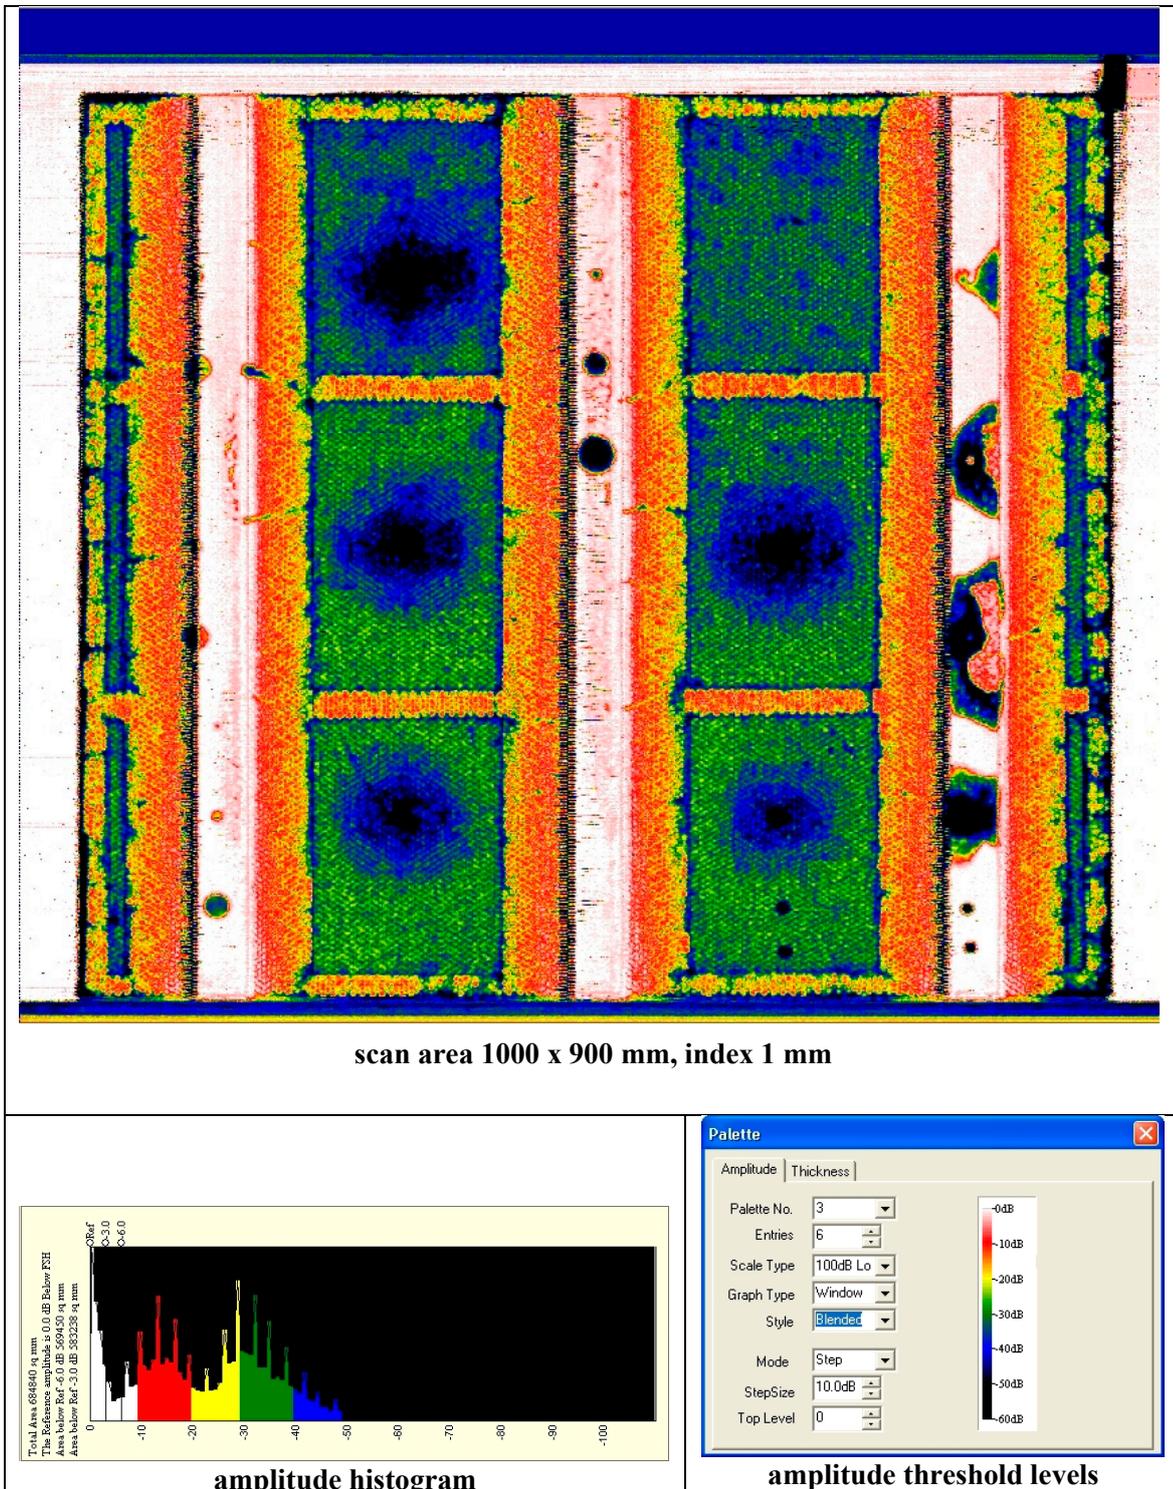
Fig. B5: Ultrasonic C-scan inspection of specimen **NLR-D**. Water-jet mode. Single through transmission (**TT**) inspection with a 2.25 MHz focused transmitter and a 2.25 straight-beam receiver (Fig. B14 from Ref. 1)

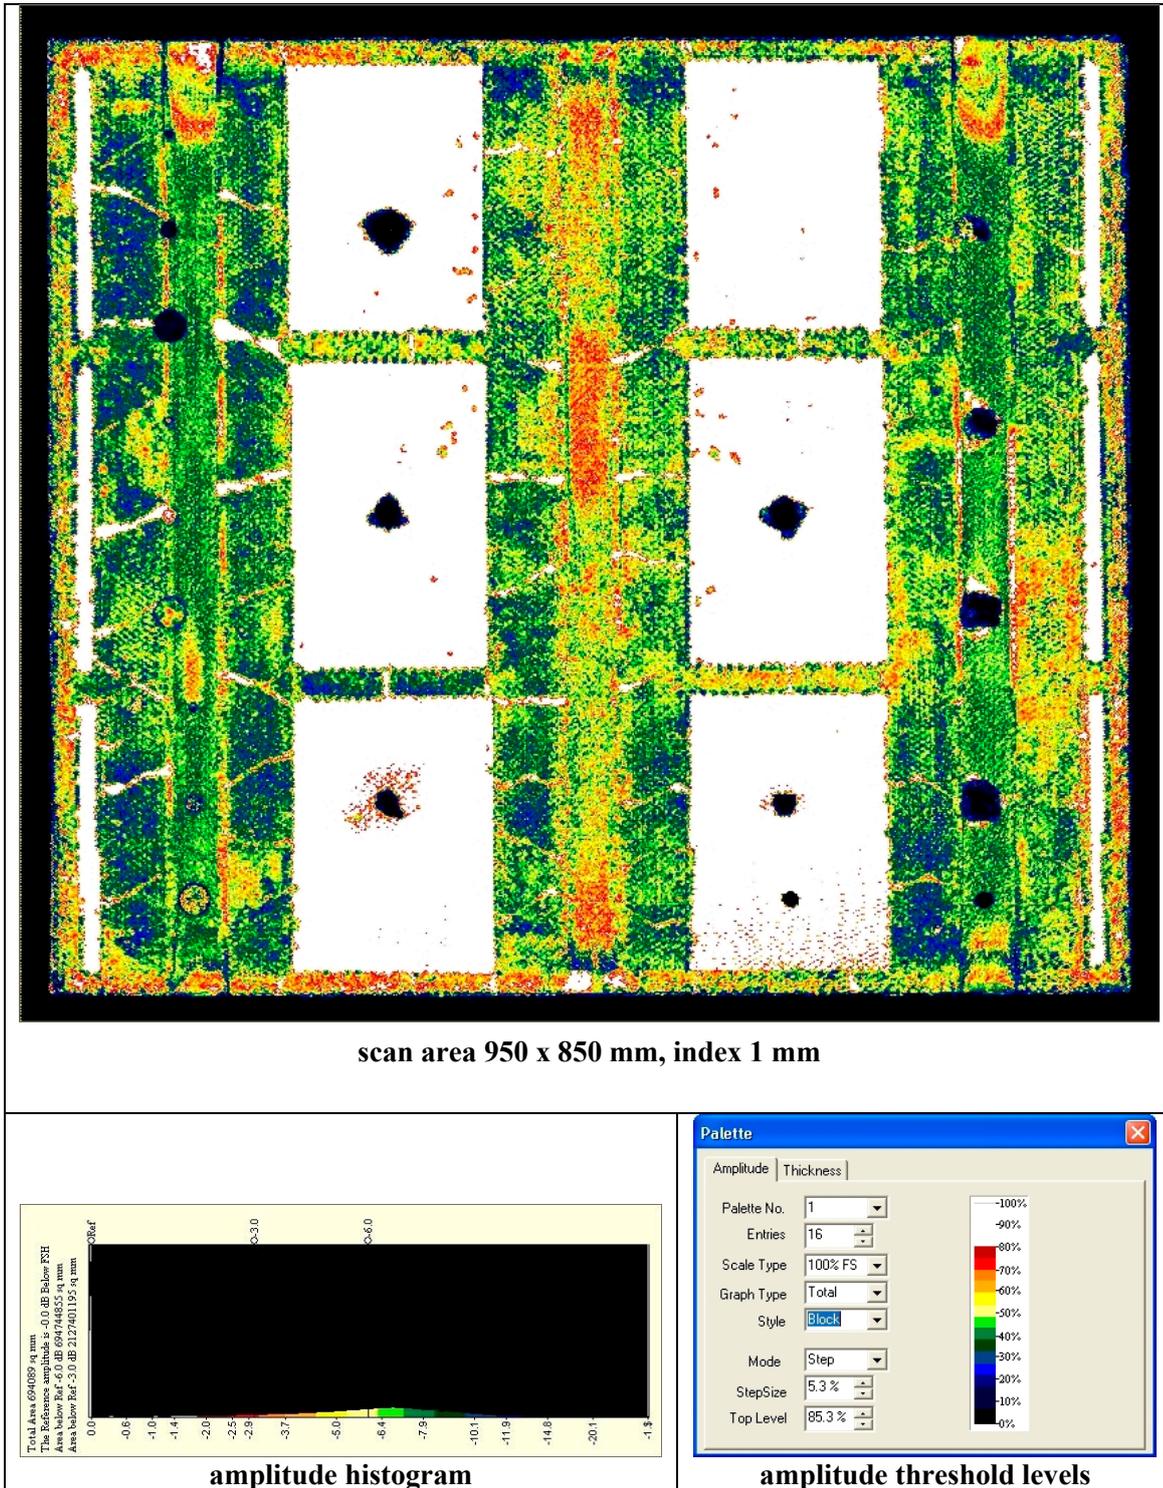
Fig. B6: Ultrasonic C-scan inspection of specimen *NLR-D*. Immersion mode. Pulse echo backwall-outer skin reflection (*PEBR1*) inspection with a 5 MHz focused transducer (Fig. B15 from Ref. 1)

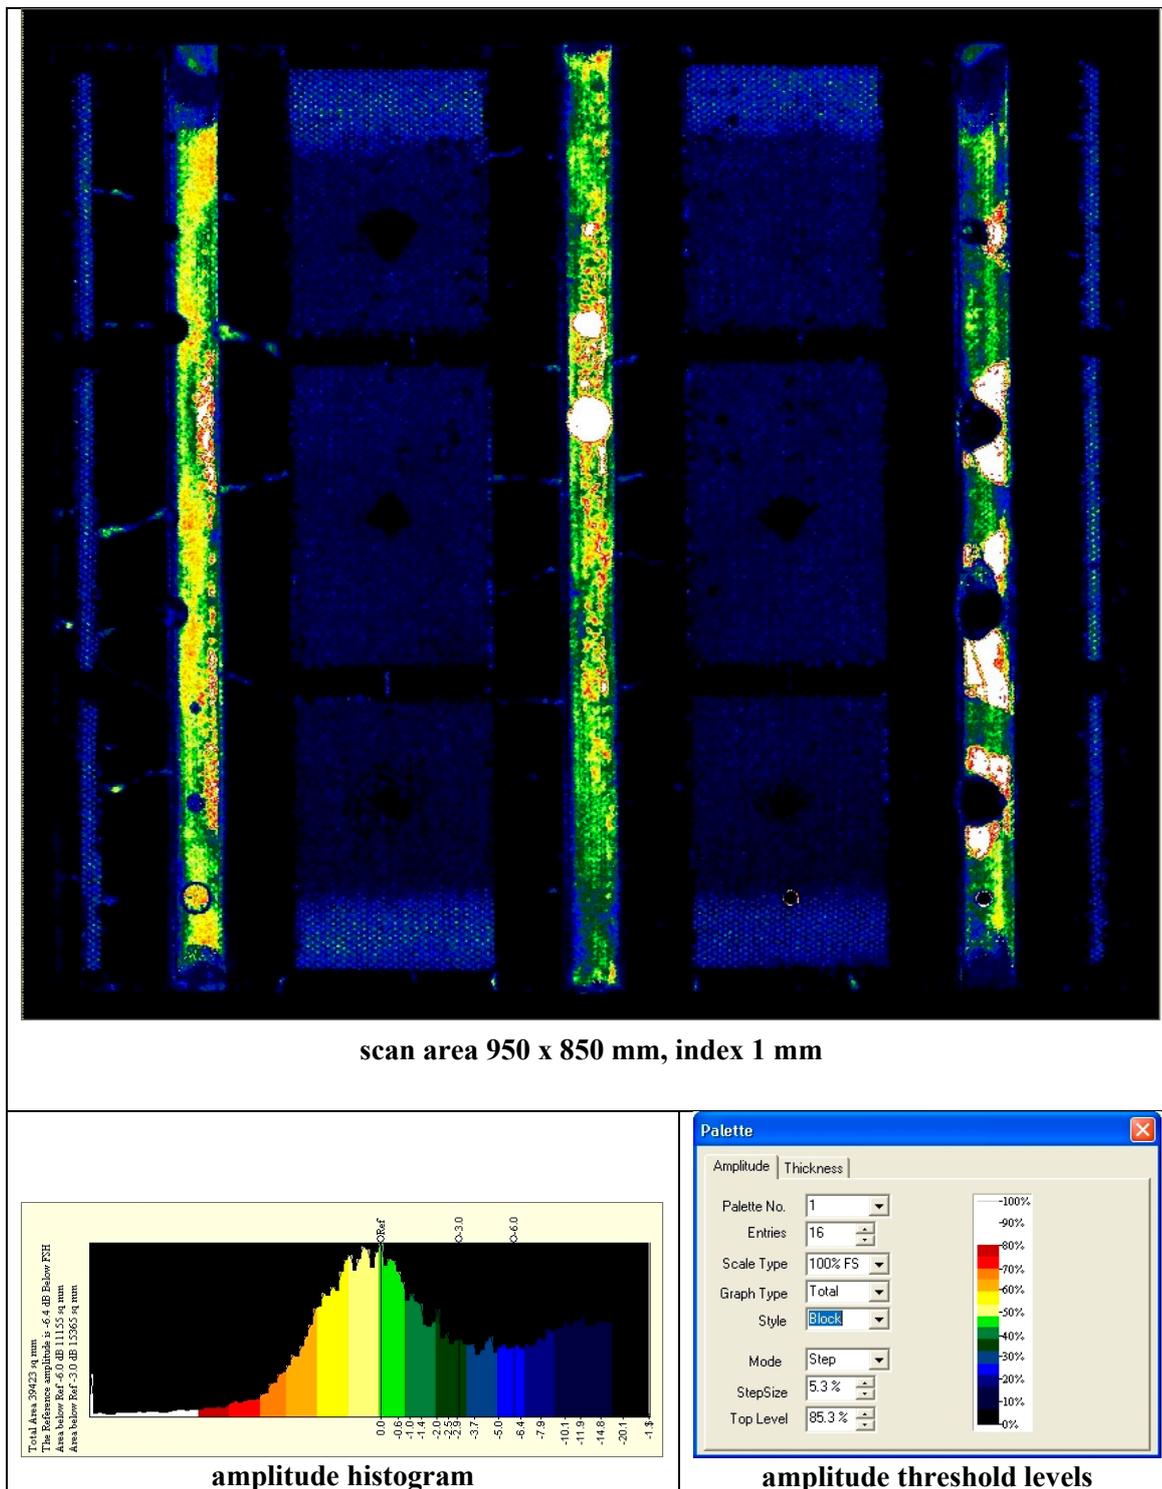
Fig. B7: Ultrasonic C-scan inspection of specimen **NLR-D**. Immersion mode. Pulse echo backwall-inner skin reflection (**PEBR3**) inspection with a 5 MHz focused transducer (Fig. B16 from Ref. 1)

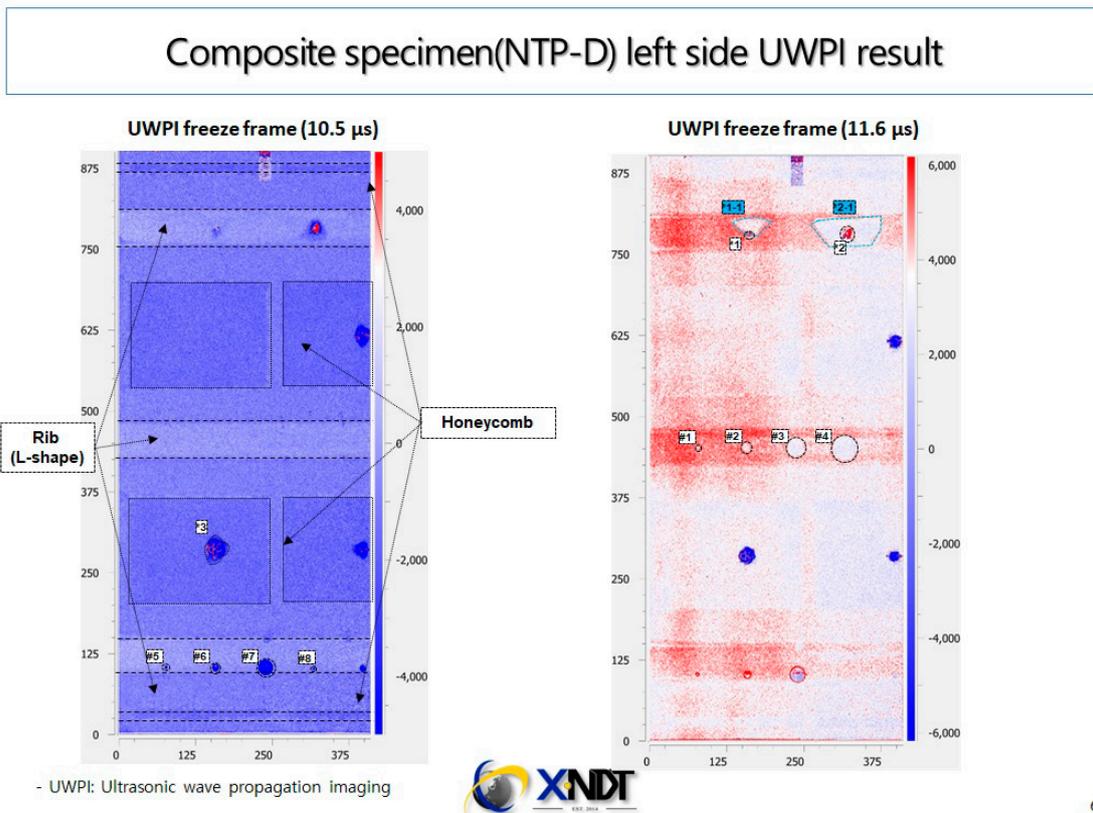
Fig. C3: PE-UPI inspection of specimen NLR-D (left side, lower half of Fig. A2). Test set-up and UWPI result
