NLR-CR-2023-140 | September 2023

SUSTAINair - Rivet detection

KET8: Robotic dismantling of EoL aircraft structures for maximised recycle value

Determine which Non-Destructive Testing method is most suitable to detect the rivets and which technique is best suited for the extraction of rivet coordinates which can be provided to the water-jet cutting robot. The following NDT methods were evaluated: Eddy Current Array, Ultrasonic Phased Array and Optical Lock-In Thermography, supported by 3D structural light scanning. Investigation was performed on actual Airbus A330 and A340 fuselage panels.

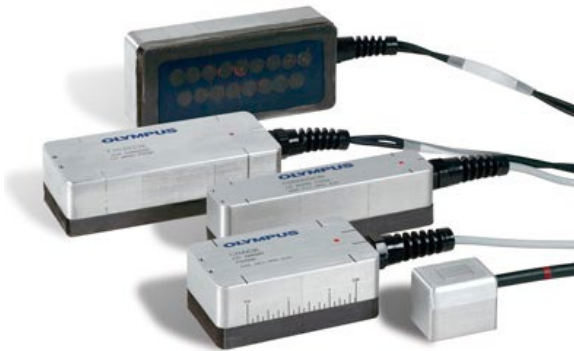
Figure 3: ECA probes [2]

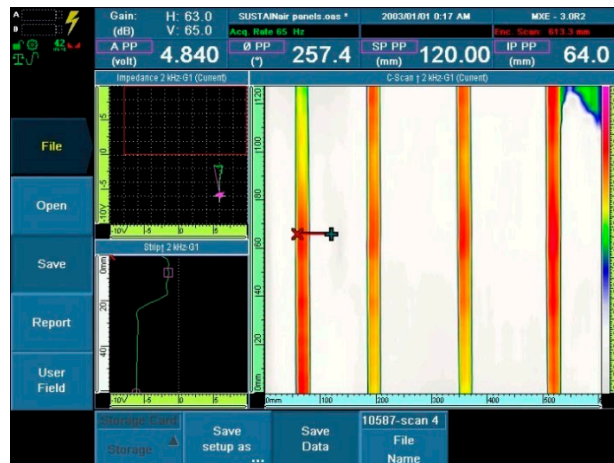
Figure 5: Example of a typical C-scan image of stringers under the skin of the panel (not to scale)

A typical aerospace application for ECA probes is the inspection of fastener rows for (sub)surface cracks. Formerly, this was done with so-called sliding probes that were centred on the fastener centre-line and subsequently scanned along the fastener row. The often complicated EC responses had to be analysed for any defect indications i.e. deviations from the 'standard' EC response of defect-free fasteners. The same complicated EC responses applies to ECA, but using monitoring gates the signals of interest are displayed on a C-scan image which immediately identifies any deviated areas, see Figure 5.

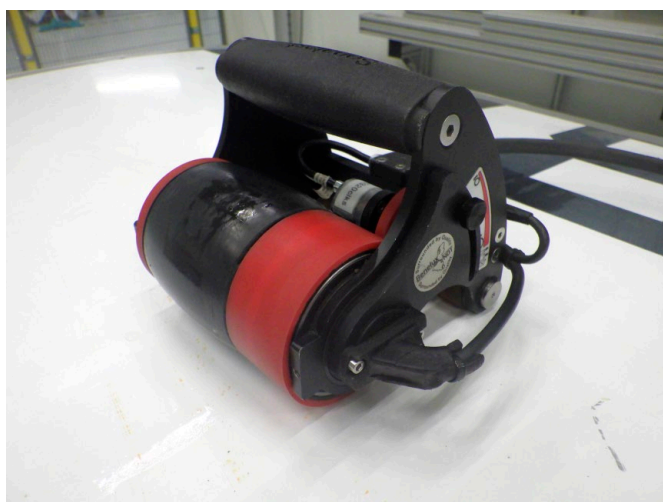
A wheel probe is an ultrasonic transducer assembly that allows rolling contact of a transducer over an inspection surface. The transducer assembly scans over the (curved) surface generally in more or less straight scan line, but steering of the wheel probe is also possible. An outer part of the assembly rotates, allowing the wheel to roll over the surface, while an inner part of the assembly holds the ultrasonic transducer at fixed angles relative to the surface. The conformable, rubber tyre is acoustically matched to water, providing low loss coupling into the test part. The probe can be used generally with a fine water spray on the test part which is used for optimum coupling.

Figure 10: Sonatest Wheel probe with 5L64 PAUT transducer

There is also a special PAUT application that uses only little couplant. An example is the Wheel probe a.k.a. RapidScan™ of Sonatest Ltd. that employs a UT phased array probe housed within a rubber coupled and water-filled wheel probe. See Figure 10.

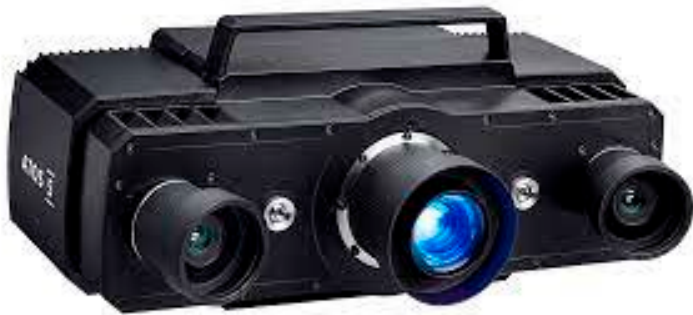
Fringe projection technique
for full-field geometry acquisition

Figure 13: ATOS 5 MV1000 system (left), and the schematic representation of the working of this system [8]

The ATOS 5 MV1000 system is a blue light optical scanner which scans three-dimensional objects and converts the images to high density point clouds. This allows accurate measurement and capture of the shape and size of the visible surface of 3D objects. The scanning is based on optical triangulation and stereo-viewing. A projector is used to project striped fringe patterns onto the object's surface. These images are captured simultaneously by the two measurement cameras from different angles. Reference markers are used on the object (or around the object) to be able to stitch the individual scans together. With the help of digital image processing, 3D-coordinates are computed fast and with high accuracy. The captured scan data is then automatically integrated in the reference marker framework. The additional data captured with two cameras of the ATOS system are used to verify the calibration of the system, detect movements and high ambient light changes during the measurement and verify the matching accuracy of the individual scans into the global coordinate system. Figure 13 Shows the system and schematic representation.

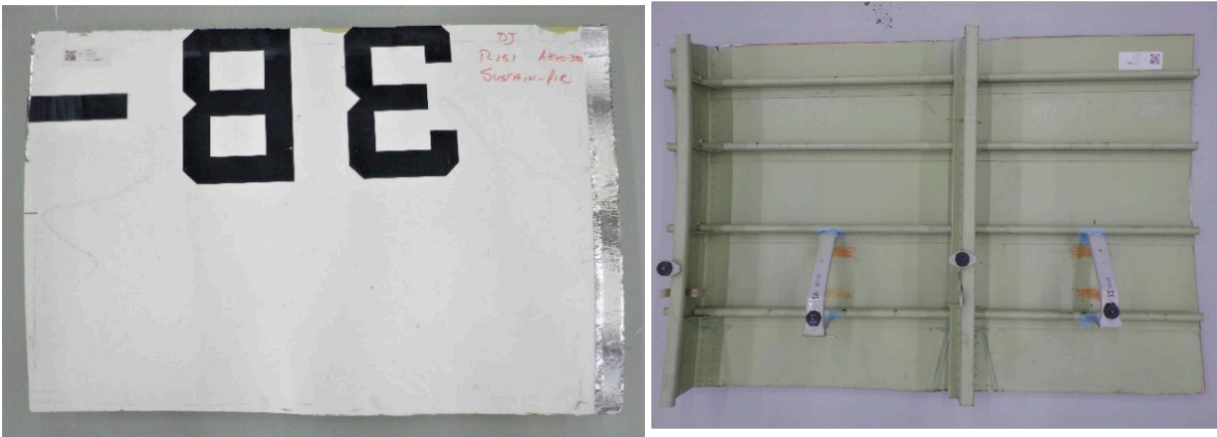
The 10587 is one of the smaller series panels (A340) and was selected because a part of a sticker (black letter and number) is adhered to the skin, probably a registration number or similar. The contrasting black sticker on the white surface can have a large influence on the test results, especially for optical NDT methods.

Figure 19: Panel 10587 (inside view picture mirrored)

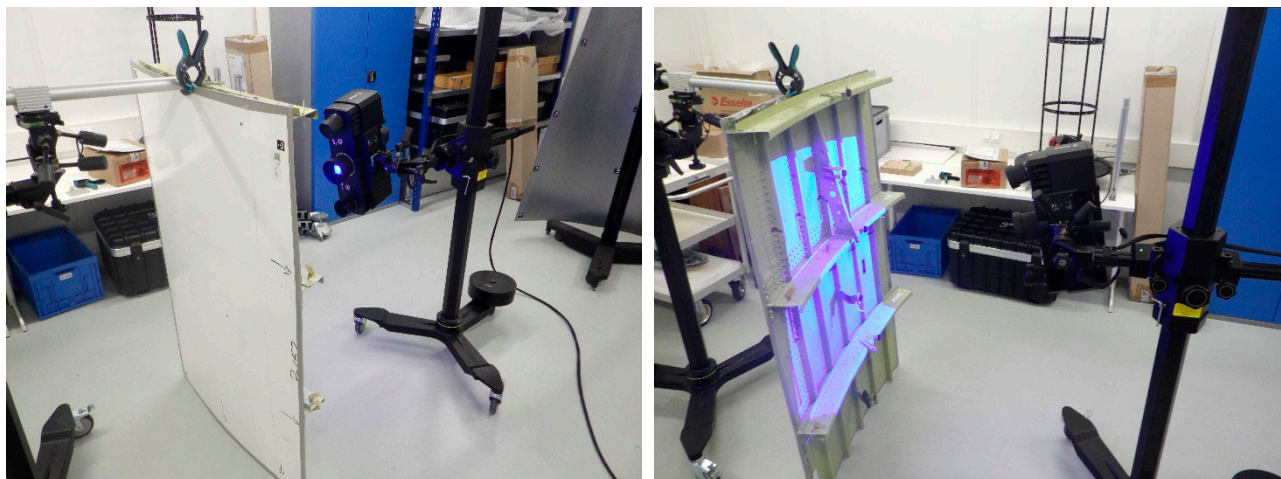
Figure 21: Photographs of the 3D scanning of panel 10597

A 3D scan has been performed on the selected panels 10587 and 10597. The 3D scan can capture the entire outside geometry of the component. It is not possible to detect rivets that are hidden beneath a thick layer of paint, so this technique is not suited for rivet detection. However, the technique will be used to get more details of the component under investigation and to provide 3D coordinates for the cutting robot. For the panels that were received both the front side and the back side are visible. By scanning both the front side and the back side the thickness of the aluminium skin can be measured, as well as pockets and rivets can be located from the back side of the panel. This cannot be done in a production scenario, where only the outside of the fuselage is visible. Figure 21 shows photographs of 3D scanning process. The panel is scanned by manually moving the scanner around the panel.

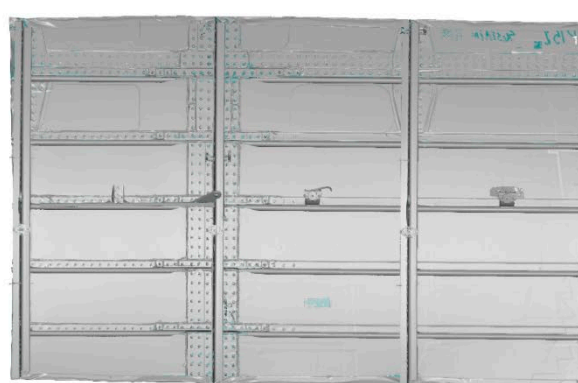
10597

The back side of these panels were also scanned, as shown in Figure 23. From the back side the structural details of the panels can be seen. In this case, the stringers, frames, clips, rivets and HI-LOK fasteners are visible. Unfortunately, scanning of the back side of the sample is not feasible in a production setting, rendering this results unsuitable for the real business case.

Figure 23: Surface mesh of the back side of both panels obtained by 3D scanning (mirrored such that it corresponds to the optical photographs)

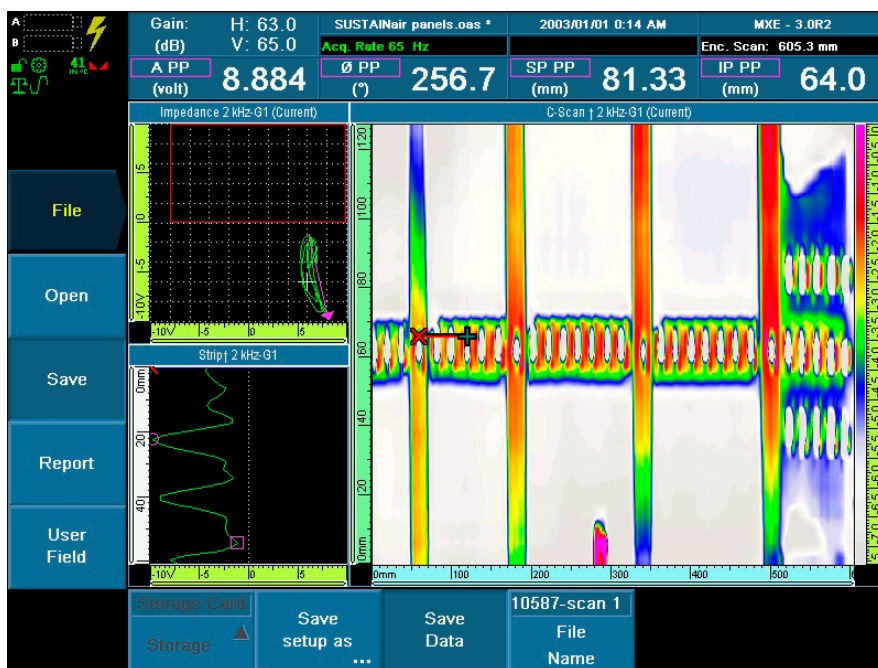
Figure 27: ECA result of stringers and rivet row of panel 10587 (not scaled in the scan axis)

Eddy Current is a very suitable technique to detect any changes, anomalies or deviating materials in a metallic structure. And in this case the detection of the rivets and stringers in the panel is for this technique not any problem. In Figure 27 the results can be observed of 1 scan line on the panel from top to bottom (shown on the picture from left to right). The scan was following a rivet line and clearly the different stringers are visible, and in the end a 3 row rivet area is shown. The image is not to scale and therefore compressed in the scan axis. But the test results are good and the rivets and stringers can be detected clearly. After some post-processing of the data the C-scan image can be scaled to have the scan axis in the same ratio as the index axis, this can be seen in Figure 28. Here the detected rivets are displayed round and the stringers are in the right proportions to each other.

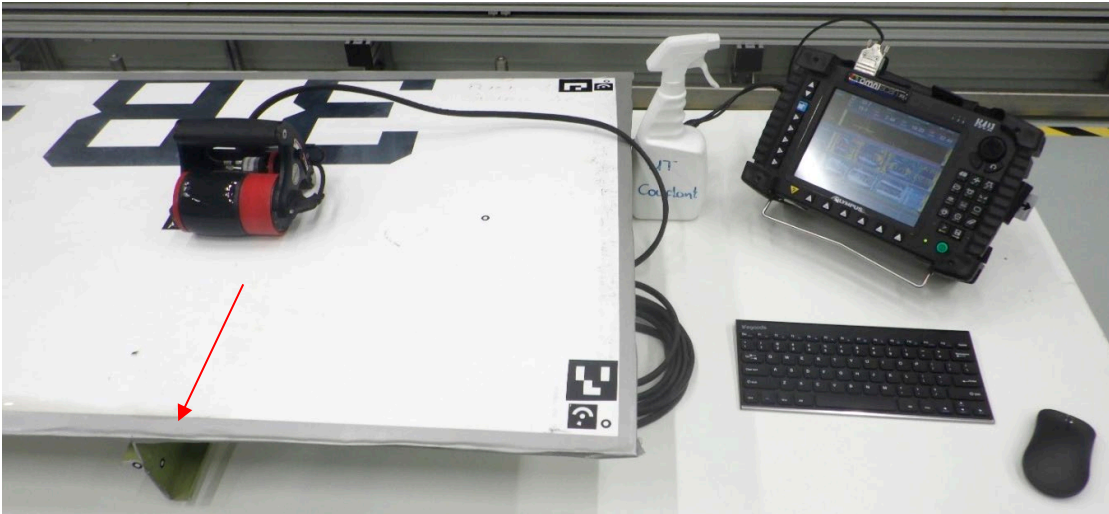
Figure 29: PAUT inspection on panel 10587 with the red arrow indicating the scan direction

The set-up for the inspection was done on the same area as it was for the ECA inspection: A single sheet of aluminium skin. For the ultrasonic method a light spray of water is necessary to obtain a good coupling between the probe and the surface. The scans were performed in the same way as the ECA inspection from the top of the panel to the bottom of the panel following the cord line of the surface. Here very similar issue as with the ECA inspection, is to keep the scan lines straight to prevent distorted images.

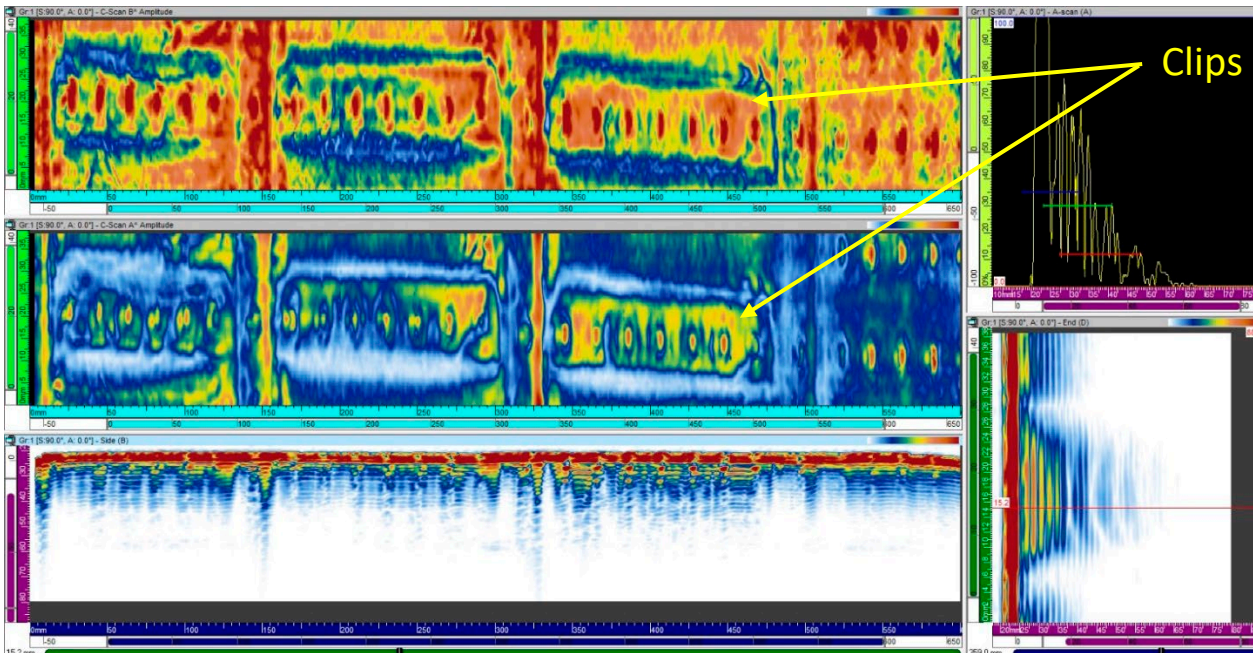
Figure 30: PAUT result of same rivet row and stringers as performed with the ECA inspection

As can be seen in Figure 30 the rivets and stringers can be detected but it is more difficult to interpret the signals from the aluminium structure. Multiple echoes due to the relative thin skin and layered structures (e.g. bonded stringer to skin) of the panel, makes it difficult to get a good inspection set-up. When there is disturbance cause by sealant or any other anomaly the returned ultrasound signal is reduced and this has an influence on the test results. This can be seen where the clips are mounted to the skin, around the edges of the clips there is a significant loss of ultrasound signal, resulting in blue coloured areas (more dampening) in those areas.

In Figure 30 the PAUT results can be observed of 1 scan line on the panel from top to bottom (shown in the picture from left to right). The scan was following the same rivet line as with the ECA inspection and clearly the difference is visible between the two techniques. At the PAUT dataset the rivet line is more difficult to separate from the backwall (in this case the aluminium skin). Also the reduced inspection width of 44 mm is clearly visible compared to the 128 mm of the ECA probe.

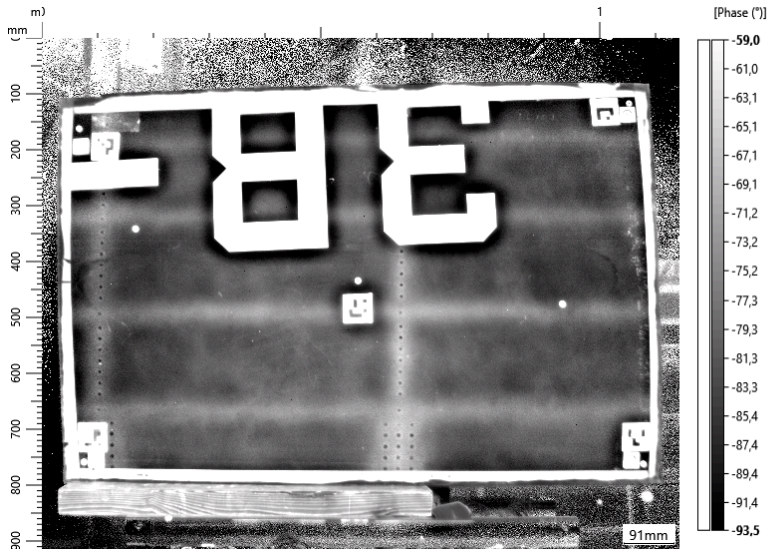
Figure 48: Panel 10587 @ 0.1Hz

On the 2 Hz image the rivets and rivet line is clearly visible on the white paint as well on the black surface (adhesive sticker). The stringers and rivet lines for this configuration are best visible at 0.1Hz. In order to detect the rivets as fast as possible, which would be the case during an industrial environment the best frequency would be 2 Hz is this case. For this FOV of approximately 1 square metre the inspection time is for 2 Hz 20 seconds and for the 0.05 Hz 40 seconds. (with the used a conditioning and acquisition cycles) So an inspection at lower frequency would require twice the amount of time needed for an inspection at high frequency. Any inspection time optimization is possible but is not further investigated in this report.
