NLR-TP-2022-071 | March 2022

# Experimental damage tolerance evaluation of thick fabric carbon/epoxy laminates under low-velocity and high-velocity impact and compression-after-impact

Royal NLR - Netherlands Aerospace Centre

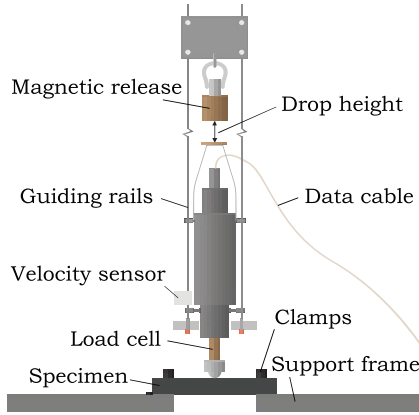
An instrumented drop-weight designed at Royal NLR was used for low-velocity impact tests, as shown in Figure 1. The 2274 g drop-weight has a steel spherical head with a 16 mm diameter and is guided by two steel rails. Using a magnet release the drop-weight is dropped from a height corresponding to the required impact energy, which is validated by measuring the actual drop-weight velocity before and after impact. The target specimen is clamped on a steel frame at the four edges of a 125×75 mm opening. In all cases, the rebound distance of the drop-weight was sufficient to manually prevent multiple impacts. A load cell, calibrated up to 80 kN and positioned between the head and the drop-weight, measures the contact force with a 250 kHz sampling frequency.

**Figure 1.** Illustration of the drop-weight setup used for large-mass (LM) impacts.

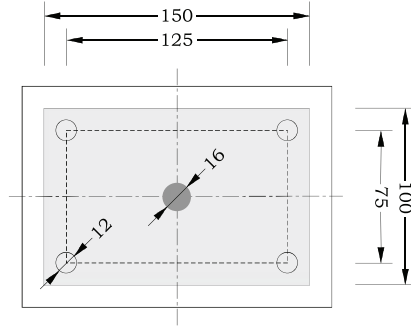
**Figure 2.** Top-view of the support fixture used for the drop-weight and gas-cannon tests.

steel ball crosses the chamber alone before impacting the specimen. The support fixture used for the drop-weight impact experiments is mounted vertically to feature identical boundary conditions. Two high-speed cameras and required lighting equipment are situated in the chamber and one wall is made of protective glass to observe the experiment.

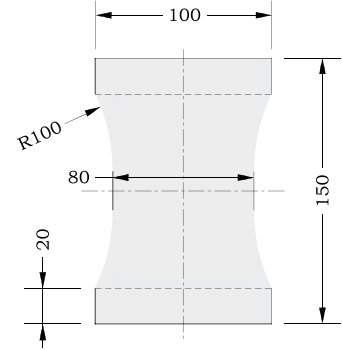
**Figure 3.** The dog-bone shape used for static compression tests of undamaged specimens.

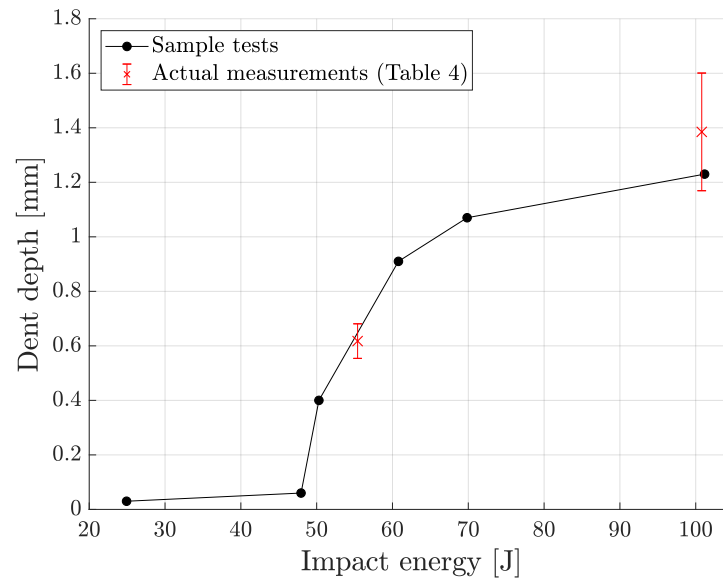
**Figure 4.** Energy level determination including the dent depths of 55 and 100 J drop-weight impact tests on 20 mm thick QI specimens.

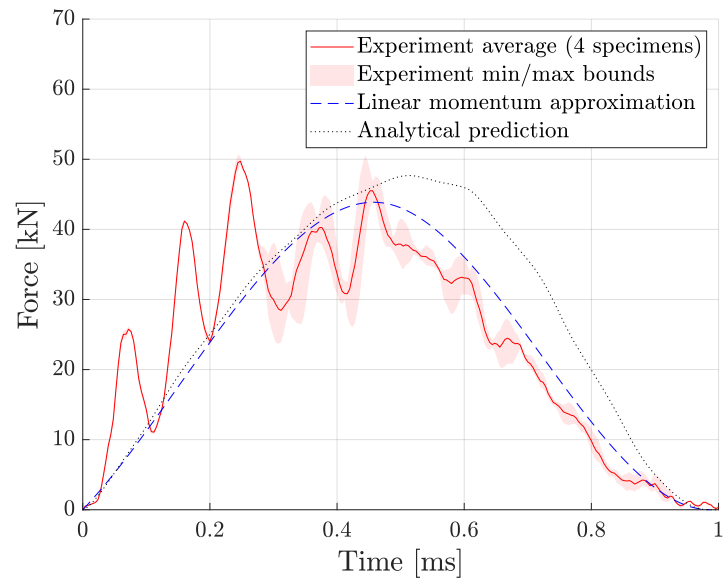
**Figure 5.** Averaged force history for 55 J drop-weight impact tests on 20 mm thick specimens.

deflection history,  $w_p(t)$ , can be estimated by assuming a contact law. Talagani<sup>11</sup> proposed a contact law for thick composites that has been implemented in an analytical impact response model in an earlier work<sup>12</sup>. An example of a drop-weight force history, including an approximation of the analytical impact response model, is given in Figure 5.

force history such as Figure 9 is obtained. The same approximation method was applied to the drop-weight impacts as verification of the method. It showed an excellent approximation of which one example is shown in Figure 5.

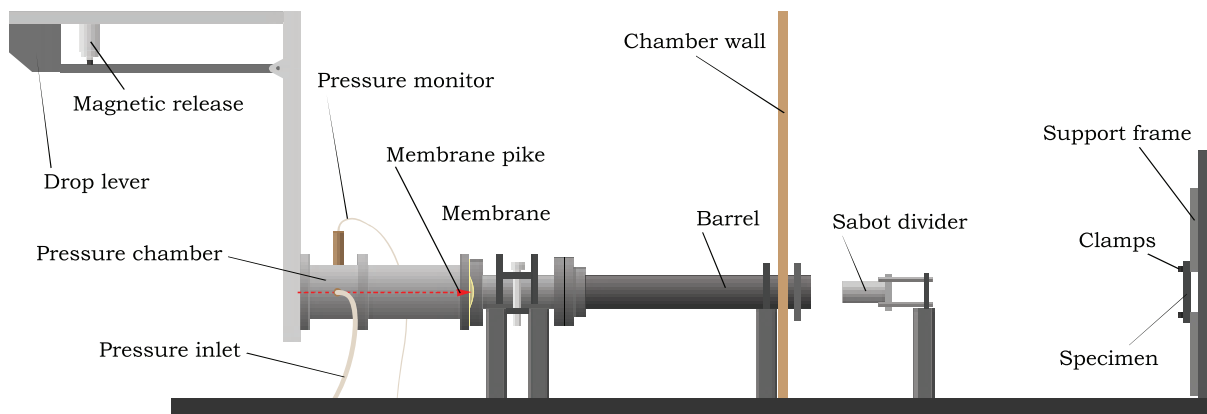
**Figure 6.** Illustration of the gas-cannon test setup used for small-mass (SM) impacts.

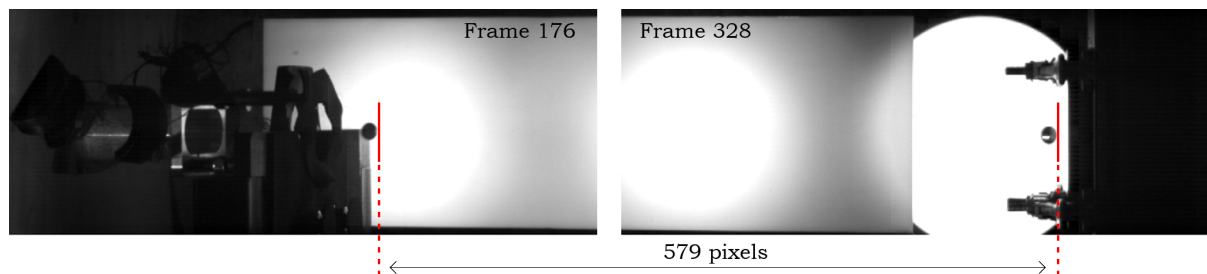
**Figure 7.** Illustration of the impact velocity determination of a gas-cannon impact on specimen 20-QI-SM-55-1. The impactor is detected at frames 176 and 328, which results in an elapsed time of 7.6 ms over a distance of 579 pixels. Knowing that 1 pixel equals 1.035 mm the resulting impact velocity is 78.87 m/s.

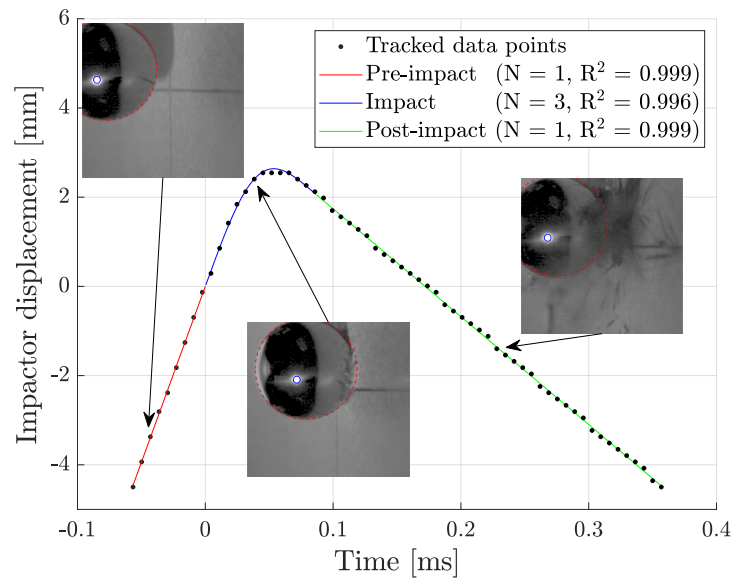
From Figure 8 it can be concluded that the impactor displacement can be tracked very accurately. The values of the tracked data points in terms of pixels are translated to length measured in mm by using the fact that the slope of the pre-impact region should be equal to the initial velocity measured from Figure 7. In addition, three regions are defined: pre-impact (red), impact (blue), and post-impact (green). During impact the tracked data points can be fitted using a cubic polynomial. Similar to the pre-impact region, the post-impact region can be fitted using a linear expression of which the slope represents the exit velocity.

**Figure 8.** Tracking the impactor during a gas-cannon impact on specimen 20-QI-SM-55-1.

start point with zero displacement at 0 ms in Figure 8 can be established by fitting the original tracked data points with the impactor displacement history. The estimated indentation history, estimated plate deflection history, and transferred energy for the gas-cannon impact case are obtained using the same procedure as for the drop-weight impact tests presented in Section 2.2.

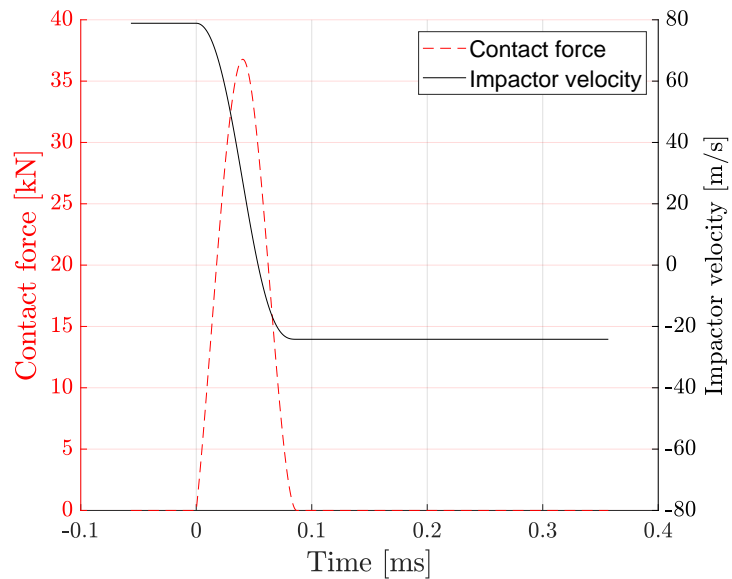
**Figure 9.** Estimated contact force and impactor velocity history of specimen 20-QI-SM-55-1.

The impactor velocity history is determined by integrating the impactor acceleration, as shown in Figure 9. Further integration of the impactor velocity history provides an alternative method to determine the impactor displacement history for the gas-cannon tests compared to the method used for the drop-weight tests. The

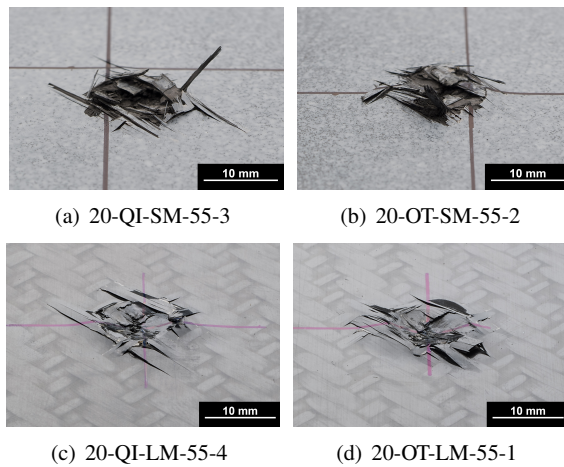
**Figure 10.** Typical dents for 55 J drop-weight impacts and gas-cannon impacts on 20 mm thick specimens with a QI and OT layout.

composite laminates. In thick composite laminates, a large portion of the energy is dissipated by creating a dent at the impact location, see Figure 10. This dent is formed due to crushing of several plies at the impact location of which some parts are propelled in the air. At the same time, material is pushed outward in the top few layers that experience compression in the longitudinal direction. In this area, kinking and buckling occurs, which is identified by protruding layers around the dent. This phenomenon may be observed in Figure 13, which shows the cross-section of a specimen subjected to 55.3 J impact. Kinking and buckling, which may be seen at the bottom left of Figure 13, is mainly observed for large-mass low-velocity impacts on 20 mm specimens, with a lower impact energy, that result in smaller dents.

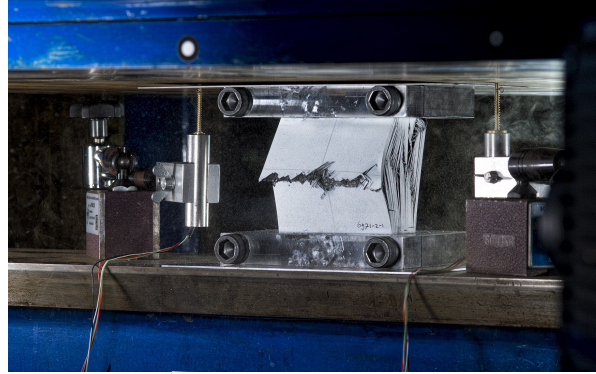
**Figure 11.** The CAI test setup with a 40 mm thick specimens subjected to a 100 J gas-cannon impact (40-QI-SM-100-1) showing a Middle Top Progressive (i.e., MTP) failure mechanism as classified in Figure 18.

The Compression-After-Impact (CAI) experiments were performed using a static test bench at Royal NLR, see Figure 11. It was chosen to deviate from the ASTM standard for determining the compressive residual strength as it is focused on testing of thin specimens. The expected failure mode, and lack of a global buckling mode, require a different support fixture, contrary to the recommendations of ASTM standard for thin laminates. Instead of the ASTM standard, the following method was applied: The support fixture is derived from previous CAI experiments performed at NLR<sup>20</sup>, and consists of two anti-brooming devices clamped on the short edges of the specimen. If not used, brooming or splitting of plies might occur at the contact surface with the test bench due to high contact forces. The applied load is measured by the test bench as well as the applied displacement. However, due to the deformation of the test bench itself, the actual displacement is measured using two calibrated Linear Variable Differential Transformers (LVDTs). These are positioned on both sides of the specimen such that an average displacement of the center point is obtained. Two synchronised high-speed cameras, pointed at the impacted and non-impacted side of the specimen, capture final failure at 20,000 fps. Damage mechanisms that occur before final failure are logged by capturing real-time images from the high-speed cameras.

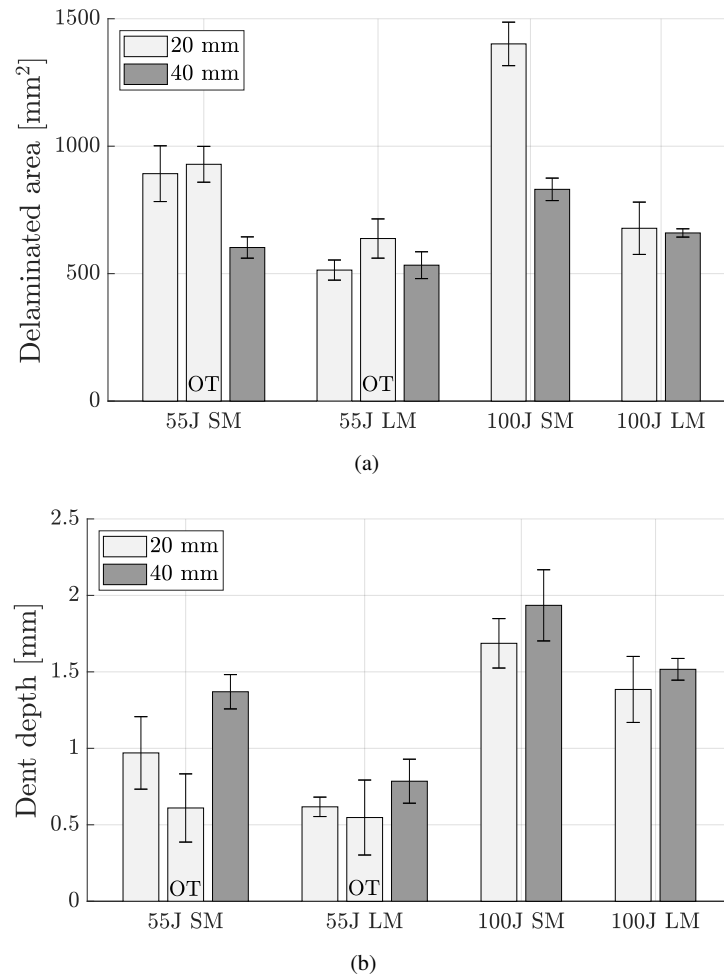
**Figure 12.** Average impact damage in terms of (a) delaminated area and (b) dent depth for large-mass (LM) drop-weight impacts and small-mass (SM) gas-cannon impacts. Note that the results annotated with OT contain the specimens with an orthotropic layout.

depth and the delaminated area for large-mass (LM) drop-weight impacts and small-mass (SM) gas-cannon impacts. With this data, the effect of four different aspects can be evaluated, namely (i) specimen thickness, (ii) drop-weight versus gas-cannon, (iii) impact energy, and (iv) specimen layout.

A thickness effect is observed when comparing impacts on 20 and 40 mm thick specimens in Figure 12. The impactor displacement of the 20 mm specimens is approximately 8-11% higher compared to the thicker specimens. For the drop-weight experiments, the dent depth of 20 mm specimens is 21.52% lower for 55 J impacts and 8.55% lower for 100 J impacts. In the case of gas-cannon impacts, the dent depth of 20 mm specimens is 29.20% lower for 55 J impacts and 12.89% lower for 100 J impacts. Accordingly, it can be assumed that this higher impactor displacement is a result of more bending. This increased bending of the 20 mm specimens on average results in a noticeably higher delaminated area in the case of the gas-cannon impacts (i.e., +48% for a 55 J impact and +69% for a 100 J impact). Surprisingly, no significant difference in delaminated area is observed for the drop-weight impacts (LM specimens in Figure 12(a)).

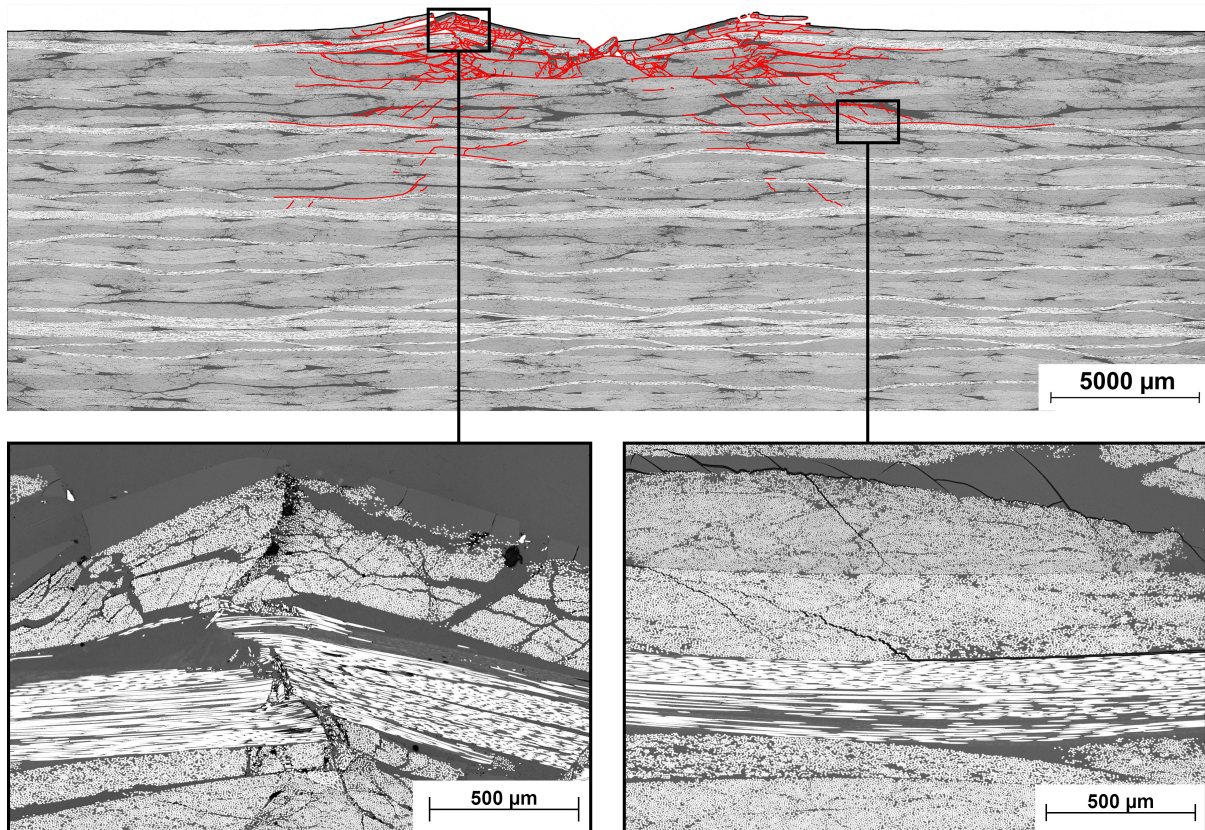
**Figure 13.** Cross-section of specimen 20-OT-LM-55-4 with highlighted crack boundaries and a detailed view of two damage mechanisms characteristic of thick composite specimens. On the left, longitudinal compressive loads resulting in fibre kinking and buckling in the top plies and, on the right, interaction between transverse cracks and delaminations.

Beside a dent, no damage is typically observed directly underneath the impact location. Due to increasing transverse shear stresses away from the centre of impact, delaminations and transverse cracks appear, resulting in a typical *hat-shaped* damage pattern as highlighted in red in Figure 13. In the same figure, the detailed interaction between delaminations and transverse cracks is illustrated in the magnified view, which shows the transition from transverse cracking to delamination. In all cross-sections the dominant delaminations extend along the interface between warp yarns. For instance, the delamination in Figure 13 initiates from a transverse crack and propagates along the warp yarn in white. Interestingly, these

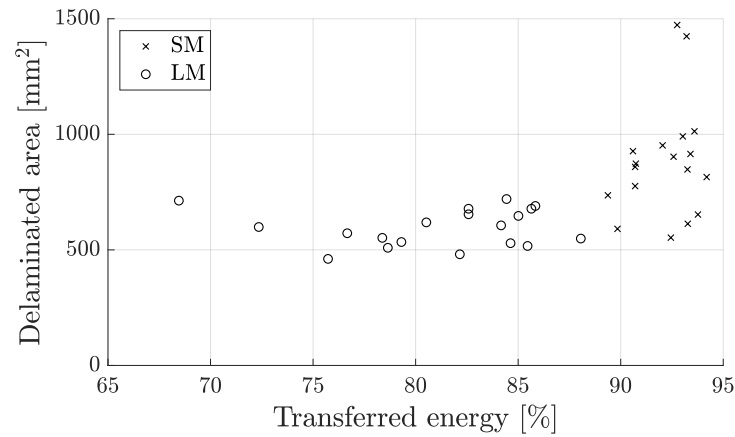
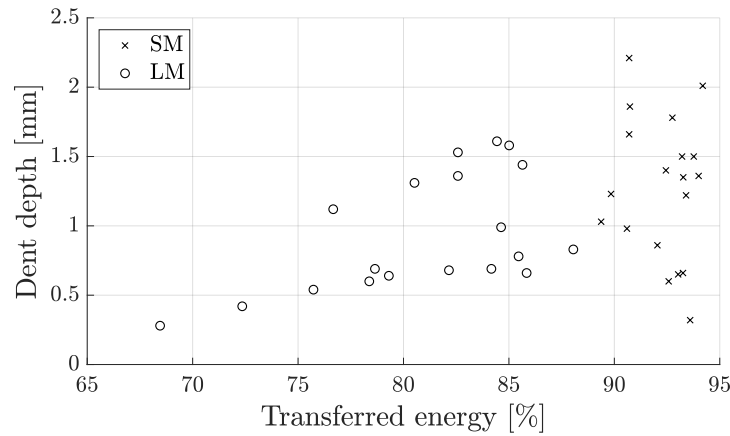
(a) Excluding specimen 20-QI-SM-100-1 (2847 mm<sup>2</sup>).

**Figure 14.** Relation between transferred energy and (a) delaminated area and (b) dent depth for large-mass (LM) drop-weight impacts and small-mass (SM) gas-cannon impacts.

To get further insight on the damage induced in each type of test, the delaminated area and the dent depth are shown in Figure 14 as functions of the energy transferred from the impactor to the specimen. The results in Figure 14 show a 68-88% transferred energy range for large-mass low-velocity test, while for small-mass high-velocity tests 89-94% of energy is transferred to the specimen. For the drop-weight impacts an overall trend is that for a higher transferred energy the dent depth increases (see Figure 14(b)), while no significant change in delaminated area is observed (see Figure 14(a)). Since drop-weight impacts generally tend to a quasi-static response, the force and displacement histories align, so that most bending energy is returned to the impactor. Therefore, it can be assumed that, neglecting thermal effects, most of the

Typical damage information based on cross-sections and C-scans is shown in Figure 15. The considerable higher delaminated area for gas-cannon impacts is shown in Figure 15 for a 100 J impact on a 20 mm thick specimen. Similar to Figure 13, the delamination shown in Figure 15 initiates from a transverse crack and propagates along the warp yarn. In Figure 15(a) all internal damage is hidden behind the dent and therefore not visible in the impact side TOF C-scans. In addition to the lower delaminated area, looking at the cross-sections, the damage extends approximately 1mm further in the thickness direction. Specimen 20-QI-SM-100-1, shown in Figure 15(b), is treated as an outlier with a delaminated area twice as large as the other three specimens. Due to this, it is excluded from Figure 14(a).

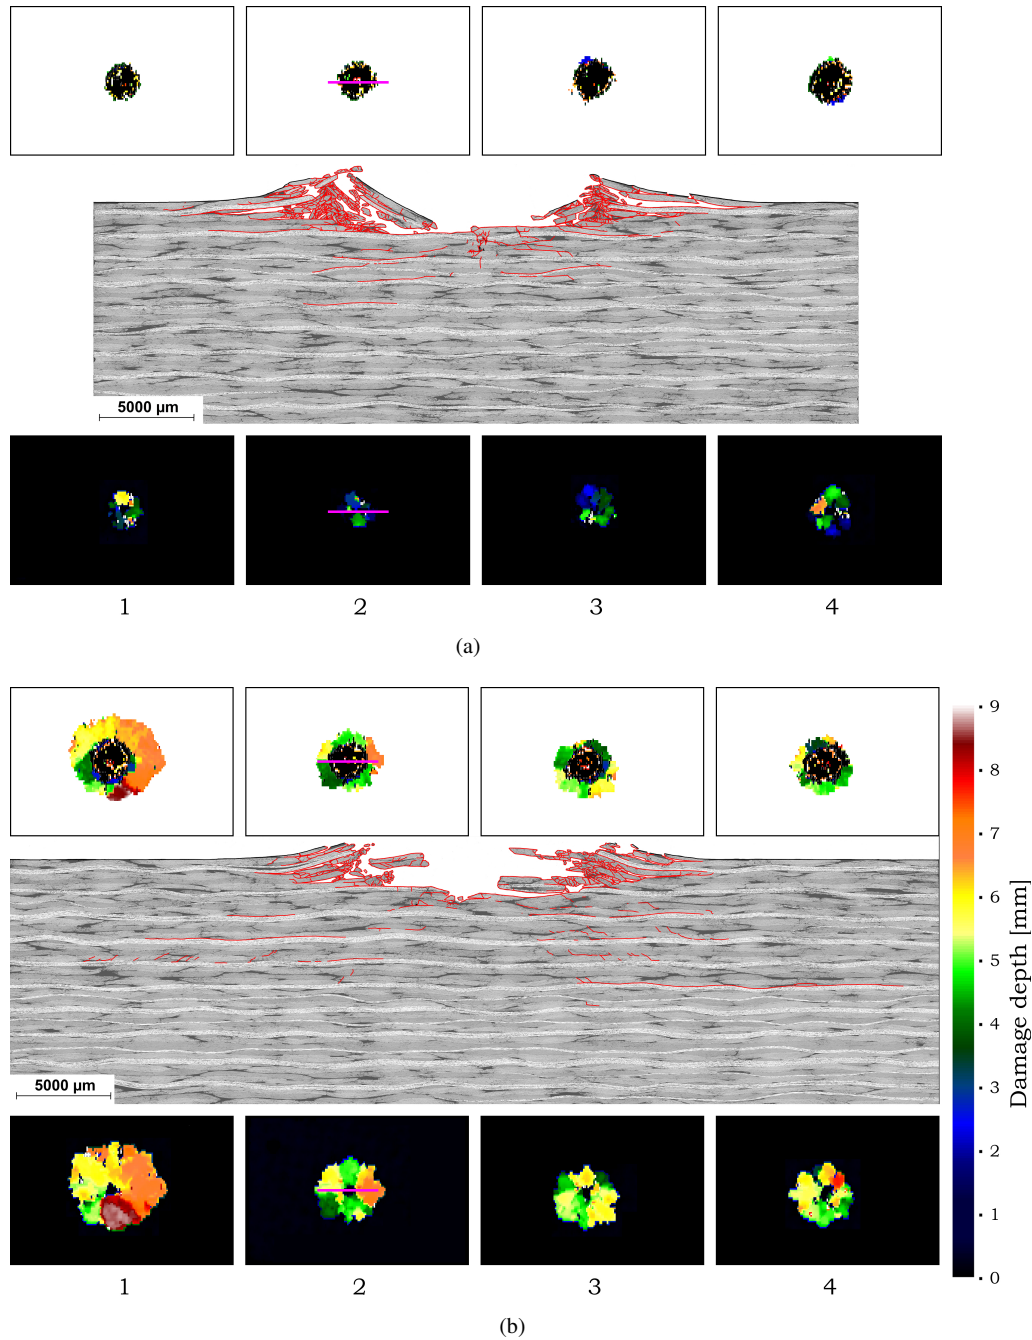
**Figure 15.** Damage comparison between 100 J (a) drop-weight impacts and (b) gas-cannon impacts on 20 mm thick specimens. In the middle the cross-section of one of the four specimens is shown, 20-QI-LM-100-2 in (a) and 20-QI-SM-100-2 in (b), where the crack boundaries have been highlighted in red. TOF scans are shown for all four specimens, the impact side on top and non-impact side on the bottom.

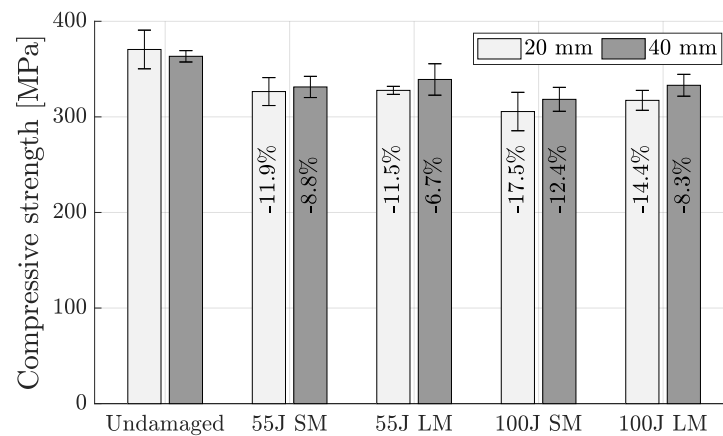
**Figure 17.** Compressive strength for 20 and 40 mm specimens subjected to large-mass (LM) drop-weight impacts and small-mass (SM) gas-cannon impacts.

The resulting compressive strengths are visualised in Figure 17. Exact values of the residual CAI strengths can be found in Table 4, while the compressive strengths of undamaged specimens are given in Table 3. As expected, the residual CAI strength is closely related to the delaminated area and damage depth. For instance, specimens subjected to a 100 J gas-cannon impact have the highest delaminated area and therefore the largest reduction in residual CAI strength (i.e., 12% and 18%). In addition, the effect of both gas-cannon and drop-weight impacts is larger on the residual CAI strength of 20 mm specimens compared to the 40 mm impacted specimens. For the 20 mm specimens with gas-cannon impacts, this is explained by larger delaminations that appear deeper in the specimen. For the 20 mm specimens with drop-weight impacts, the gap with 40 mm specimens is larger, with no significant change in delaminated area. A possible explanation is that the delaminations are approximately 25% deeper for 20 mm specimens. Deeper delaminations mainly affect the sub-laminate bending stiffness, which results in failure at a lower load.

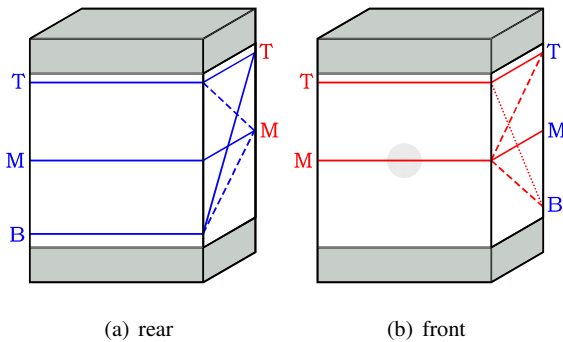
**Figure 18.** Failure mechanisms observed during the CAI tests with buckling of sub-laminates at the middle (M), top (T), or bottom (B) of the specimen. Distinction is made between symmetric failure (MM and TT) and asymmetric failure (MT, MB, and TB). A distinction between Progressive (P) and Instant (I) failure is made.

Symmetric failure (MM and TT) occurs when delaminated plies start to buckle at approximately the same location on the impact and non-impact side of the specimen. As a result, the through-thickness damage pattern is also symmetric and usually horizontal, with variations that have a V or W shape. Within the

symmetric failure mechanism two distinctions are made. MM failure occurs at the middle of the specimen, usually through the impact location, and represents 11% of the cases. TT failure occurs near the anti-brooming device at the top of the specimen and is the second frequent observed mechanism in 34% of the cases. No symmetric failure near the bottom of the specimen (BB) is observed.

Asymmetric failure (MT, MB, and TB) occurs when sub-laminate buckling of delaminated plies occurs at a different location on the impact side and non-impact side. For instance, the most common case is an MT failure mechanism observed in 45% of specimens. In this mechanism, the impact side sub-laminate buckling occurs in the middle (M) and on the non-impact side at the top of the specimen (T). Sub-laminate buckling generally starts at the impact side. During progressive failure the cracks in the thickness direction propagate to the location of sub-laminate buckling on the other side. Asymmetric MB and TB failure is observed in two specimens for each mechanism.

In addition to the symmetric and asymmetric failure mechanisms, a distinction is made between progressive (P) and instant (I) failure. Progressive failure describes the case when one or multiple delaminations and corresponding load drops occur prior to final failure. On the other hand, instant failure gives no indication of damage prior to failure and no significant load drops are visible in the stress-strain curve. Overall, 20 specimens showed progressive failure and 18 specimens instant failure.

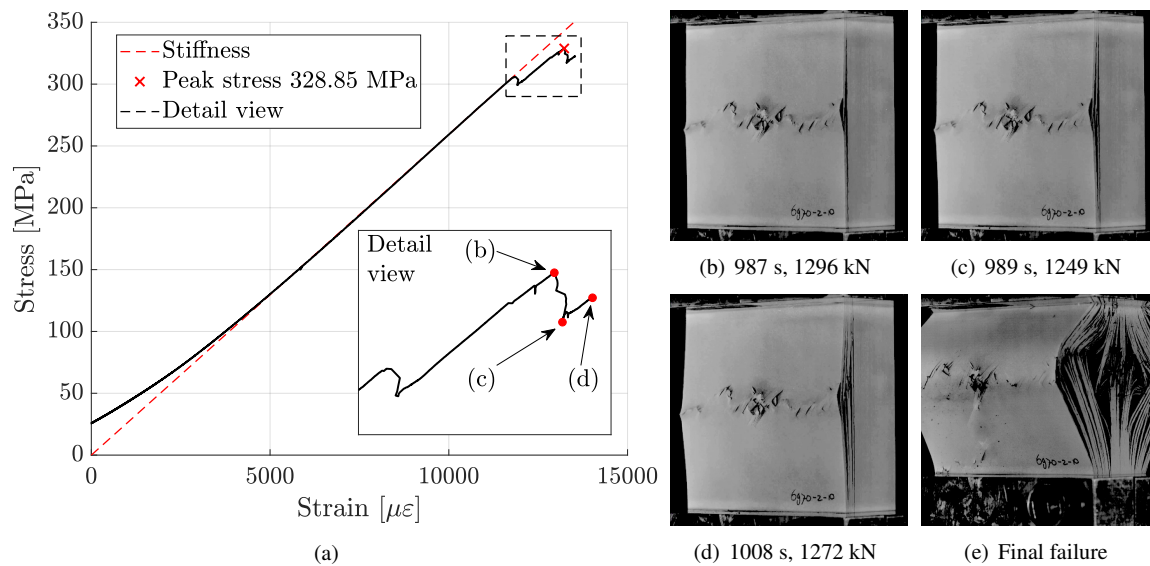
**Figure 19.** CAI test of a 40 mm thick specimen subjected to a 55 J drop-weight impact (40-QI-LM-55-4) with in (a) the stress-strain curve and detail view of progressive sub-laminate buckling (b)-(d) leading to (e) final failure with a MMP failure mechanism.

An example of a CAI test is illustrated in Figure 19. A 40 mm thick specimen subjected to a 55 J drop-weight impact shows progressive damage of category MMP. It is observed that it takes a while for the stress-strain curve to align with the stiffness slope, which indicates that the test bench and specimen are settling. The slope of the stress-strain (i.e., compressive stiffness) originates from the centre and is used to align the stress-strain curve. A compressive stiffness of 25.9 GPa is approximately 50% lower than the undamaged compressive stiffness and comparable discrepancies are observed for the other specimens. Only a part of this difference is explained by the impact damage. For instance, specimen 40-QI-LM-55-4 in Figure 19 has a damage depth of 4 mm, which is approximately 10% of the specimen thickness. The apparent stress, and thus compressive stiffness, should only be 10% higher if it is assumed that this 4 mm of the specimen does not bear any load. The main reason is that due to high compressive forces the steel support of the test bench started to indent, resulting in additional displacement measured by the LVDTs. Since a measured compressive stiffness has no effect on the residual strengths the values obtained are still valid.
