NLR-CR-2018-365-RevEd-1 | January 2022

# Evaluation of in-service active thermography for composite structures

WP2 NDI (Non-destructive Inspection) in-service

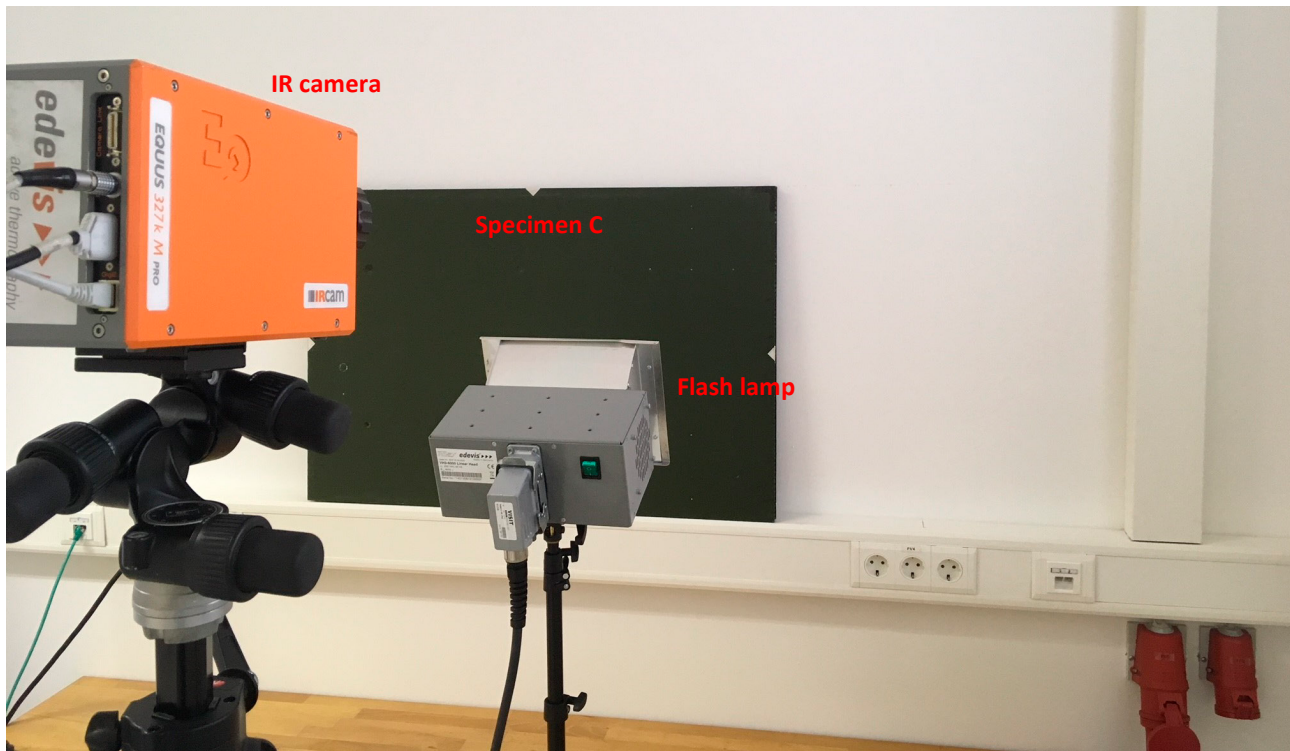
Figure 5.11: PT thermography inspection of reference specimen C by Edevis GmbH

The laboratory set-up to inspect both reference specimens with Pulse Thermography (PT) can be seen in Figure 5.11. In this case, the inspection was performed from one side which is most realistic for in-service conditions. The distance of the camera was chosen to cover  $\frac{1}{4}$  of the total surface area of the reference specimen, resulting in an approximate field of view of 450 x 300 mm. It is possible to increase the camera/specimen distance and to cover the total surface area during one acquisition. The position of the lamp is chosen, such that the specimen is homogeneously illuminated and that no disturbing reflection signals are reflected into the lens of the IR camera.
