Experimental damage tolerance evaluation of thick fabric carbon/epoxy laminates under low-velocity and high-velocity impact and compression-after-impact

Journal of Composite Materials
2022, Vol. 56(5) 761–778
© The Author(s) 2022

Abstract

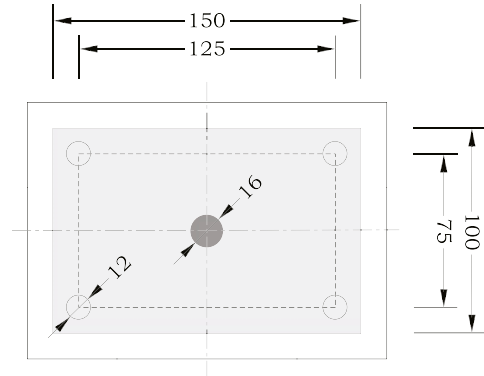
Figure 3. Top-view of the support fixture used for the drop-weight and gas-cannon tests.

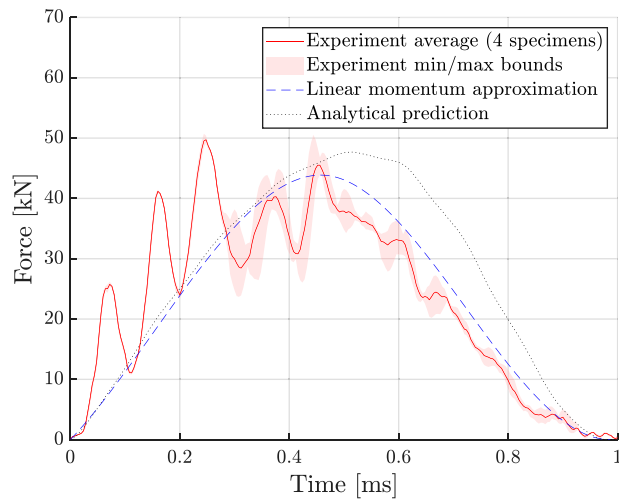
Figure 4. Averaged force history for 55 J drop-weight impact tests on 20 mm thick specimens.

In addition to the outputs that can be calculated directly from the experimental measurements, estimations can be made based on alternative models. For instance, the impactor indentation history, $\delta(t)$, and plate deflection history, $w_p(t)$, can be estimated by assuming a contact law. Talagani¹¹ proposed a contact law for thick composites that has been implemented in an analytical impact response model in an earlier work.¹² An example of a drop-weight force history, including an approximation of the analytical impact response model, is given in Figure 4.

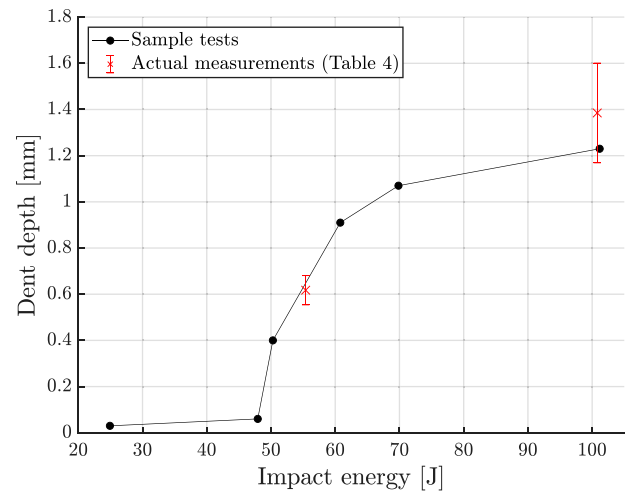
Figure 5. Energy level determination including the dent depths of 55 and 100 J drop-weight impact tests on 20 mm thick QI specimens.

were performed to determine the relation between impact energy and dent depth (e.g. permanent indentation δ_0). From the results in Figure 5, a maximum impact energy of 100 J was chosen (i.e. the limit of the gas-cannon) and, in addition, an impact energy at the point where BVID is expected to occur (i.e. 55 J). For the drop-weight impacts, these impact energies correspond to approximately 6.96 and 9.38 m/s for a 2274 g impact mass.

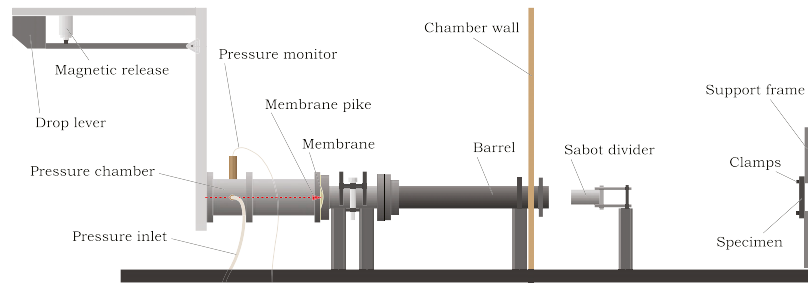
Figure 6. Illustration of the gas-cannon test setup used for small-mass impacts.

For the high-velocity impact tests, a gas-cannon designed at Royal NLR is used, as shown in Figure 6. This gas-cannon was originally designed for hail impact and modified for a 16 mm steel ball with a mass of 16.72 g, which resulted in a maximum impact energy of 100 J previously indicated. The 55 and 100 J impact energies translate to an impact velocity of 81.11 and 109.37 m/s. To match the diameter of the gas-cannon barrel, the steel ball is positioned in a 3D printed sabot that consists of two halves. By puncture of a plastic membrane, the pressurised gas is released and the sabot, including steel ball, travels through a 1 m long barrel. At the end of this barrel, it enters an approximately $2 \times 2 \times 2$ m chamber, illustrated in the high-speed images in Figure 7, on the left side. Immediately the sabot is split in half and blocked by a divider, and the steel ball crosses the chamber alone before impacting the specimen. The support fixture used for the drop-weight impact experiments is mounted vertically to feature identical boundary conditions. Two high-speed cameras and required lighting equipment are situated in the chamber and one wall is made of protective glass to observe the experiment.

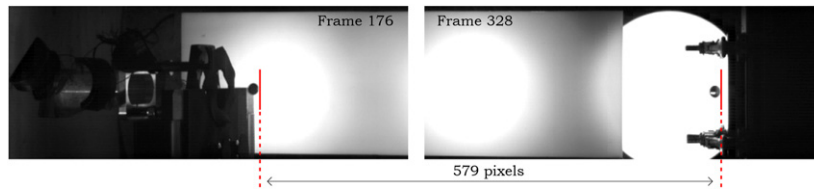
Figure 7. Illustration of the impact velocity determination of a gas-cannon impact on specimen 20-QI-SM-55-1. The impactor is detected at frames 176 and 328, which results in a elapsed time of 7.6 ms over a distance of 579 pixels. Knowing that 1 pixel equals 1.035 mm the resulting impact velocity is 78.87 m/s.

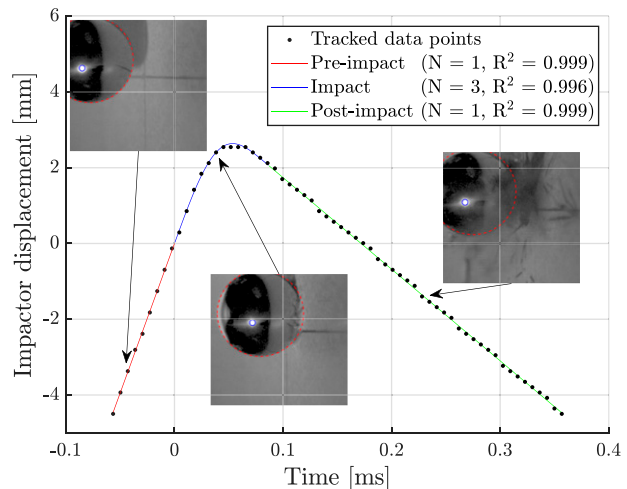
Figure 8. Tracking the impactor during a gas-cannon impact on specimen 20-QI-SM-55-1.

From Figure 8, it can be concluded that the impactor displacement can be tracked very accurately. The values of the tracked data points in terms of pixels are translated to length measured in mm by using the fact that the slope of the pre-impact region should be equal to the initial velocity measured from Figure 7. In addition, three regions are defined: pre-impact (red), impact (blue) and post-impact (green). During impact the tracked data points can be fitted using a cubic polynomial. Similar to the pre-impact region, the post-impact region can be fitted using a linear expression of which the slope represents the exit velocity.

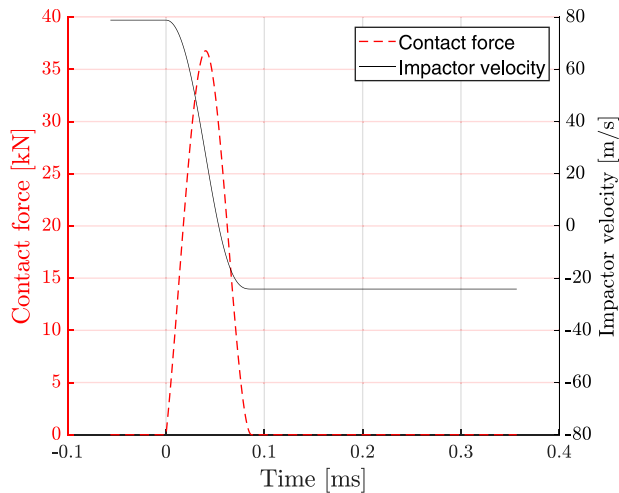
Figure 9. Estimated contact force and impactor velocity history of specimen 20-QI-SM-55-1.

The impactor velocity history is determined by integrating the impactor acceleration, as shown in Figure 9.

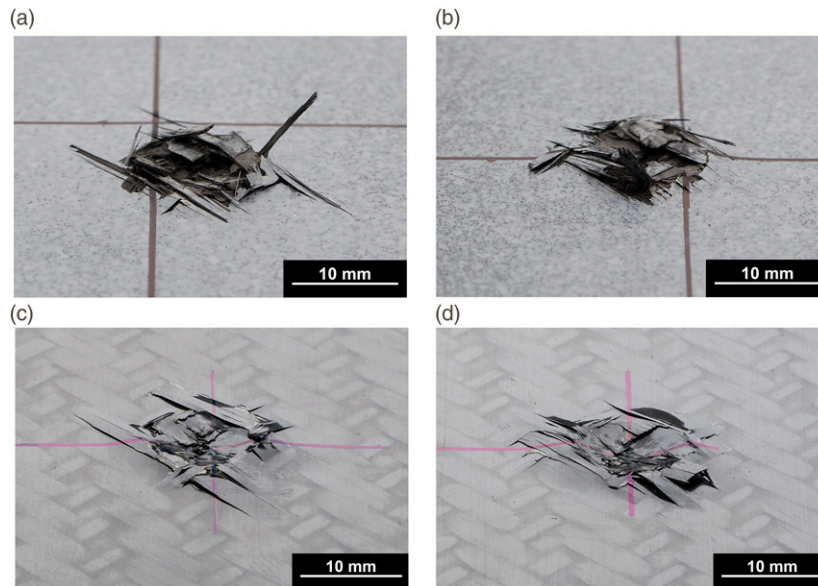
Figure 10. Typical dents for 55 J drop-weight impacts and gas-cannon impacts on 20 mm thick specimens with a QI and OT layup.

energy is dissipated by creating a dent at the impact location, see Figure 10. This dent is formed due to crushing of several plies at the impact location of which some parts are propelled in the air. At the same time, material is pushed outward in the top few layers that experience compression in the longitudinal direction. In this area, kinking and buckling occurs, which is identified by protruding layers around the dent. This phenomenon may be observed in Figure 13, which shows the cross-section of a specimen subjected to 55.3 J impact. Kinking and buckling, which may be seen at the bottom left of Figure 13, is mainly observed for large-mass low-velocity impacts on 20 mm specimens, with a lower impact energy, that result in smaller dents.

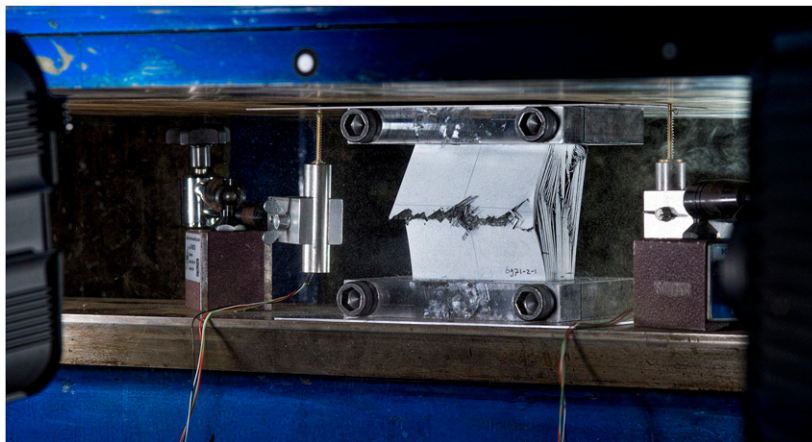
Figure 11. The CAI test setup with a 40 mm thick specimen subjected to a 100 J gas-cannon impact (40-QI-SM-100-1) showing a Middle Top Progress failure mechanism. Note: CAI: compression-after-impact.

The CAI experiments were performed using a static test bench at Royal NLR, see Figure 11. It was chosen to deviate from the ASTM standard for determining the compressive residual strength as it is focused on testing of thin specimens. The expected failure mode, and lack of a global buckling mode, require a different support fixture, contrary to the recommendations of ASTM standard for thin laminates. Instead of the ASTM standard, the following method was applied: The support fixture is derived from previous CAI experiments performed at NLR,²⁰ and consists of two anti-brooming devices clamped on the short edges of the specimen. If not used, brooming or splitting of plies might occur at the contact surface with the test bench due to high contact forces. The applied load is measured by the test bench as well as the applied displacement. However, due to the deformation of the test bench itself, the actual displacement is measured using two calibrated Linear Variable Differential Transformers (LVDTs). These are positioned on both sides of the specimen such that an average

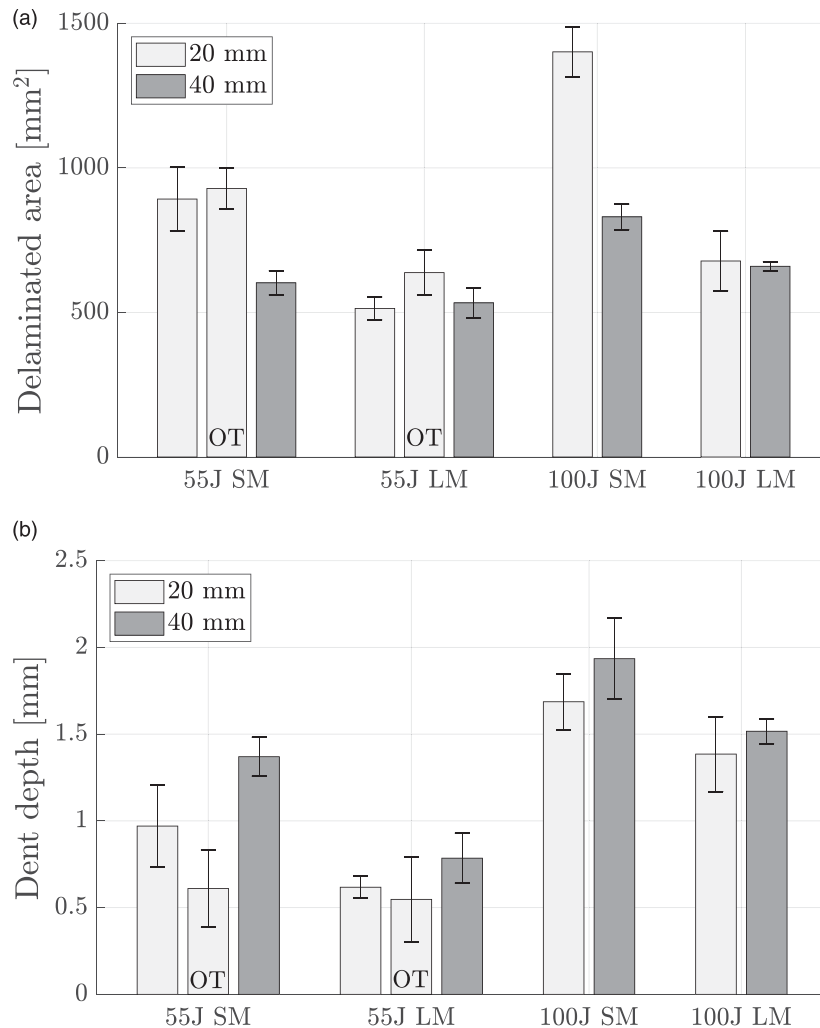
Figure 12. Average impact damage in terms of (a) delaminated area and (b) dent depth for LM drop-weight impacts and SM gas-cannon impacts. Note that the results annotated with OT contain the specimens with an orthotropic layup. Note: LM: large-mass; SM: small-mass.

This section starts with a description of the observed characteristic impact damage of thick composite laminates. A complete overview of the measured damage can be found in [Appendix 1. Figure 12](#), which is based on the detailed data given in the Appendix, shows the average impact damage in terms of the dent depth and the delaminated area for large-mass (LM) drop-weight impacts and small-mass (SM) gas-cannon impacts. With this data, the effect of four different aspects can be evaluated, namely (i) specimen

The effect of laminate thickness. A thickness effect is observed when comparing impacts on 20 and 40 mm thick specimens in Figure 12. The impactor displacement of the 20 mm specimens is approximately 8–11% higher compared to the thicker specimens. For the drop-weight experiments, the dent depth of 20 mm specimens is 21.52% lower for 55 J impacts and 8.55% lower for 100 J impacts. In the case of gas-cannon impacts, the dent depth of 20 mm specimens is 29.20% lower for 55 J impacts and 12.89% lower for 100 J impacts. Accordingly, it can be assumed that this higher impactor displacement is a result of more bending. This increased bending of the 20 mm specimens on average results in a noticeably higher delaminated area in the case of the gas-cannon impacts (i.e. +48% for a 55 J impact and +69% for a 100 J impact). Surprisingly, no significant difference in delaminated area is observed for the drop-weight impacts (LM specimens in Figure 12(a)).

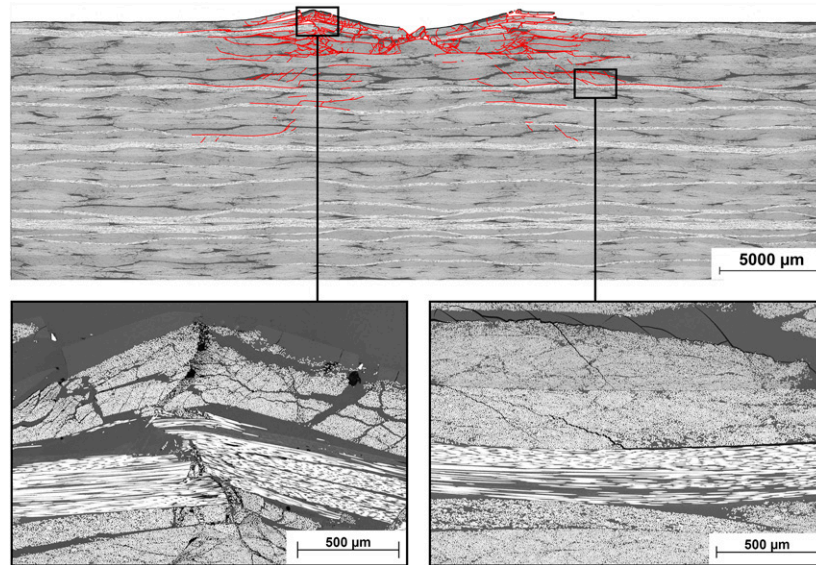
Figure 13. Cross-section of specimen 20-OT-LM-55-4 with highlighted crack boundaries and a detailed view of two damage mechanisms characteristic of thick composite specimens. On the left, longitudinal compressive loads resulting in fibre kinking and buckling in the top plies and, on the right, interaction between transverse cracks and delaminations.

Beside a dent, no damage is typically observed directly underneath the impact location. Due to increasing transverse shear stresses away from the centre of impact, delaminations and transverse cracks appear, resulting in a typical *hat-shaped* damage pattern as highlighted in red in Figure 13. In the same figure, the detailed interaction between delaminations and transverse cracks is illustrated in the magnified view, which shows the transition from transverse cracking to delamination. In all cross-sections the dominant delaminations extend along the interface between warp yarns. For instance, the delamination in Figure 13 initiates from a transverse crack and propagates along the warp yarn in white. Interestingly, these delaminations only occur above the warp yarns. The bending, although limited, leads to compressive forces in the top half of the specimen. The compression causes slight buckling of the warp yarn, which makes it easier for these interfaces to delaminate. The depth of delaminations is approximately 4–7 mm. In

contrast to impact damage in thin composite specimens, the damage does thus not fully extend to the bottom of the specimen and no fibre breakage is observed at the back side. Due to this, beside the dent, all the critical damage for the residual strength is not visible.

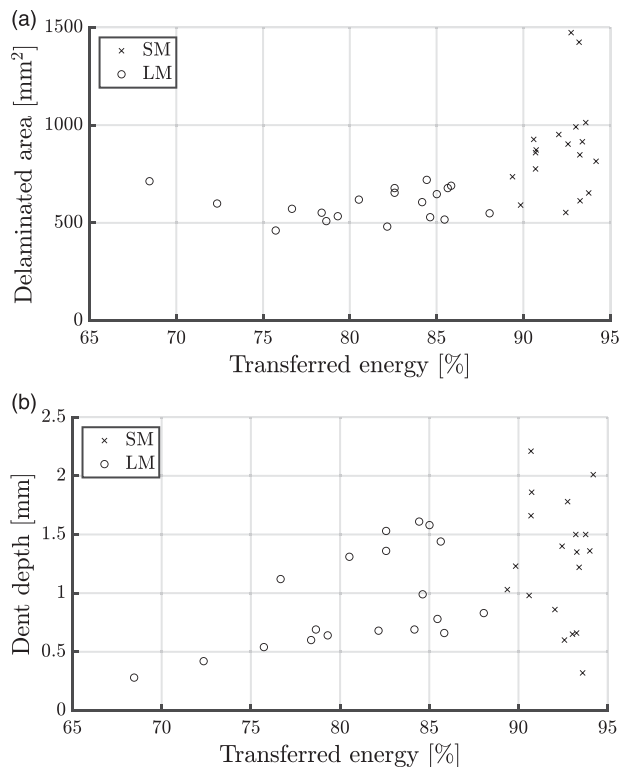
**Figure 14.** Relation between transferred energy and (a) delaminated area and (b) dent depth for LM drop-weight impacts and SM gas-cannon impacts. Note: LM: large-mass; SM: small-mass.

To get further insight on the damage induced in each type of test, the delaminated area and the dent depth are shown in Figure 14 as functions of the energy transferred from the impactor to the specimen. The results in Figure 14 show a 68–88% transferred energy range for large-mass low-velocity test, while for small-mass high-velocity tests 89–94% of energy is transferred to the specimen. For the drop-weight impacts an overall trend is that for a higher transferred energy the dent depth increases (see Figure 14(b)), while no significant change in delaminated area is observed (see Figure 14(a)). Since drop-weight impacts generally tend to a quasi-static response, the force

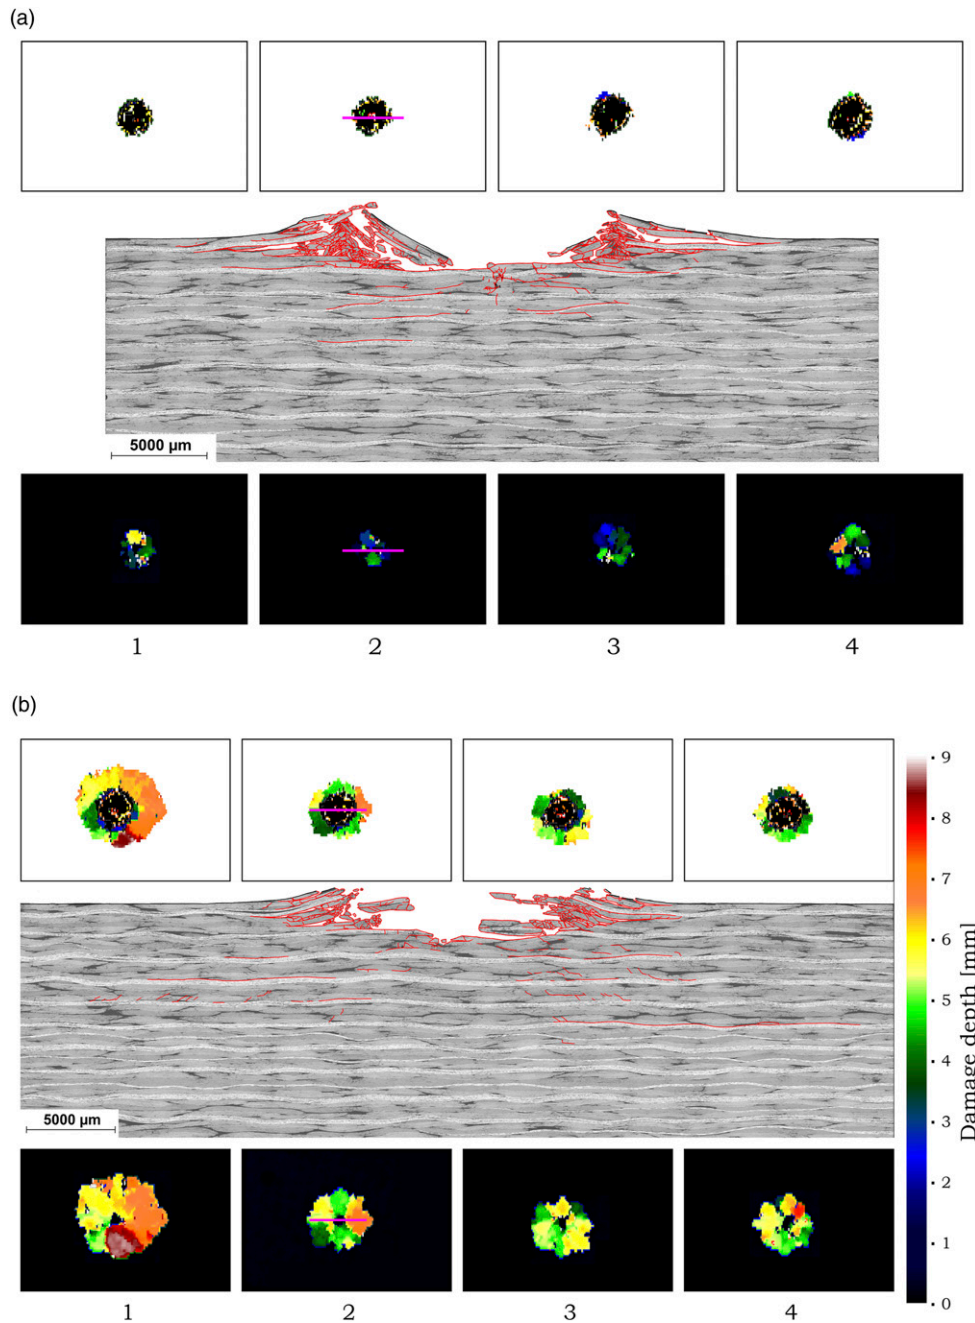
Figure 15. Damage comparison between 100 J (a) drop-weight impacts and (b) gas-cannon impacts on 20 mm thick specimens. In the middle, the cross-section of one of the four specimens is shown, 20-QI-LM-100-2 in (a) and 20-QI-SM-100-2 in (b), where the crack boundaries have been highlighted in red. TOF scans are shown for all four specimens, the impact side on top and non-impact side on the bottom. Note: LM: large-mass; SM: small-mass; TOF: time of flight.

Typical damage information based on cross-sections and C-scans is shown in Figure 15. The considerable higher

delaminated area for gas-cannon impacts is shown in Figure 15 for a 100 J impact on a 20 mm thick specimen. Similar to Figure 13, the delamination shown in Figure 15 initiates from a transverse crack and propagates along the warp yarn. In Figure 15(a) all internal damage is hidden behind the dent and therefore not visible in the impact side

TOF C-scans. In addition to the lower delaminated area, looking at the cross-sections, the damage extends approximately 1 mm further in the thickness direction. Specimen 20-QI-SM-100-1, shown in Figure 15(b), is treated as an outlier with a delaminated area twice as large as the other three specimens. Due to this, it is excluded from Figure 14(a).

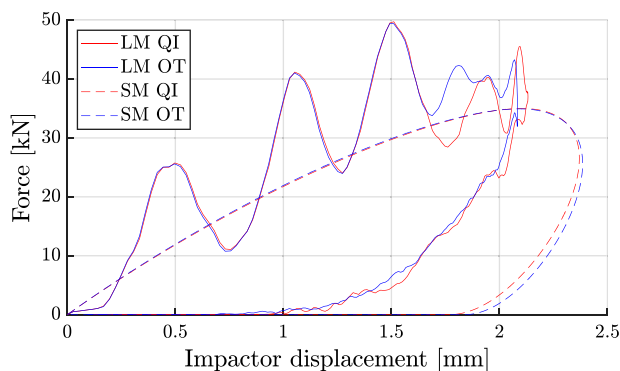
Figure 16. The effect of layup for 55 J LM drop-weight impacts and SM gas-cannon impacts on 20 mm thick specimens. Note: LM: large-mass; SM: small-mass.

For 55 J impacts on 20 mm thick specimens, the impact force as a function of the impactor displacement, is shown in Figure 16. From the figure, it can be seen that the drop-weight and gas-cannon impact each have a distinct impact response. Gas-cannon impacts generally have a higher impactor displacement and lower peak force.

The effect of laminate layup. Comparing the responses for the distinct layouts, it can be concluded from Figure 16 that the details of the layup have a negligible effect on the overall impact response. However, there are some important differences in terms of damage. In Figure 12, the observed damage in 20 mm specimens with a OT layup are compared to 20 mm specimens with a QI layup. For the gas-cannon impacts, specimens with the OT layup show on average a 37% shallower dent compared to the specimens with a QI layup. At the same time, the delaminated area is only 4% higher on average. For the drop-weight impacts, the decrease in dent depth is only 11% and increase in delaminated area 24%. According to these results, it seems that the QI layup is more sensitive to crushing of the first few plies. As more energy is dissipated in this damage mechanism, the energy that is left for bending and subsequent delaminations is lower.

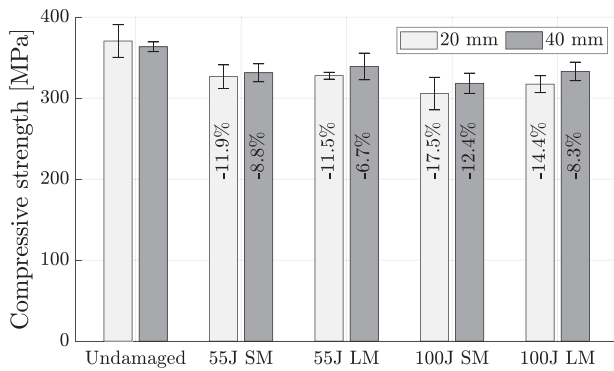
Figure 17. Compressive strength for 20 and 40 mm specimens subjected to LM drop-weight impacts and SM gas-cannon impacts. Note: LM: large-mass; SM: small-mass.

The resulting compressive strengths are visualised in Figure 17. Exact values of the residual CAI strengths can be found in Table A4, while the compressive strengths of undamaged specimens are given in Table 3. As expected, the residual CAI strength is closely related to the delaminated area and damage depth. For instance, specimens subjected to a 100 J gas-cannon impact have the highest delaminated area and therefore the largest reduction in residual CAI strength (i.e. 12% and 18%). In addition, the effect of both gas-cannon and drop-weight impacts is larger on the residual CAI strength of 20 mm specimens compared to the 40 mm impacted specimens. For the 20 mm specimens with gas-cannon impacts, this is explained by larger delaminations that appear deeper in the specimen. For the 20 mm specimens, with drop-weight impacts, the gap with 40 mm specimens is larger, with no significant change in delaminated area. A possible explanation is that the delaminations are approximately 25% deeper for 20 mm specimens. Deeper delaminations mainly affect the sub-laminate bending stiffness, which results in failure at a lower load.

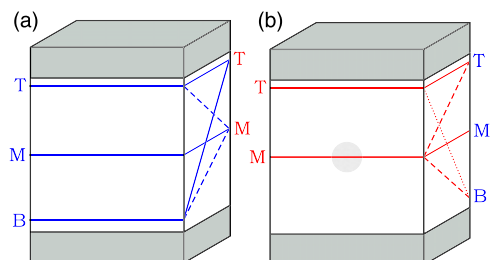
Figure 18. Failure mechanisms observed during the CAI tests with buckling of sub-laminates at the middle (M), top (T) or bottom (B) of the specimen. Distinction is made between symmetric failure (MM and TT) and asymmetric failure (MT, MB and TB). Note: CAI: compression-after-impact.

categorised based on the location of sub-laminate buckling. Depending on the location where buckling initiates, the failure is identified with a letter as follows: T for top, M for middle and B for bottom. This is recorded for each side of the specimen separately, so TT indicates that buckling initiated at the top of the specimen on both sides. Similarly, MT indicates that buckling initiated in the middle on one side and at the top on the other side. By convention, the first letter refers to the side of the specimen that was previously damaged by impact. Due to the absence of global buckling, these damage mechanisms are usually not observed in CAI tests on thin composite specimens. For instance, in addition to the in-plane behaviour, the through-thickness behaviour is equally important for thick composite specimens.

Symmetric failure (MM and TT) occurs when delaminated plies start to buckle at approximately the same location on the impact and non-impact side of the specimen. As a result, the through-thickness damage pattern is also symmetric and usually horizontal, with variations that have a v or w shape. Within the symmetric failure mechanism two distinctions are made. MM failure occurs at the middle of the specimen, usually through the impact location, and represents 11% of the cases. TT failure occurs near the anti-brooming device at the top of the specimen and is the second frequent observed mechanism in 34% of the cases. No symmetric failure near the bottom of the specimen (BB) is observed.

Asymmetric failure (MT, MB and TB) occurs when sub-laminate buckling of delaminated plies occurs at a different location on the impact side and non-impact side. For instance, the most common case is an MT failure mechanism observed in 45% of specimens. In this mechanism, the impact side sub-laminate buckling occurs in the middle (M) and on the non-impact side at the top of the specimen (T). Sub-laminate buckling generally starts at the impact side. During progressive failure, the cracks in the thickness direction propagate to the location of sub-laminate buckling on the other side. Asymmetric MB and TB failure is observed in two specimens for each mechanism.

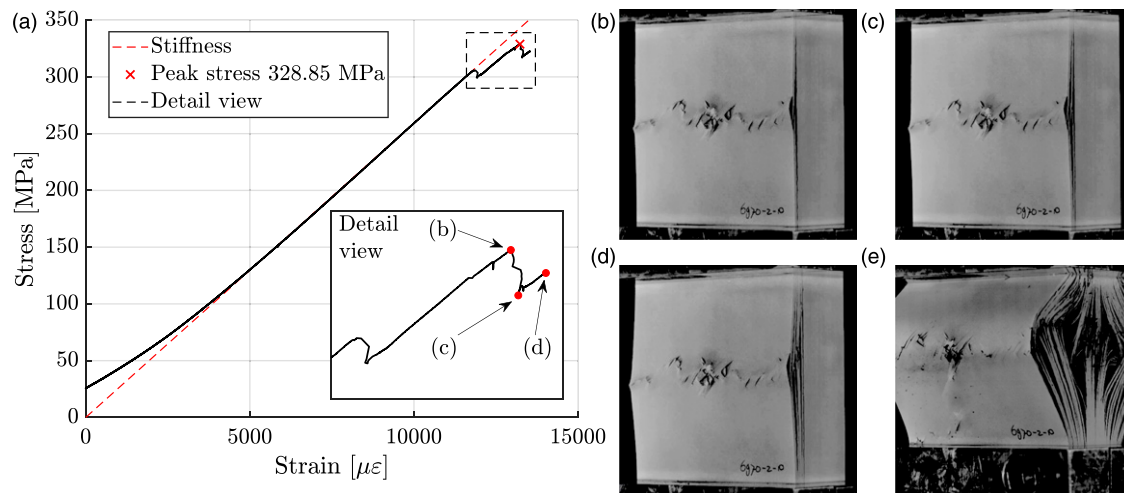
Figure 19. CAI test of a 40 mm thick specimen subjected to a 55 J drop-weight impact (40-QI-LM-55-4) with in (a) the stress-strain curve and detail view of progressive sub-laminate buckling (b)–(d) leading to (e) final failure with a MMP failure mechanism. Note: CAI: compression-after-impact; LM: large-mass; SM: small-mass.

An example of a CAI test is illustrated in Figure 19. A 40 mm thick specimen subjected to a 55 J drop-weight impact shows progressive damage of category MMP. It is observed that it takes a while for the stress–strain curve to align with the stiffness slope, which indicates that the test bench and specimen are settling. The slope of the stress–strain (i.e. compressive stiffness) originates from the centre and is used to align the stress–strain curve. A compressive stiffness of 25.9 GPa is approximately 50% lower than the undamaged compressive stiffness and comparable discrepancies are observed for the other specimens. Only a part of this difference is explained by the impact damage. For instance, specimen 40-QI-LM-55-4 in Figure 19 has a damage depth of 4 mm, which is approximately 10% of the specimen thickness. The apparent stress, and thus compressive stiffness, should only be 10% higher if it is assumed that this 4 mm of the specimen does not bear any load. The main reason is that due to high compressive forces the steel support of the test bench started to indent, resulting in additional displacement measured by the LVDTs. Since a measured compressive stiffness has no effect on the residual strengths the values obtained are still valid.

From the detailed view in Figure 19(a), it is observed that multiple events occur prior to final failure. The first load drop at 1205 kN indicates propagation of one or multiple

delamination(s) and subsequent sub-laminate buckling. This propagated delamination is present when the specimen reaches its peak strength, visualised in Figure 19(b). A second load drop of 47 kN occurs due to a second delamination that propagates, see Figure 19(c). Between this point and the point illustrated in Figure 19(d), a third delamination propagates, after which final failure occurs. Despite multiple delaminations, the specimen is able to carry an increasing load.
