Comparison of Laser Ultrasonic Testing and traditional Ultrasonic Testing

Benjamin van Elburg, William Kramer, Patrick H. Jansen
Royal Netherlands Aerospace Centre,
Marknesse, 8316 PR, The Netherlands
+31 88 511 4700
benjamin.van.elburg@nlr.nl

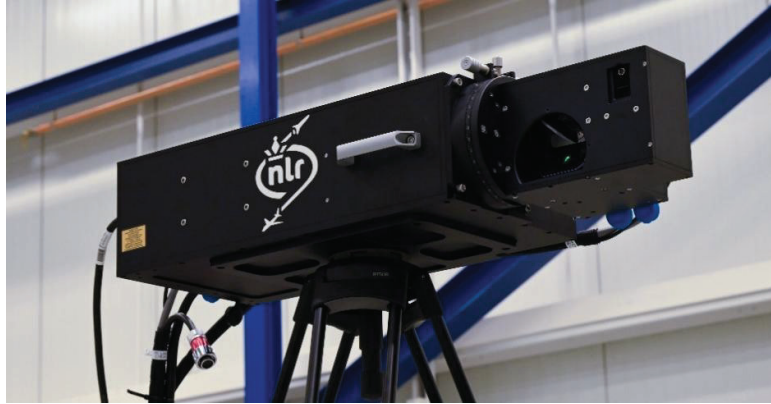
Figure 1: The angular laser ultrasonic system. On the right side a green aiming laser is visible on the steering mirror.

The laser ultrasonic system is the HUPI (Hybrid Ultrasonic Propagation Imaging) system made by Space NDT (South Korea) and is shown in Fig. 1. The system has a linear mode, where a translation stage moves the laser beams, and an angular mode, where a mirror system steers the laser beams. Only the angular mode was used to obtain the results in this paper.

The Q-Switched generation laser within the system is the Sol 40W 1064nm (Bright Solutions, Italy) and the sensing laser is the VibroFlex QTec (Polytec, Germany) laser doppler vibrometer (LDV). The generation laser was used at a 100% power setting of 2 mJ per pulse at a pulse repetition frequency of 10 kHz. The measuring frequency band was set between 1 and 1.5 MHz, the sampling rate was 80 MHz and a total of 1000 samples were measured per location. The scan index in both directions was set at 0.5 mm for all samples. Each scan was repeated three times (unless indicated otherwise) to improve the SNR. The data was analysed in MATLAB (The Mathworks, USA).

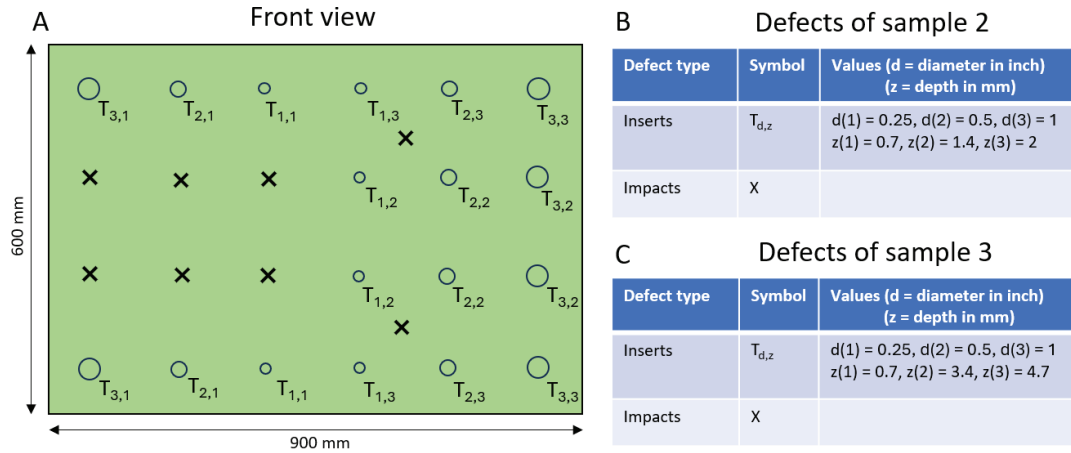
Figure 3: (A) A schematic drawing of the front view of samples 2 and 3. Defects are located at the same locations on both samples. (B) A list of all the defects with their size and depth of sample 2. (C) A list of all the defects with their size and depth of sample 3.

Sample 2 and 3 are made of the same materials as sample 1. Both samples have defects as shown on the schematic Fig. 3A. Sample 2 has a thickness of 2.7 mm and sample 3 has a thickness of 5.4 mm. The foils simulating delaminations were inserted at different depths for sample 2 and 3 as indicated in Fig. 3B and C.

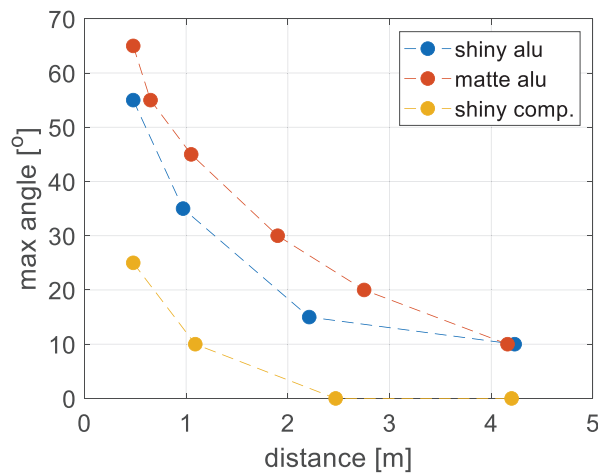
Figure 8: The maximum angle of incidence at which the LDV can accurately measure.

A traditional ultrasonic pulse echo measurement requires the transducer to be perpendicular to the surface. This requirement is less strict for laser ultrasonic testing as the sensing laser beam has a (partly) diffuse reflection on the surface. The accuracy of the LDV system as a function of stand-off distance and angle of incidence was tested with 3 different types of surfaces: shiny aluminium, matte aluminium and shiny CFRP composite. Testing was done by detecting the vibration of the front side surface of the test material. The vibration was constant and generated by a single element transducer placed on the backside of the test material. The maximum angle of incidence was determined by incrementally increasing the angle until the SNR sharply dropped.

Fig. 8 shows the maximum angle of incidence for the 3 materials. The angle decreases with distance and differs per material. The shiny composite is the most sensitive to the angle of incidence, resulting in a 10 degree tolerance at a 1 meter stand-off distance. This allows the laser ultrasonic system to completely scan a composite component, curved in one direction, with 18 orientations. This, combined with the high scanning speed, makes laser ultrasonics ideal for fast inspection of curved composites.

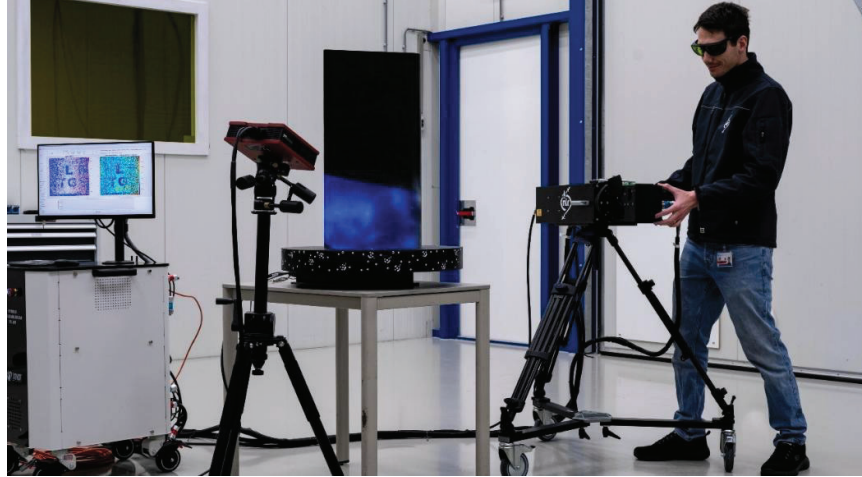
Figure 9: The automatic inspection system for curved composites with from left to right: the laser ultrasonic pc, the 3D scanner, the rotation table with a curved component, the laser ultrasonic scanner and the first author.

A fast and automated inspection system for composites is presented here, that utilizes the long stand-off distance between component and scanner and the tolerance in angle of incidence of the LUT system. The system (Fig. 9) consists of a structured-light 3D scanner (Atos Core, Zeiss, Belgium), a software controlled rotation table with coded markers and the laser ultrasonic system.
