NLR's experience with flight testing on wet and flooded runways

National Aerospace Centre NLR

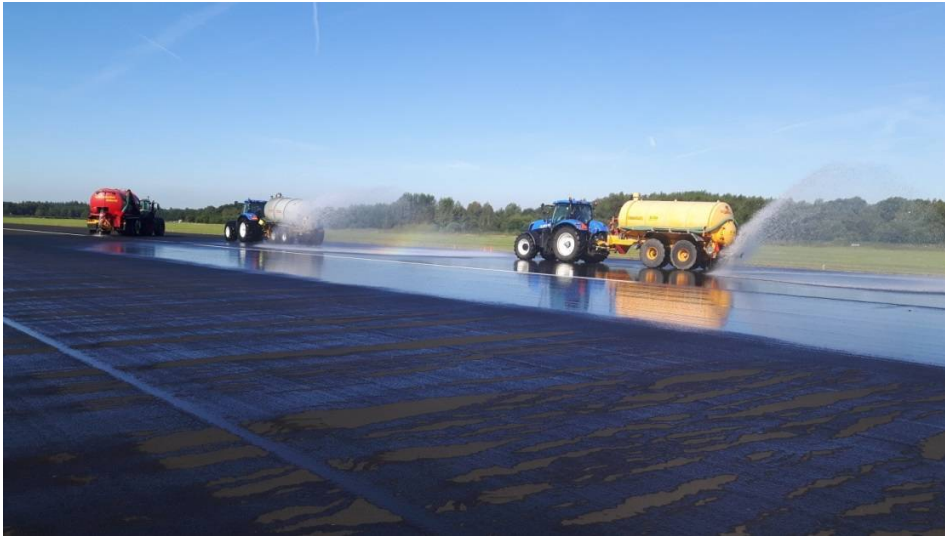
Figure 1: Tests to determine amount of water required to wet the runway.

In absence of natural rain conditions, the runway was artificially wetted. This is a common way to wet runways for flight testing. At the start of the project it was unclear how much water was needed to get the runway wet. As the runway had a high macrotexture it was expected that a lot of water would be needed. A review of previous wet runway tests done by e.g. FAA, NASA, and others gave some useful information on the best practices. However most of these tests were conducted on rather smooth runways, requiring less water to get it wet. Therefore before the flight tests were conducted, experiments were organised to determine the amount of water needed to wet the runway. For this purpose water trucks were run along a section of the runway, dropping water at different rates (see Figure 1). Each time the water depth was measured at fixed locations from the centreline that corresponded to the location of the main gear wheels of the test aircraft. The water depth was measured using the NASA

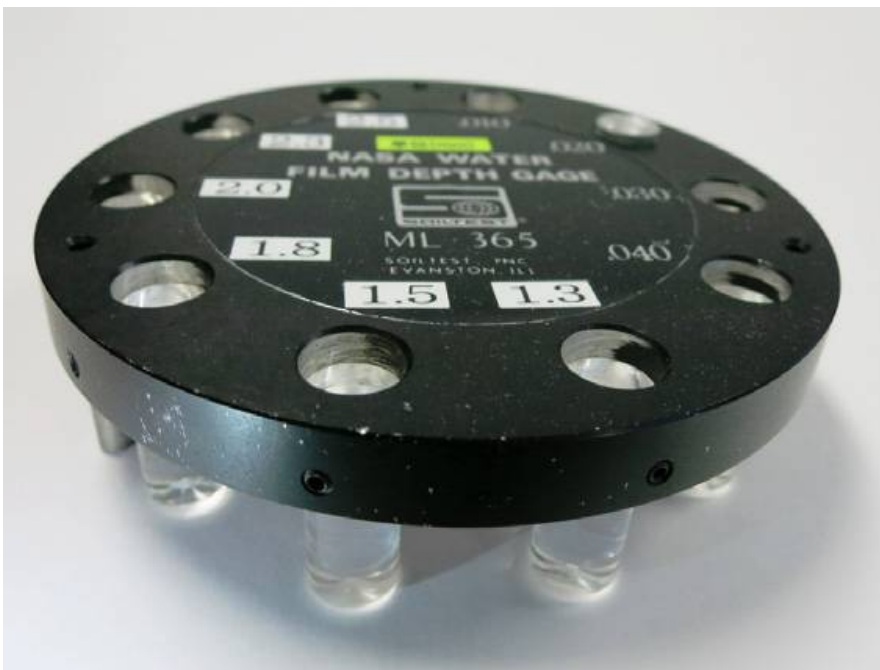
Figure 2: NASA water film depth gauge.

water film depth gauge (see Figure 2) at different time intervals. This device has been used for many years in wet runway testing. The NASA gauge works on the principle of reflectivity. Plexiglas rods of different lengths that protrude through its body are calibrated and marked with numbers from 0.0 to 0.10 inch to indicate water depth. Since water is highly reflective and will reflect more light than the runway surface, rods that are not touching the water will appear lighter than those that are touching or submerged in water. The dark rod with the highest number, therefore, indicates the water depth. Wind during these test varied between 6-10 kts and the temperature varied between 20-24 °C. There were no clouds during the tests. Figure 3 gives some results of the water depths measured as function of drainage time during the initial tests at Twente airport (speed of water trucks was 10 km/h, flow rate around 3-4 m³/min). Water depths of 1-2 mm were measured around 150 sec. after water application in this example. A water depth range of 0.5-0.8 mm was measured 150-230 sec. after water application and a range of 0.25-0.50 mm was after 230-300 sec. All water depth measurements were taken at the wheel track of the Cessna Citation test aircraft. Based on these initial tests the amount of water needed to wet the runway for the full-scale aircraft braking tests was estimated. Tests conducted by FAA and NASA showed that runway water depths of more than 1.5 mm are not feasible as the water is drained immediately when water trucks spray the runway surface and the aircraft cannot land directly after the trucks are done spraying. Water depths between 0.25 and 0.8 mm are more realistic to achieve. For the present flight tests this range of water depths was set as the target range. Higher values (if achieved) are of course also acceptable as long as runway does not become flooded (more than 3 mm water depth). Runways with a water depth lower than 0.25 mm are not considered wet.

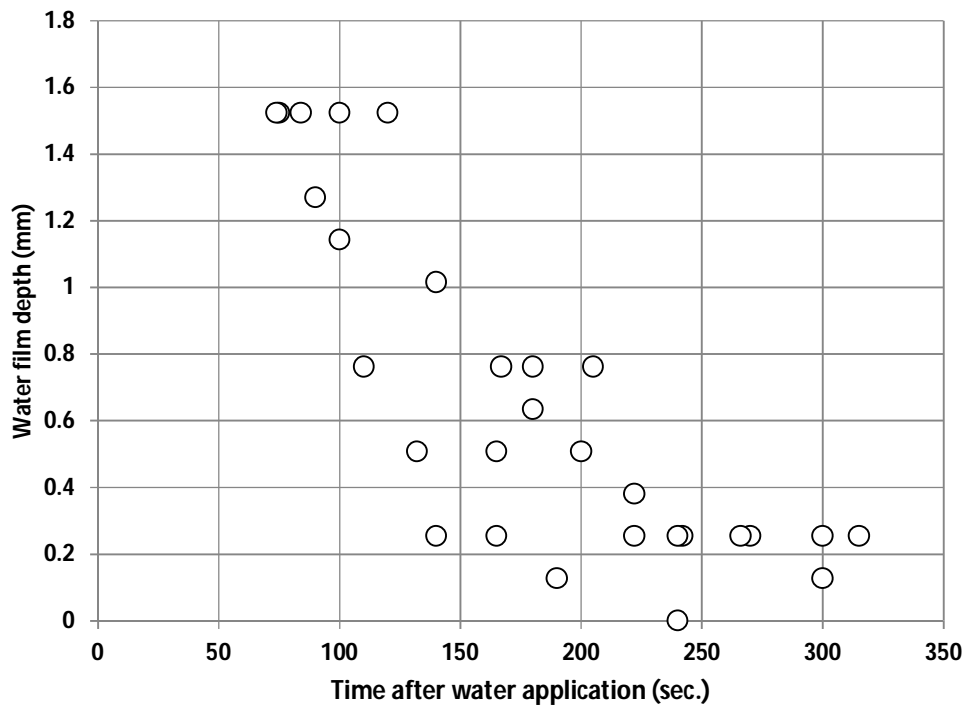
Figure 3: Example of measured water depths as function drainage time during initial tests.

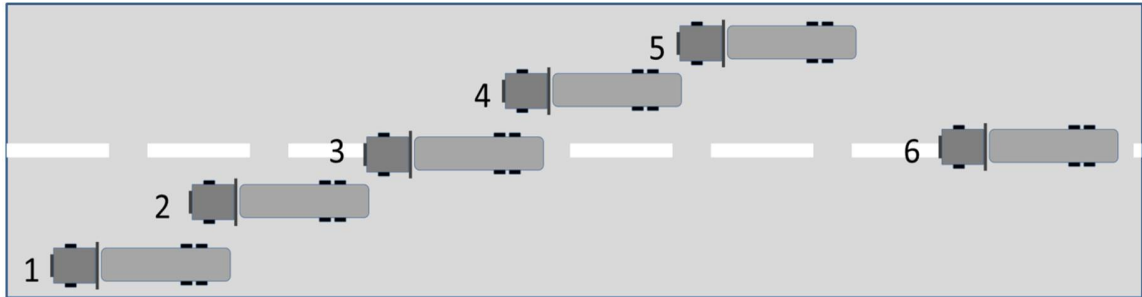
Figure 4: Arrangement of water trucks.

The test aircraft was dispatched prior to wetting the runway for a test condition. A section of 300 m long and 45 m wide of the runway was wetted using 6 water tank trucks. The tanks had a capacity of 35 m³. During each run about 8 m³ of water was released by each water tank truck. The trucks were arranged as shown in Figure 4. This layout ensured a timely exit of the trucks when they had finished spraying the runway. Figure 5 shows a picture of the water trucks on the runway. Shortly after the wetting of the test section the aircraft landed and maximum brakes were applied in the wetted area. The pilots used full brake-pedal deflection, which permitted the anti-skid brake system to modulate pressure to a value commensurate with the friction level available. The area in which the aircraft should brake was indicated by markers set at the runway edge. Braking started after passing these markers. Figure 6 and Figure 7 show pictures of the aircraft braking at the beginning of the wet section and at the end. The time between ending of the water spraying and the aircraft braking in the wet section was between 20-30 seconds during the tests. The aircraft was kept on the centreline during the ground roll. After the aircraft landed the water depth was measured in the middle of the wetted area, 2.70 m from both sides of the runway centreline (corresponds to main wheel location). Several water depth measurements were recorded at different intervals from the time the aircraft entered the wet section of the runway. These data are used to estimate the water depth when the aircraft was in the wet section.

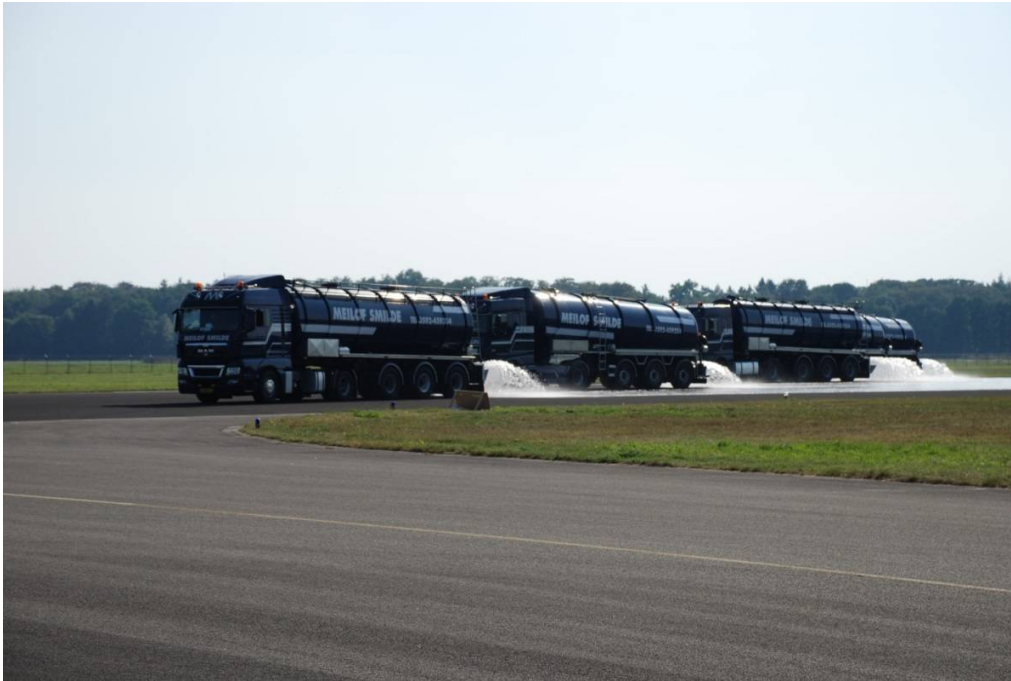
Figure 5: Wetting of the runway using water tank trucks.

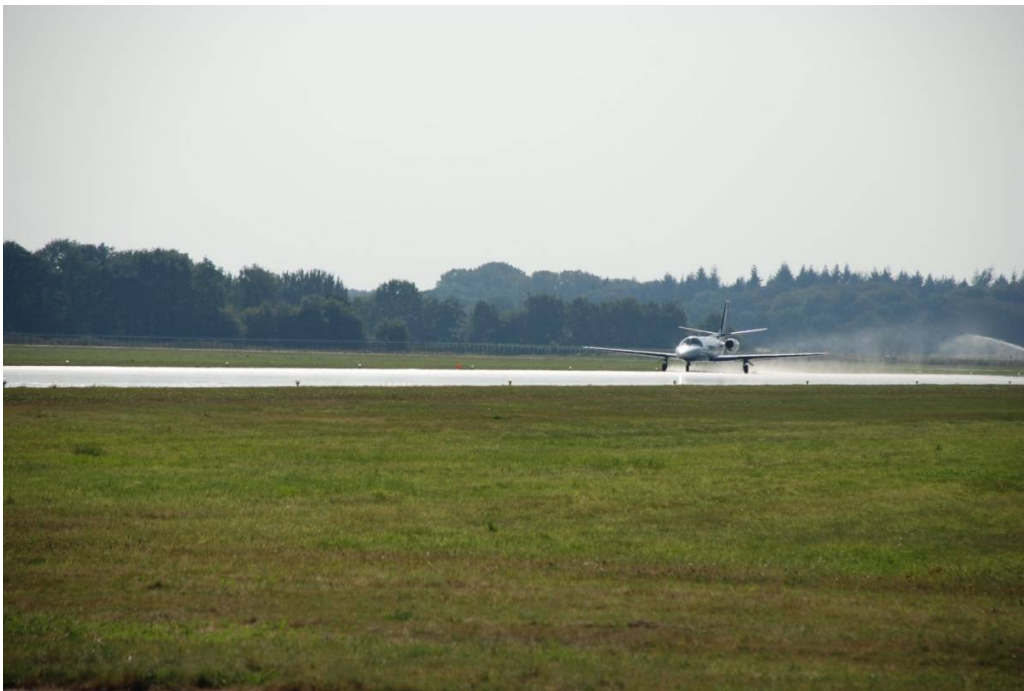
Figure 6: Aircraft braking at the beginning of the wet test section.

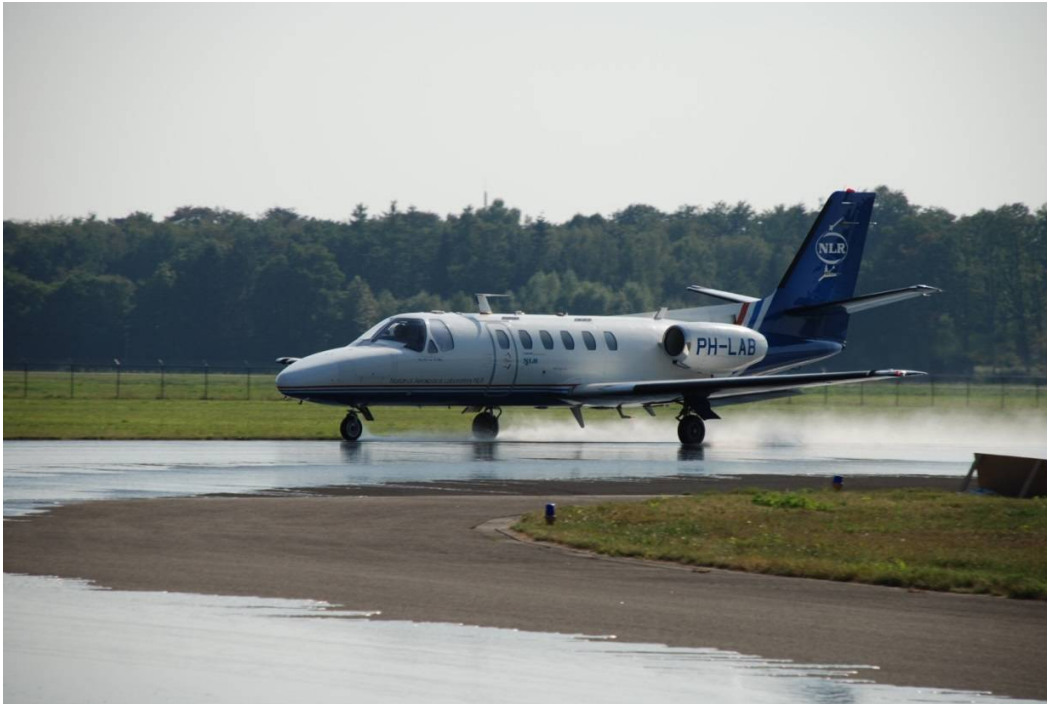
Figure 7: Aircraft braking at the end of the wet section.

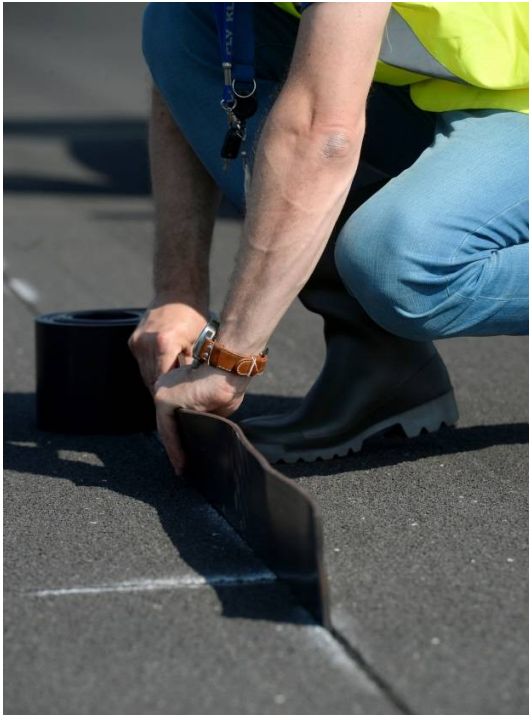
Figure 8: Flexible rubber strip in a runway groove.

The objective of the test programme required a runway covered with a target depth of around 15 mm of standing water. This is a lot more than for a wet runway. The build-in cross slope of a runway prevents that such a quantity of water stays on the runway, unless there is heavy rainfall. A water pond is therefore needed to create an area of sufficient water depth that stays at this level for long enough time for an aircraft to pass. Such water ponds are normally constructed using flexible re-enforced rubber strips as dikes to contain the water. These rubber strips are then put into grooves that are cut into the runway surface (see Figure 8). This is a classical way of building a water pond on a runway. It has been used for water certification ingestion tests as well as for braked tests with a wide range of civil transport aircraft since the 1960s. Earlier water ingestion tests conducted by NLR at Cranfield airport also used this approach.

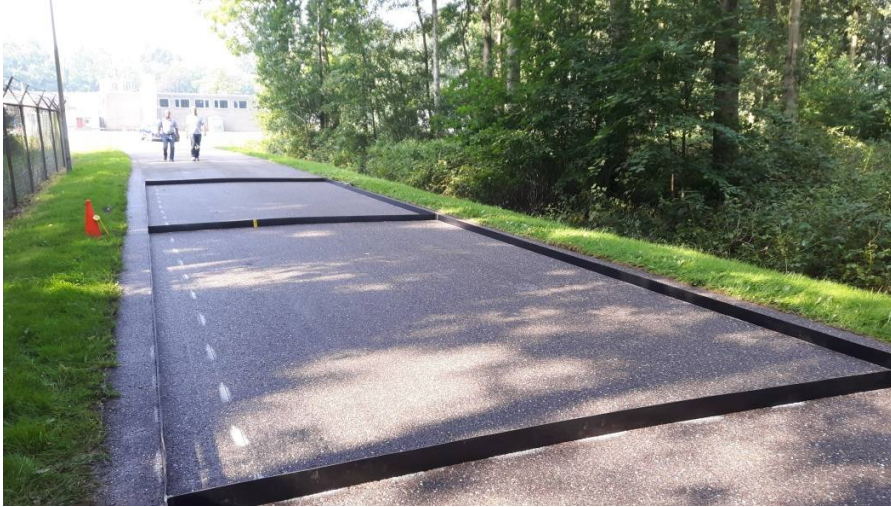
Figure 9: Test water pond.

Initially the tests were planned to take place at Cranfield airport. However, due to several reasons it became impossible to use this location. After considering a number of alternatives the same test location as for the wet runway tests was chosen, namely Twente Airport. This runway is ideally for such tests as it has a long and wide runway. Furthermore the traffic volumes are very low at this airport. However, the runway at Twente did not have a water pond facility at the start of the project. This facility had to be constructed. A classical water pond consists of series of grooves into which flexible rubber strips are put to form dikes. To gain some experience with such a setup, a small test pond was constructed at the NLR premises before making one at Twente airport. This water pond measured 4 by 10 m and is shown in Figure 9 (empty). The test pond was filled to several water levels. A large water truck was also run through the pond to see how the construction would behave (see Figure 10). Experiences were gained in grooving, fixing the rubber strips into the grooves, measuring of water depths and managing leakage of the pond with these experiments.

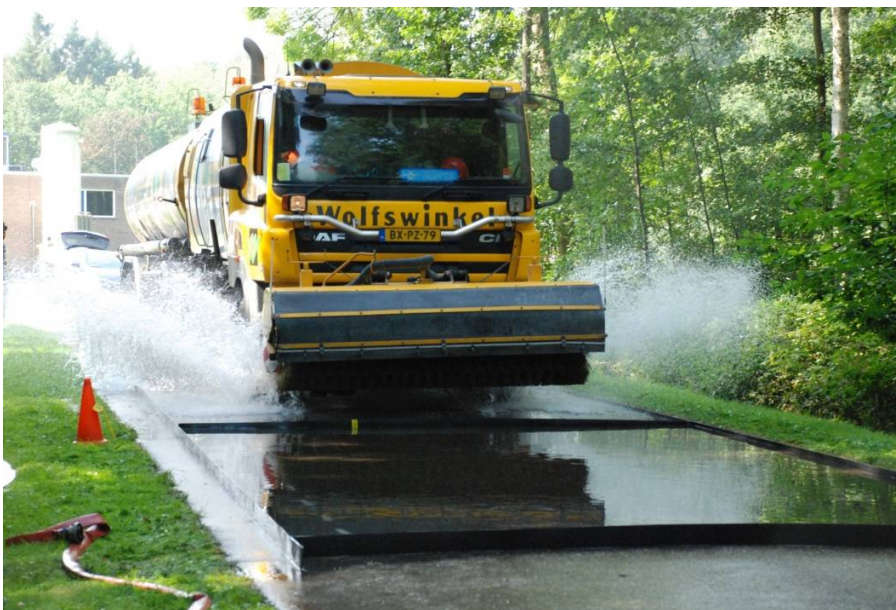
Figure 10: Large truck running through the test water pond.

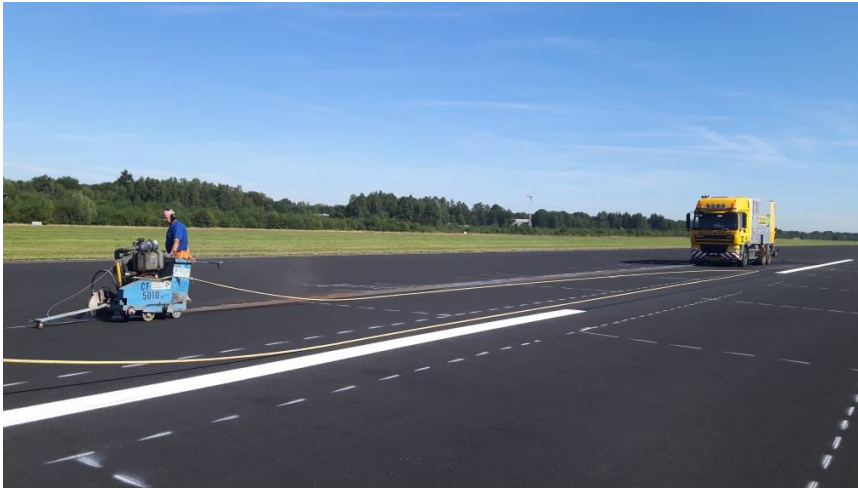
Figure 11: Construction of grooves into the runway for the water pond.

After positive experiences gained with the test water pond it was decided to construct a water pond at the flight test location. The runway at Twente airport has a very consistent longitudinal slope of 0.2% along the runway. Likewise the cross slope is also very consistent along the runway being 0.6-0.8% at the runway centreline and 1.5-1.6% further away from the centreline. The longitudinal slope required that several rubber cross dams had to be constructed to get reasonable consistent water levels in the water pond. These cross dams were placed every 7.7 m to form 13 separate sections. The construction of the grooves into the runway is shown in Figure 11. The final water pond on the test runway is shown in Figure 12. As the aim of the flight tests is to analyse

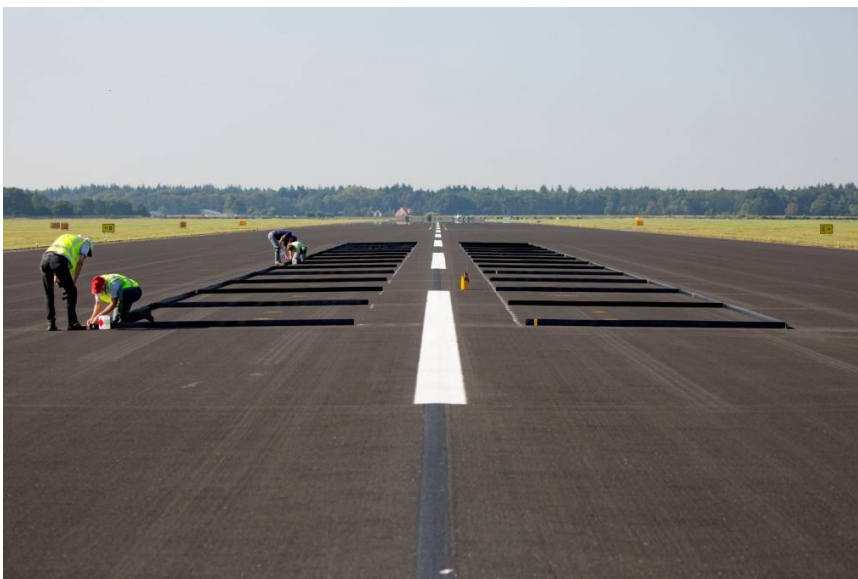
Figure 12: Water pond at Twente airport.

The overall length of the water pond was 100 m. This is sufficient long to obtain useful test data. Braked tests done by NASA used a water pond of similar length. The water pond starts 1.15 m from the centreline and stretches to 5 m from the centreline. The target average water depth in the water pond at the main wheels was set to 15 mm. Along each section the actual water depth will normally vary both in longitudinal as well as in lateral direction as the test section is not completely flat. However the main gear tyres should be exposed to target water depth when the aircraft does not deviate significantly from the runway centreline. Deviations from the centreline were observed on a few test runs, however, these were not significant enough to influence the test results.

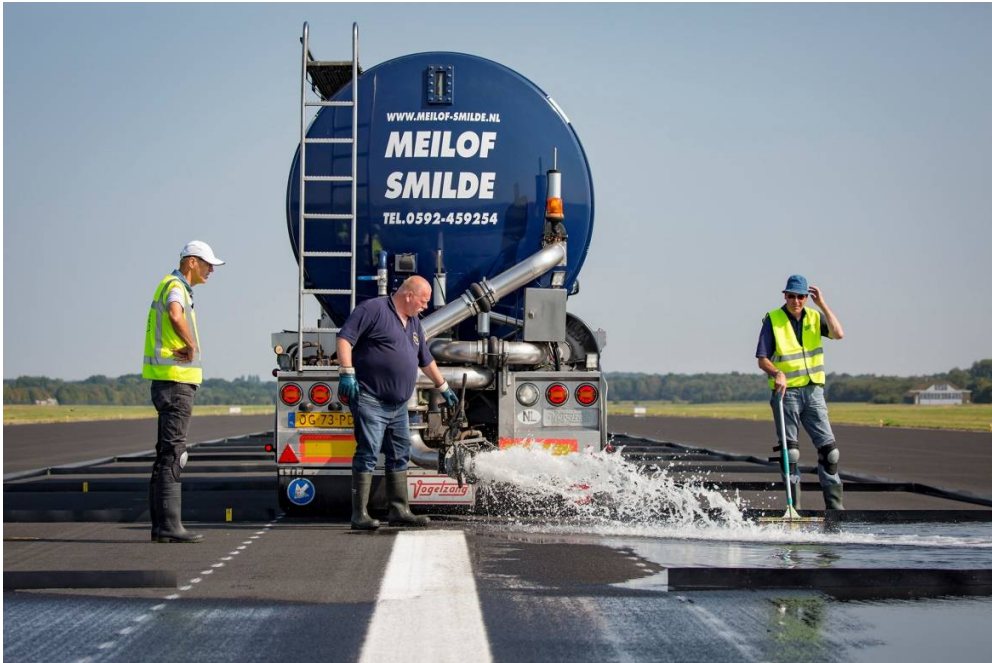
Figure 13: Filling of the water pond.

The water pond was filled to the target depth using water trucks as shown in Figure 13. Water depths were measured using a specially constructed wedge which is shown in Figure 14. Prior to each run water depth measurements were taken and recorded at pre-defined positions in each section of the water pond (see Figure 15). These positions matched the location of the main gear tyres. Water proof road marking chalk was used to locate these positions. However, it was noted after a few runs that the aircraft main gear tyres removed the chalk. In later tests a water proof spray paint was used instead. This proved to be much more resistant against the tyres running over it. If the water depth was well off the target value, water was either removed from the section or added. After each pass of the aircraft, about 30% of the water went out off the water pond, requiring a refill. Leakage at the side of the pond was also noted (see Figure 15). It was decided that no further sealing of the rubber strips was needed as this loss was not significant. Typically the water pond kept to its target water levels for more than 20-25 minutes under calm wind conditions. At high wind conditions this time reduces.

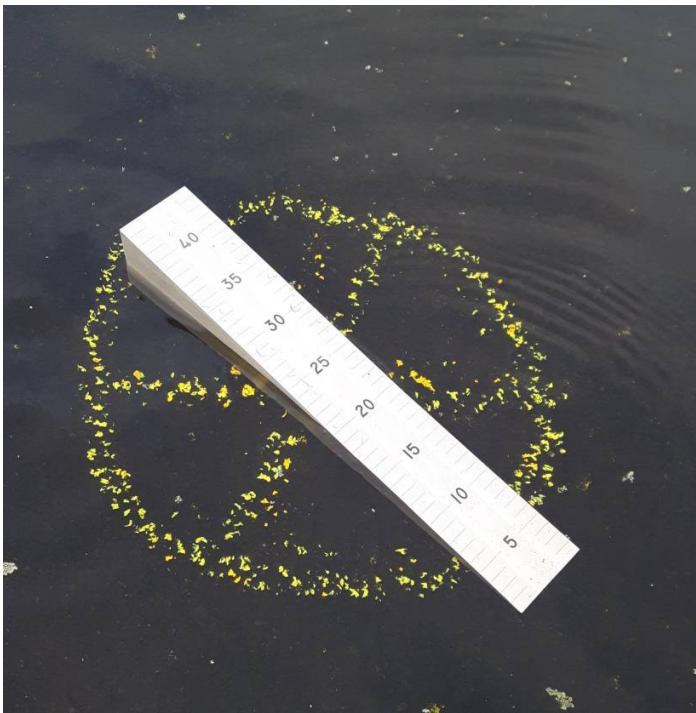
Figure 14: water depth gauge.

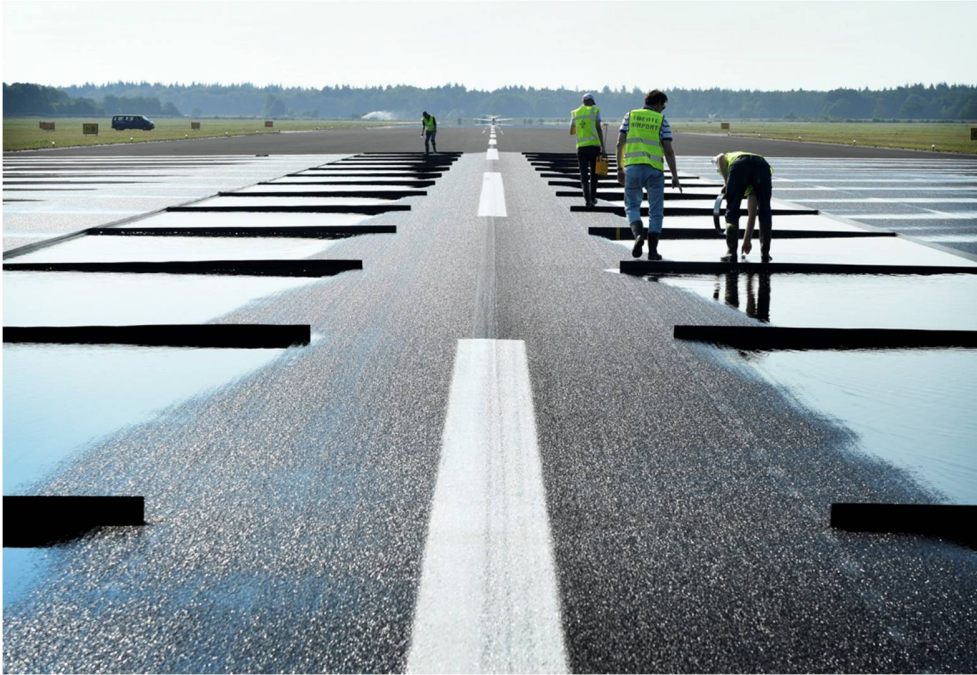
Figure 15: Example of measuring water depth level in each section.

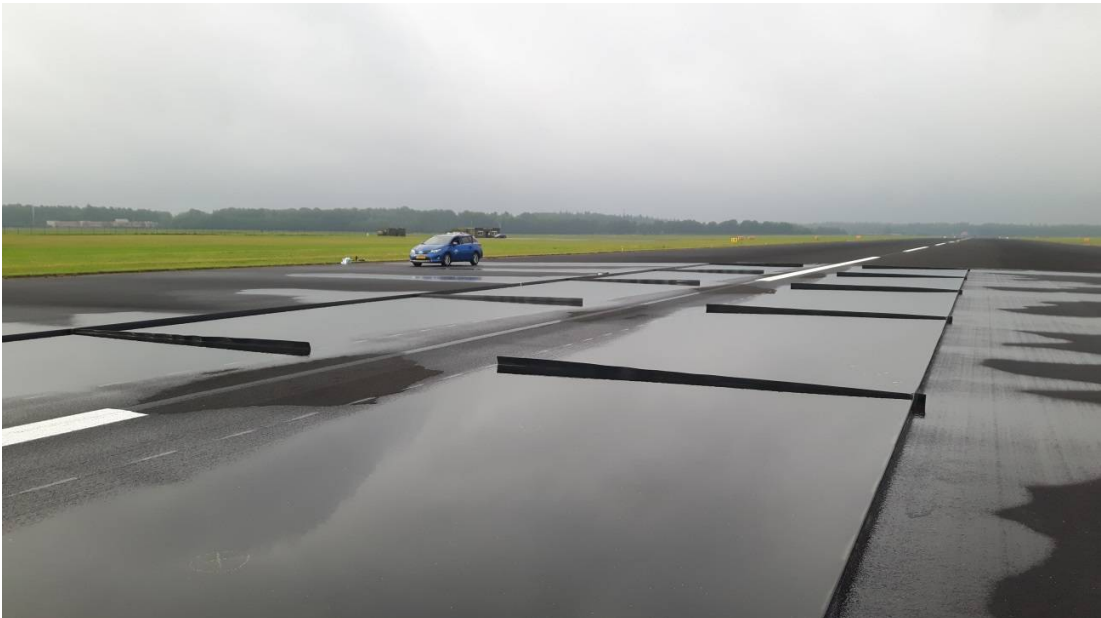
Figure 16: Water pond in calm wind conditions.

High winds can also make it difficult to maintain consistent water levels. Based on previous experiences with water pond testing a maximum wind speed of 12 kt. was defined for the test programme. Figure 16 and Figure 17 show the surface of the water pond under calm and light windy conditions. In order to minimise the influence of wind on the water depth measurements, a metal ring was placed around the water depth gauge as illustrated in Figure 18. This practice was taken from other water ingestion tests.

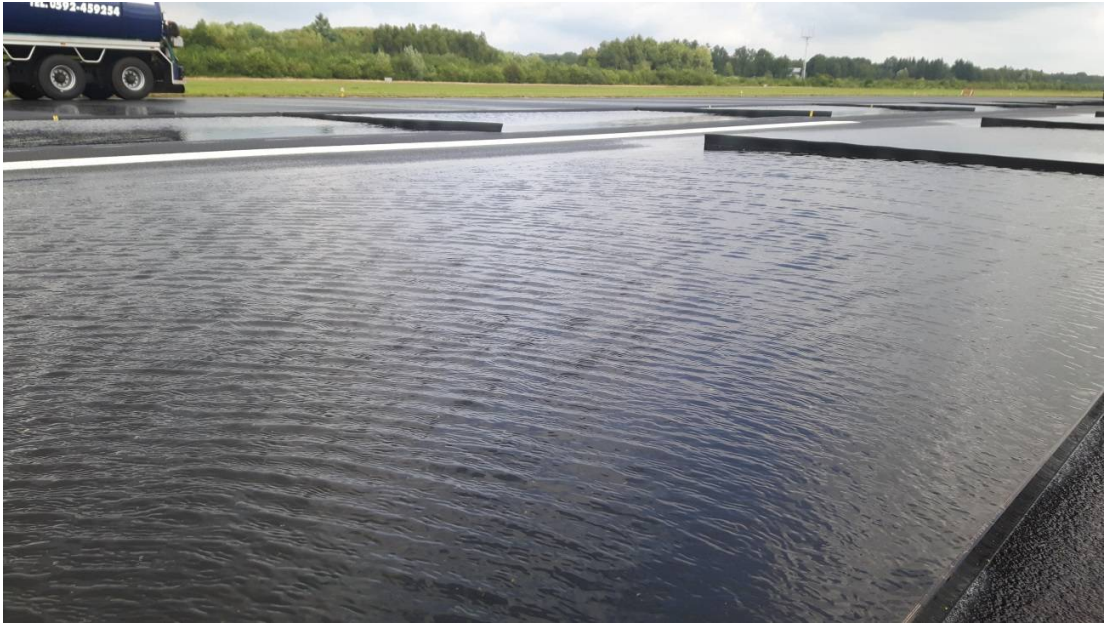
Figure 17: Water pond at 8 kt. wind.

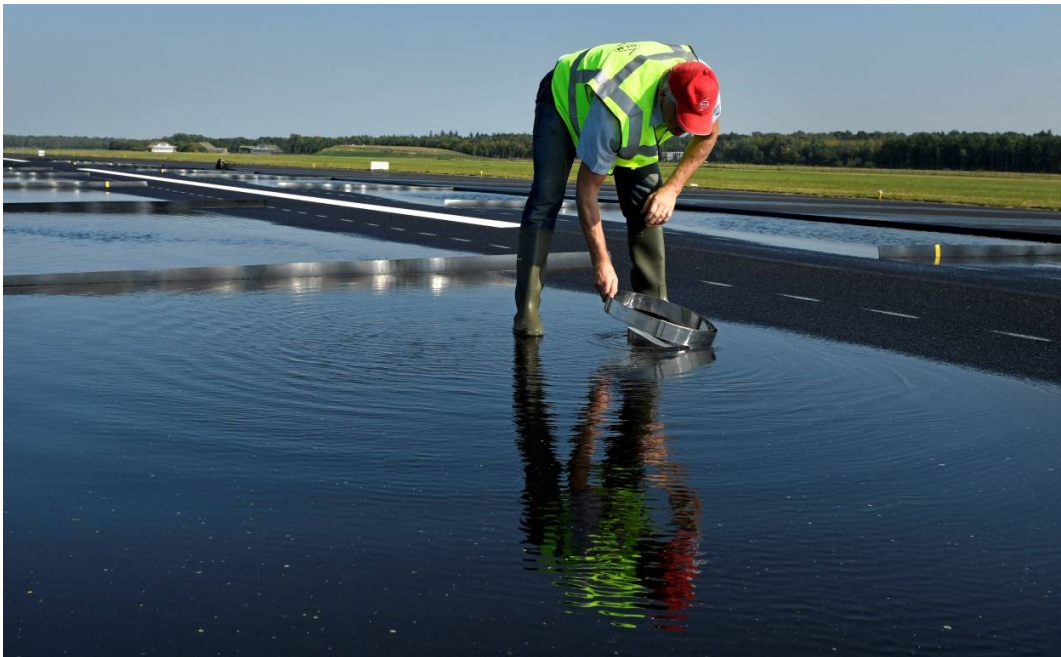
Figure 18: Measuring of water depth using a metal ring around the water depth gauge.

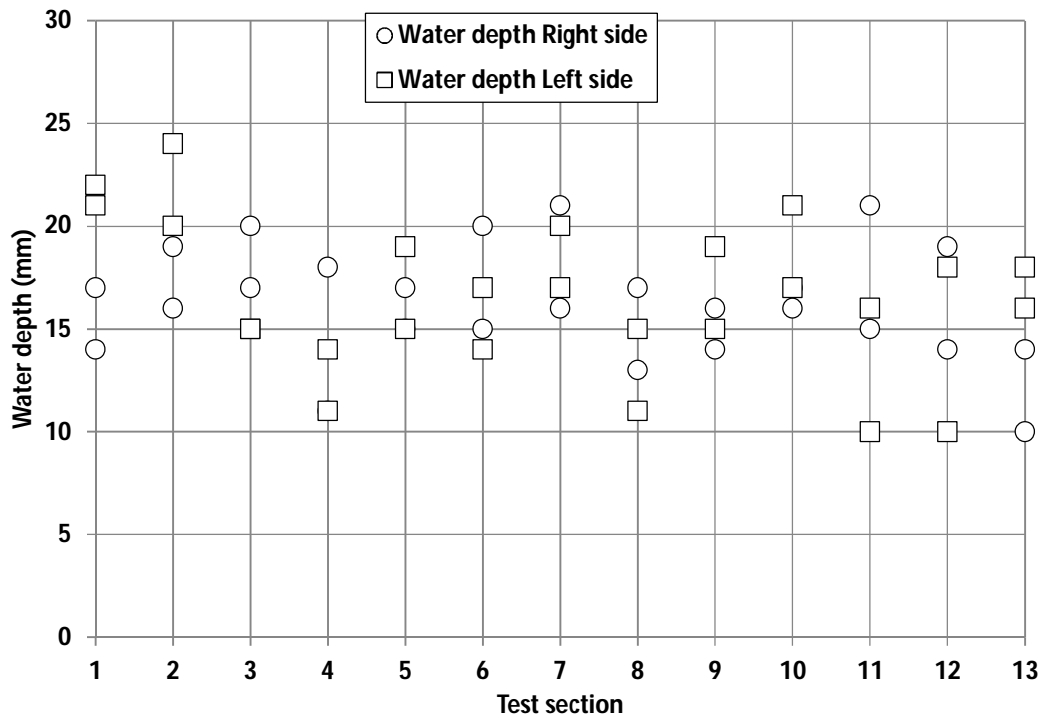
Figure 19: Example of the water depth levels measured along the water pond (numbers refer to section).

The target water depth was set to 15 mm at the main gear tyre track. This is slightly above the normal certification limit of 13 mm for transport aircraft. In many of the earlier flight tests on flooded runways the water depth was much less and close to the wet-flooded runway threshold of 3 mm as defined in the regulations. For the present tests a high water depth was chosen as this is more representative to a runway under extreme rain conditions. During the test programme the overall average water depth level was somewhat higher than this target (16.7 mm). This was not considered a major issue for the objectives of the project. An example of the measured water depths in the different test sections is shown in Figure 19. Two measurements were taken in each left and right section. The direction of flight is from section 1 to 13.

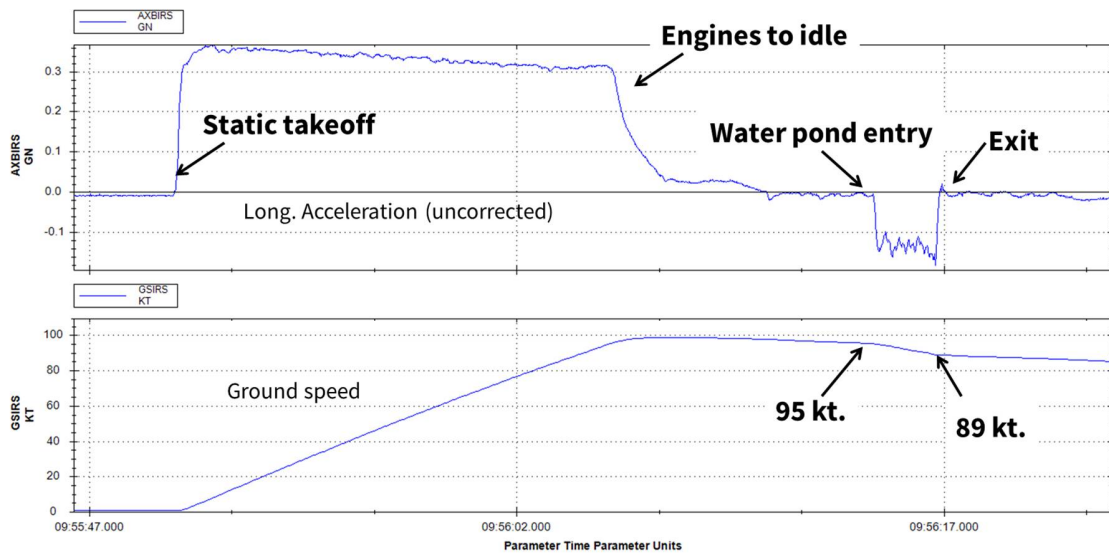
Typical run

Figure 20: Longitudinal acceleration and ground speed time-history plot for a typical test run.

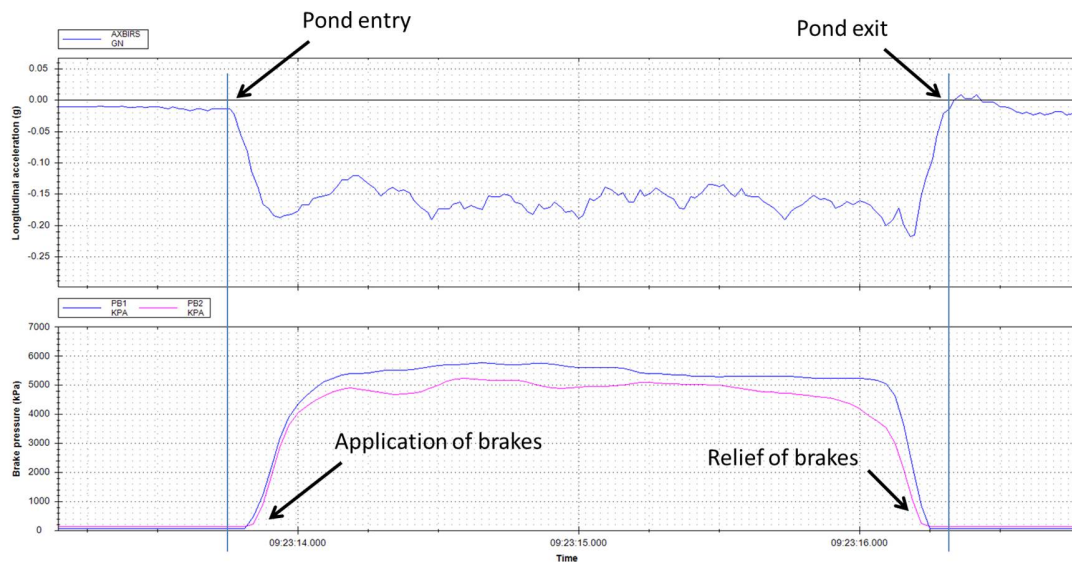
Figure 21: Example time-history plot of longitudinal acceleration and brake pressure when running through the water pond (ground speed between 85-78 Kt.).

For each test run the water pond was filled to the target water depth level. The aircraft was positioned at a pre-determined distance from the water pond. As soon as the water pond was ready, a static takeoff was commenced. The engines were set to idle at a marked position before the water pond. The position of the idle thrust marker and the position for the static takeoff were determined as such as the aircraft would enter the water pond near the target speed and with the engines in idle thrust. The calculations for this were done using an in-house developed performance program. The results of these calculations were validated before conducting the actual tests with the water pond. An example of a typical run is shown in Figure 20. This shows the time-history plot of the (uncorrected) longitudinal acceleration and the ground speed. As can be seen from the plot the aircraft is accelerated to a certain speed from the static takeoff point. After reaching the idle marker the engines were set to idle at which the normal acceleration starts to drop. As the aircraft reaches the water pond the aircraft is slightly decelerating due to aerodynamic and rolling friction forces being larger than the idle forward thrust. This was the case for all test runs conducted. When entering the water pond the aircraft starts to decelerate more as illustrated in Figure 20. Depending on the test point the test pilot would apply maximum brakes or leave the aircraft rolling without brakes being applied. During a braked test run, maximum brakes were applied by the pilots just when the aircraft had entered the water pond (see Figure 21). Just before leaving the water

pond the brakes would be released again (see Figure 21). Between each run sufficient time was taken for the brakes to cool down. Also the airframe and tyres were inspected for damages after each run. Video recordings and still images were made from the outside and inside the aircraft. These images were used in case water ingestion into the engines was suspected (see e.g. **Figure 22**). The videos and still images were also used in the post processing to analyse spray patterns for hydroplaning indications.

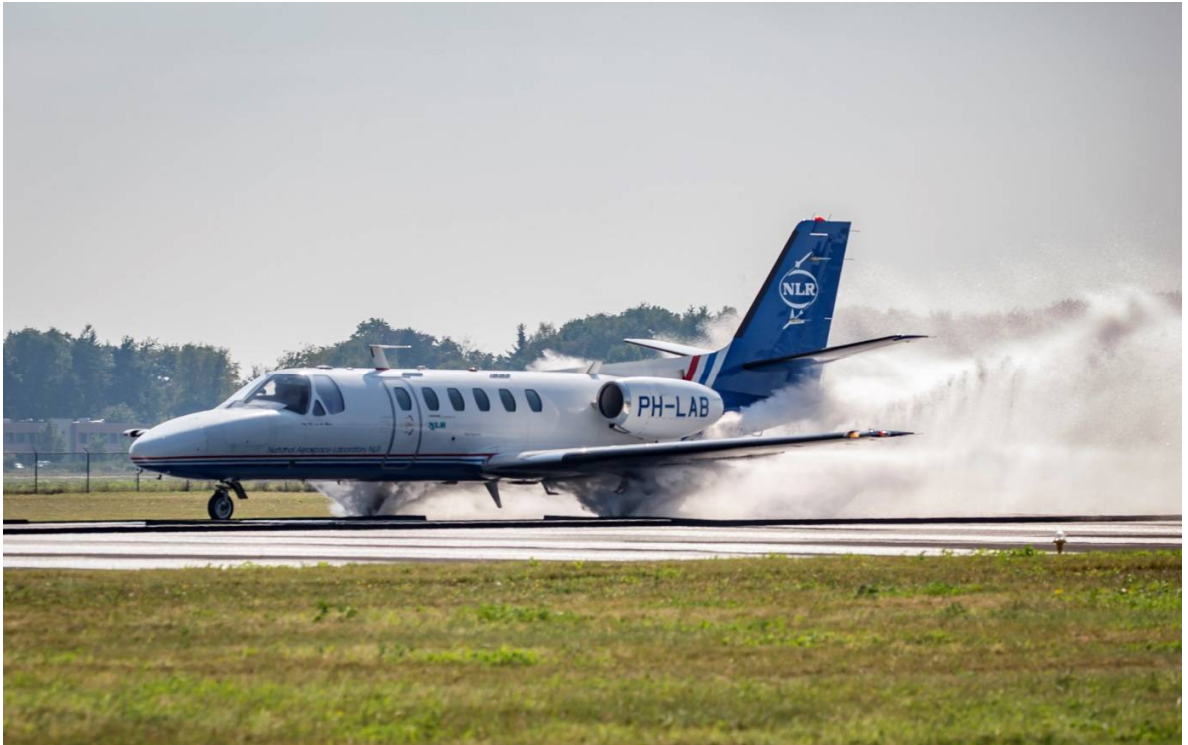
Figure 22: Cessna Citation test aircraft running through the water pond.
