NLR-TP-2002-289

Material-based failure analysis of a helicopter rotor hub

Revised edition

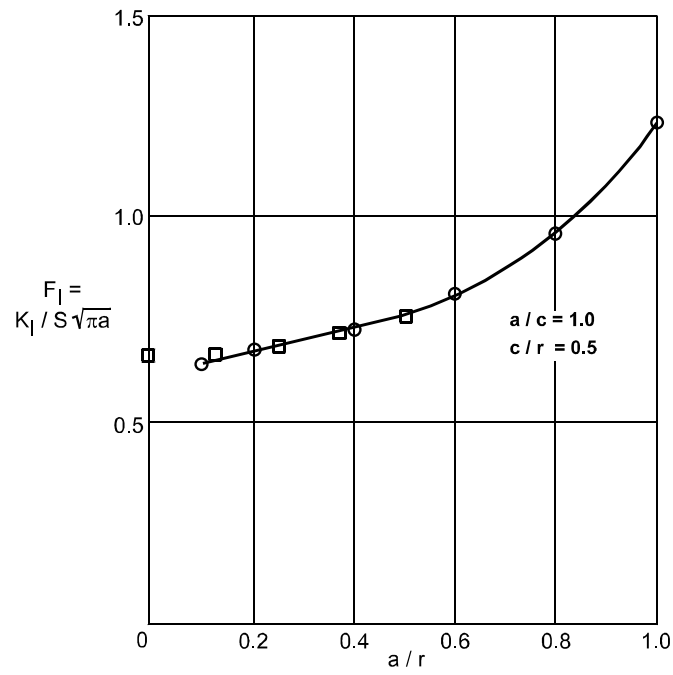
Since the specimens were cylindrical, the fracture roughness transition boundaries approximated to the configuration of semi-elliptical cracks in round bars. There is no straightforward stress intensity factor solution for this configuration, but Murakami's Handbook [11] gives functional relationships for certain values of a/c , a/r and c/r , where a , c and r are shown in figure 8. The Handbook results closest to the configurations in figure 8 are summarised in figure 9, where we assume $a/c = 1$. The actual a/c values were 1.15, 1.23 and 1.29, but there are no Handbook data for $a/c > 1$. We assume further that the dimensionless stress intensity factors, F_1 , in figure 9 apply to the specimen crack sizes and shapes at the fracture roughness transition boundaries. Interpolation of the functional relationship in figure 9 then gives the results in table 5. The constancy of the $K_{\max,T}$ values in table 5 is evidence for fracture mechanics control of the roughness transition boundaries.

Fig. 9 Dimensionless stress intensity factors, F_I , at point A (see figure 8) for semi-elliptical cracks in tension-loaded round bars. After Murakami [11]

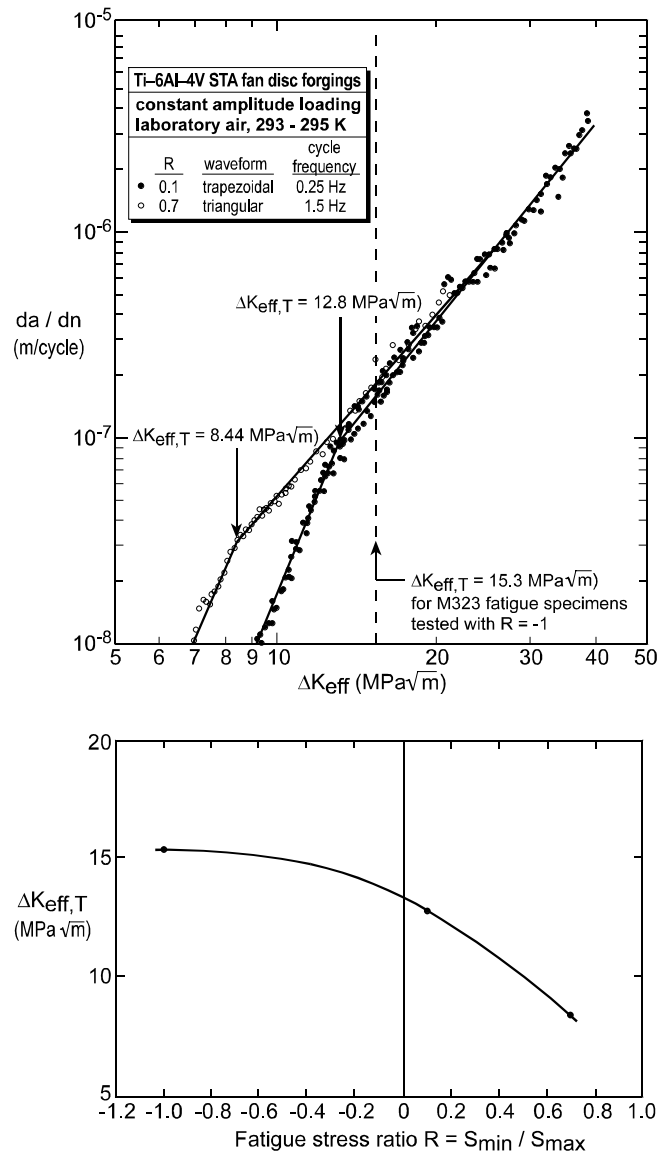
Further necessary information is obtainable by converting $K_{\max,T}$ to $\Delta K_{\text{eff},T}$. This may be done using equation (7) and taking the specimens' R value of -1 . The average result is $\Delta K_{\text{eff},T} = 15.3 \text{ MPa}\sqrt{\text{m}}$. Figure 10 compares this result with $\Delta K_{\text{eff},T}$ values obtained for similarly processed Ti-6Al-4V [9]. From what is generally known about stress ratio effects on fatigue crack growth

rates (see e.g. Newman [10]), figure 10 shows a plausible functional dependence of $\Delta K_{\text{eff},T}$ on R. The consequences of this plausibility are twofold:

Although point (b) might seem problematical, figure 10 shows there is little change in $\Delta K_{\text{eff},T}$ over a wide range of negative R. Returning to the question of stress ratio differences discussed for the Method (I) modified estimates, from figure 10 we obtain $\Delta K_{\text{eff},T}$ values of $15.3 \text{ MPa}\sqrt{\text{m}}$ and $15.0 \text{ MPa}\sqrt{\text{m}}$ for $R = -1.14$ and $R = -0.59$ respectively. This difference in $\Delta K_{\text{eff},T}$ values can be neglected in the present context of service stress level estimates.

Fig. 10 Functional dependence of $\Delta K_{eff,T}$ on R. The fatigue crack growth data are from Wanhill and Looije [9]
