NLR-TP-98139

## **Impact damage prediction and failure analysis of heavily loaded, blade-stiffened composite wing panels**

J.F.M. Wiggeraad, X. Zhang\* and G.A.O. Davies\*\*

Division:	Structures and Materials
Issued:	17 March 1998
Classification of title:	Unclassified

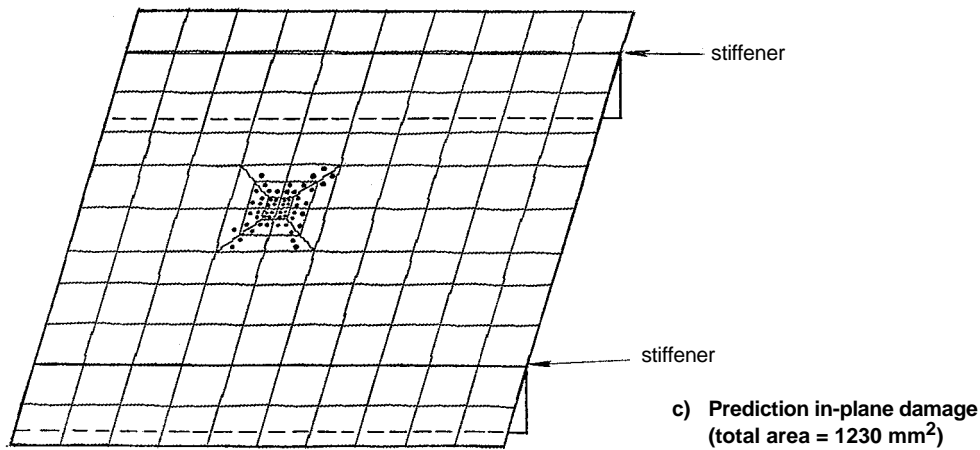
Fig. 14 Comparison of FE prediction with test - higher energy, large deflection  
(Panel C, site M3, 26 J, with damage)

Figure 14 shows a higher energy impact (26 J). The shape of the recorded impact force history and the *C*-scan image revealed that considerable flexural degradation took place. Thus degrading the FE model was necessary to bring the force history in line with the test result as shown in figure 14a. Both the predicted and experimentally recorded maximum impact forces were close to the value of 6800 N. The measured maximum displacement was approximately 6 mm as shown in figure 14b, about 1.5 times of the panel skin thickness, thus the non-linear analysis was necessary. The predicted in-plane damage area of 1230 mm<sup>2</sup>, figure 14c, agreed very well with the *C*-scan measured 1100 mm<sup>2</sup>. The actual damage is essentially multi-layer delamination damages as shown in figure 5. The *C*-scan detected damage area, 1100 mm<sup>2</sup>, is the envelope of total delamination damages. This is a simple measure of the damage area contributed by all layers of the laminate. Although the FE model uses 2-D plate elements, each layer's properties have been assembled in the plate stiffness matrix.

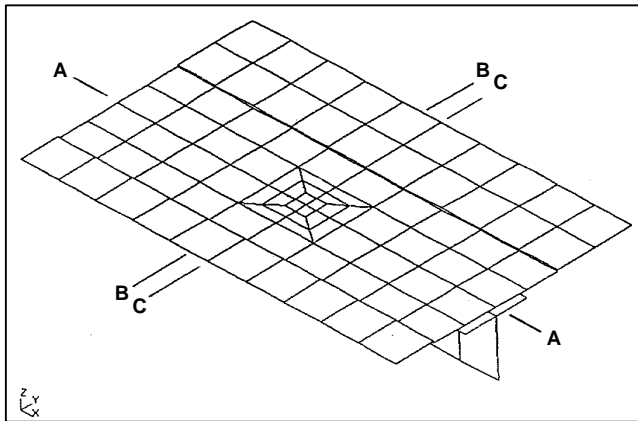
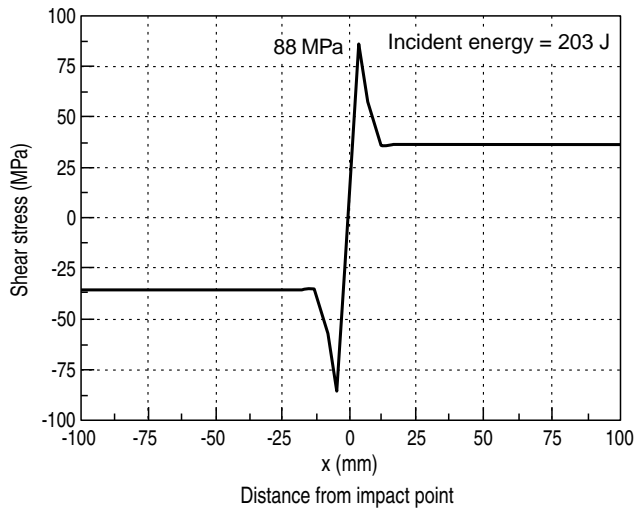
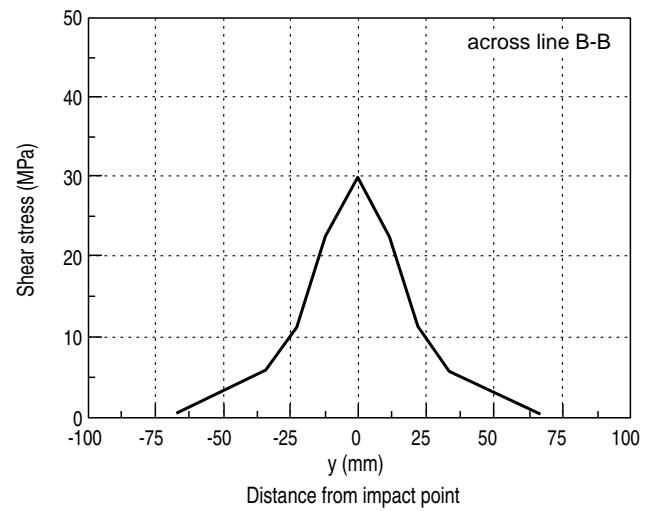
Fig. 15 Transverse shear stress distributions for impact over stiffener centre (Panel D, site S5, 203 J)

In the *FE* model, the mesh was refined near the impact site to capture the stresses more accurately. The important transverse shear,  $\tau_{xz}$ , was modelled as constant through the depth of the plate-stiffener flange therefore the maximum values could be up to 50 per cent higher. The flange/blade intersection was really a local stress concentration area but the FE model should give an estimate of the peak shears at the middle of the blade-angle/skin-doubler intersection, before they die away to zero at the edge of the stiffener flanges. Figure 15a shows the local sections used to display stresses along the stiffener length (A–A) and across section B–B. Results for impact site S5 (panel D) with 203 J are presented which is equidistant from the rib supports so that stresses are symmetrical about C–C. Figure 15b shows the distribution of stresses at the stiffener flange and blade intersection (along A–A). The peak stress of 88 MPa occurred very close to the impact site and then decreased to an almost constant value of 40 MPa, all the way to the support. This confirmed where the shear stress, in the skin beyond the flange edge 53 mm, has become very small there was no diffusion to adjacent panels and the variation of stress across section B–B also confirms this (fig. 15c). The peak shear of 88 MPa should be 50% higher for the following reason. The *Mindlin* plate elements only give constant interlaminar shear stresses through the thickness, but the real shear stress distribution through the

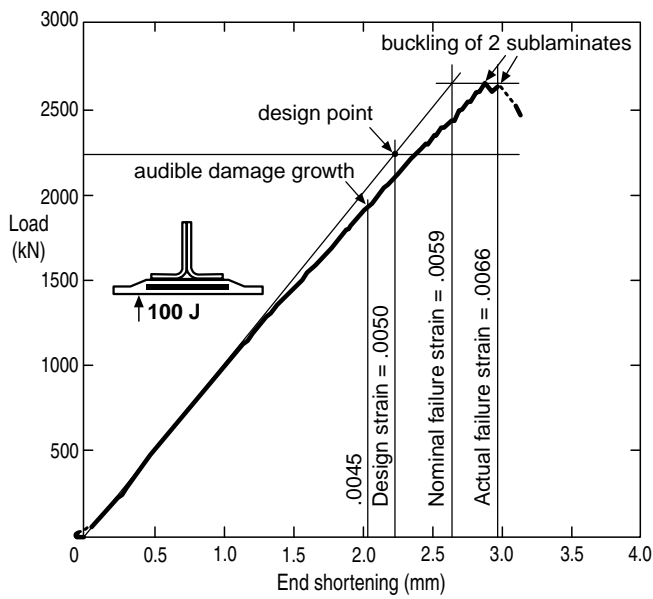
Fig. 16 Load versus end shortening of 3-stringer panel A with 100 J damage

During the late eighties and the early nineties, several series of composite stiffened wing panels were fabricated and tested by NLR to support a composite wing box technology programme of Fokker. Baseline panels A and B (with 100 J impact damage under the stiffener edge) were among these panels, and their load versus end-shortening curves are shown in figs 16 & 17. From these curves it is apparent that the failure modes were stable over quite a loading range. Audible damage growth was perceived first at strain levels of approximately 0.0045, and even during the final loading stage, several load drops were experienced after which reloading was possible before the panels collapsed. However, the failure loads of the two panels were quite different, at nominal failure strains of 0.0059 for panel A and 0.0047 for panel B (table 5). The nominal failure strain is defined as failure load divided by panel stiffness at zero load. Actual failure strains, which incorporate the apparent stiffness nonlinearity of the panels and the local failure phenomena that occurred, were higher

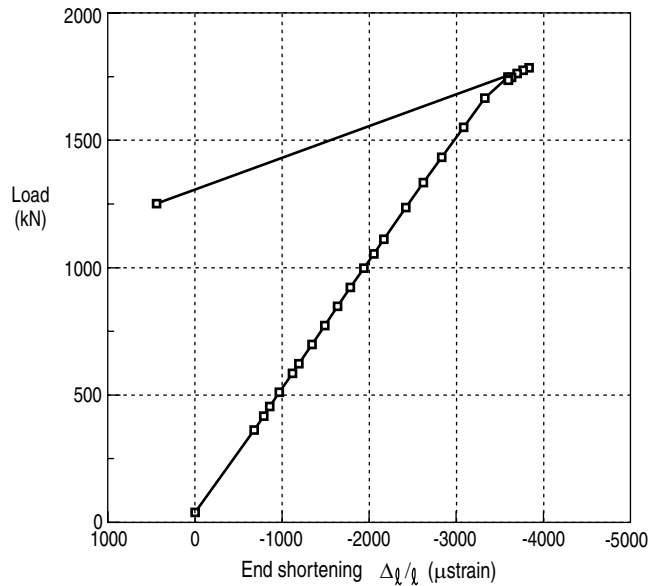
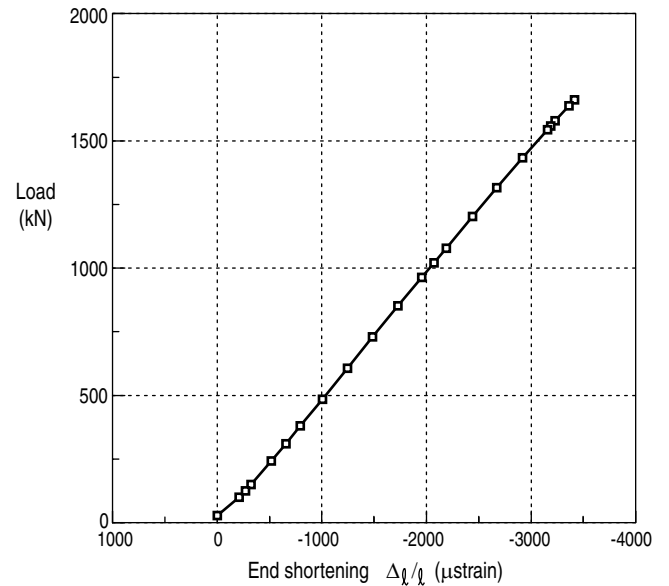
Fig. 27 Load versus end-shortening

In figures 27-32 the test data for panels C and D are compared. The data for panel C were recorded during the second and final test run up to failure, for panel D the data were recorded during the third and last test run, which was stopped before failure. The load versus end-shortening curves are shown in figure 27. The curve for panel C became non-linear during the final loading stage as the result of the propagation of the impact damage, as discussed later. The curve for panel D remained linear, but the test was stopped at the load level where the curve of panel C became non-linear. Figure 28 shows the absence of any significant bending or buckling of the skin away from the impact damage location. Figure 29 shows for both panels that from the onset of loading, considerable bending took place of the centre stiffener in the direction towards the flat, impacted side of the panel, while the adjacent stiffener remained straight all the way through. Load (strain) redistribution is shown in figure 30. Apparently, the outer stiffener away from the impact damage (strain gauge #1) escapes some of the loading, which occurred from the onset of loading. Figure 31 shows the strain distribution in the damaged region. Strain gauge 7, located on top of the impact site, escapes the loading already in the lower loading range. This happened earlier and more significantly for panel C, but it should be kept in mind that this behaviour reflects the deformation of the outer delaminated sublaminate. Strain gauge 7 shows that the surface is undergoing tensile relief, that is, a sublaminate near the impact damage is buckling at an applied mean strain less than  $1000 \mu\epsilon$ . In the case of panel C, this sublaminate is probably only two plies thick (the first 90-degree ply is only three plies deep), while in case of panel D, this sublaminate is probably four plies thick.
