NLR-TP-2026-008 | February 2026

# Failure/accident investigation

Lecture notes

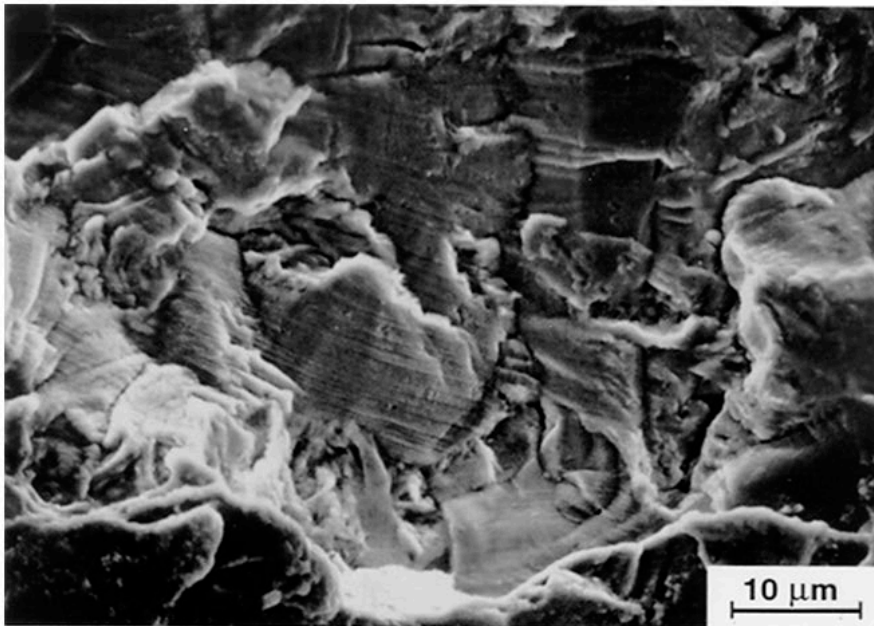
The striations are clearly visible (parallel lines).

Each striation is caused by one load cycle.

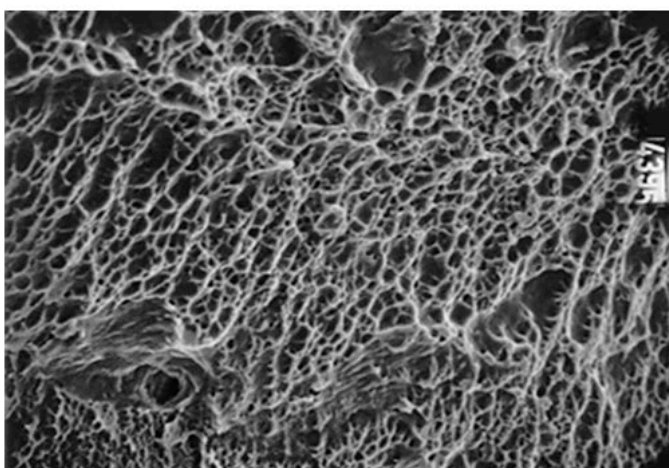
Fracture caused by formation and subsequent combination of small holes; typical surface after overload fracture.

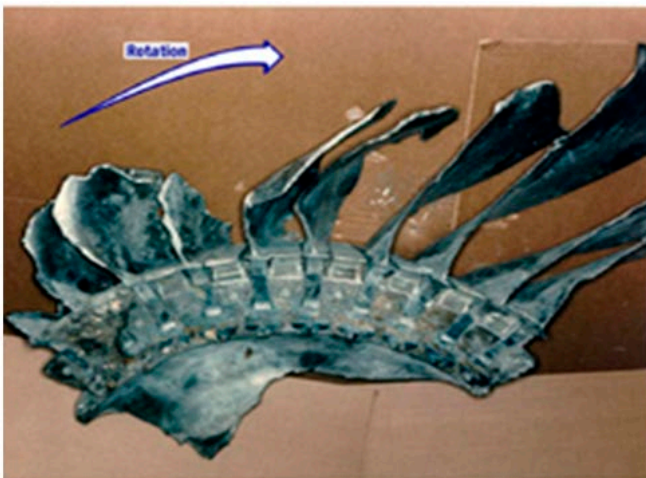
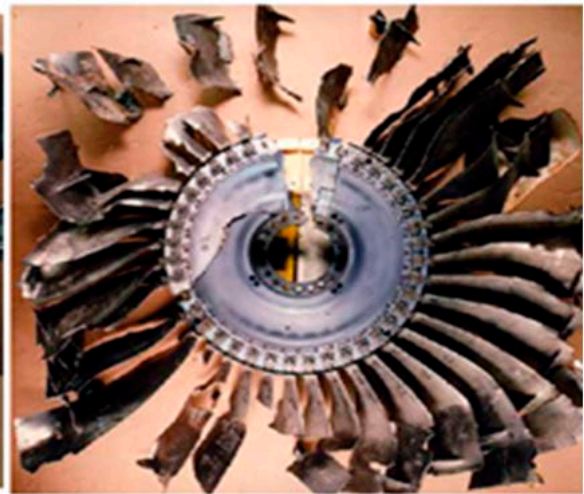
### Remnants of failed fan disk

A defect that went undetected in a titanium fan disk was responsible for the failure of the disk.

**Fatigue crack originated at a hard  $\alpha$  defect present after manufacture**

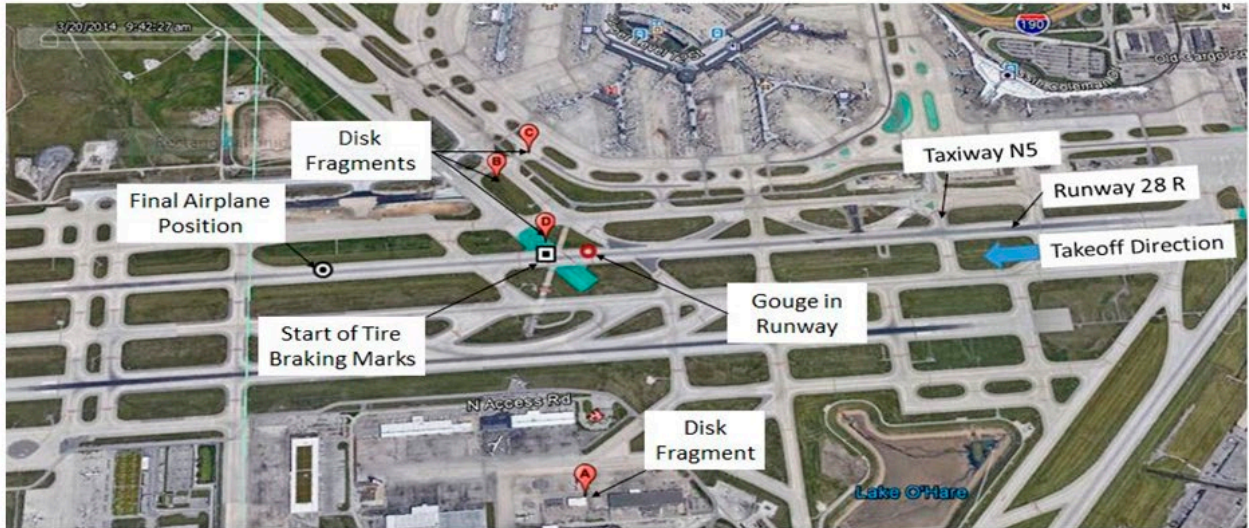
Airport Overview with Disk Fragment Locations

The right engine stage 2 high pressure turbine disk fractured into at least 4 pieces. One piece went through the inboard section of the right wing, over the fuselage and into a UPS warehouse facility (location A).

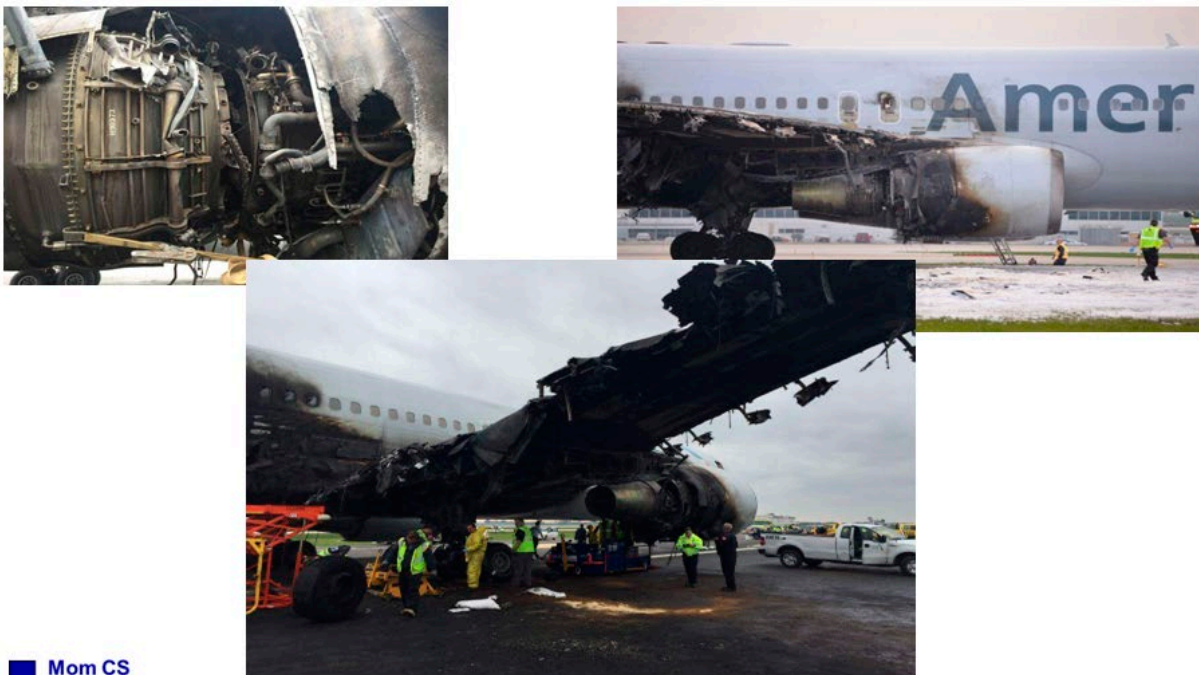
## American Airlines flight 383 Cause: Turbine Disk 2 failure

- Engine and wing debris were found at far-off locations.
- The majority of the stage 2 disk was recovered.
- One of the fractures exhibited features consistent with fatigue cracking initiating at an internal inclusion in the hub's inner bore.

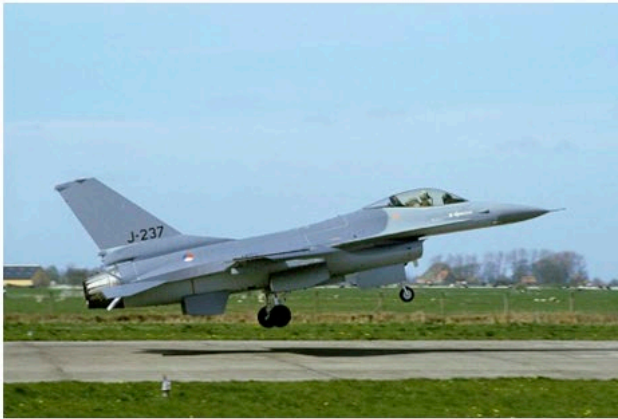
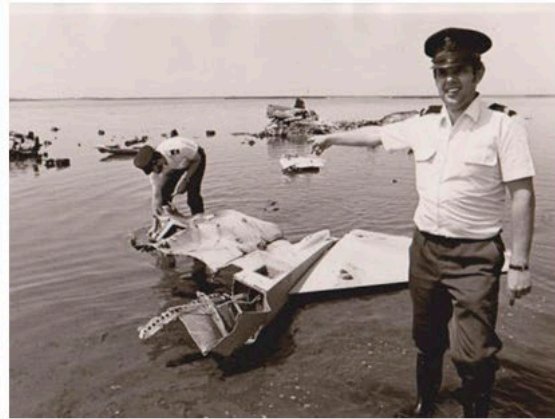
# F16 crash Lauwersmeer June 1981

Engine failure (stall/explosion): no thrust any more. Pilot activates ejection seat and lands safely. Aircraft lands in Lauwersmeer; engine relatively undamaged; engine is recovered and investigated at Woensdrecht AFB.

After disassembly of the engine, it turned out that the inlet of the turbine was heavily damaged. Broken 1<sup>st</sup> stage turbine blades are clearly visible; 2<sup>nd</sup> stage relatively undamaged.

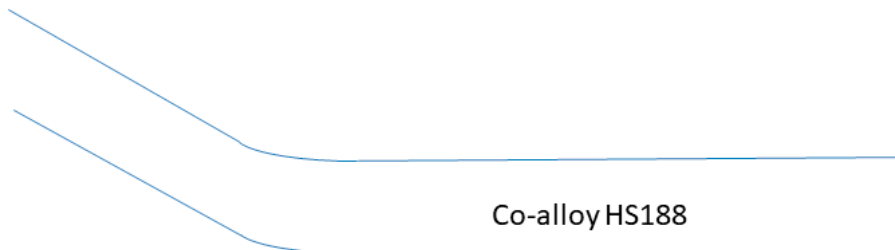
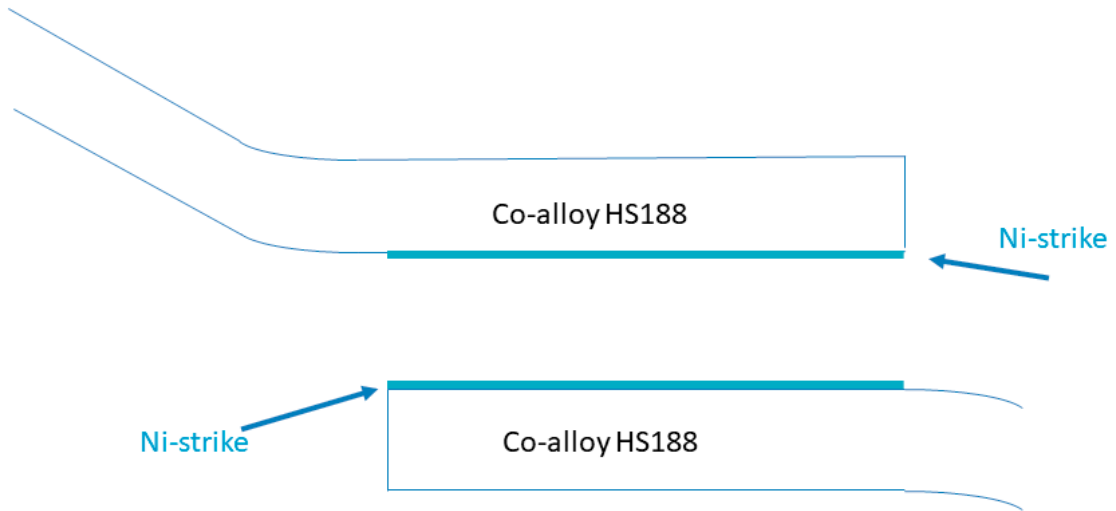
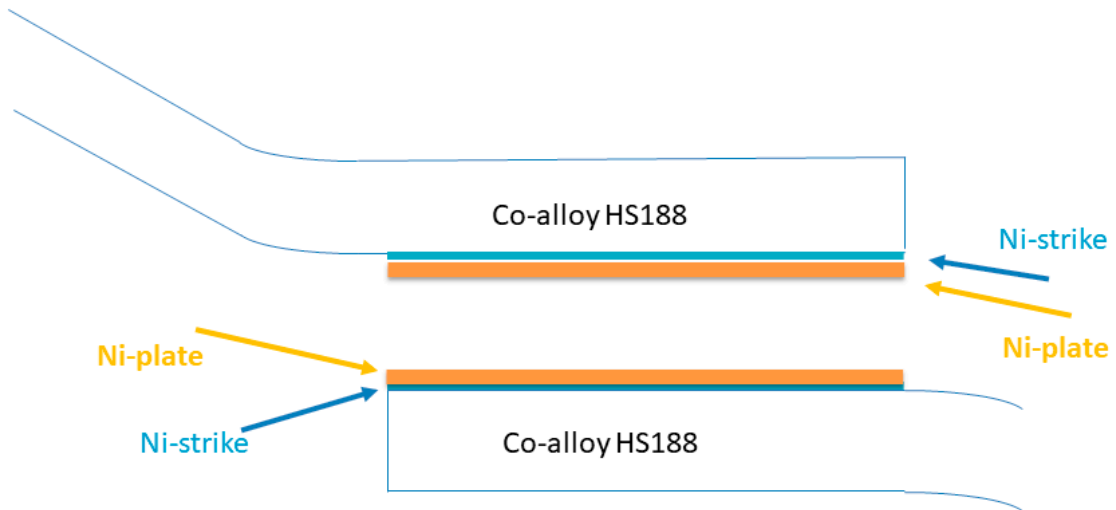
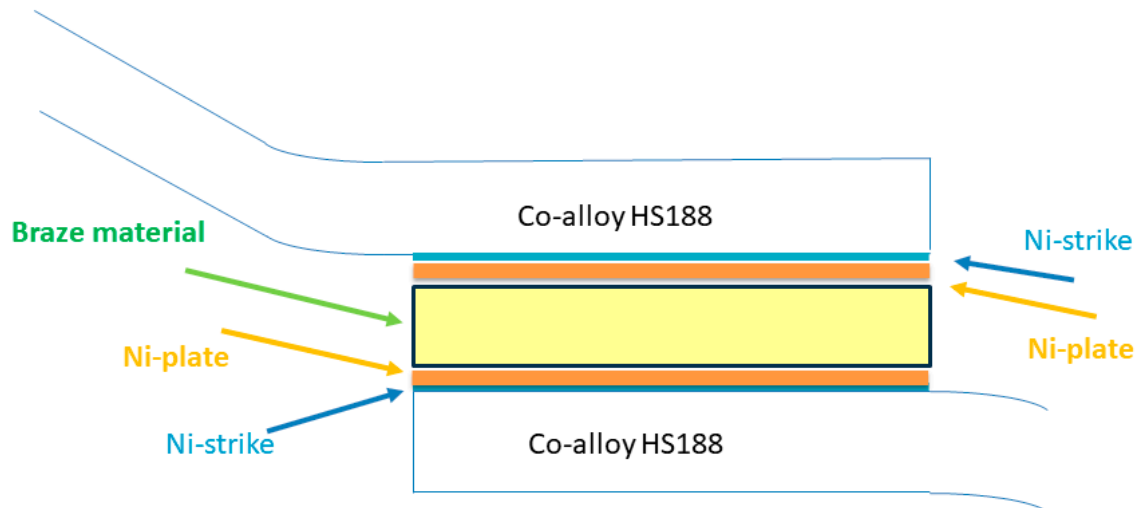
Turbine sealing ring failed by braze joint failure between ring 1 and part 2 and 3.  
 Cause: oxide layer build up during Ni-plating prior to brazing (NLR MP 87037, presented at BVM symposium, Wageningen, 1986)

- Production process was interrupted between application of Ni-strike and Ni-plate (production fault)
- Formation of extremely thin oxide layer between Ni-strike and Ni-plate
- Lower Co-alloy ring sheared off from upper ring (because of internal hot gas pressure) and cut all first stage turbine blades.

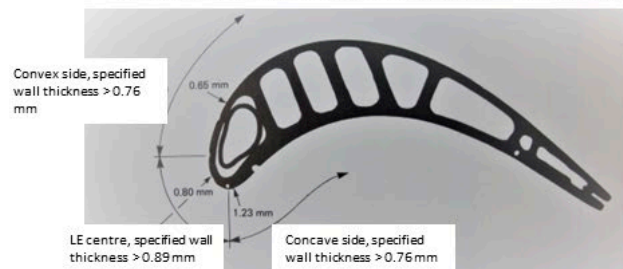
Crack initiation at location where film cooling hole intersects blade wall

- ceramic core shift during casting leading to thin leading edge convex walls
- acid stripping of old coating during repair: leading to cooling hole enlargement
- reduced internal blade pressure (total airflow restricted); ineffective cooling

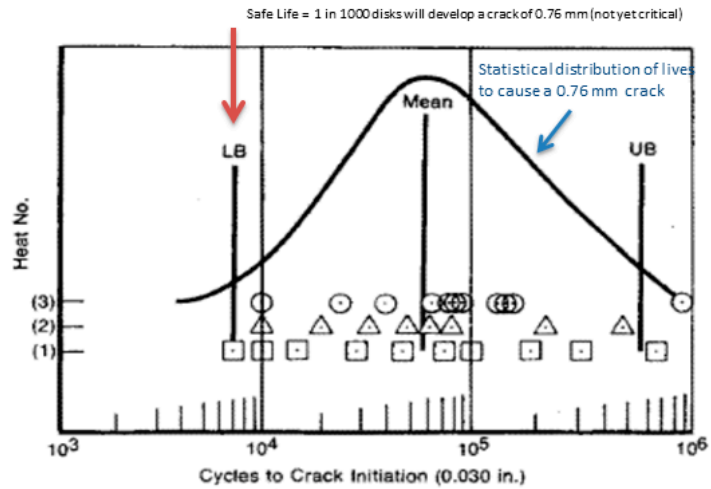
Fig. 2 Material data scatter results in conservative life prediction.

- Safe Life = 1 in every 1000 disks develops a crack of 1/31 inch (0.76 mm), not yet critical.
- Most disks have a much longer service fatigue life!

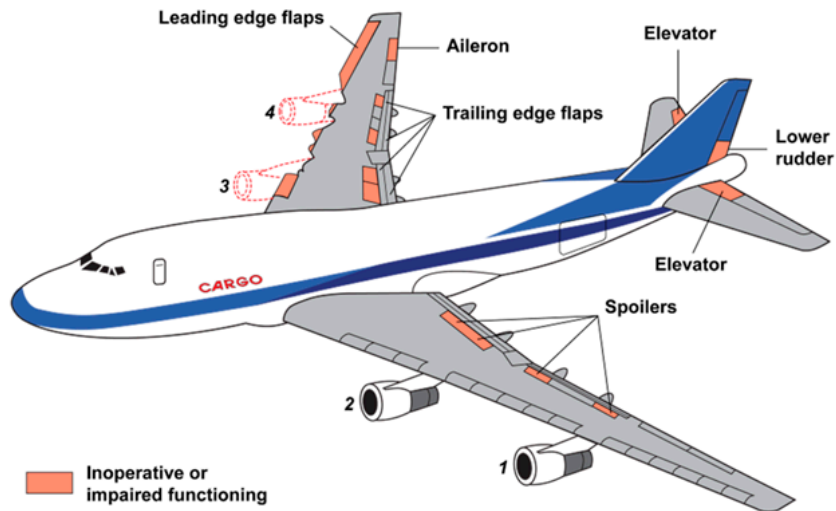
## In-flight final situation

This ultimately caused - probably initiated by fatigue in the inboard midspar fuse-pin - the n°3 pylon and engine to separate from the wing in such a way that the n°4 pylon and engine were torn off, part of the leading edge of the wing was damaged and the **use of several systems was lost or limited**.

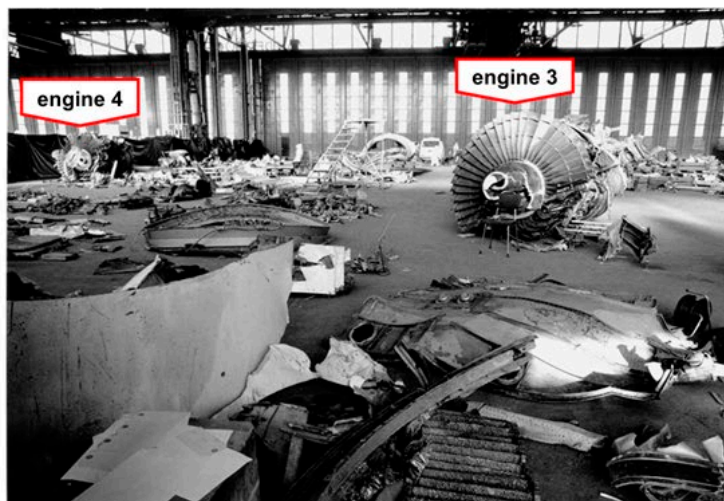
**Some of the wreckage, including engines 3 and 4 recovered from the Gooimeer lake**

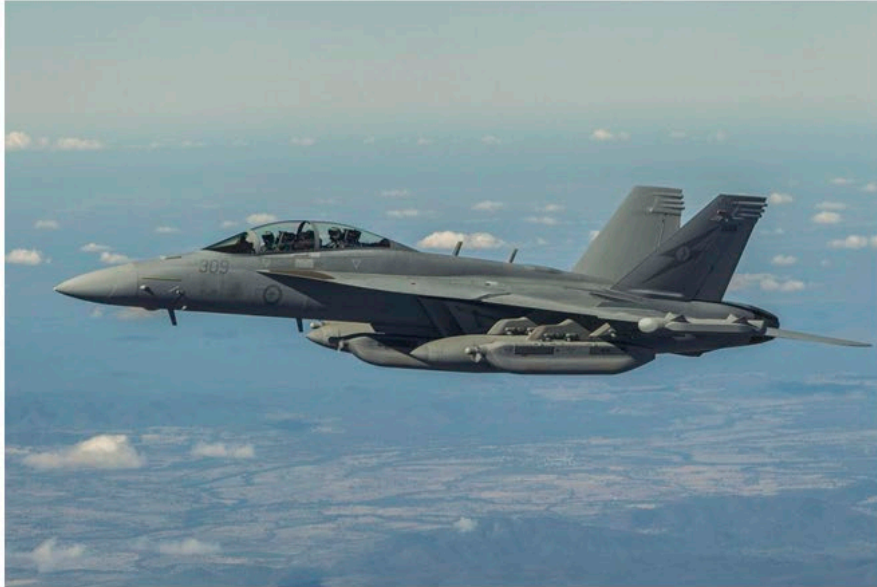
***The Australian EA-18G Growler aircraft (variant of Boeing F/A F18 Super Hornet), lost in an accident at Nellis Air Force Base (AFB), Australia, on 27 January 2018.***

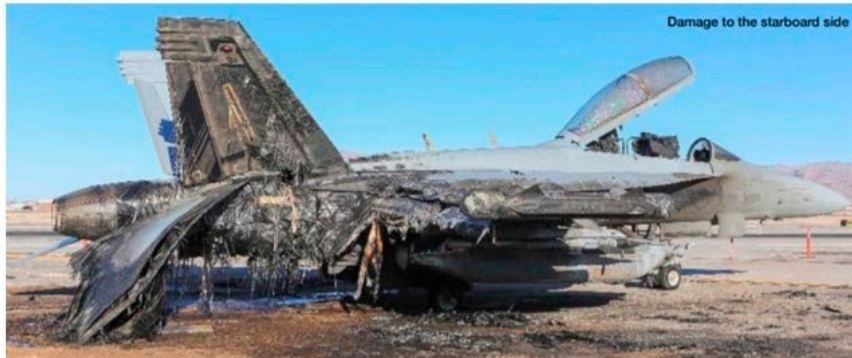
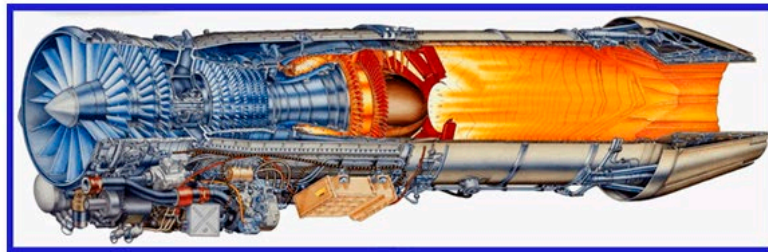
**The aircraft experienced an uncontained F414 engine fan disc failure during the latter stages of its take-off roll at Nellis AFB.**

**The righthand engine failed; uncontained material from that engine caused the simultaneous failure of the lefthand engine and a fierce fuel/airframe fire.**

The uncontained failure of the 1st stage fan disc was considered to be an unusual event by metallurgists. Subsequent discussions with the OEM sub-contractor responsible for producing the 1st stage fan disc forgings revealed that they had previously experienced three cracked forgings during manufacture, affirming the conclusion that the failure of A46-311 engine component was introduced during the forging process.
