National Aerospace Laboratory NLR

Service experience with single crystal superalloys for high pressure turbine shrouds

It is shown that uncoated single crystal superalloy HPT shrouds primarily degrade by environmental attack. Depending on the engine Report no. NLR-TP-2011-547

This report is based on a presentation held at the 5th International Gas Turbine Conference: "The Future of Gas Turbine Technology", Brussels, Belgium, 27-28 October 2010.

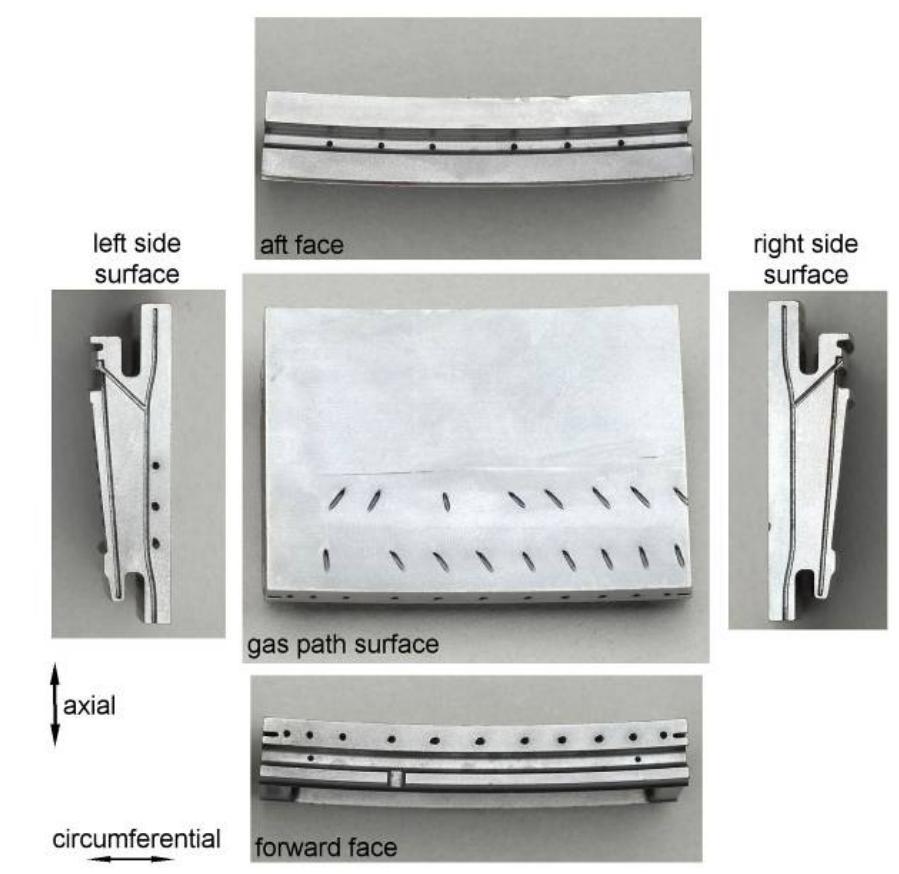
Fig. 1: Macrographs of a CFM56-5C shroud recorded along different directions (the back surface is not shown). The hot gasses flow from the forward to the aft face over the shroud's gas path surface.
