NLR-TP-99408

Corrosion and fatigue assessment of aircraft pressure cabin longitudinal lap splices

This paper has been prepared for publication in the proceedings of the 5th International Aerospace Corrosion Control Symposium, 3-5 November, 1999, Amsterdam.

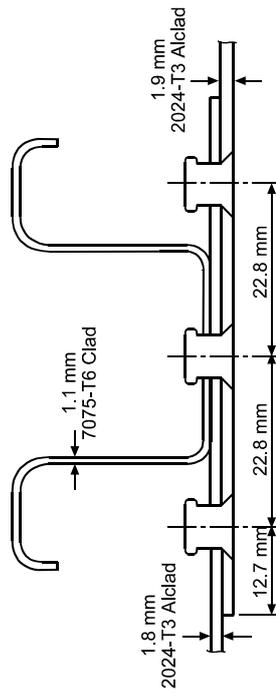
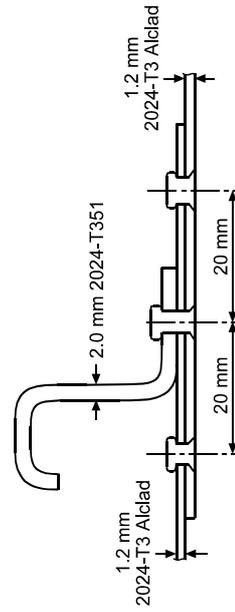
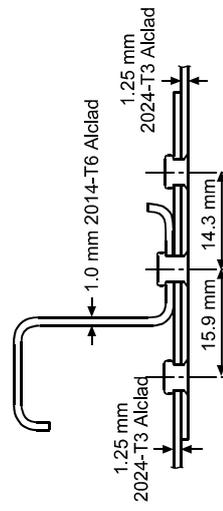
Fig. 3 Configurations of the lap splices looking FORWARD

- The crack growth rates for different aircraft types are fairly similar in the range of crack sizes from 0.5 mm to 2mm. This is remarkable in view of the differing joint designs, see figure 3 and Ref. (12).

- rivet pitch 28-30 mm
- rivet diameter 4.9-5.1 mm
- sheets and stiffener primed
- interfac sealant

- rivet pitch 16.6 mm
- rivet diameter 4 mm
- sheets chromic acid anodised and primed

- rivet pitch 20 mm
- rivet diameter 3.2 mm
- sheets chromic acid anodised, primed and cold bonded

- stiffener rivet pitch 12.7 mm
- sheet rivet pitch 25.4 mm
- rivet diameter 3.2 mm
- sheets chromic acid anodised and primed
- interfac sealant

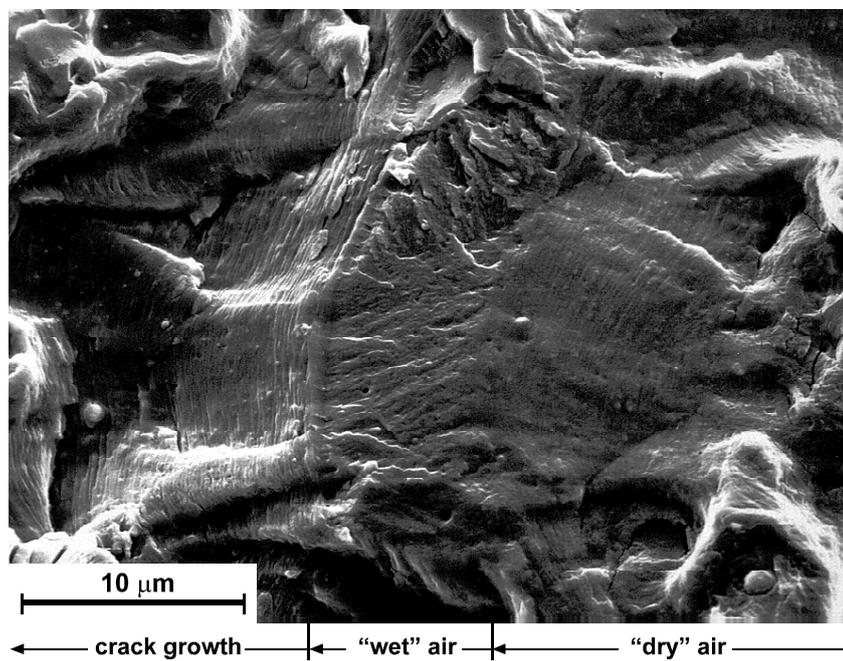
Fig. 13 Fatigue fracture topographical change for 2024-T3 cycled at 0.003 Hz in "dry" and "wet" air: $R = 0.05$, $\Delta K \sim 8.5 \text{ MPa}\sqrt{\text{m}}$ (11)

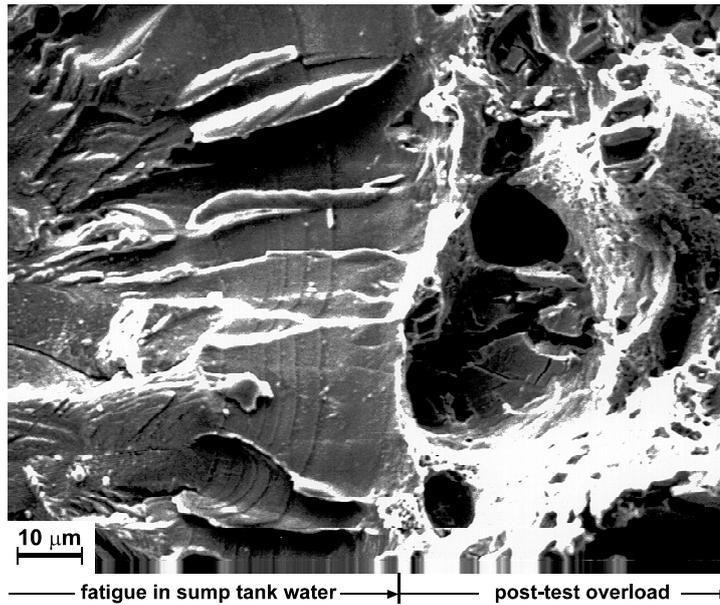
- (2) Figure 14 shows a secondary fatigue fracture surface from the B 727-100 lap splice, with special features (arrowed) similar to those found – albeit more abundantly – for corrosion fatigue at low stress intensities, figure 15.

Fig. 15 Corrosion fatigue of 2024-T3 Alclad cycled at 13 Hz in sump tank water: $R = 0.1$, $\Delta K \sim 3.6 \text{ MPa} \sqrt{\text{m}}$ (9)

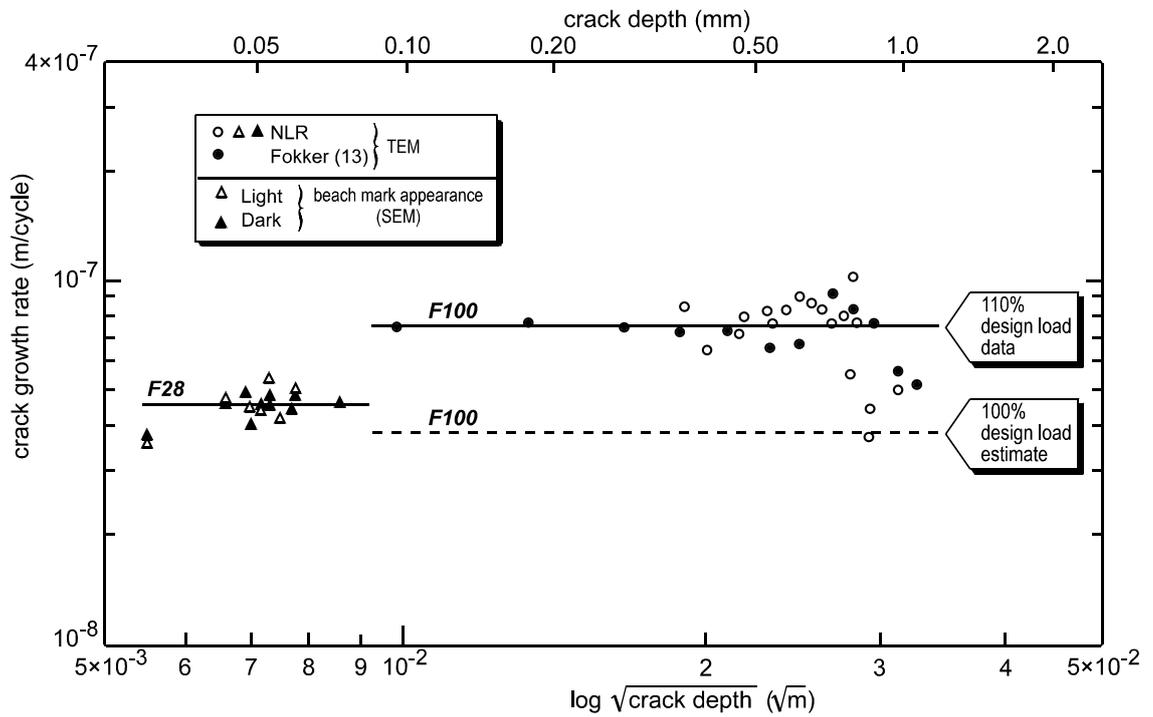
(1) Transverse (through-thickness) crack growth rates: Observation of transverse fatigue crack growth near the rivet holes was usually hampered by fretting products and, in the case of service aircraft, fracture surface corrosion. Figure 16 shows NLR and Fokker data from fatigue striation measurements on comparatively clean and undamaged fracture surfaces. Also shown is an estimate for the F100 test at 100 % design load. This estimate is obtained from the factor $(100/110)^{7.1}$, where 7.1 is the “Paris Law” exponent in a piecewise linear fit to $\log da/dN$ versus $\log \Delta K$ data for 2024-T3 in the same range of crack growth rates. There are two noteworthy features in figure 16:

- (2) The transverse (through-thickness) fatigue crack growth rates are nearly constant, e.g. figure 16.
- (3) The transverse and longitudinal fatigue crack growth rates are similar for cracks with dimensions less than twice the sheet thickness, compare figures 16 and 17 (sheet thicknesses 1.2–1.3 mm, see figure 3).

Fig. 16 Summary of transverse (through-thickness) fatigue crack growth rates: TEM = Transmission Electron Microscopy of replicas; SEM = Scanning Electron Microscopy

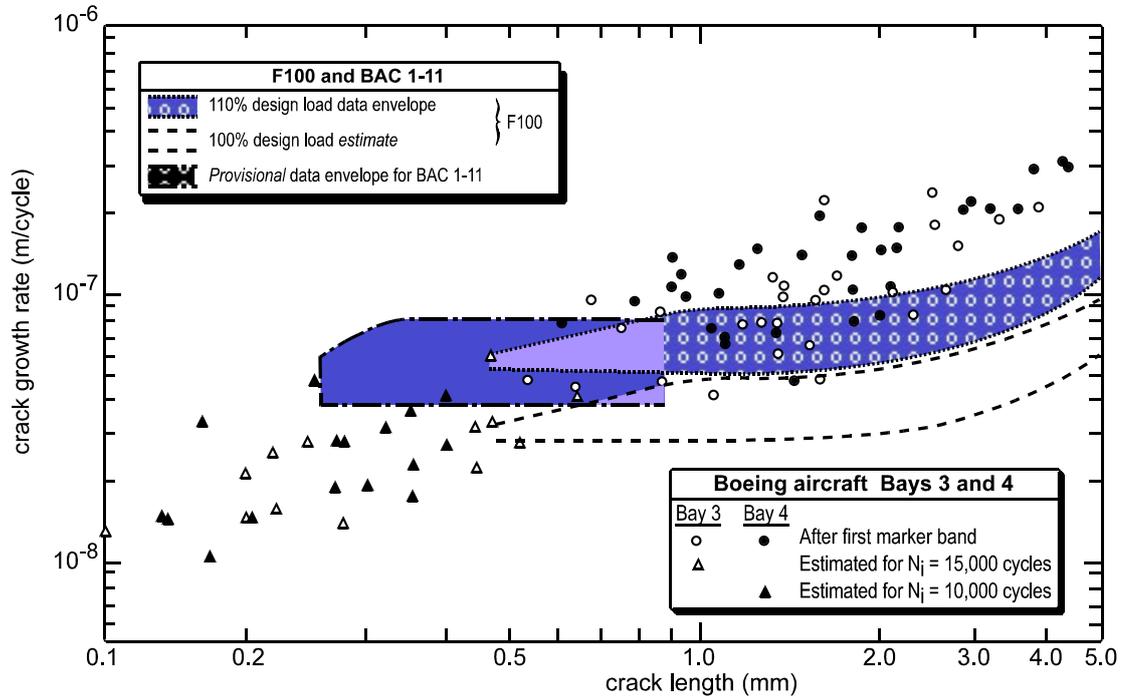
(2) Longitudinal crack growth rates: Figure 17 summarises NLR, Fokker and NASA data obtained from fatigue striation and marker band measurements for the F100, BAC 1-11 and a Boeing aircraft, together with an estimate for the F100 test at 100 % design load, as discussed above. The NLR and Fokker data are presented more fully in Refs. (13, 14). There are two noteworthy features in figure 17:

Fig. 17 Summary of longitudinal fatigue crack growth rates: Boeing aircraft data from (8)

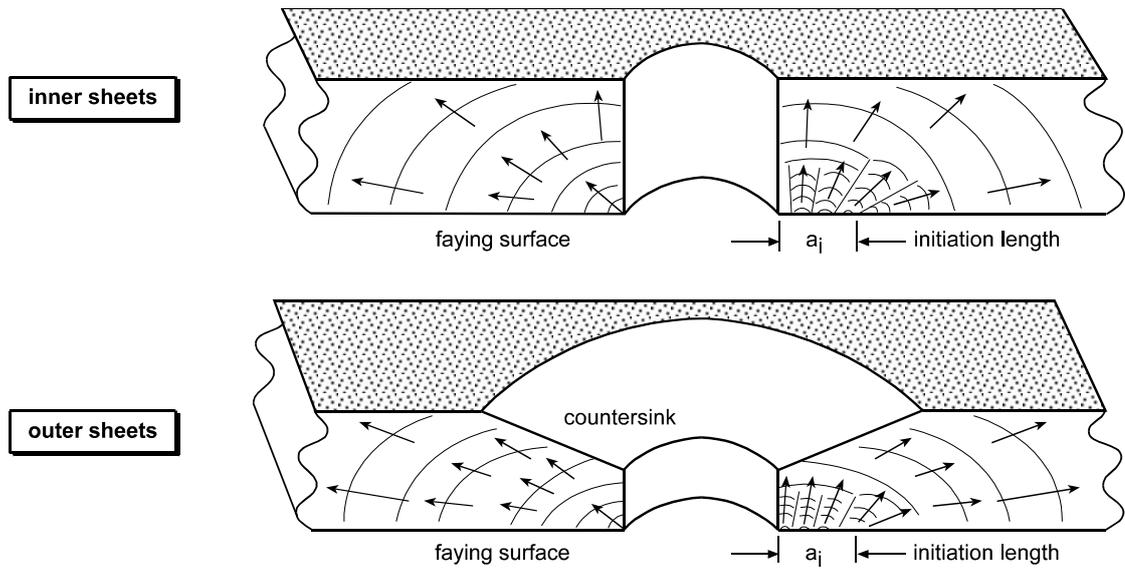
- (1) MSD fatigue cracks tend to initiate at several sites near or at rivet hole corners and grow in directions varying gradually from transverse to longitudinal, see figure 18.

Fig. 18 Most common MSD fatigue initiation sites from service experience and full-scale testing

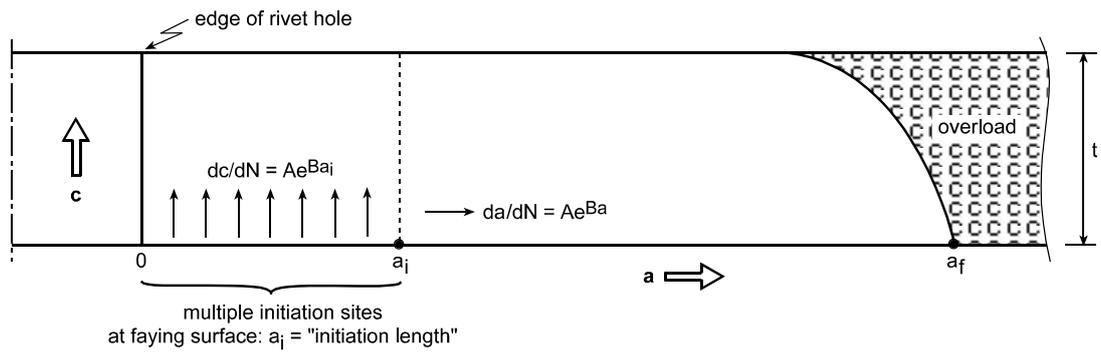
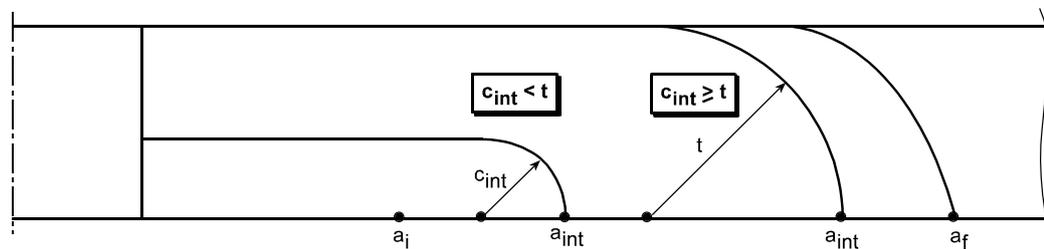
Figure 19 is a schematic of the model. There are three main assumptions, the first two being derived from the foregoing observations. These assumptions are:

These assumptions are convenient but not essential. For example, the model can be used for non-constant dc/dN and for crack initiation at rivet hole corners, i.e. $a_i = 0$ in figure 19. Also the model can be used for both non-countersunk and countersunk lap splice sheets.

- a_i , a_f and N_f are known. Calculate N_i from: $N_f - N_i = \frac{1}{AB} (e^{-Ba_i} - e^{-Ba_f})$
- Calculate intermediate values of a for given values of n : $a_{int} = -\frac{1}{B} \ln [e^{-Ba_i} - AB(N_{int} - N_i)]$
- For each a_{int} calculate c_{int} from: $c_{int} = (N_{int} - N_i) Ae^{Ba_i}$
- Construct crack fronts as follows:

Fig. 19 Eijkhout's empirical model illustrated for a non-countersunk sheet and multiple fatigue initiation sites

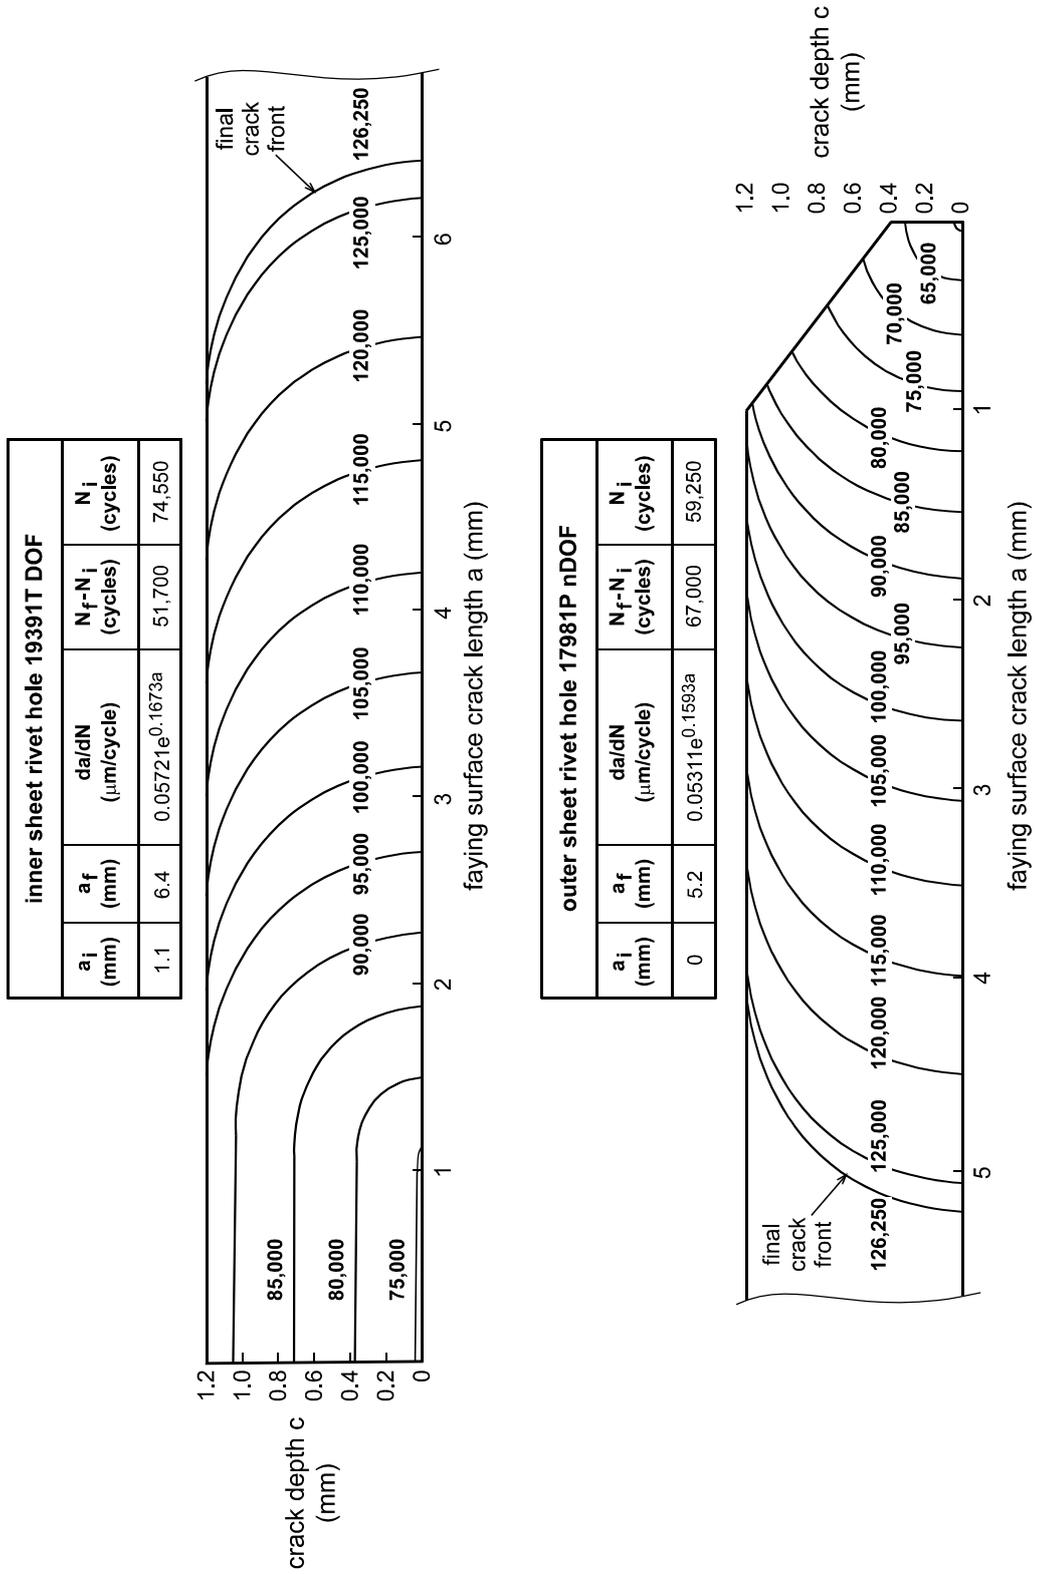
Figure 20 gives examples of the model’s use. It is seen that besides providing estimates of the fatigue crack growth lives and hence the fatigue initiation lives, the model also enables estimates of the lives at which cracks become through-thickness. This information is potentially useful for in-service non-destructive inspection.

Fig. 20 Examples of the use of Eijkhout's empirical model to predict "iso-life" fatigue crack fronts for two MSD fatigue cracks in the F100 full-scale test lap splice (13): DOF = Direction Of Flight; nDOF = opposite to Direction Of Flight

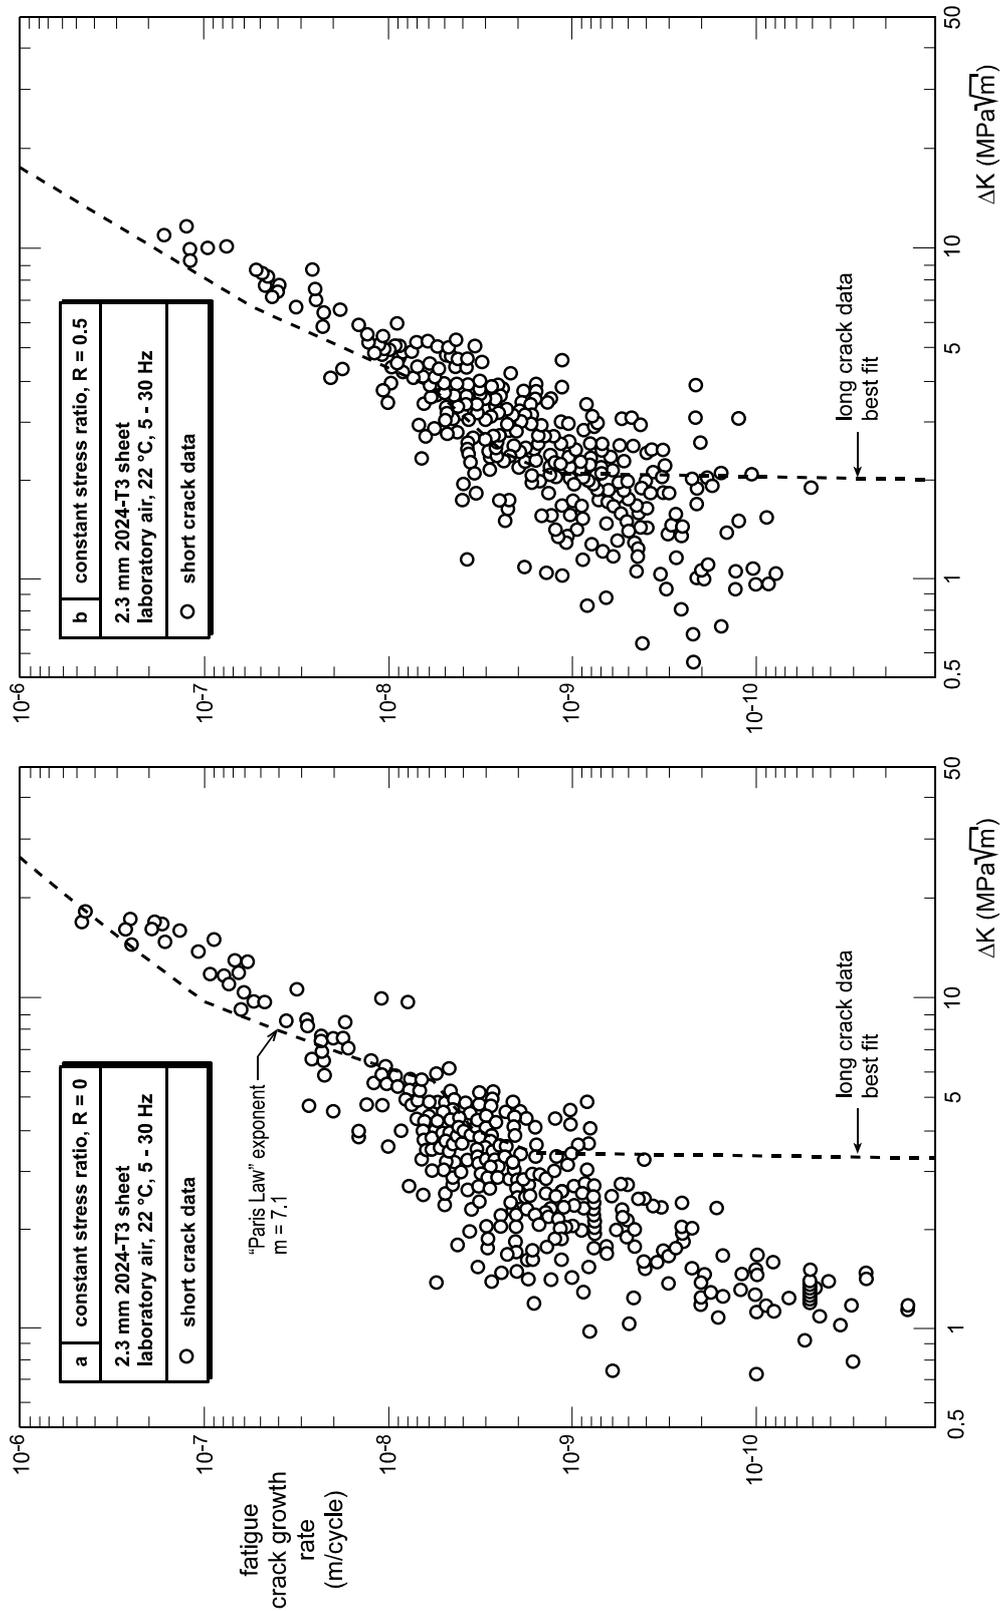
From the sub-section of this paper on early MSD crack growth and figures 16 and 17 it is apparent that the transverse and longitudinal fatigue crack growth rates were above 10^{-8} m/cycle for crack sizes ranging from 30 μ m to 5 mm. This result has to be compared with figure 21, which shows the short and long fatigue crack growth behaviour of 2024-T3 for two stress ratios covering the range to be expected in fuselage longitudinal lap splices (15). Figure 21 shows that at crack growth rates above 10^{-8} m/cycle there is only long crack growth behaviour. In other words, one should not expect any difference between short and long fatigue crack growth behaviour in fuselage longitudinal lap splices, which facilitates crack growth modelling.

- The stress-dependence of fatigue initiation life will probably be very different to that of fatigue crack growth, e.g. Ref. (26).
- Actual fatigue crack growth rates could be in a different “Paris Law” regime, i.e. the exponent m in the relation $da/dN = C(\Delta K)^m$ could be different. An example of a surprisingly high but realistic exponent, $m = 7.1$, was mentioned for transverse (through-thickness) crack growth rates and is shown in figure 21.

Fig. 21 Comparisons of short and long fatigue crack growth rates for 2024-T3 aluminium alloy sheet: data for specimens loaded parallel to the sheet rolling direction (21)

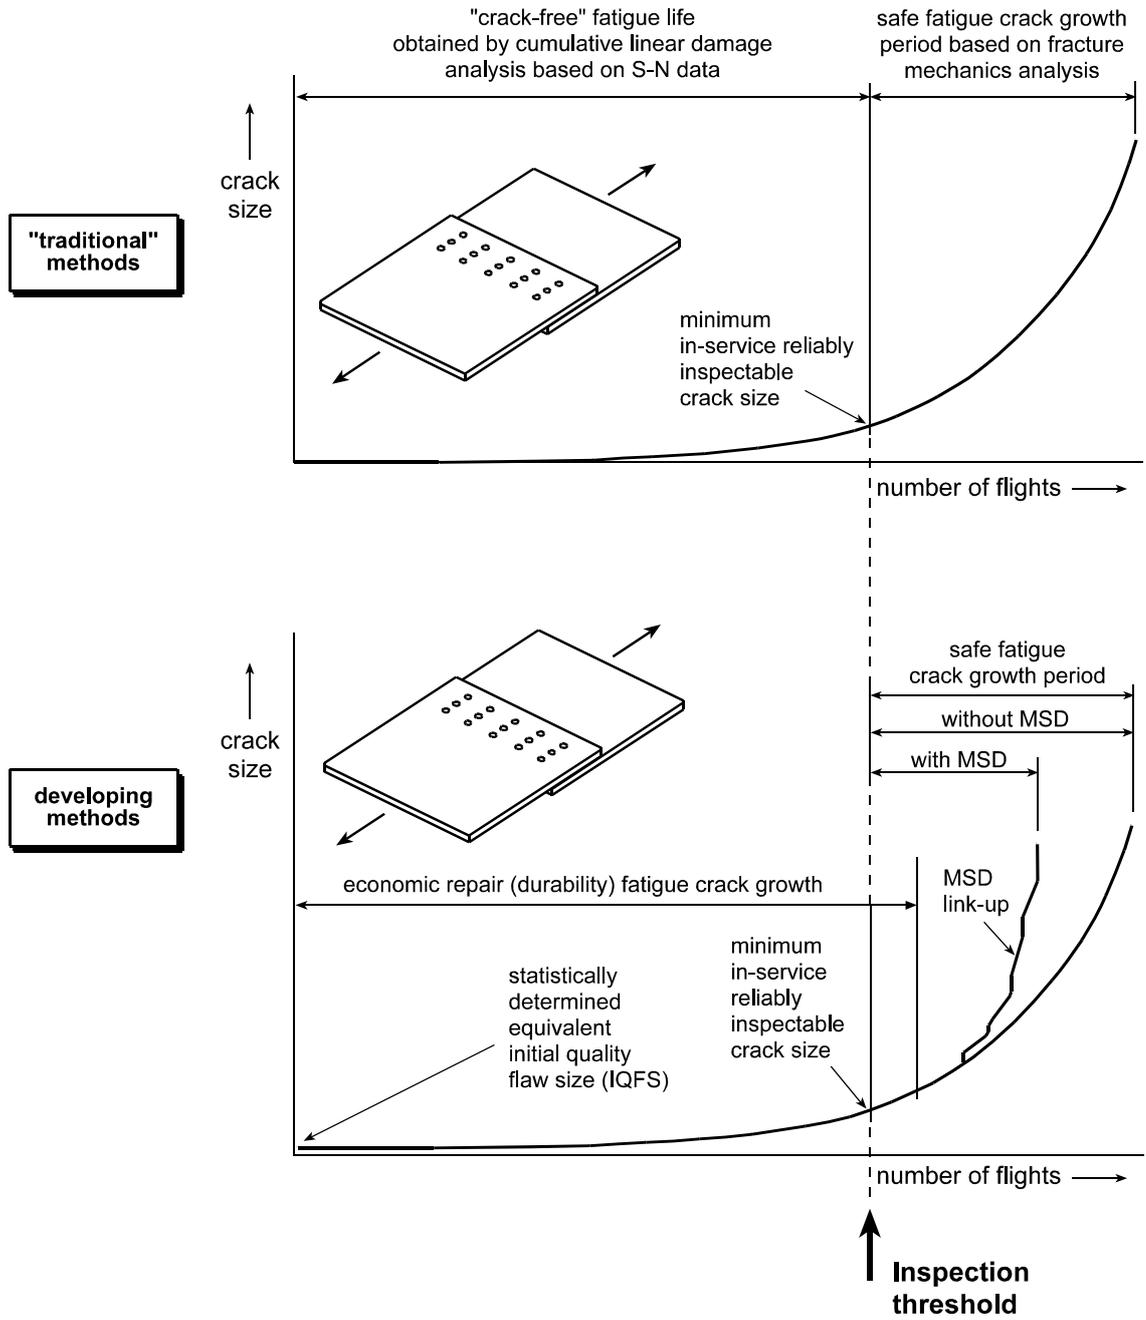
(1) Analysis methods: Figure 22 shows the “traditional” and developing fatigue analysis methods for transport aircraft fuselage lap splices:

Fig. 22 Fatigue analyses for transport aircraft fuselage lap splices

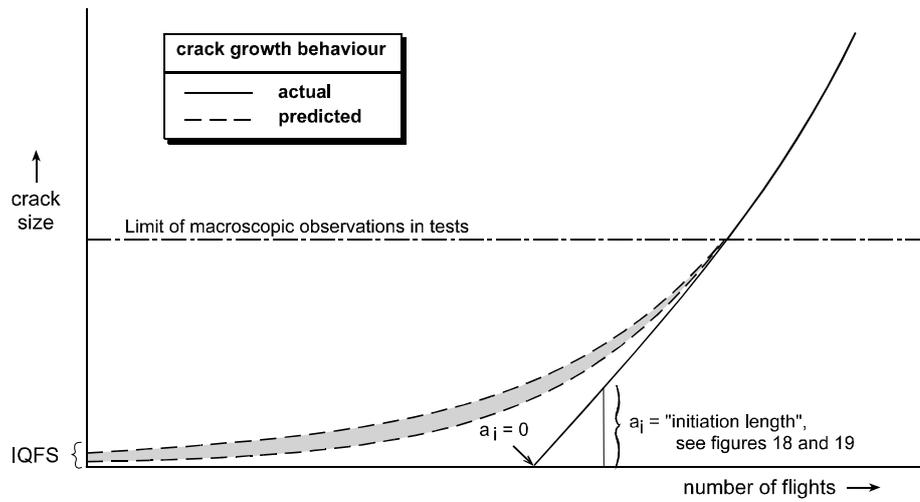
- (2) Analysis problems of actual versus predicted behaviour: Figure 23 is a schematic of the likely differences between actual early MSD crack growth behaviour, as described in the present paper, and predictions using macroscopic (long) crack growth modelling, whereby the IQFS values are obtained either from actual data for manufacturing flaws or by back-extrapolation using a long crack growth model.

Fig. 23 Schematic of differences between actual and predicted early crack growth behaviour in transport aircraft fuselage longitudinal lap splices: the predictions are fitted to the macroscopic observations and the IQFS values are obtained from actual manufacturing flaws or by back-extrapolation using a macroscopic (long) crack growth model
