Failure analysis of metallic materials: a short course

NLR-TP-2010-550

February 2011

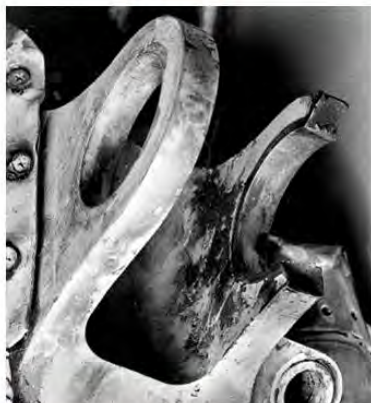
Inboard

- Inner lug bent
- Outer lug failed by tensile + bending overload

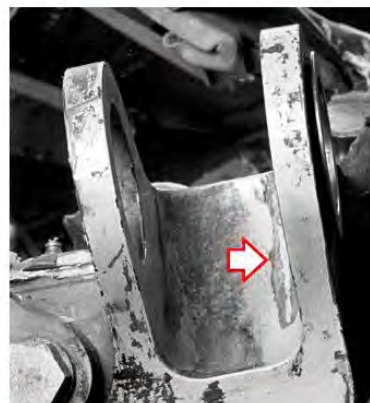
Outboard

- Scraping in lug throat

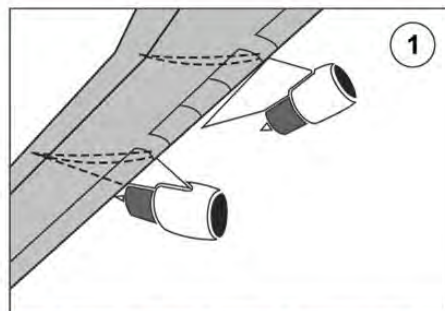
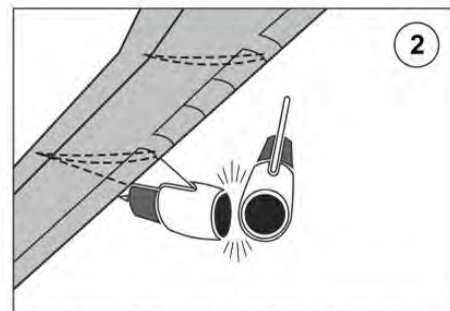
Separation of engines 3 and 4

● Engine 3 and pylon separation

● Engine 3 collision with engine 4

- Both engines and pylons fell into the Gooimeer lake (see slide 32)

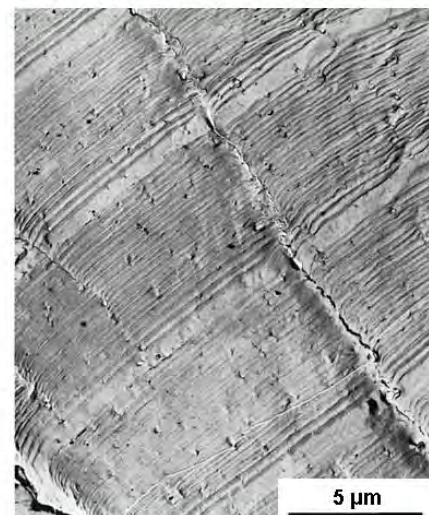
Postscript - II: “fuse pin” fatigue fracture surface

- The OEM suggested that the large striations in slide 44 represent only the large striations shown opposite
- This implied that
 - on a cycle-by-cycle basis the crack growth in the fuse pin remnant was much slower than a striation count from slide 44 would indicate
 - the aircraft operator should therefore have detected the cracked fuse pin before failure
- However, the fractograph shown here is for 2024-T3 aluminium alloy and was published already in 1967*

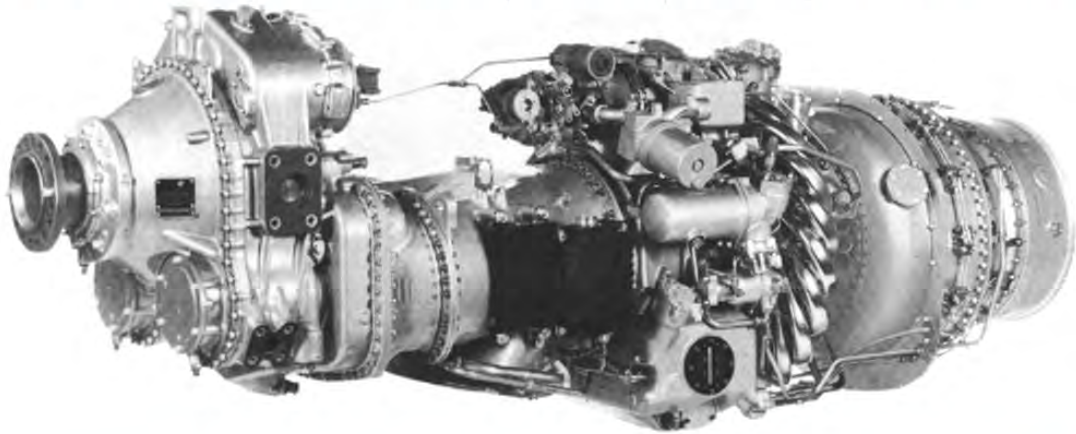
- Problem: No.2 engine torque indication dropped to zero and flight aborted

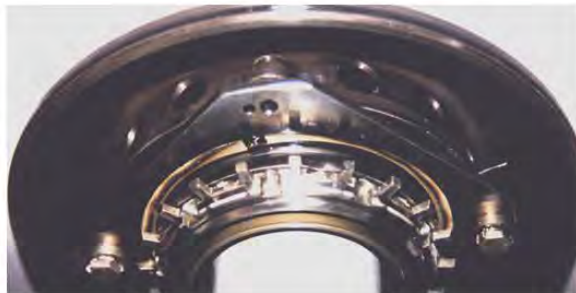
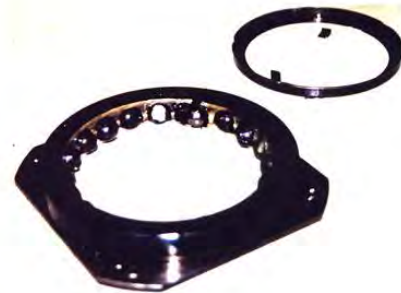
Partially disassembled No.3 bearing from the No.2 engine

- Investigation showed the bearing had failed, with extensive secondary damage: *engine internally destroyed*

- **Physical cause: undersize ball**
 - put into the race *during the previous overhaul*
 - unable to take loads, causing abnormal loads on adjacent balls and cage
- ↓
- fatigue in the cage ligaments on either side of the ball
 - cage failure and expansion to rub on the outer race
 - rubbing-induced overheating, causing lubrication loss and bearing failure
- **Remedial action: install new engine**

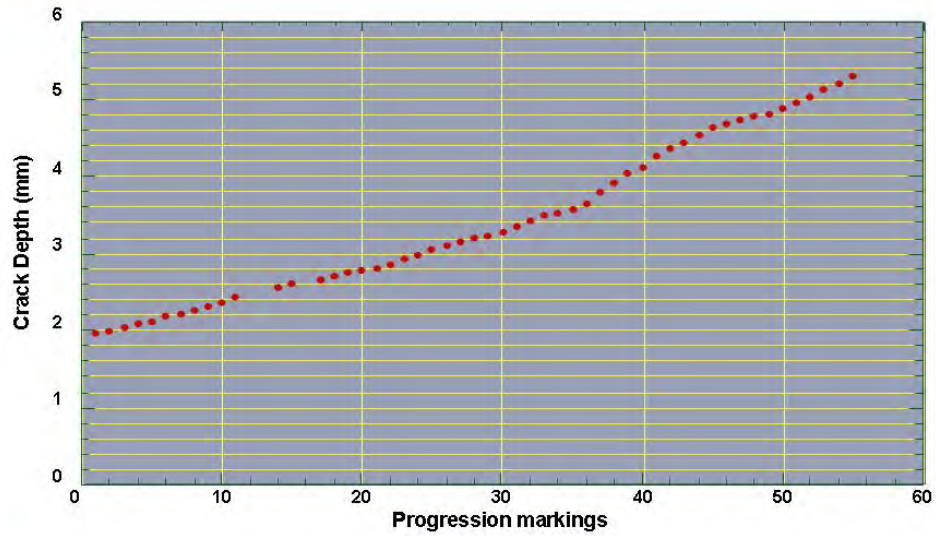
Cage failure details – II: Quantitative fractography (QF) results for the progression markings

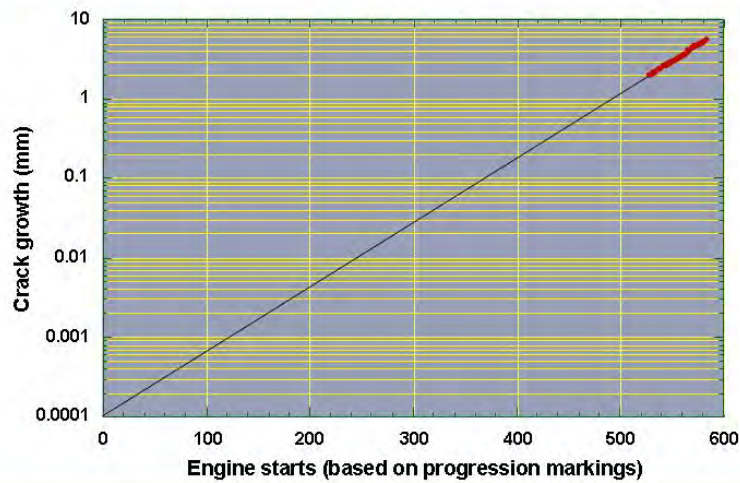
Cage failure details – III: QF suggested exponential crack growth ($a = a_0 e^{\lambda N}$ and $\ln(a) = \lambda N + \ln(a_0)$)

- Extrapolation to extremely small initial crack size, a_0 , gave an estimated crack growth life less than 600 engine starts:

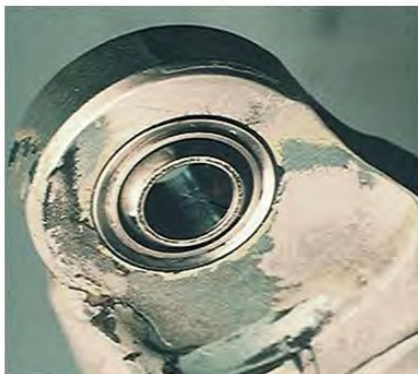
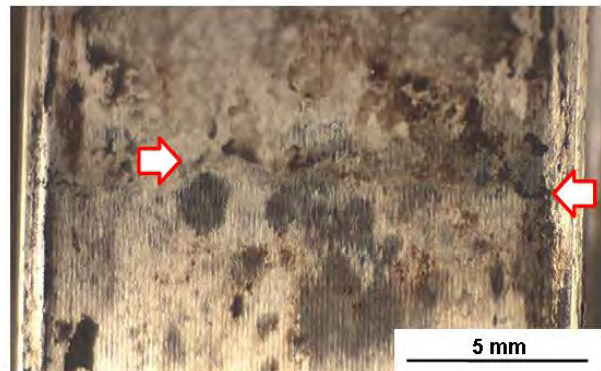
Examination of TEF hinges - I: A hinge lug + monoball bearing; and the bearing from the A21-009 failed lug

- A hinge lug and bearing showing deterioration of the corrosion protection system
- A21-009 monoball bearing outer surface with marking suggesting extent of sub-critical cracking just before lug failure

- Initial crack size assumed to be 0.1 mm. This is based on secondary cracks, e.g. slide 73
- Critical crack size derived from
 - (a) The marking on the A21-009 monoball bearing, see slide 69. This suggests a crack depth (along the bore) of 9 mm when the lug failed
 - (b) From the profile of the largest crack in the A21-015 lug, see slide 71, a critical crack depth of 9 mm corresponds to a critical crack length of 6.2 mm. This is shown in the schematic

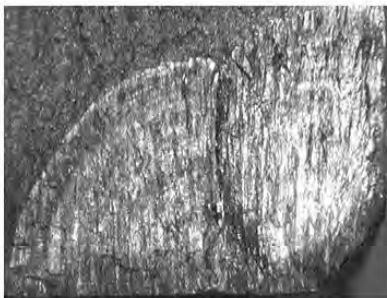
- A21-015 cracks (both sides of lug)

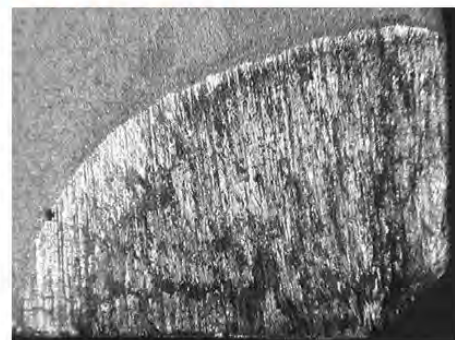
- A21-021 crack

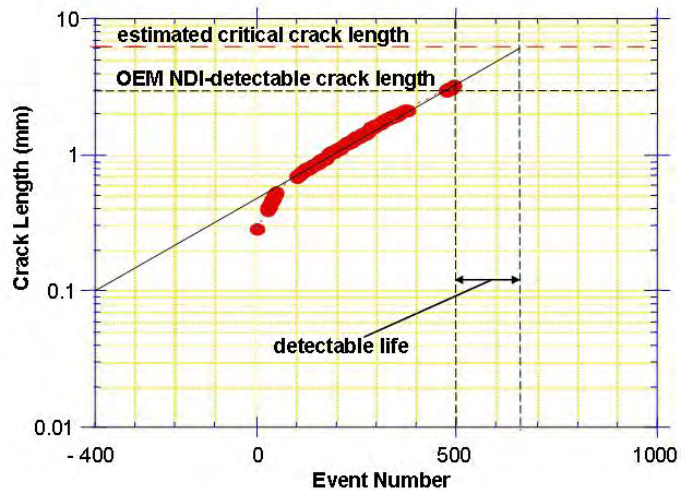
- Total crack growth life ~ 1060 events
- Detectable crack growth life ~ 160 events
- Assume 1060 events = 1377 flight hours, see slide 70.
- Then the detectable crack growth life is 208 flight hours and the inspection interval is ~ 100 hours
- This inspection interval is too short for service applications

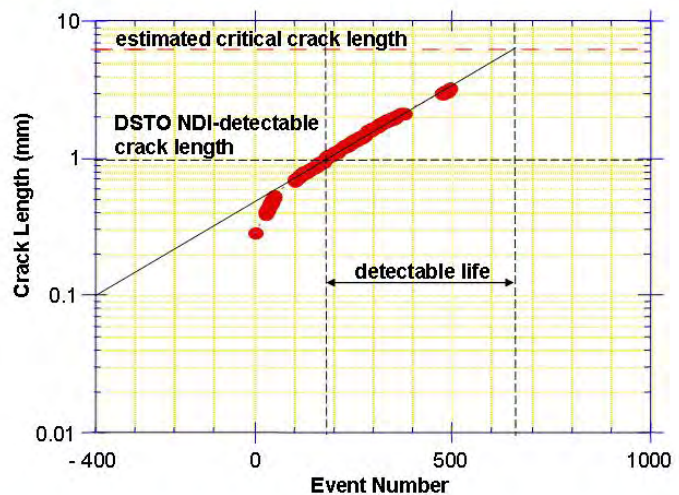
- Detectable crack growth life ~ 480 events
- Assume 1060 events = 1377 flight hours, as before
- Then the detectable crack growth life is 624 flight hours and the inspection interval is ~ 300 hours
- DSTO NDI method now used as supplementary inspection for TEFs on RAAF aircraft

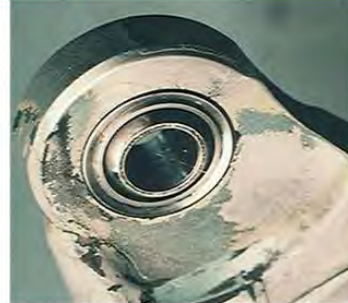
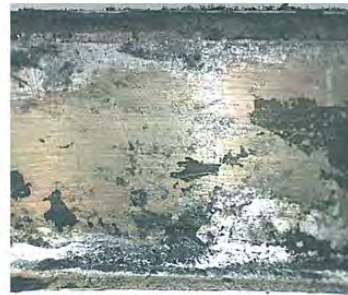
Corrosion protection improvement for the monoball bearing and TEF hinge lug assembly

- Inspect lugs for corrosion
- Chemically remove corrosion products
- Re-inspect for cracking
- Reapply chemical conversion coating
- Wet set monoball bearing
- Improve sealant around edges of bearing

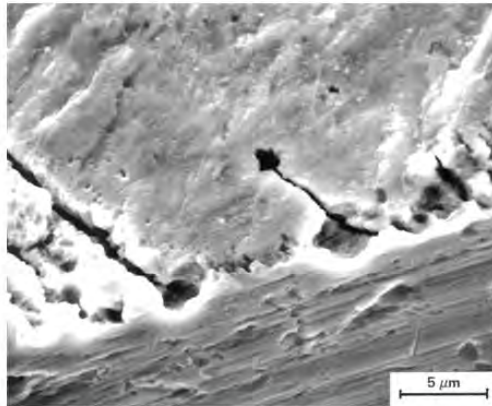
- Corrosion pits and slots starting from hole in pin head

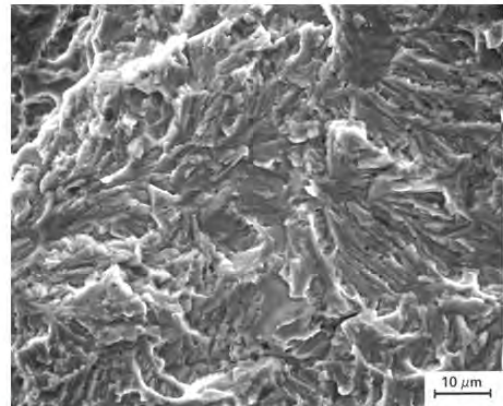
- Transgranular stress corrosion cracking (SCC)

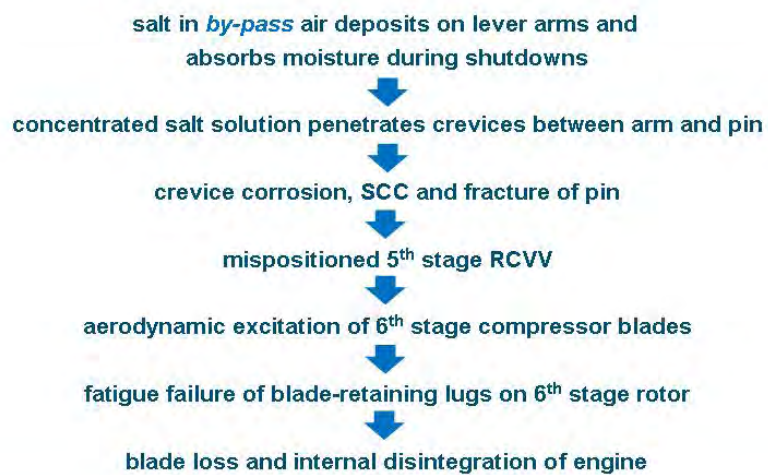
- Physical causes overview

- Nitronic 60 SCC susceptibility unknown to P&W before failure
- SCC in salt solution enabled by high residual stresses from cold-upsetting the pin head to attach it to the lever arm

- change pin material to Inconel 625 (immune to SCC in salt water)
- replace Inconel 718/Nitronic 60 assemblies by Inconel 718/Inconel 625:
 - change part number (PN)
 - frequent inspections of “old” assemblies until replacement complete
- scrap Inconel 718/Nitronic 60 assemblies

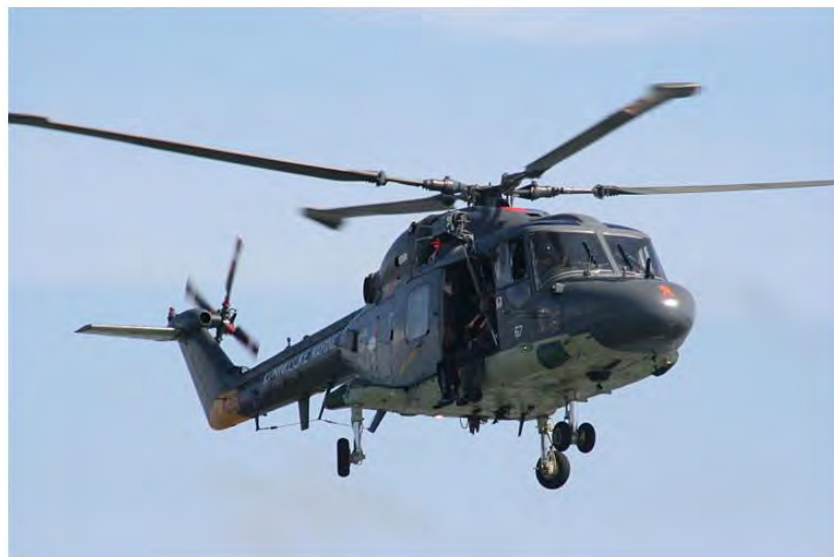
Aircraft *type*: Westland Lynx SH14D

Lynx-282 airframe wreckage after rotor hub failure

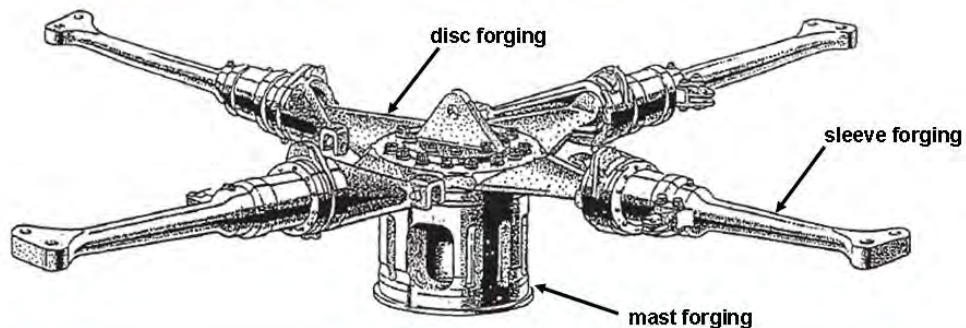
Causes of failure and remedial actions

- **Physical cause: too-high dynamic stresses → fatigue**
- **Contributing cause: inadequate fatigue design analysis**
- **Remedial action: new design rotor hub**
 - non-“monobloc” bolted-on arms
 - Ti-10V-2Fe-3Al β titanium alloy replacing Ti-6Al-4V
