NLR-TP-2001-273

## **Practical investigation of aircraft pressure cabin MSD and corrosion**

This report is based on a paper held at the 5<sup>th</sup> Joint NASA/FAA/DoD Conference on Aging Aircraft, HYATT-Orlando, Florida, September 2001.

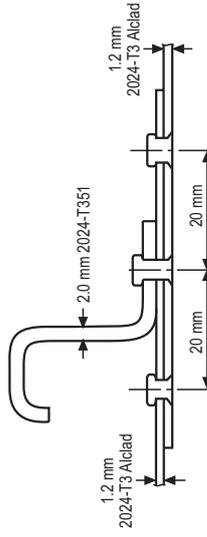
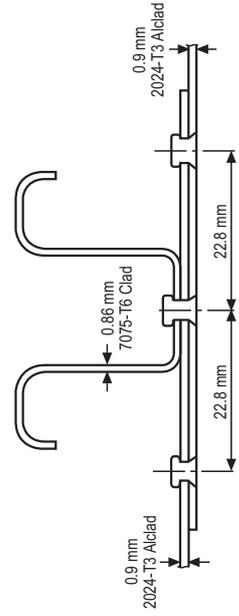
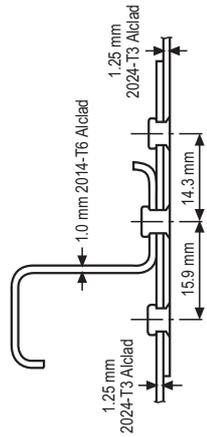
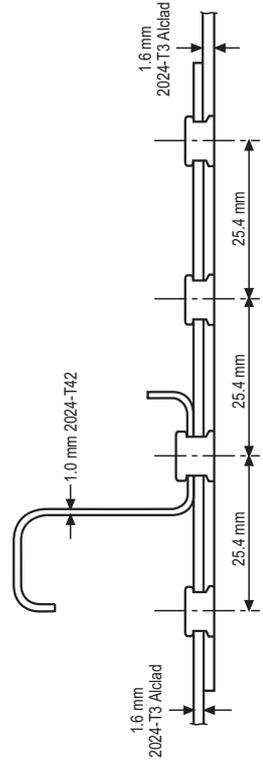
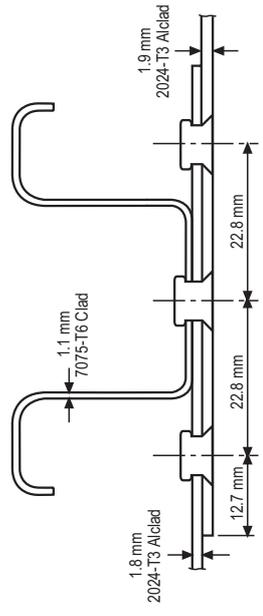
Fig. 1 Configurations of the lap splices. MSD fatigue: F28 Mk4000, F100, BAC 1-11, B747-400, B737-200. Corrosion: F28 Mk 1000, B727-100

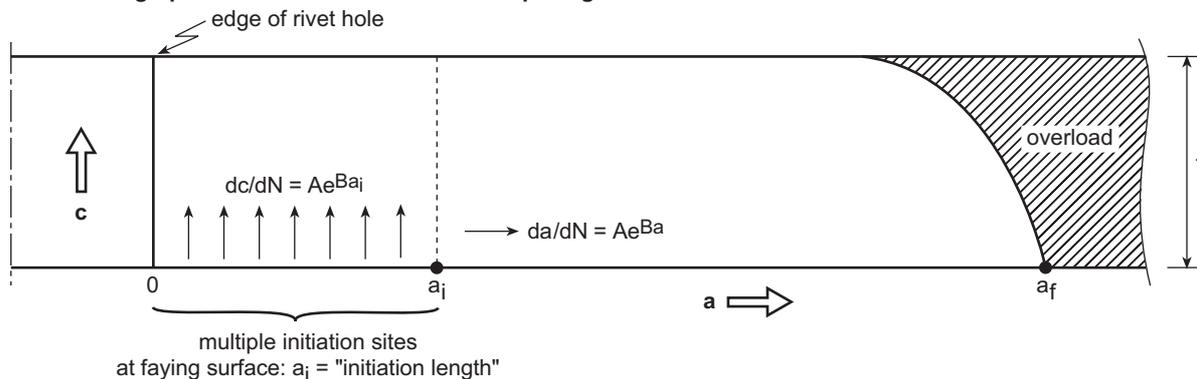
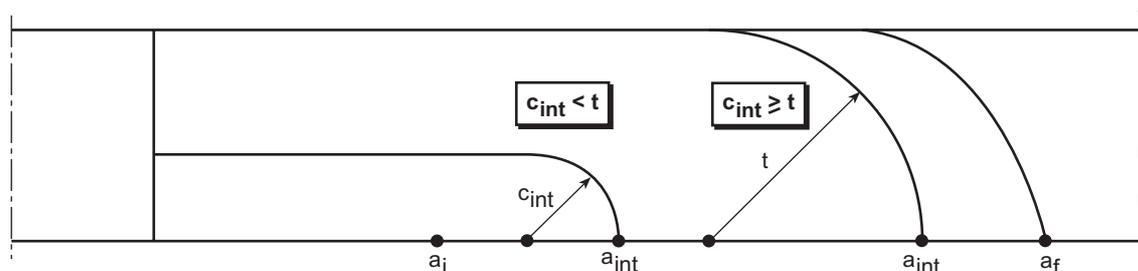
Fig. 6 Eijkhout's empirical model illustrated for a non-countersunk sheet and multiple fatigue initiation sites

Figure 6 shows the model, which is based on (1) MSD fatigue cracks initiating at several sites near or at rivet hole corners, and (2) nearly constant transverse (through-thickness) crack growth rates and initially similar transverse and longitudinal crack growth rates, see figure 3.

and for crack initiation at rivet hole corners, i.e.  $a_i = 0$  in figure 6. Also the model can be used for both non-countersunk and countersunk lap splice sheets.

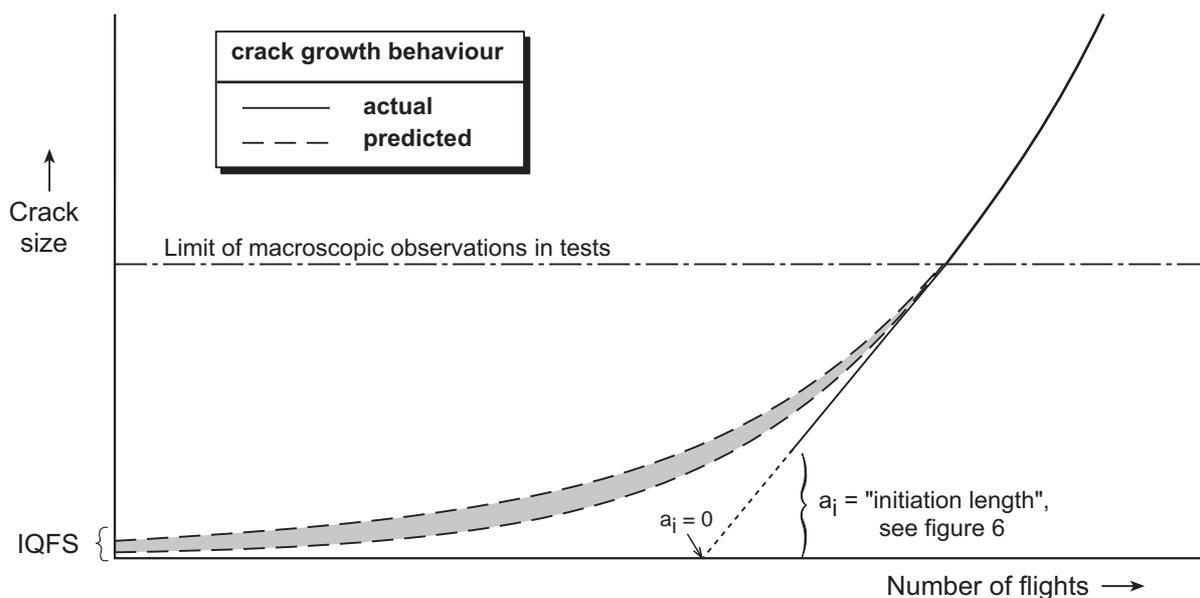
Figure 7 shows schematically the probable differences between actual early MSD fatigue crack growth and predictions that fit crack growth models to the IQFS values, using back-extrapolation because of the limit of macroscopic observations of crack growth during tests. The major incongruity is the modelling assumption that regular crack growth begins immediately, i.e. there is no fatigue “initiation” life. This assumption is incorrect. Table 2 gives estimates of the MSD fatigue “initiation” lives for the BAC 1-11 service aircraft and the F100 and B747-400 full-scale tests. The lives to first crack “initiation” are significant fractions of the total lives, bearing in mind that B747-type aircraft were designed for a service life of 20,000 flights. Thus it would seem inadvisable to discount or ignore the fatigue “initiation” life, however arguable its definition.

Fig. 7 Schematic of differences between actual and predicted early crack growth behaviour in transport aircraft fuselage longitudinal lap splices: the predictions are fitted to the macroscopic observations and the IQFS values are obtained from actual manufacturing flaws or by back-extrapolation using a macroscopic (long) crack growth model
