Fractography-based estimation of fatigue crack "initiation" and growth lives in aircraft components

NLR-TP-2006-184

R.J.H. Wanhill
T. Hattenberg

December 2006

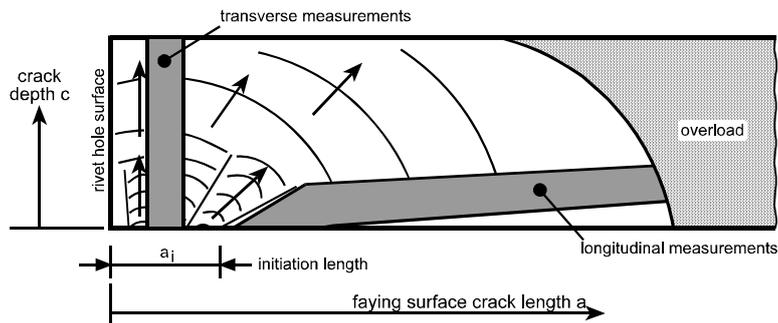
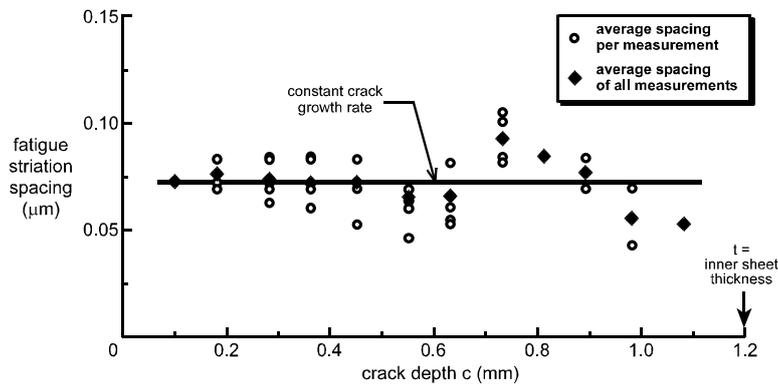
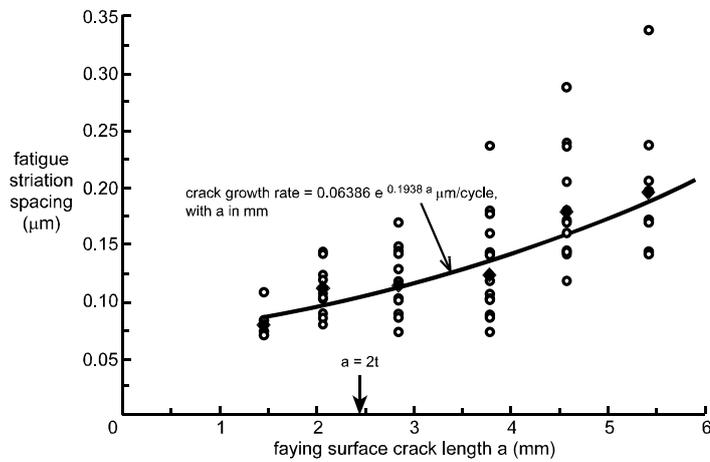
- (1) MSD fatigue cracks tended to initiate at several sites close to the rivet holes, and grew in directions varying gradually from transverse to longitudinal, see the top diagram in figure 3.
- (2) The transverse (through-thickness) striation spacings (and hence fatigue crack growth rates) were virtually constant, see the upper graphic in figure 3.
- (3) Transverse and longitudinal striation spacings (and hence fatigue crack growth rates) were similar for crack dimensions less than twice the sheet thickness: compare the graphics in figure 3.

Figure 3 Example of striation measurements in selected directions: MSD crack from the faying surface of a pressure cabin longitudinal lap splice (Wanhill et al. 2001)^[7]. Note the multiple initiations constituting an initiation “length”

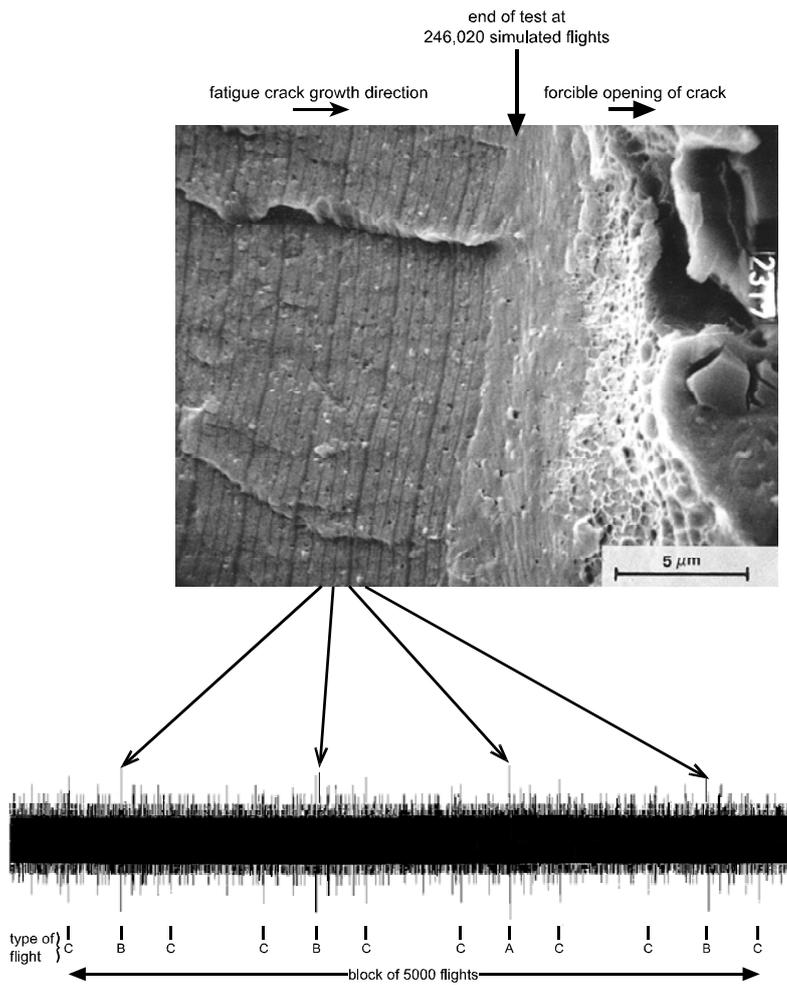
Figure 12 Illustration of the fatigue “striation” pattern owing to repeated blocks of 5000 simulated flights in the gust spectrum loading of a vertical stabilizer (Hattenberg 1994)^[17]

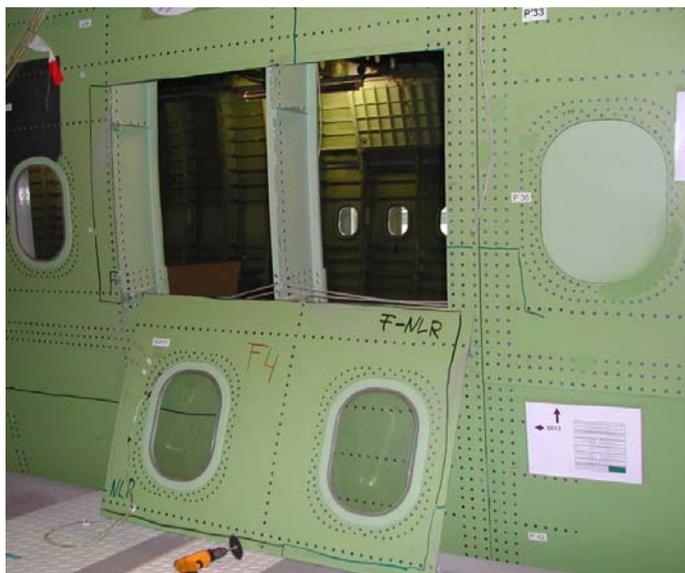
Figure 14 GLARE window area cut from the MLB

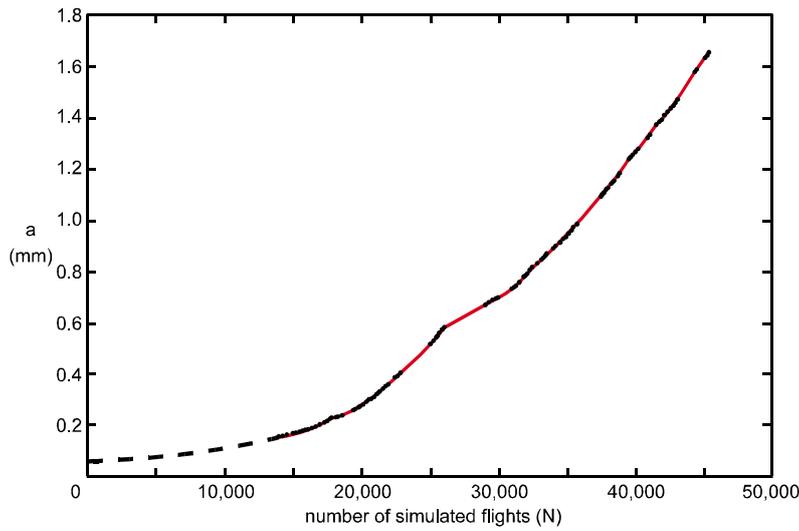
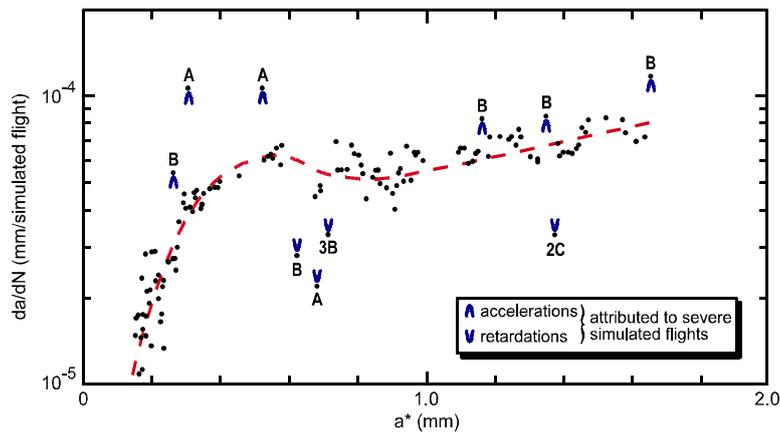
Figure 16 Crack growth curves for the largest fastener hole crack in either of the window frames. The material was die forged aluminium alloy 7175-T73

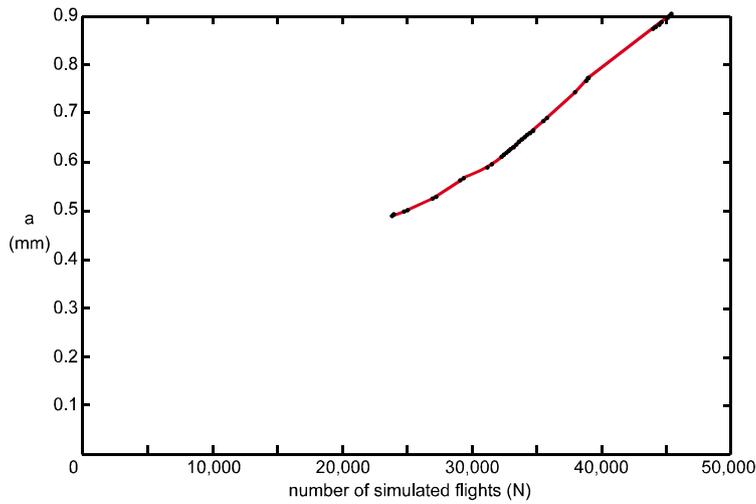
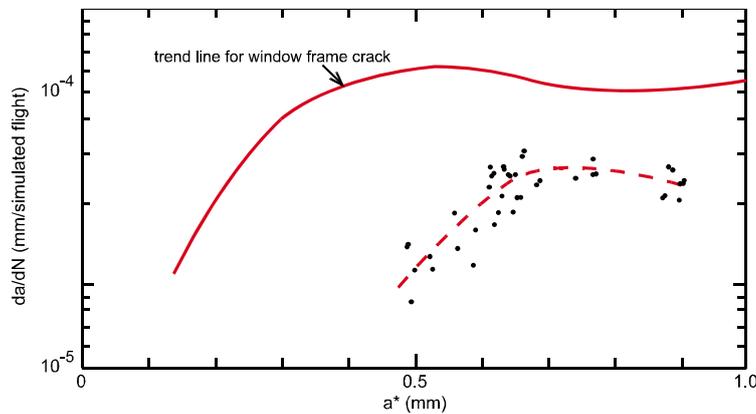
Figures 17a and 17b present the crack growth curves. The data are limited, but sufficient to show that the “plateau” crack growth rates were about 50% of those in the aluminium window frame.

Back-extrapolation of the *a versus N* curve in figure 17a is unfeasible, owing to the limited data. Hence an estimate of the fatigue “initiation” life is not possible.

Figure 17 Crack growth curves for the largest “readable” fastener hole crack in an aluminium layer of the GLARE skin. The material was 0.3mm 2024-T3 sheet

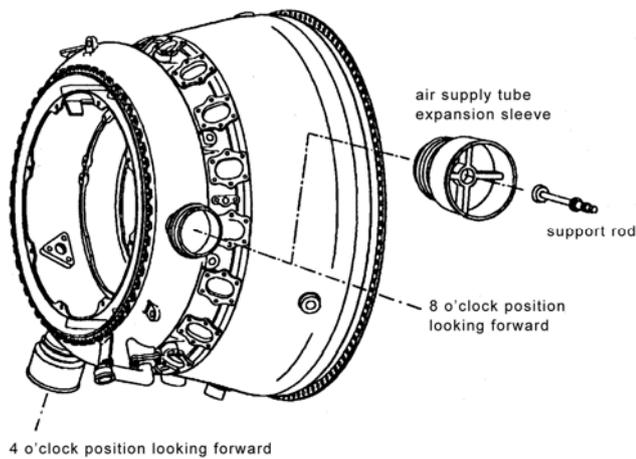
Bending fatigue failure occurred in a support rod linking the bleed air supply manifold to the diffuser case in a military jet engine. Figure 18 shows the location of the support rod with respect to the diffuser case, and table 4 gives the engine operating history.

Figure 18 Diffuser case and one air supply tube expansion sleeve and a support rod (broken in the incident engine)

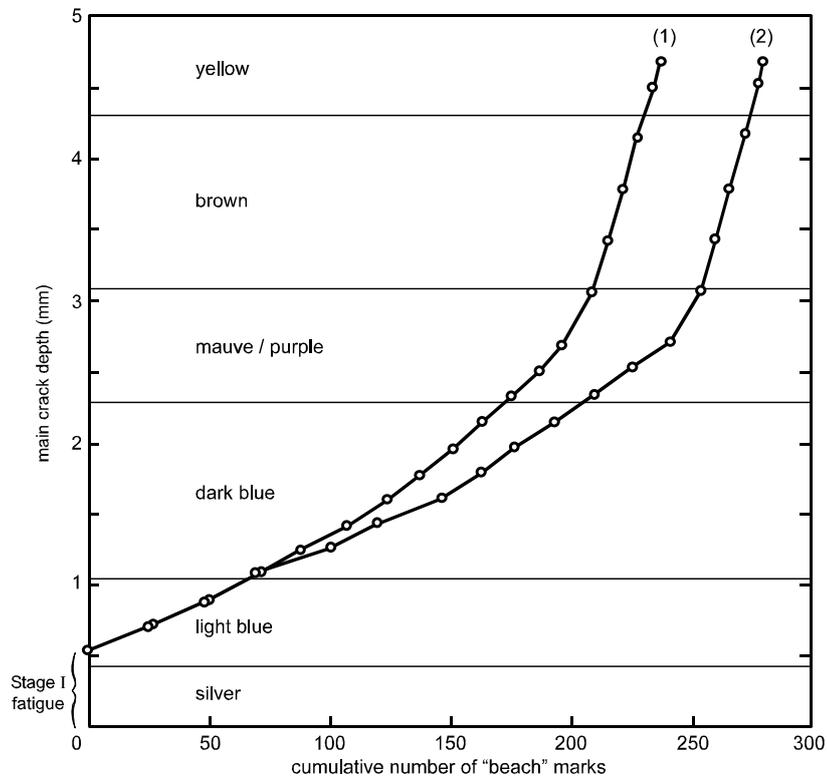
The “beach” marks were counted by two independent fractographers. Figure 20 shows the results related to the main crack depth and the broad divisions of interference colours. If the “beach” marks were to correspond to start-stop cycles of the engine, then figure 20 would indicate a Stage II fatigue crack growth life of about 250 flights.

Figure 20 Cumulative number of "beach" marks for the Stage II fatigue region of the main fatigue fracture surface of the broken rod. (1) and (2) are independent measurements by two fractographers
