NLR TP 96719

Fatigue and Fracture in an Aircraft Engine Pylon

R.J.H. Wanhill and A. Oldersma

FATIGUE AND FRACTURE IN AN AIRCRAFT ENGINE PYLON

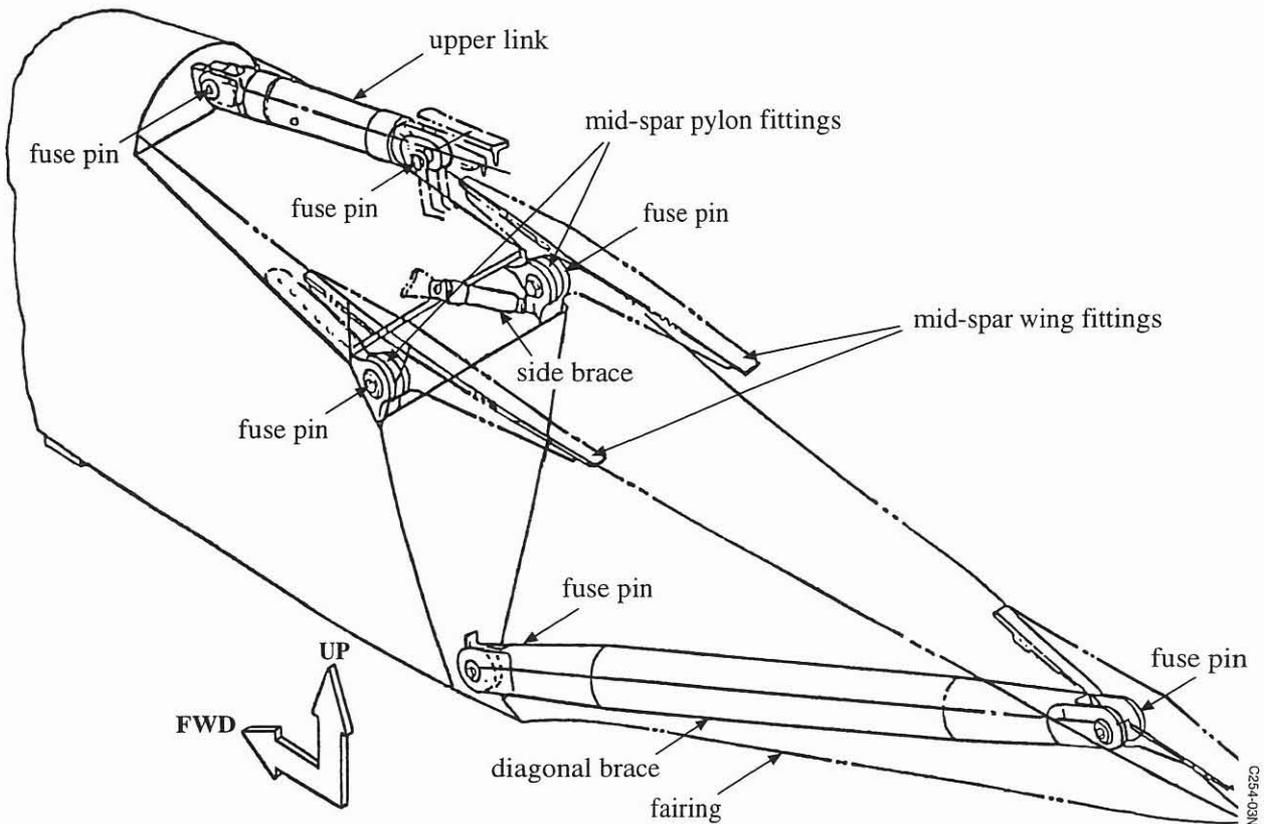
Figure 1 Pylon-to-wing connections: for the #3 pylon the left-hand side is inboard.

Figure 1 is a schematic of the engine pylon-to-wing connections. These connections are at the aft end of the upper link, the aft end of the diagonal brace, and at the two mid-spar fittings. The design incorporates six "fuse pins" which are less strong than other parts of the connections. If extreme loads occur on an engine and pylon, for example during extreme turbulence or an emergency landing, the fuse pins are supposed to shear off and allow a clean separation from the wing, thereby precluding damage to the wing and possible rupture of the wing fuel tank. However, as found in the present case, and at least one other, engine and pylon separation was accompanied by severe damage to the wing leading edge.
