Teardown of a GLARE window area from the Airbus MegaLiner Barrel fatigue test article

NLR-TP-2006-183

R.J.H. Wanhill
D.J. Platenkamp
T. Hattenberg
A.F. Bosch

April 2006

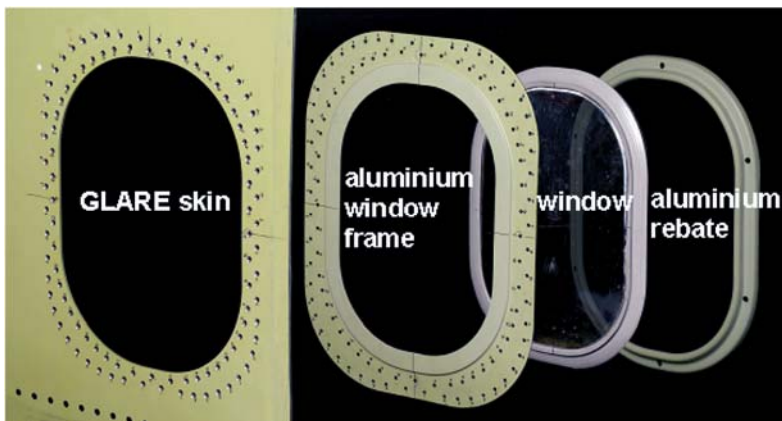
Figure 2 Example of a disassembled window

The Hi-Lok fasteners were carefully removed for the first eddy current inspections and C-scan mapping. Then the aluminium window frames needed to be separated from the GLARE skin. This was done by using small plastic wedges carefully driven between the aluminium window frames and the GLARE skin. Figure 2 illustrates the fully disassembled parts.

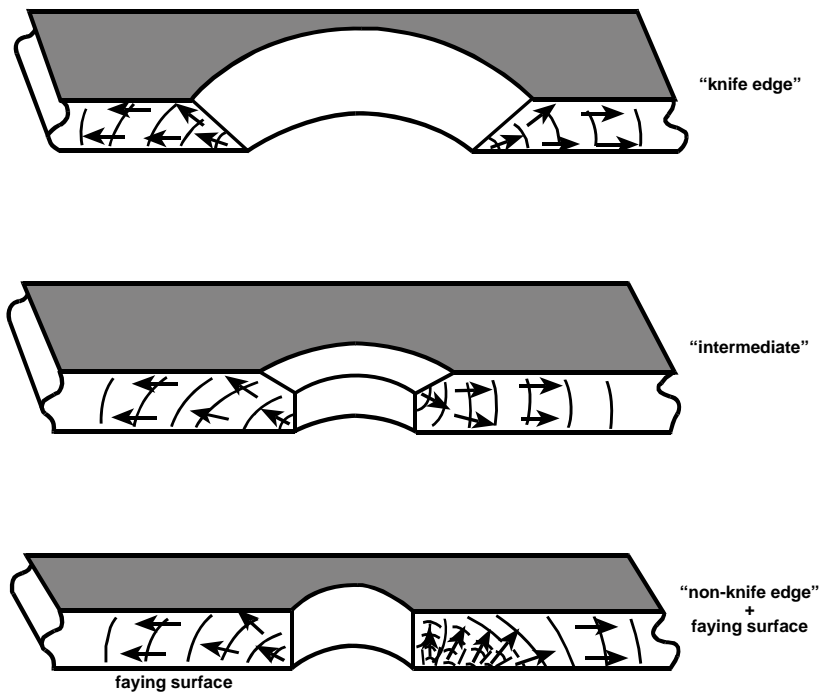
Figure 3 shows several fatigue initiation possibilities in the GLARE aluminium layers. The “intermediate” and “non-knife edge” types can be detected with a cylindrical rotor probe. Fatigue cracks that initiate at “knife edges” require special countersink probes: otherwise, the countersink inspections follow the same procedure as the rotor probe inspections. The countersink probe was 3/16" in diameter and operated at 300 kHz and 1000 – 1500 RPM.

Figure 3 Schematic of possible fatigue initiation and growth sites in GLARE : crack length, a , is along the aluminium layers

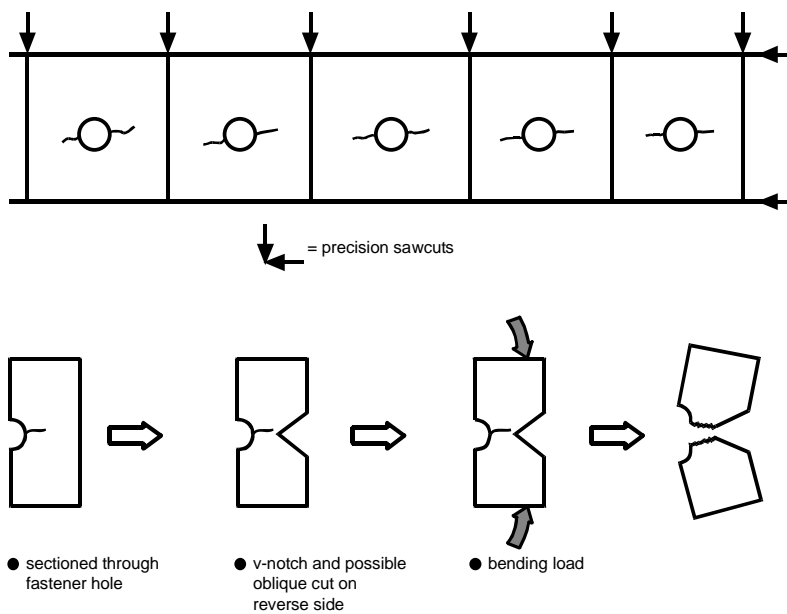
Figure 4 shows the procedure for opening up cracks in GLARE. NDI-indicated fastener holes are removed with a jeweller’s saw. These are sectioned through the holes, v-notched, and obliquely cut into (if there are uncracked aluminium layers) before bending to failure. In this way the glass fibre resistance to fracture can be minimised and there is less risk of distorting the aluminium layers. The same procedure was used for the aluminium window frames.

Figure 4 Procedure for opening GLARE cracks
