NDI and teardown fractography of a GLARE window panel (F4) from the Airbus MegaLiner Barrel (MLB) fatigue test.

NLR-TP-2006-183

**Teardown of a GLARE window area from the Airbus MegaLiner Barrel
fatigue test article**

The MegaLiner Barrel (MLB) test was done to study the fatigue behaviour of a double-deck fuselage configuration. The test was part of the Airbus 380 development programme, and was discontinued after 45,402 simulated flights. The NLR is carrying out teardowns and supplemental fatigue tests of GLARE (GLASS REinforced aluminium laminate) panels from several key locations of the MLB. This paper describes the teardown of a GLARE window area. The teardown began with Non-Destructive Inspection (NDI), and was followed by fractographic investigation of the NDI-indicated cracks. The teardown had the following main objectives, which were largely achieved:

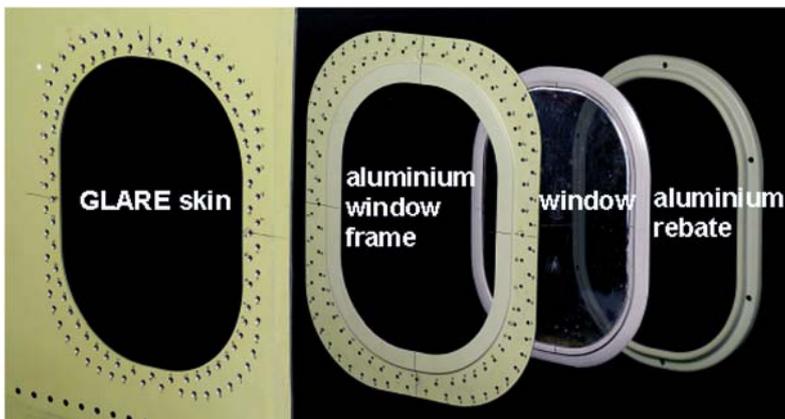
Figure 2 Example of a disassembled window

The Hi-Lok fasteners were carefully removed for the first eddy current inspections and C-scan mapping. Then the aluminium window frames needed to be separated from the GLARE skin. This was done by using small plastic wedges carefully driven between the aluminium window frames and the GLARE skin. Figure 2 illustrates the fully disassembled parts.

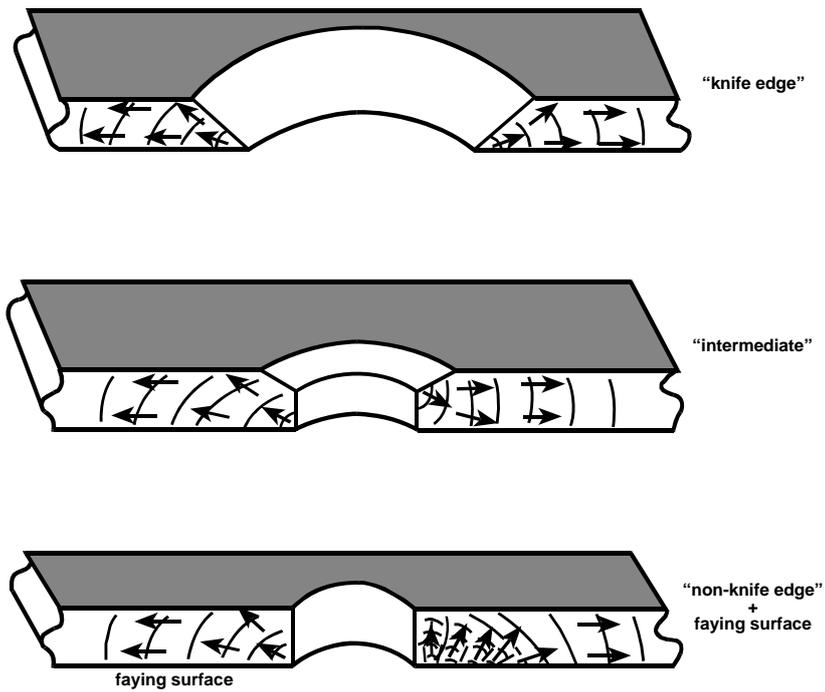
Figure 3 Schematic of possible fatigue initiation and growth sites in GLARE : crack length, a , is along the aluminium layers

Figure 3 shows several fatigue initiation possibilities in the GLARE aluminium layers. The “intermediate” and “non-knife edge” types can be detected with a cylindrical rotor probe. Fatigue cracks that initiate at “knife edges” require special countersink probes: otherwise, the countersink inspections follow the same procedure as the rotor probe inspections. The countersink probe was 3/16" in diameter and operated at 300 kHz and 1000 – 1500 RPM.

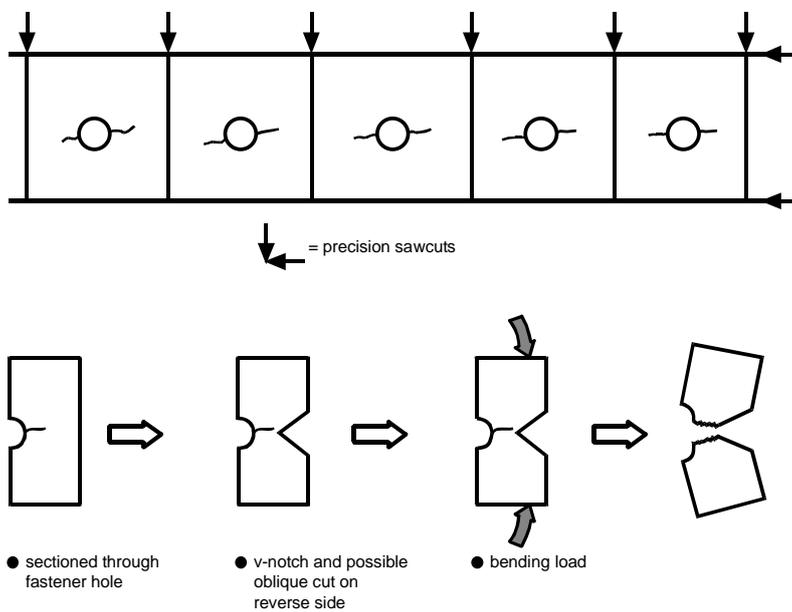
Figure 4 Procedure for opening GLARE cracks

Figure 4 shows the procedure for opening up cracks in GLARE. NDI-indicated fastener holes are removed with a jeweller’s saw. These are sectioned through the holes, v-notched, and obliquely cut into (if there are uncracked aluminium layers) before bending to failure. In this way the glass fibre resistance to fracture can be minimised and there is less risk of distorting the aluminium layers. The same procedure was used for the aluminium window frames.
