NLR-TP-2002-048

## **Thermal testing of low porosity microcracked thermal barrier coatings**

M.F.J. Koolloos and M.J.W. Schouten\*

Customer: National Aerospace Laboratory NLR

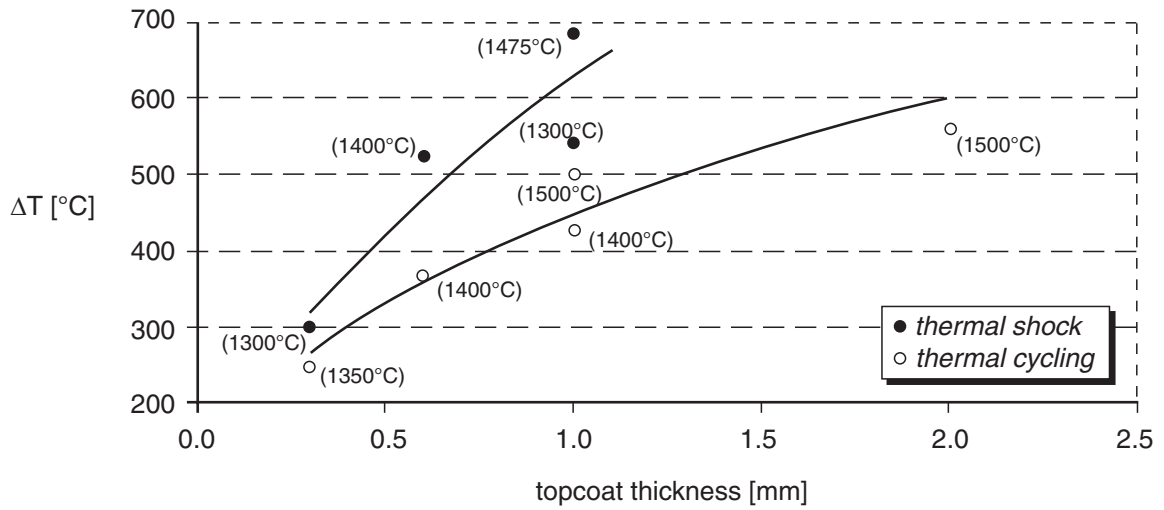
Figure 1 shows a measure of the through thickness temperature differences in the strips tested with the burner rig. As expected, the temperature difference between the top coat surface and the substrate rear side,  $\Delta T = T_{\text{surf}} - T_{\text{sub}}$ , increased with increasing top coat thickness and was larger during the thermal shock tests. Also, the data for the 1 mm thick top coats show that the thermal barrier effect was greater for greater heat input, i.e.  $\Delta T$  increased with increasing  $T_{\text{surf}}$  for both types of test.

Fig. 1 Temperature difference ( $\Delta T = T_{surf} - T_{sub}$ ) during the beginning of each burner rig test, plotted against topcoat thickness. The temperature values are the corresponding surface temperatures of the topcoats. For thermal shock tests  $\Delta T$  is at 30 s from starting a cycle, while for thermal cycling  $\Delta T$  represents steady-state conditions

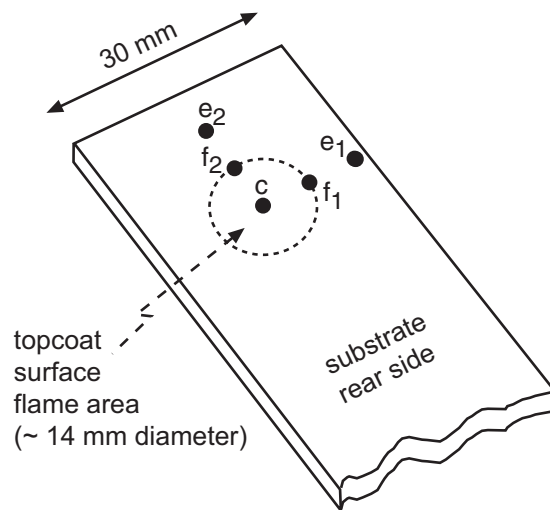
Figure 2 gives an example of radial temperature profiles measured with thermocouples on the substrate rear side during a burner rig test. The temperature decrease towards the top edge of the strip (c-f2-e2) is larger than that across the strip (c-f1-e1), namely 200 °C compared to 100 °C. This is explicable (generically, for all tests) because the distance between e2 and the top edge is larger than that between e1 and the side edge. This means there is more material between the flame area and the top edge to act as a heat sink.

Substrate rear side	
Location	$T_{sub}$ (°C)
c	1006
f <sub>1</sub>	976
e <sub>1</sub>	906
f <sub>2</sub>	936
e <sub>2</sub>	800

Fig. 2 Example of radial temperature profiles at the substrate rear side during a burner rig test. This example is for a topcoat thickness of 0.3 mm, heating time 30 s and  $T_{surf} = 1300^\circ\text{C}$ . The locations  $f_1$  and  $f_2$  and  $e_1$  and  $e_2$ , are equidistant from the centre of the topcoat surface flame area,  $c$
